Strathprints Institutional Repository

This version is available at <http://strathprints.strath.ac.uk/57788/>

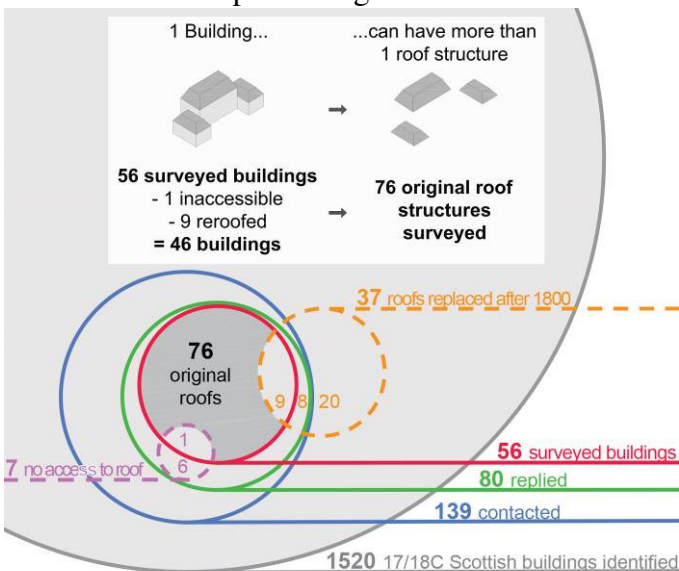
Figure 1. The key buildings' selection process

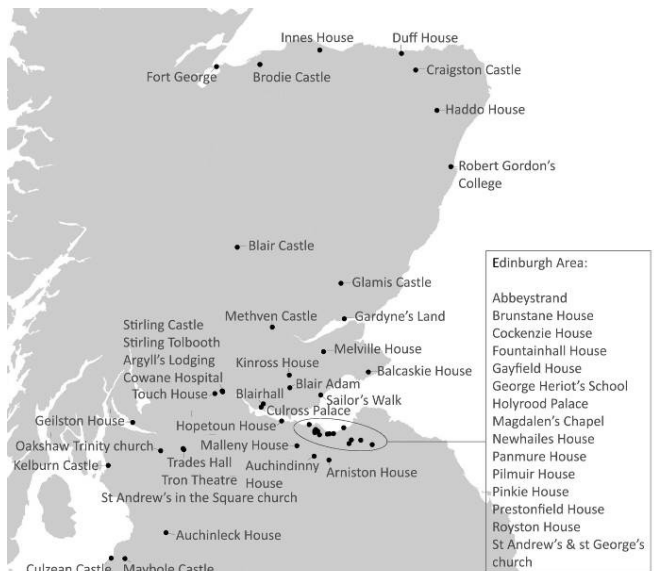
Figure 2. The 56 buildings surveyed across Scotland

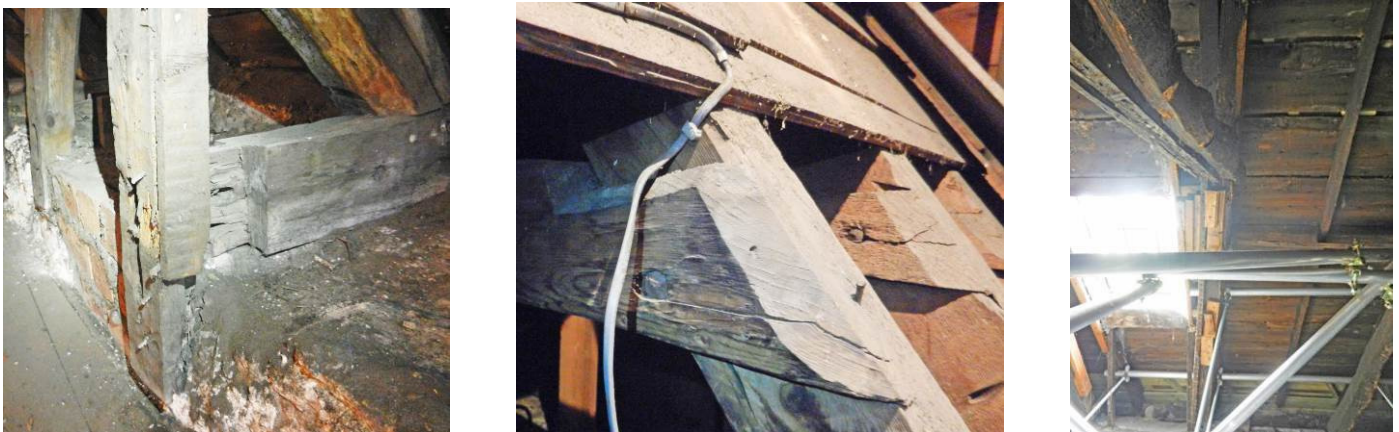
Figure 5. Mechanical damage in common rafter roofs. From left to right: joint disconnection in Sailor's Walk (Kirkcaldy, Fife), joint splitting in Touch House (St Ninians, Stirling), stacking up in Geilston House (Cardross, Argyll and Bute).

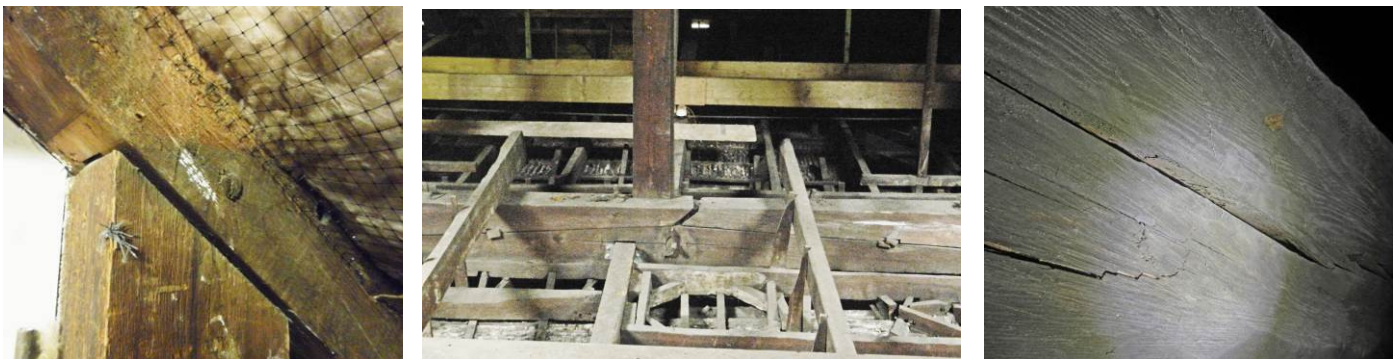
Figure 6. Mechanical damage in Trussed roofs. From left to right: joint disconnection in Fort George Ordnance Store (Ardersier, Highland), joint disconnection in Oakshaw Trinity Church (Paisley, Renfrewshire), crack in rafter in Glasgow Trades Hall.

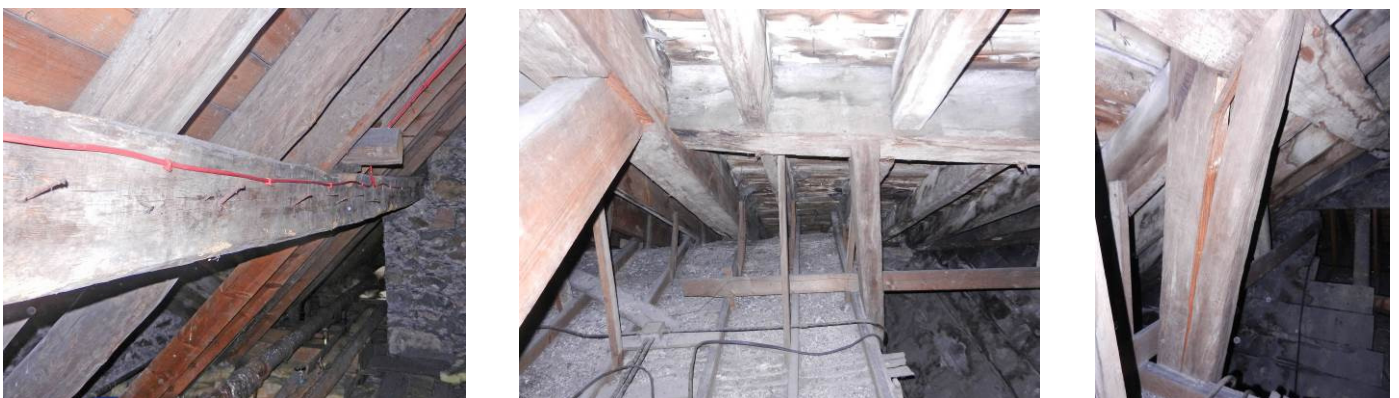
Figure 7. Mechanical damage in purlin roofs. From left to right: deflected purlin in Melville House (Monimail, Fife), deflected purlin in Touch House (St Ninians, Stirling), crack in strut in Touch House (St Ninians, Stirling).
