Soft novel form of white-etching matter and ductile failure of carbide-free bainitic steels under rolling contact stresses

W. Solano-Alvarez^{a,*}, E.J. Pickering^b, M.J. Peet^a, K.L. Moore^b, J. Jaiswal^c, A. Bevan^c, H.K.D.H. Bhadeshia^a

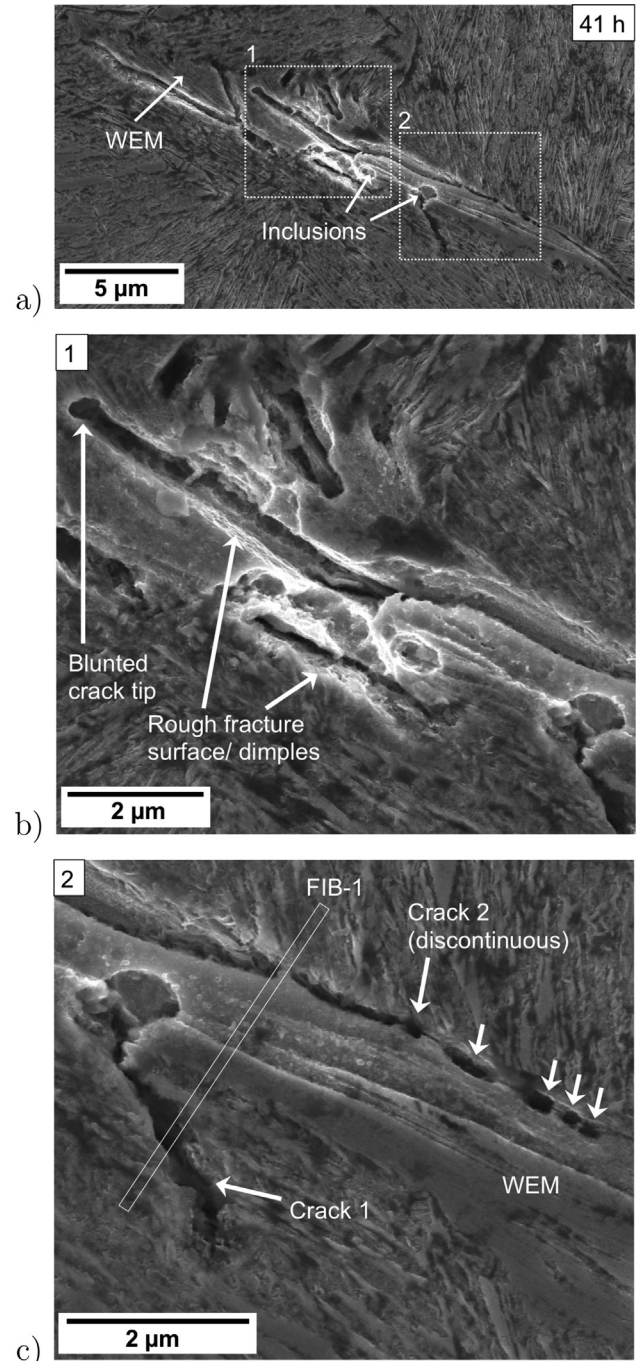
Fig. 2. Secondary electron SEM image of a) butterfly studied in the sample that ran for 41 h with b) detail of cracks in area 1 and c) location of the extracted lamella (FIB-1) in area 2.

The annotated images of the butterflies studied in the nanostructured bainite after rolling contact fatigue testing are presented in Figs. 2 and 3. In the butterfly present in the sample that lasted 41 h, a few different inclusions were observed but none of them seemed to be the origin of the butterfly cracks. It is likely that the main inclusion was either ground away during preparation or located further inside the material. Nonetheless, suspected WEM areas due to their distinct topography were still found along those cracks and a region was selected for FIB extraction (FIB-1). Despite etching artefacts, the shape of the first butterfly in the 948 h sample (Fig. 3a) is more conventional with just two cracks at opposite sides of the main inclusion. However, the total crack length and amount

A few important aspects to note about the cracks formed around inclusions are that they are discontinuous (Fig. 2c), have a misshapen appearance (Fig. 3c), possess dimples at the fracture surface, and have blunted tips (Fig. 2b). These features indicate ductile failure, unlike the well-documented brittle cracking at inclusions in conventional 1C-1.5Cr steels (Fig. 4a) [14]. The

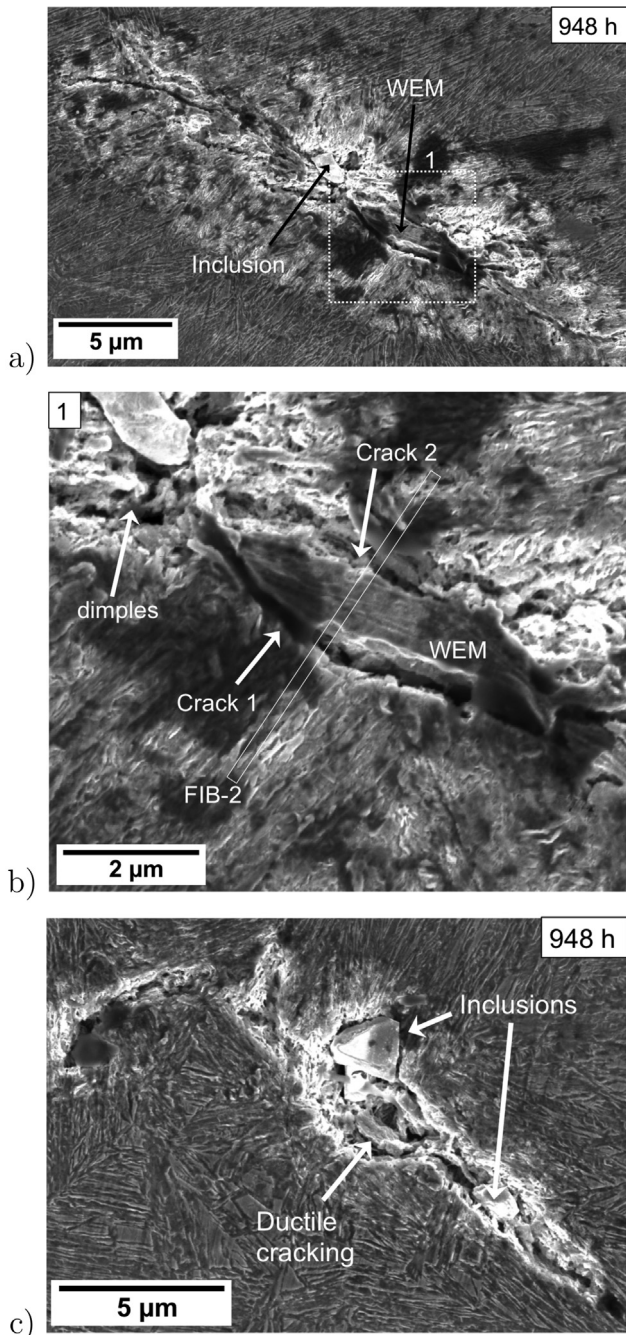
of WEM is similar to the one in the 41 h sample, possibly suggesting no progressive damage evolution due to the presence of WEM, a fact that could be attributed to its softness with respect to the matrix.

Fig. 3. Secondary electron SEM image of two butterflies (a and c) found in the sample that ran for 948 h with b) location of the extracted lamella (FIB-2) in area 1.

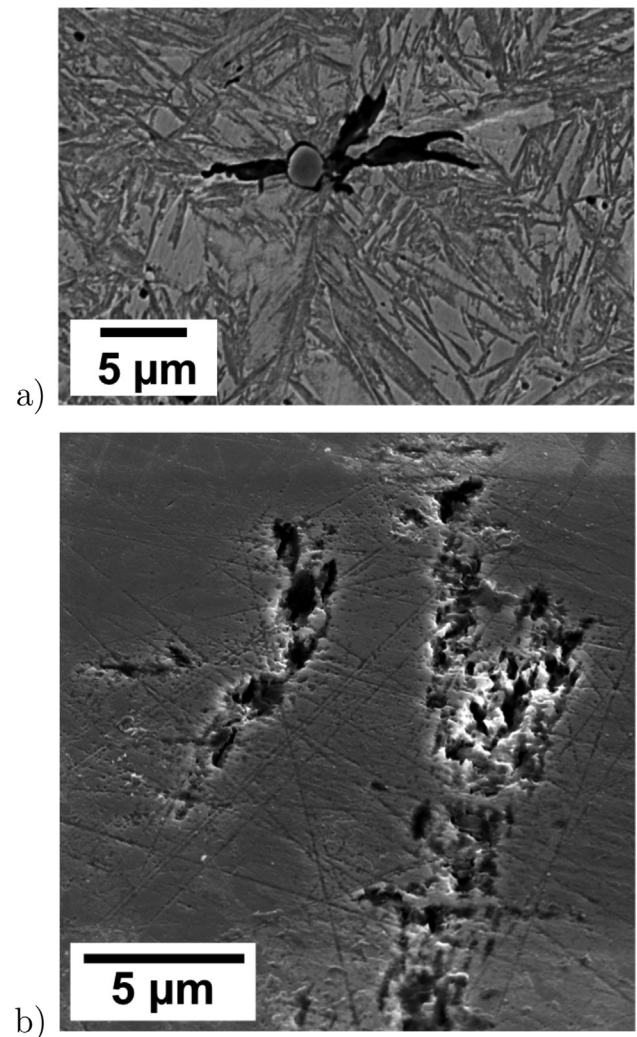
Fig. 4. Secondary electron SEM images of a) brittle butterfly cracks with sharp tips in a martensitic 1C-1.5Cr steel tested at 3.5 GPa using the same rod-ball RCF machine and b) void-coalesced crack in the nanostructured bainite sample that clocked 948 h showing ductile void formation and a lack of surrounding WEM. The sample was tilted 52° with respect to the electron beam to distinguish more clearly the misshapen appearance of the damaged region.

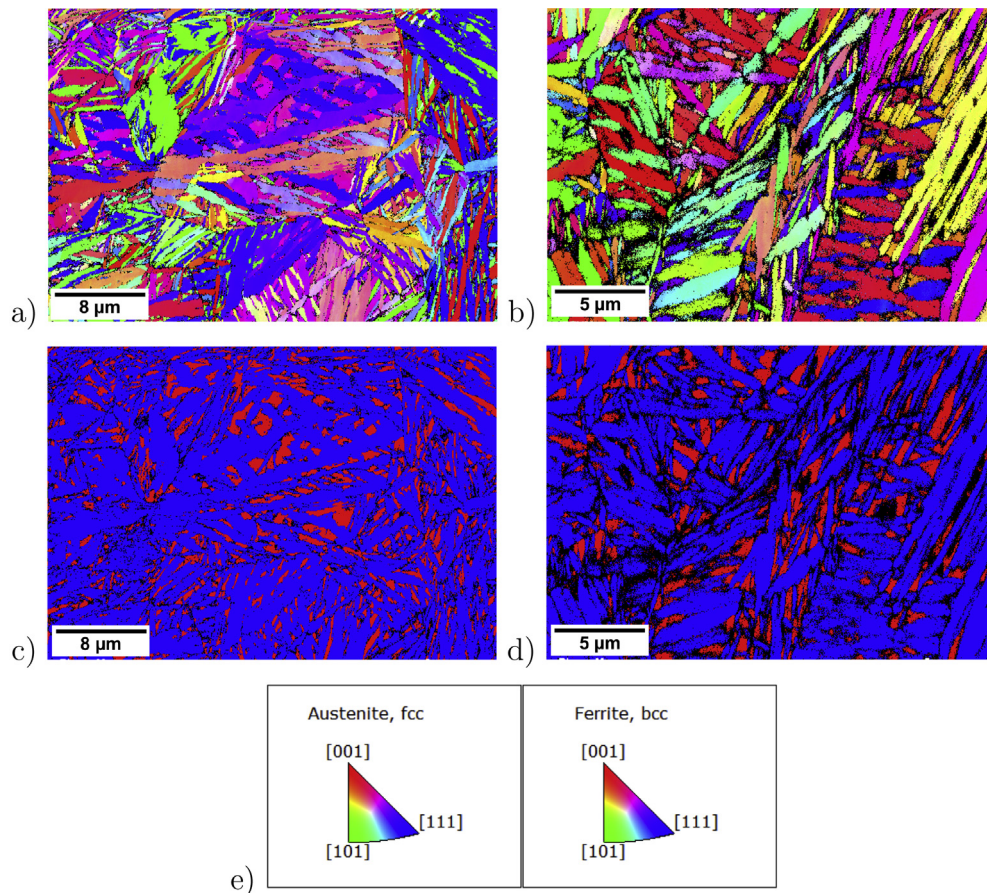
EBSD patterns performed at two different locations within the depth of maximum subsurface orthogonal shear stress in the 948 h sample after polishing with colloidal silica are presented in Fig. 5. The resolution is naturally limited by the technique (not sufficient to assess nanostructural changes) but the images nevertheless show that there is no major disruption of the structure in spite of the voiding damage mechanism caused by the subsurface shear stresses due to prolonged rolling contact. Likewise, the phase maps shown in Fig. 5c and d are evidence of the stability of the larger carbon-enriched retained austenite regions (which should be less mechanically stable than the films [28,29]) and agree with X-ray diffraction data [6] that revealed a fraction 0.21 ± 0.01 of retained austenite persisting after RCF. Both the integrity of the nanostructure and stability of the retained austenite (due to its volumetric expansion in the event of martensitic transformation) are important factors when considering a steel for bearing

Fig. 5. EBSD maps of two different regions: region 1 (a and c) acquired with a step size of 67 nm, a voltage of 20 kV and a working distance of 15 mm, and region 2 (b and d) using a step size of 42 nm, a voltage of 20 kV and a working distance of 14.9 mm (a and b) are standard inverse pole figure maps (key in e) and (c and d) show phase maps with bainitic ferrite coloured blue and retained austenite in red. (For interpretation of the references to colour in this figure legend, the reader is referred to the web version of this article.)

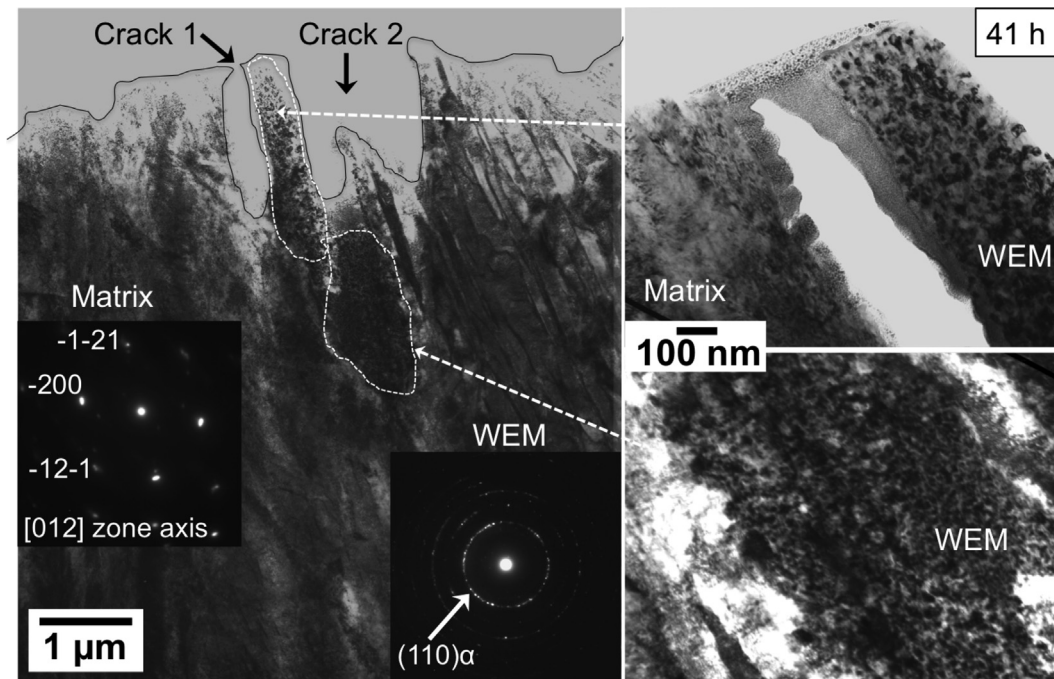
The TEM bright field images and associated electron diffraction patterns of the extracted lamellae are presented in Figs. 6 and 7. Due to contrast artefacts in Fig. 6, the borders of the lamella in the low magnification frame as well as the suspected WEM regions are outlined with a black solid and dashed white line respectively. Cracks are marked to show correspondence to the SEM images. Despite the already nanostructured pattern of the bainitic ferrite matrix, the suspected WEM regions show a very distinct dotted morphology consisting of fine equiaxed ferrite grains, 20–40 nm in diameter, and a characteristic ring-like powder diffraction pattern due to its fine scale, which confirms they are indeed white-etching matter. In the case of the 948 h sample, the electron diffraction pattern indicates the development of a preferred crystallographic orientation or texture of the nanosized ferritic grains. It is worth mentioning that although the matrix does show progressive microstructural degradation after 948 h of RCF, it is not related to the presence of white-etching matter since the same degradation was observed in the WEM-free void coalesced cracks in the original study [6].

Fig. 6. Bright field TEM images of lamella FIB-1 (41 h sample) and associated selected area electron diffraction patterns.

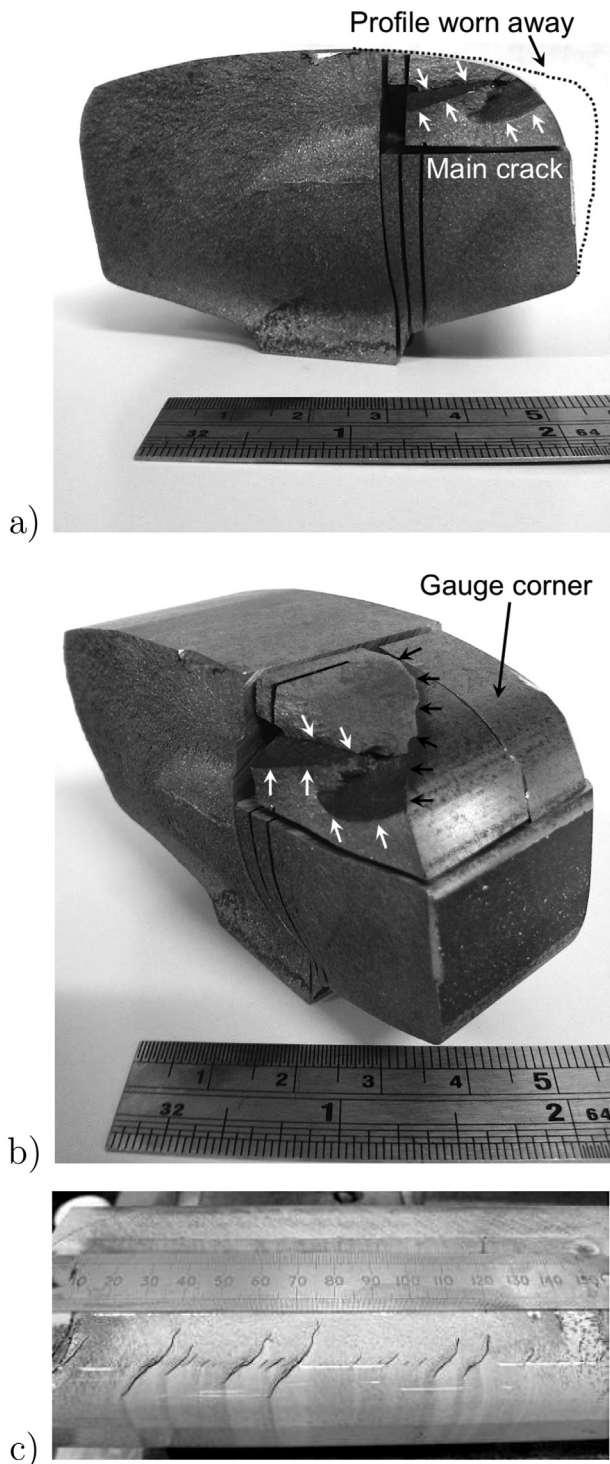
Macroscopic images of the serviced carbide-free bainitic rail are shown in Fig. 8. Annotated SEM images of the crack studied are shown in Fig. 9. The crack shown in Fig. 9a is a minor branched crack located ~500 μm deep under the gauge corner along the length of the rail, although the true depth is most likely to be around 5 mm due to the loss of rail profile caused by wear and grinding operations (Fig. 8a) [32]. The abrupt upper edge of the steel in image Fig. 9a corresponds to the bottom surface of the main surface-breaking RCF crack, presumably caused by plastic flow and ductility exhaustion [33,34] although coarse grinding during maintenance operations could have also led to ridges being folded over to form a ledge, which then acts as a crack initiation site. In Fig. 9b, distinct areas of homogeneous topographical contrast, suspected to be white-etching matter (later corroborated through TEM), can be seen running along both sides of the length of the crack. In rails, the shear stresses due to rolling contact fatigue have a maximum at the surface and at a depth of ~2 mm or deeper for decreasing friction coefficients due to an elliptical contact patch in rail/wheel contact, as opposed to a strip contact in the case of laboratory RCF tests [35]. The depth of this crack indicates a prolonged propagation stage from the surface rather than a high

Fig. 8. Serviced carbide-free bainitic rail showing: a) the original profile shape marked with a dotted black line and the subsurface edges of the main surface-breaking crack (white arrows), b) the gauge corner where the RCF crack breaks the surface (black arrows) and the crack edges under the surface (white arrows), and c) sample extracted from track after rust removal using fine SiC paper where the running direction is along the length of the ruler used for scale.

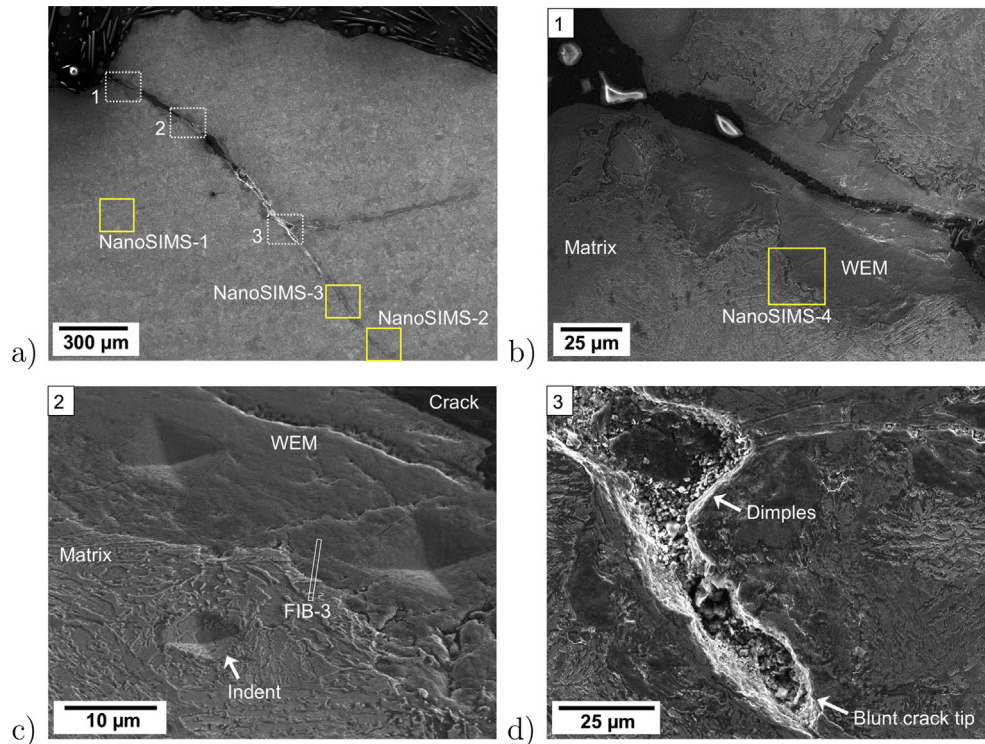
friction coefficient since it is a branch and not a subsurface initiated crack. The long propagation stage allowed sufficient crack face rubbing, which is manifested by the large portions of suspected WEM observed. It is also worth noting that this crack shows the same signs of ductile failure as the butterfly cracks presented previously, such as dimples and blunted tips (Fig. 9d) despite the bainitic matrix not being nanostructured, suggesting that the ductility originates from the lack of carbides in the bainite rather than the refinement of the structure.

Fig. 9. Secondary electron SEM images of serviced carbide-free bainitic rail showing a) an overview of the crack, b) the crack mouth showing large areas of surrounding WEM, c) position of extracted lamella FIB-3 observed at 52° with respect to the electron beam to show also the relative difference of indent size between the WEM and matrix, and d) crack tip showing signs of ductile failure. The yellow solid line squares denote some areas analysed with NanoSIMS. (For interpretation of the references to colour in this figure legend, the reader is referred to the web version of this article.)

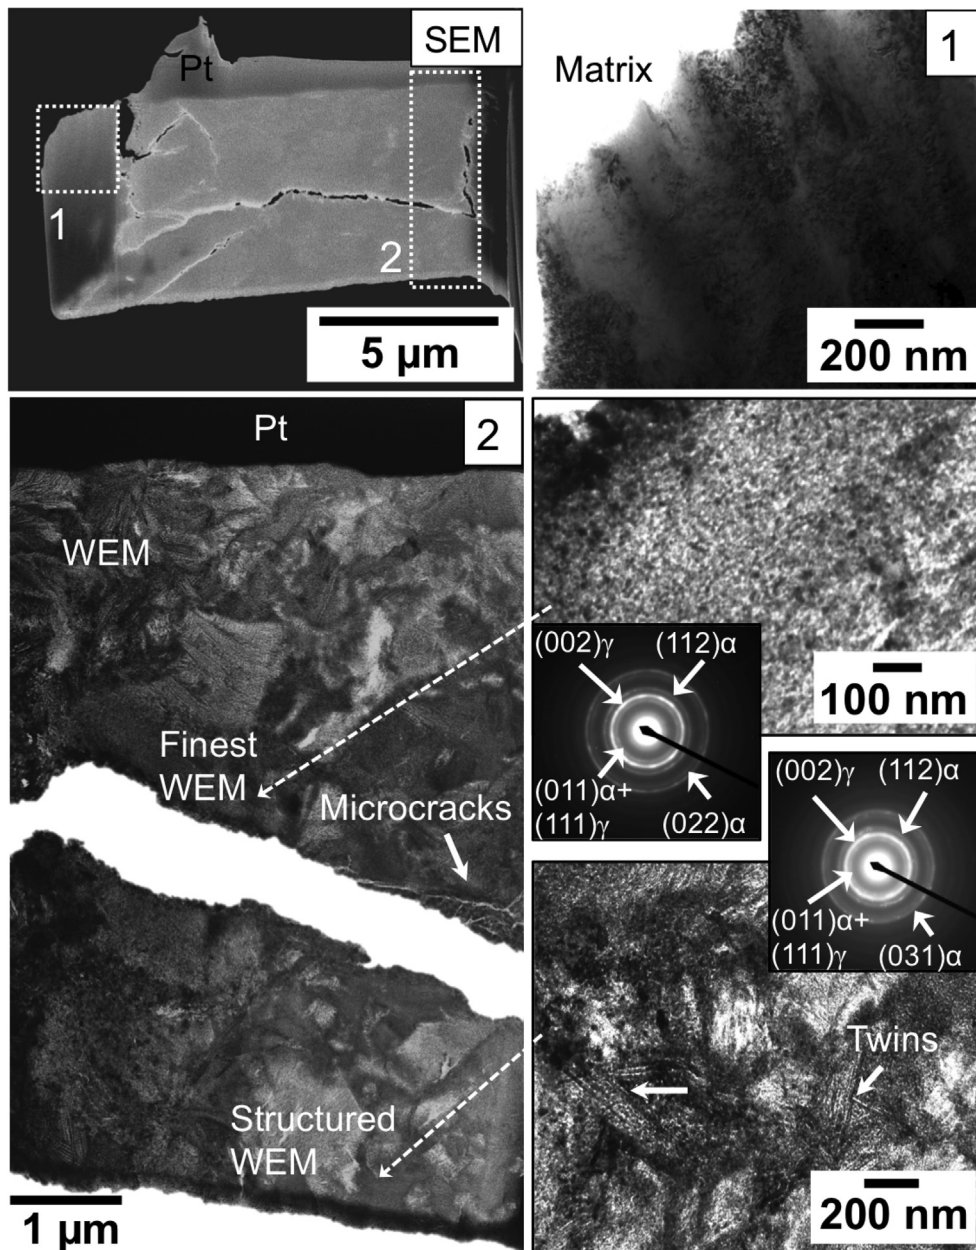
The TEM images and electron diffraction patterns of the lamella extracted from the suspected WEM regions of the serviced rail (FIB-3) are presented in Fig. 10. As opposed to the WEM found in butterflies, which has a dotted pattern distinguishable even at low TEM magnifications, this one is much finer and can only be distinguished as such at very high magnifications and in close proximity to cracks. Otherwise, a low magnification overview of region 2 shows how this WEM has a structure reminiscent of the bainitic matrix once present before deformation.

appearance even at higher magnifications including features such as twins, plate boundaries, voids, and some microcracks. Nevertheless, selected area electron diffraction patterns reveal that there is no compositional difference between the finer regions and the more structured regions further from cracks apart from some stronger individual reflexions of ferrite in the structured areas suggesting slightly less grain refinement. In any case, the ring electron diffraction patterns confirm that both regions are in fact white-etching matter as previously suspected.

Fig. 10. Lamella FIB-3 extracted from the serviced rail as seen during the last thinning stage inside the focused ion beam SEM (secondary electron image) and bright field TEM images of the matrix in area 1 and WEM in area 2 with high magnification images and respective selected area electron diffraction patterns of regions adjacent and distant from a crack.

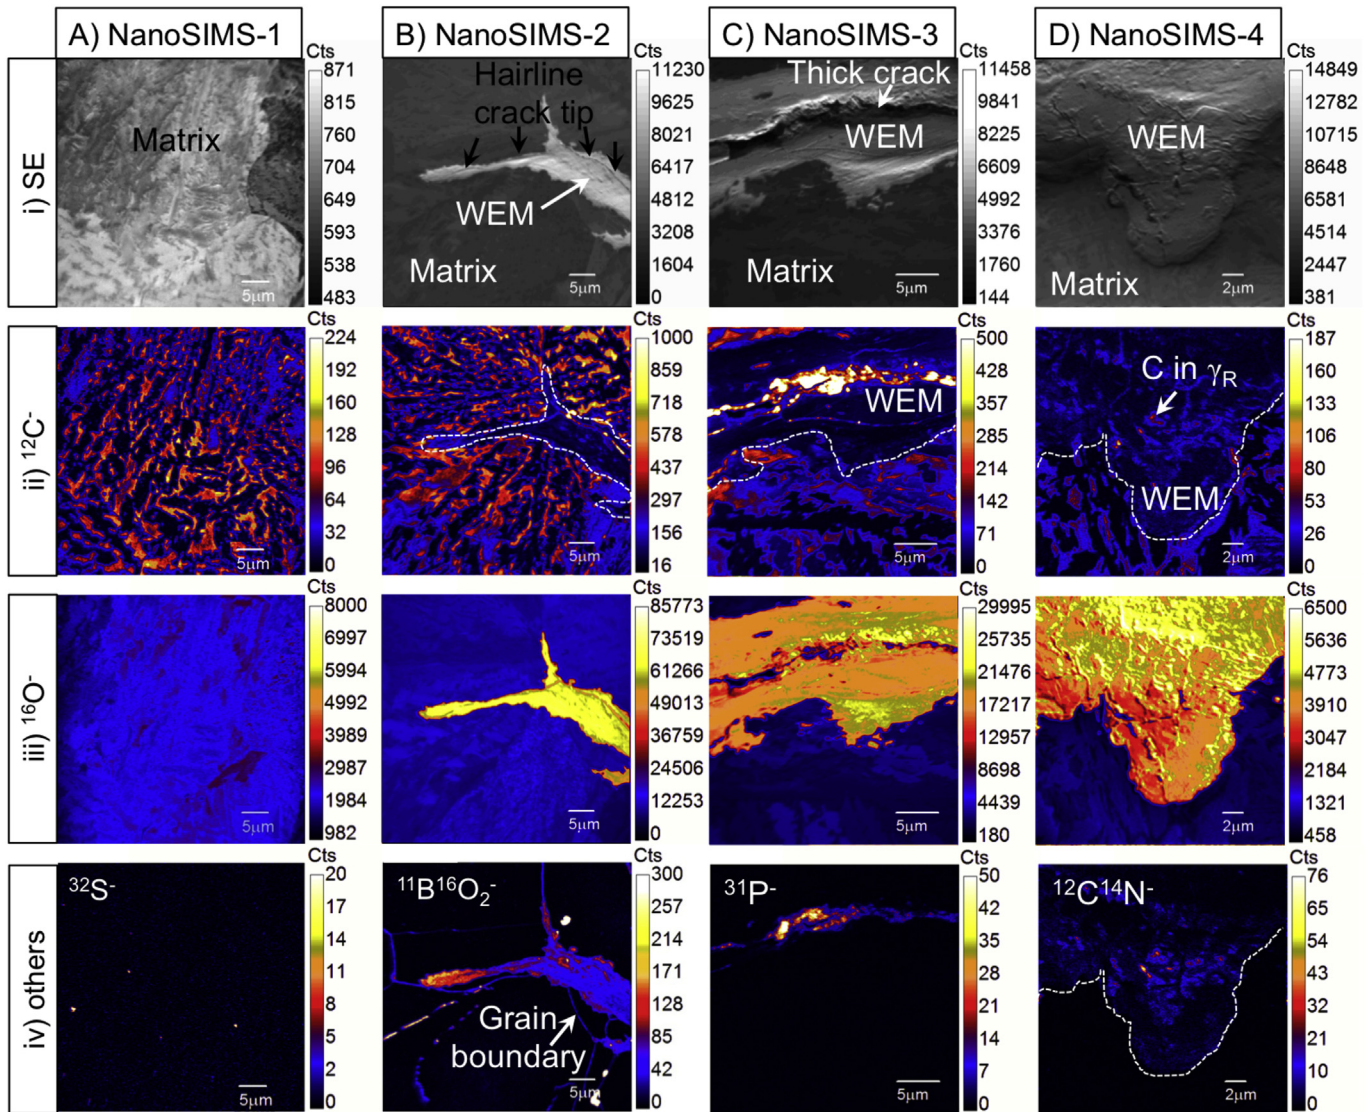
A surprising finding in the NanoSIMS results was the relatively high signal of oxygen, measured as $^{16}\text{O}^-$ ions, in the WEM in comparison with the matrix (Fig. 11-iii). Due to the fact that the crack analysed broke the surface, it is speculated that the beating action of the crack faces incorporated oxygen and nitrogen (Fig. 11D-iv) into the WEM. It is worth mentioning that rails run without lubrication so it is unlikely the oxygen enrichment originates from lubricant breakdown. An alternative mechanism responsible for some of the carbon depletion of the WEM could be the possible formation of CO at the surface due to the ingress of oxygen into the deformed region. Although NanoSIMS could not be performed on the nanobainitic RCF samples due to the difficulty of finding small and scarce butterflies in unetched samples, it would not be expected to find oxygen incorporated into the WEM butterfly wings since butterfly cracks are subsurface initiated and normally do not break the surface. An analysis of sulphur ($^{32}\text{S}^-$) in the matrix revealed the potential presence of sulphides, most likely MnS, in the matrix (Fig. 11A-iv), although the counts obtained were too few to reach any definite conclusions. Phosphorous was expectedly found to match the path of the crack due to its embrittling effect (Fig. 11C-iv), whilst boron, despite its small concentration in this alloy, was found to decorate the prior austenite grain boundaries (Fig. 11B-iv) [44–46].

Fig. 11. NanoSIMS maps from A) the matrix (NanoSIMS-1), B) the very tip of the branched crack (NanoSIMS-2), C) a region next to a wider section of the crack (NanoSIMS-3), and D) region around the crack mouth (NanoSIMS-4), as shown in secondary electron (SE) images. Different elements such as carbon (C), oxygen (O), nitrogen (N), sulphur (S), boron (B), and phosphorous (P) were mapped as respectively indicated. Some borders between the matrix and WEM are marked with a white dashed line for clarity. (For interpretation of the references to colour in this figure legend, the reader is referred to the web version of this article.)
