Root Cause Determination of On-orbit Degradation of the VIIRS Rotating Telescope Assembly

M.R. Ciofalo, P.D. Fuqua, J.D. Barrie, M.J. Meshishnek,
C.T. Chu, J.A. Chaney, and R.M. Moision,
The Aerospace Corporation

August 30, 2012

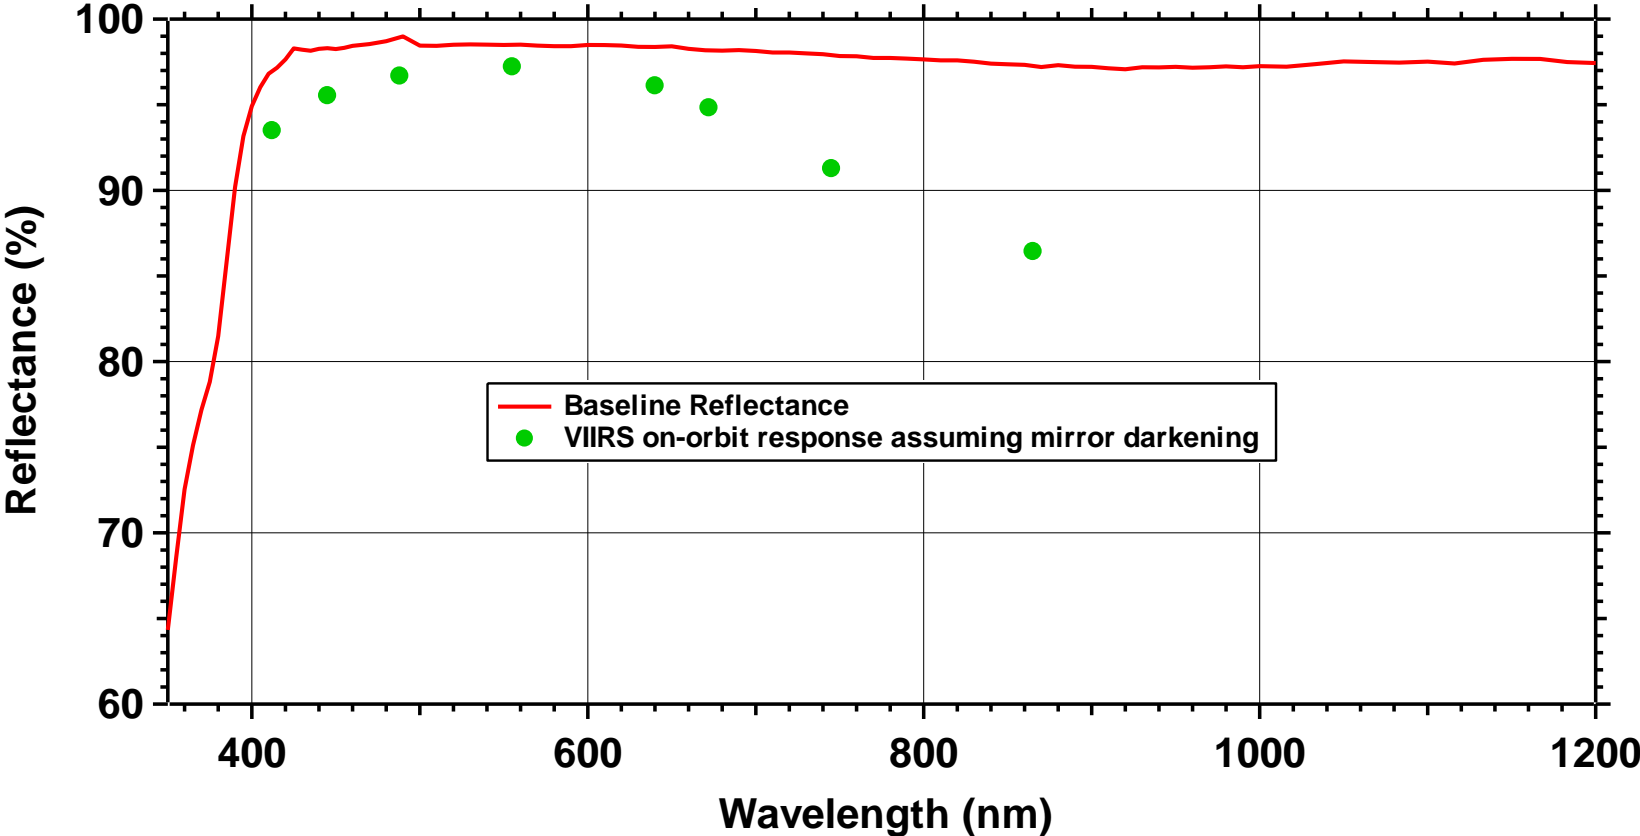
TWM Reflectance

On-orbit response inferred from F-factor data (through orbit 882); assumes all observed degradation could be assigned to one mirror.

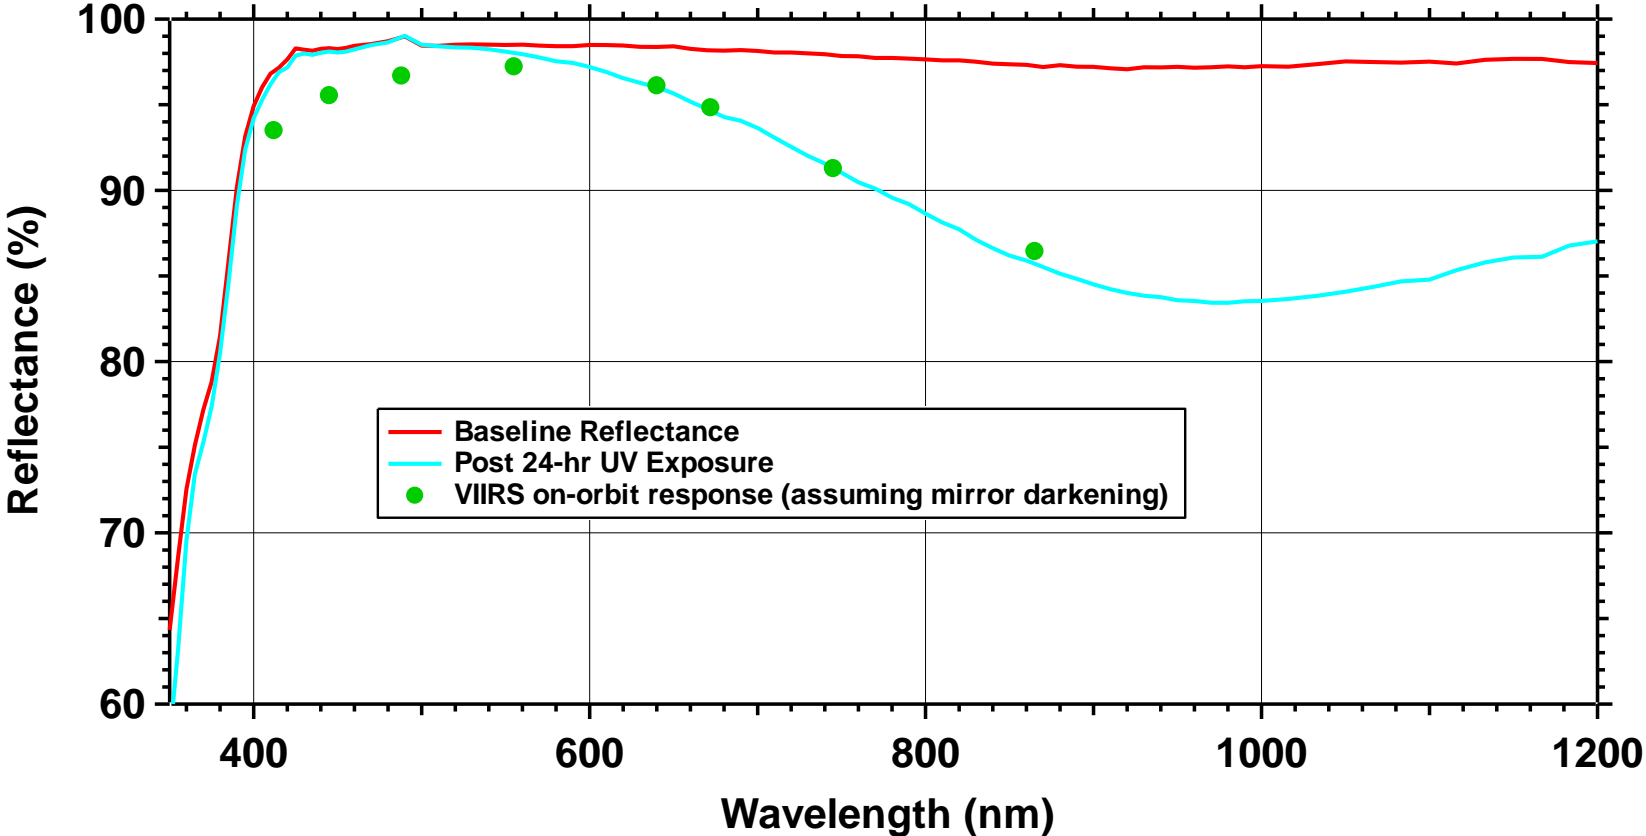
TWM Reflectance

UV-induced degradation of TWM matches on-orbit VIIRS response, particularly for $\lambda > 600$ nm.

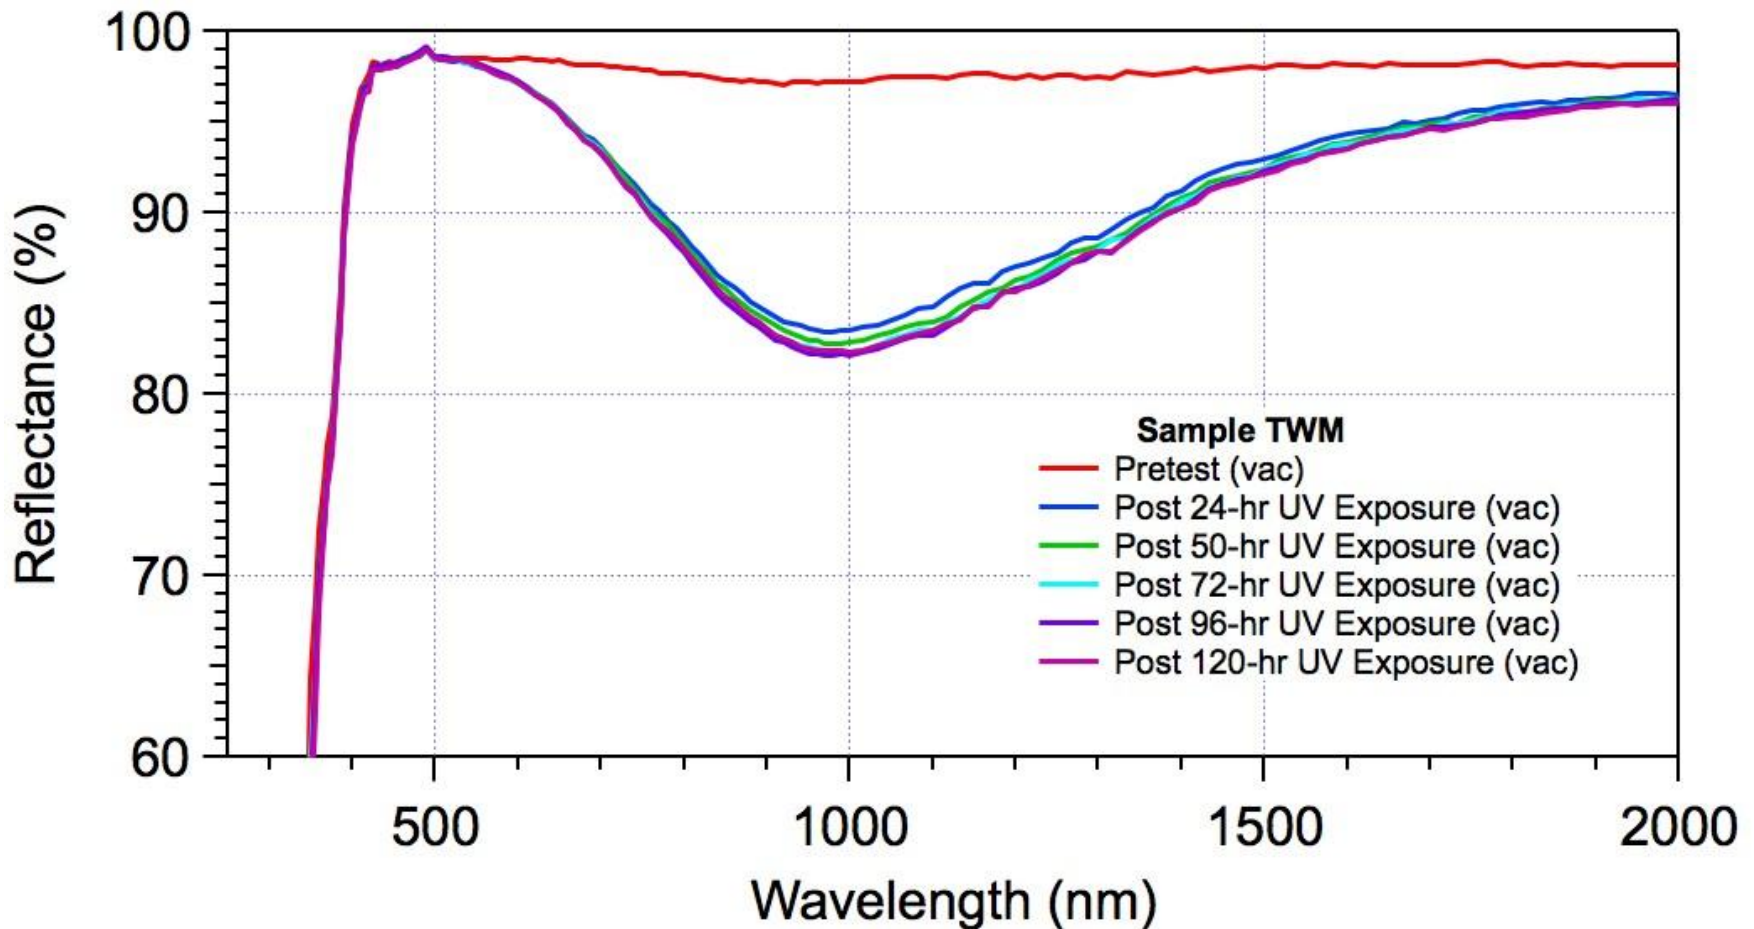
TWM Reflectance

UV-induced degradation of TWM saturates after ~3 days of simulated exposure.

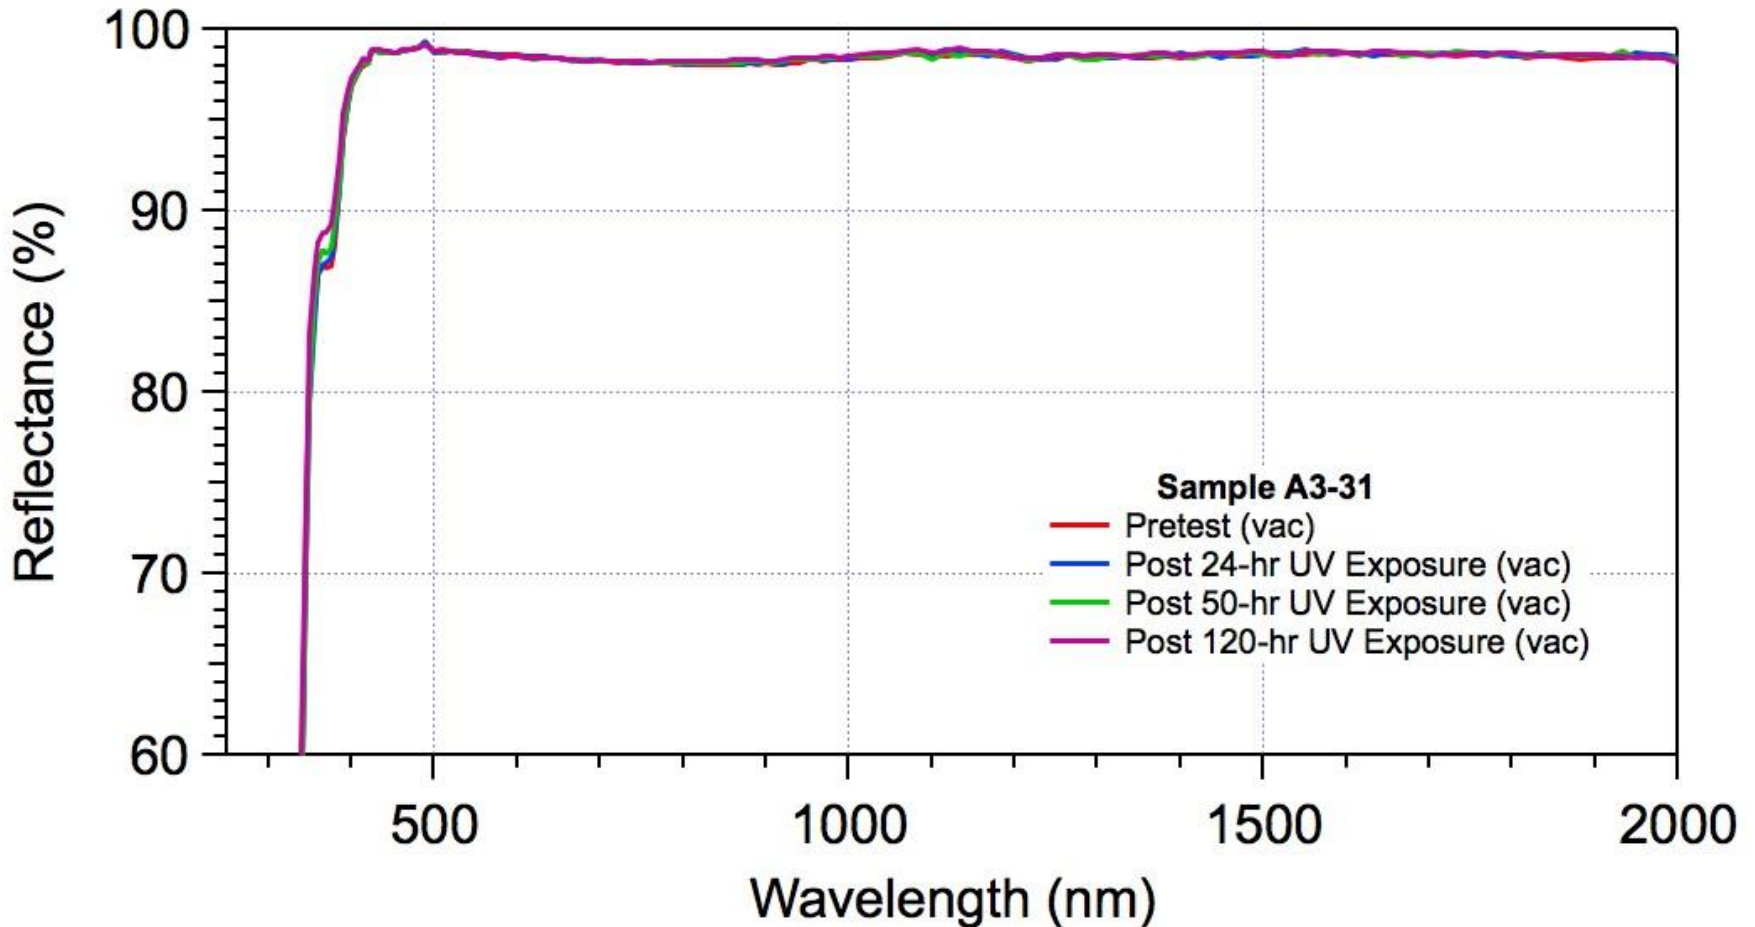
A3-31 Reflectance

Mirror of the same design as TWM, but produced in a different coating run, was unaffected by the UV exposure.

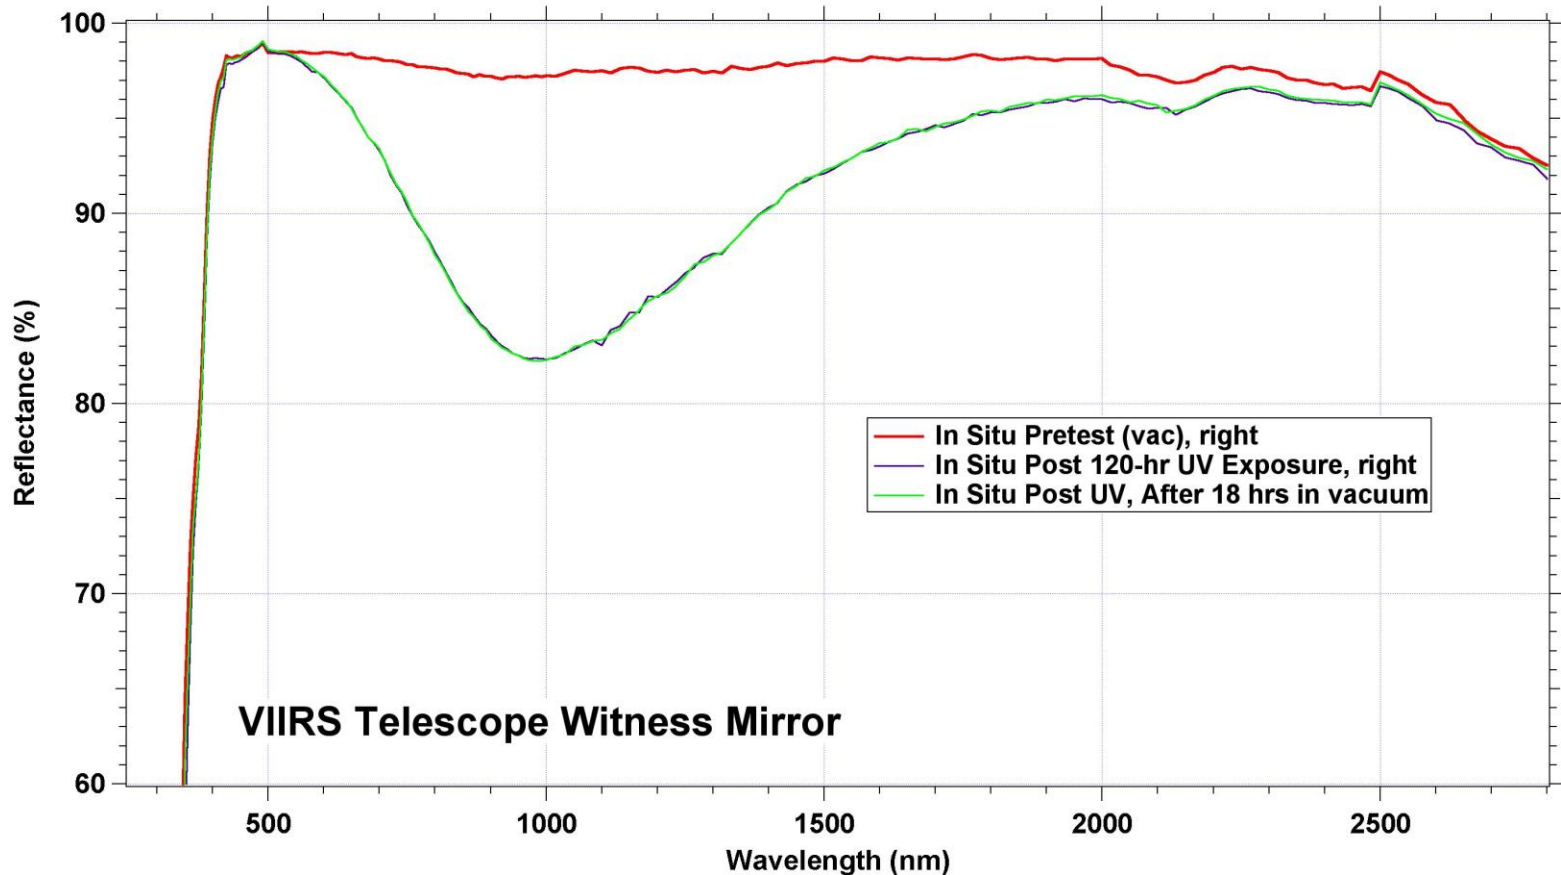
Does the degradation anneal in vacuum?

The reflectance loss persisted after the UV exposure ended. No change was observed overnight in vacuum at room temperature.

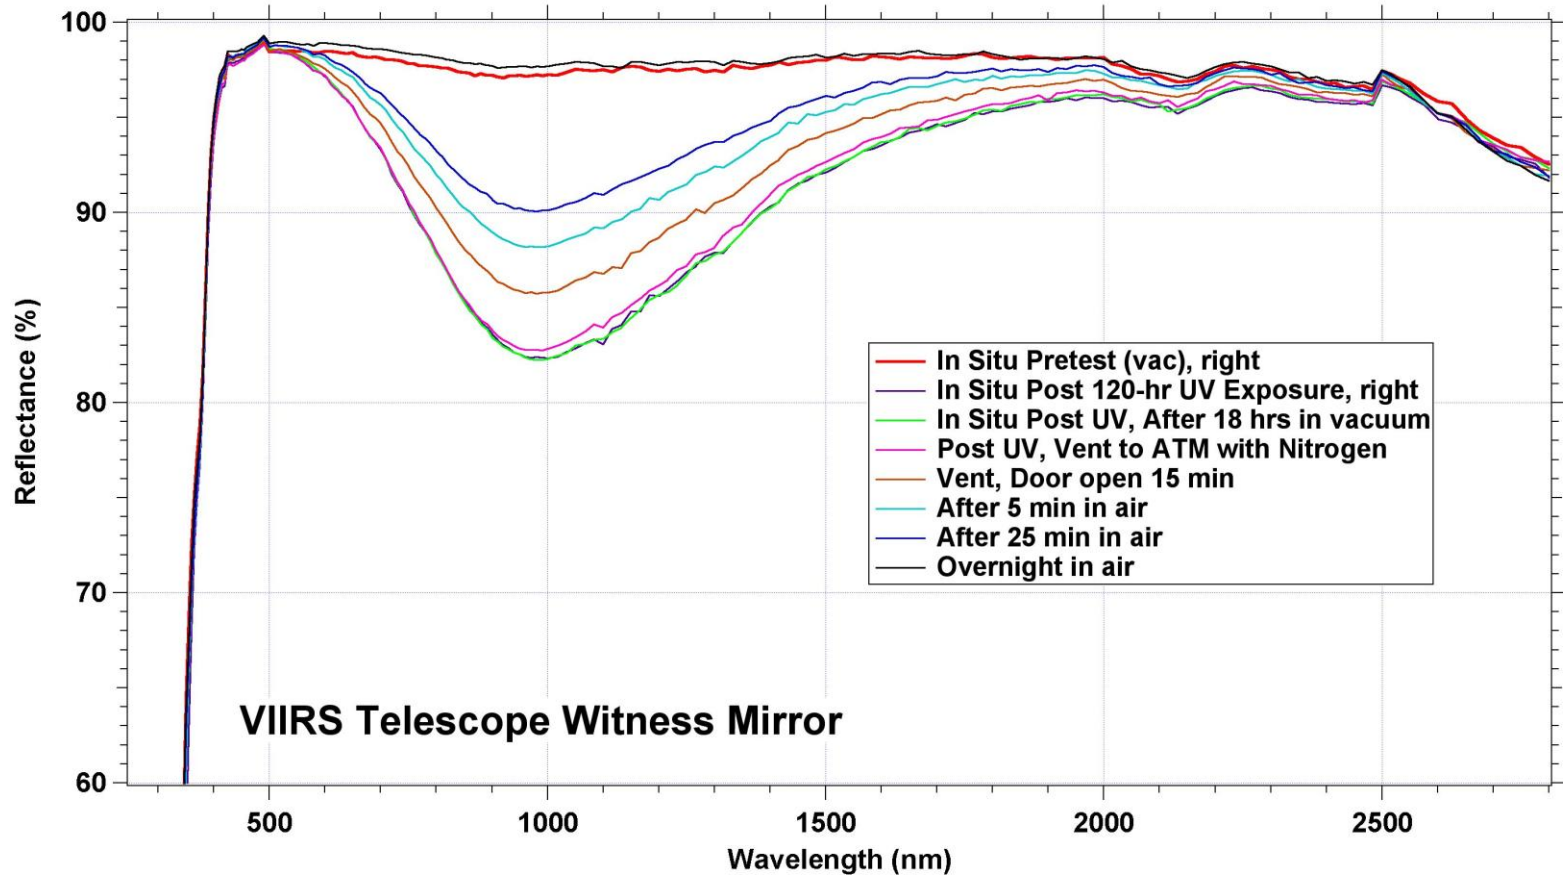
Does it recover upon exposure to air?

By the following morning, the degraded reflectance had bleached back to its pretest response.

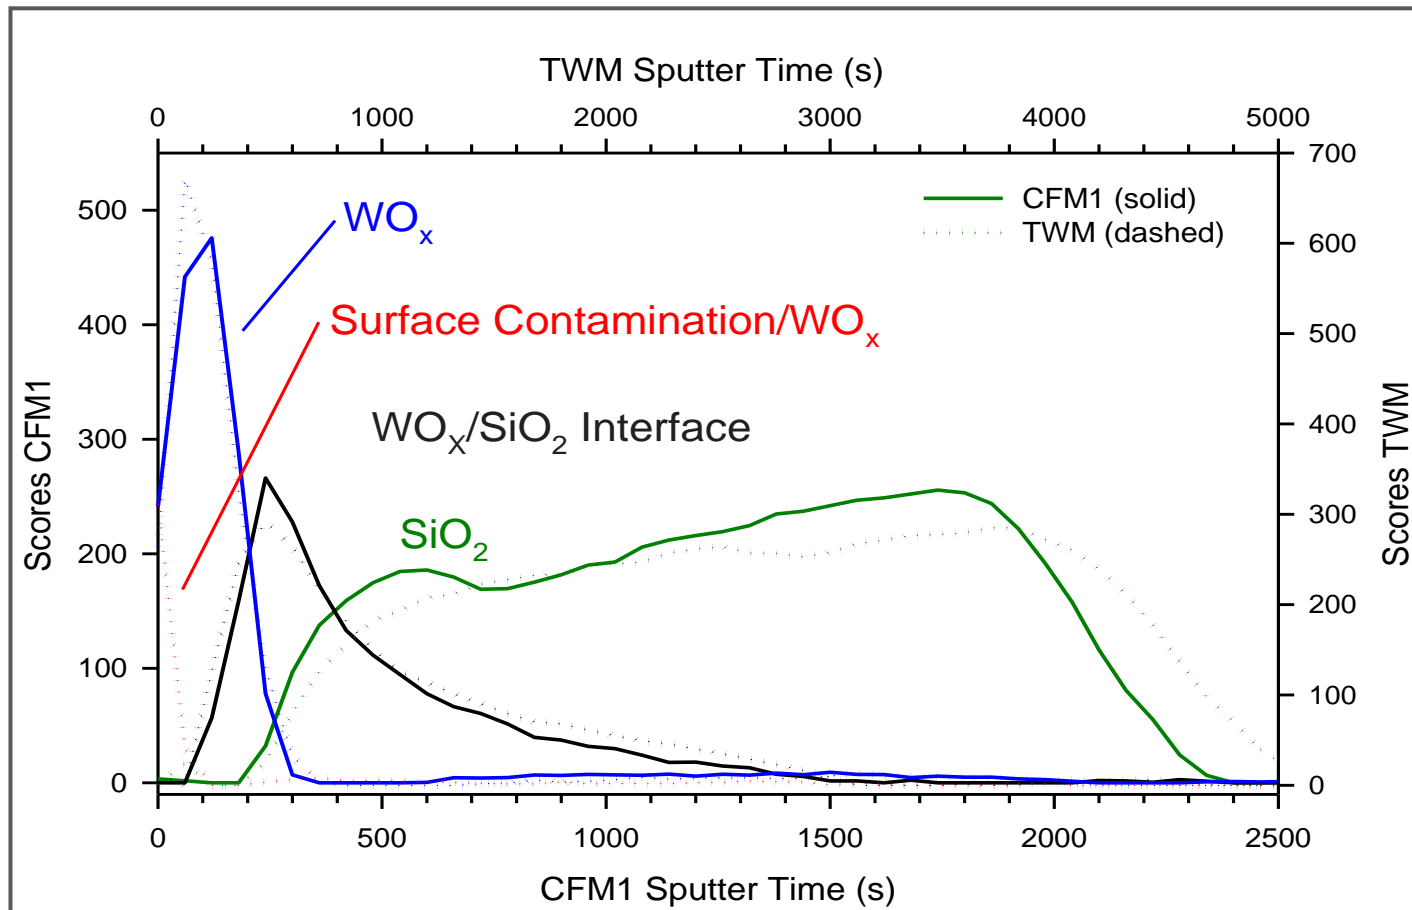
ToF-SIMS Depth Profile

The two witness mirrors [from the RTA coating run] are very similar in composition; the surface of TWM shows contamination consistent with Al&T.

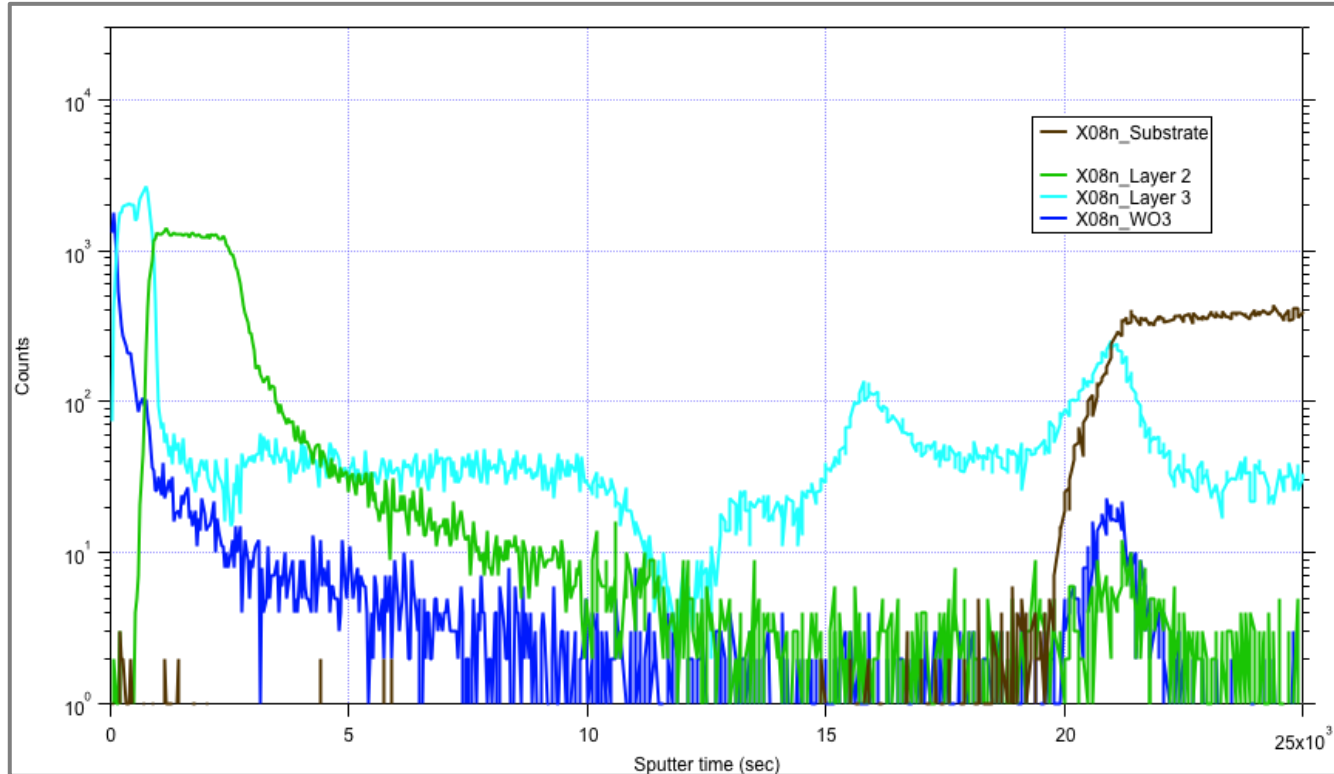
ToF-SIMS Depth Profile

Tungsten oxide found in two places: A thin layer at the top of the coating and in smaller "trace" quantities below the silver layer.

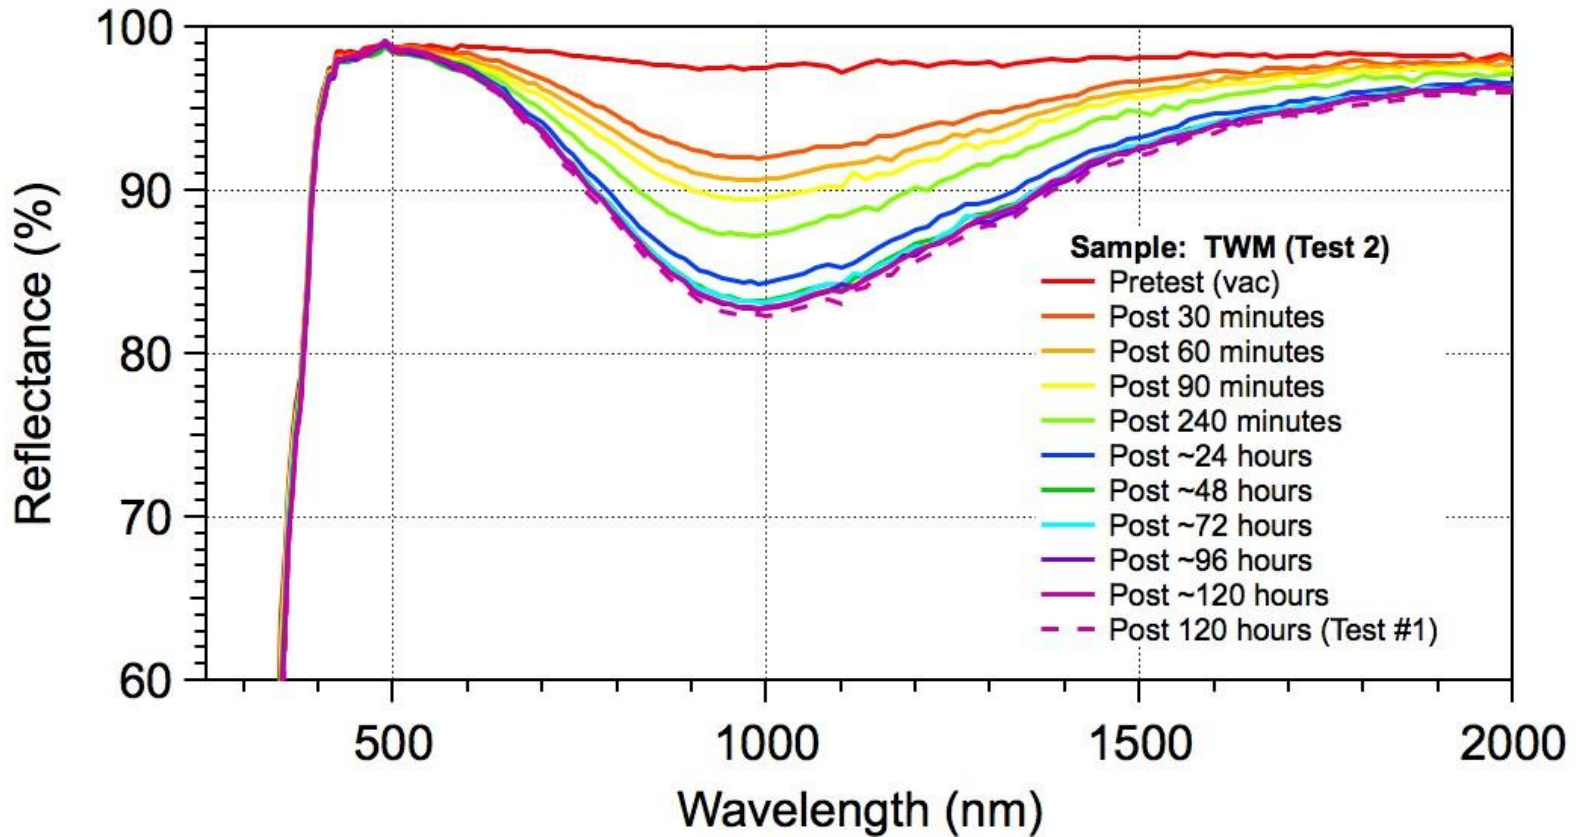
TWM Reflectance - UV Test 2

A second UV exposure induces reflectance loss similar to that in Test 1.

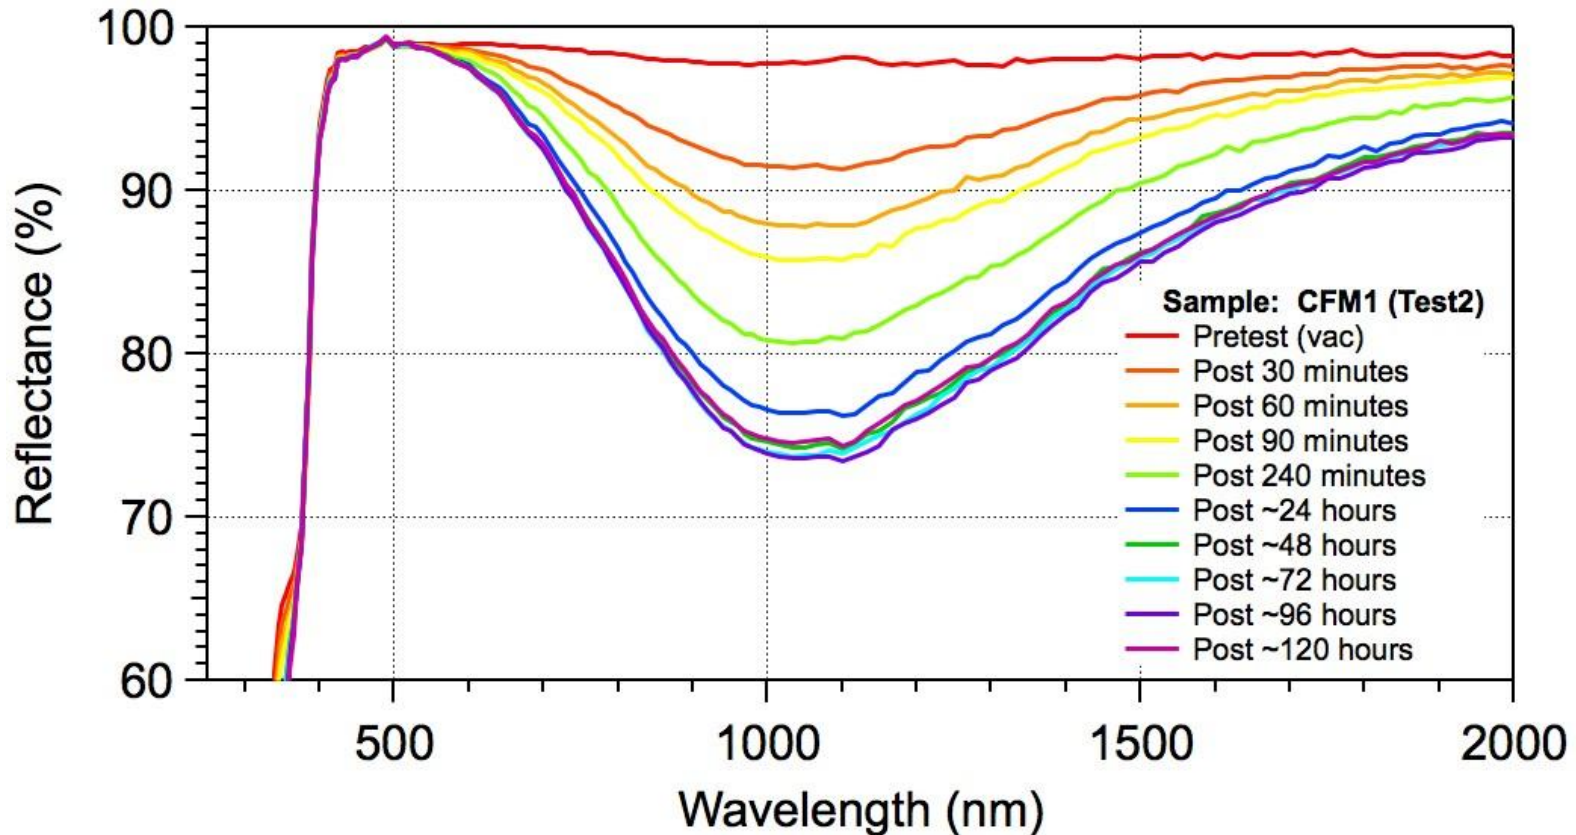
CFM1 Reflectance - UV Test 2

The second 'pristine' mirror [from the same coating run as the VIIRS RTA mirrors] is also degraded by UV exposure, with an even greater loss in reflectivity. This mirror was not exposed to AI&T.

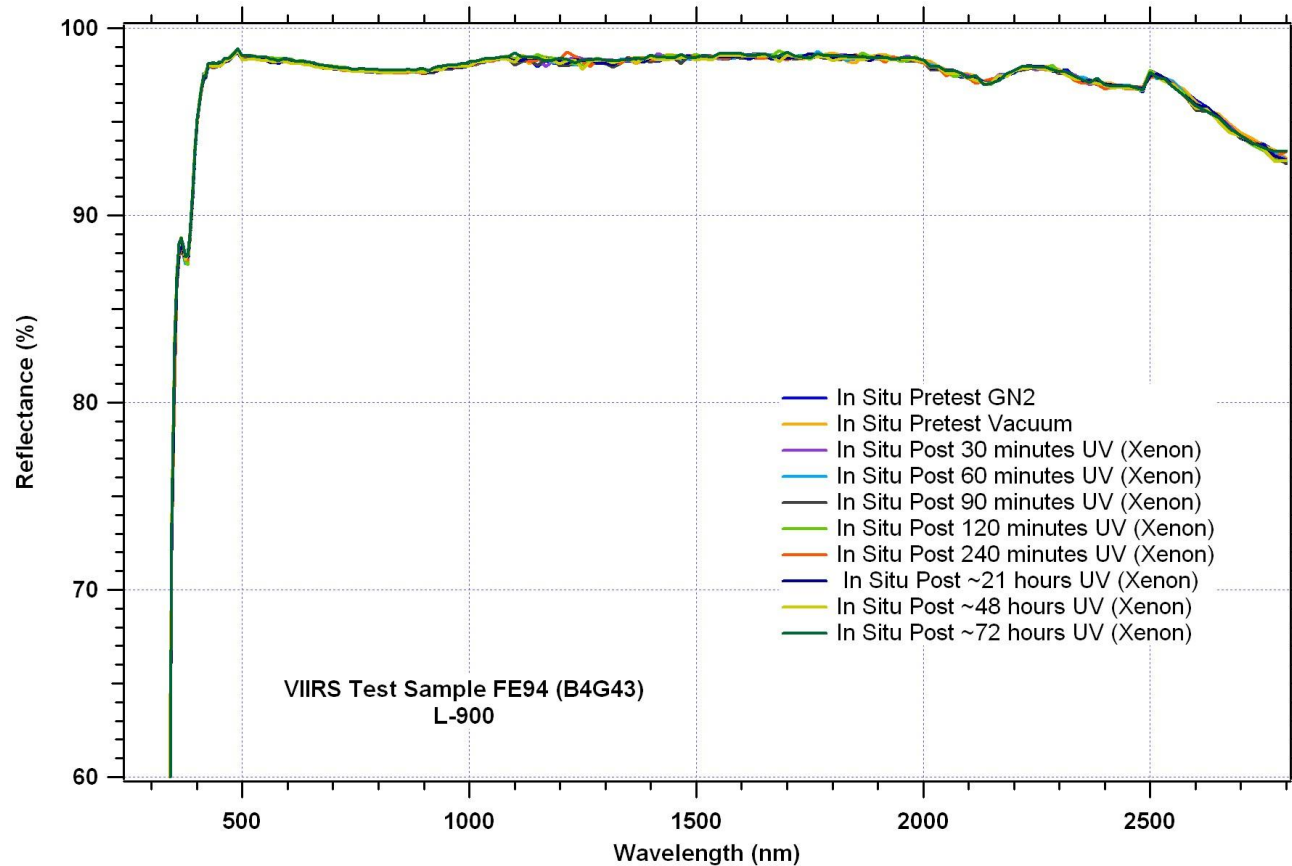
FE94 Reflectance - UV Test 2

The mirror from a different coating run was unaffected by UV exposure.

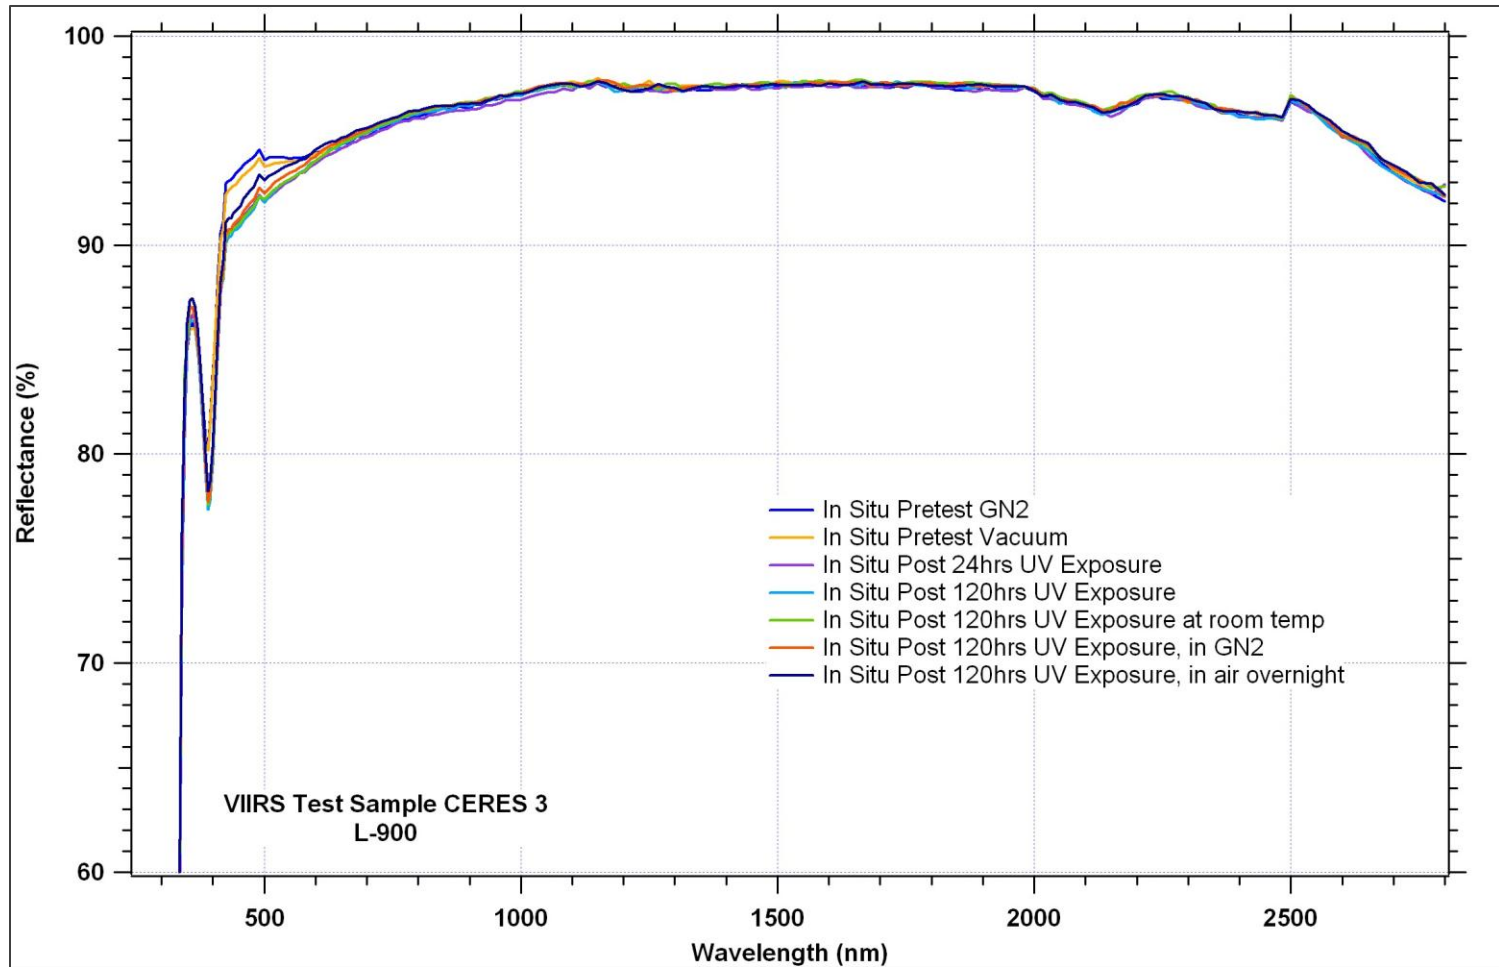
CERES Mirror - UV Test 1

A CERES witness mirror, with a different spectrum than the VIIRS mirrors, was also exposed to UV during the test. The NIR absorption loss was not observed, but there was a slight decrease in short wavelength reflectance.

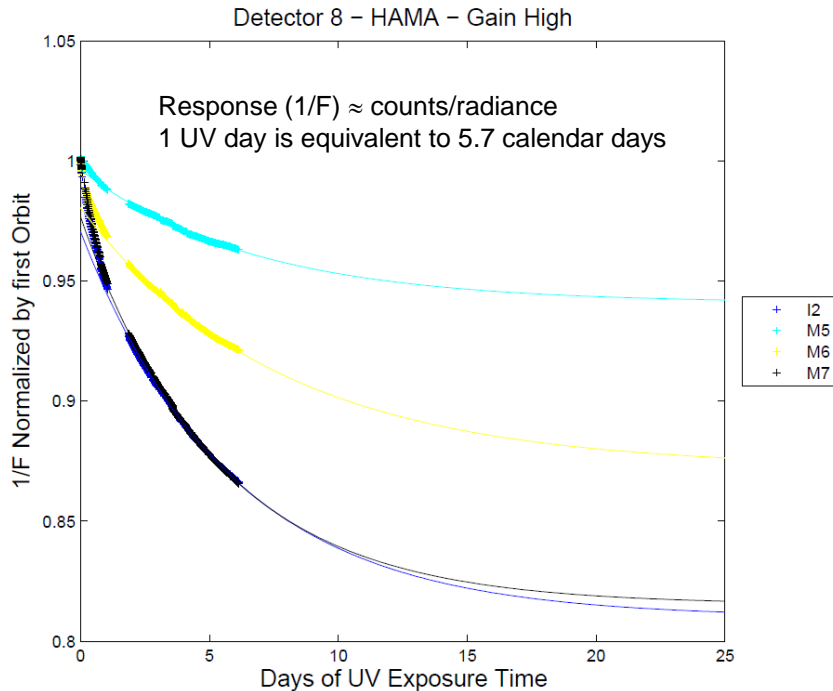
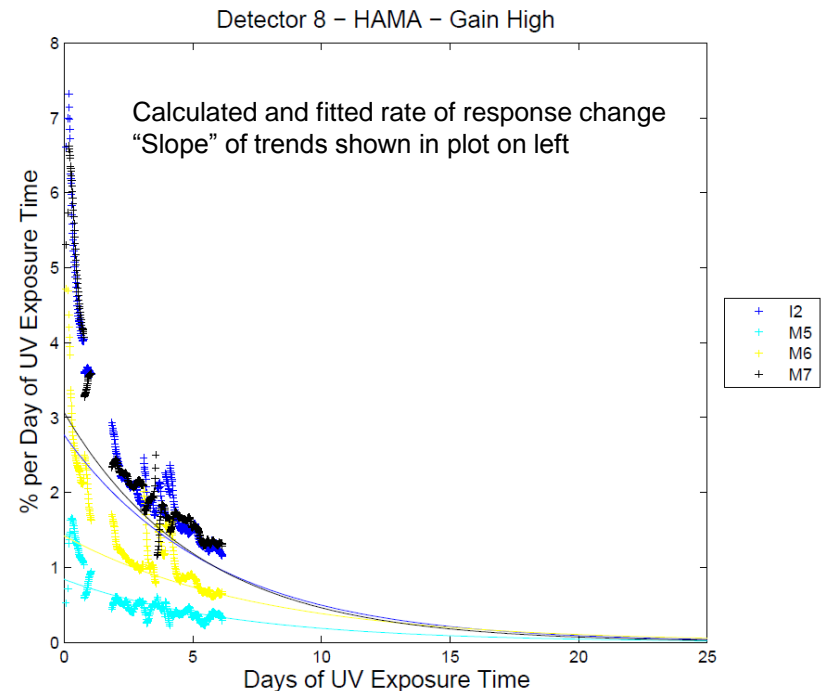
Aerospace trends VIIRS response and rate of response change twice per day in all VisNIR bands
 Longer wavelength bands are most affected (I2/M7 = 865 nm, M6 = 746 nm, M5 = 672 nm)

Rate of response change is slowing down as expected based saturation of darkening effect observed in witness sample measurements
