## South Channel Dam Rehabilitation Project - Successfully Addressing Dam Rehabilitation Challenges

## South Channel Dam Rehabilitation Project: Successfully Addressing Dam Rehabilitation Challenges

M.D. Graeser<sup>1</sup> and M.C. Jensen<sup>2</sup>

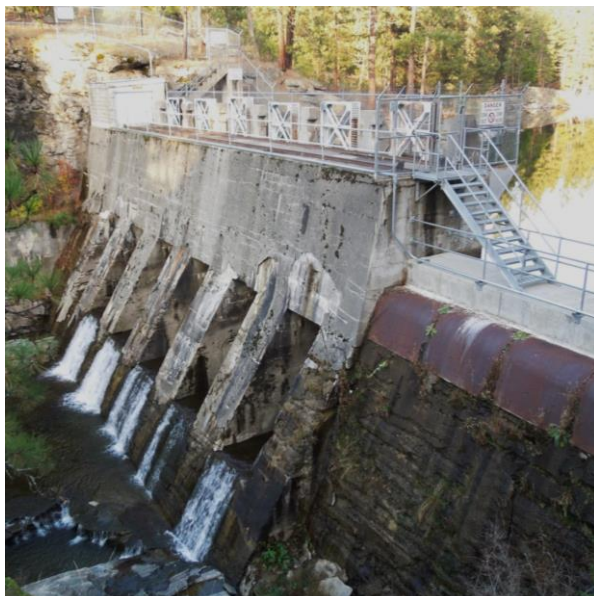
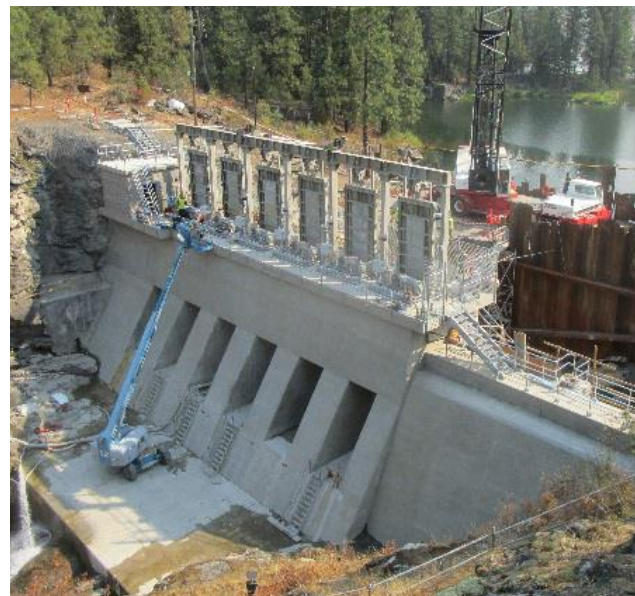
Figure 1. South Channel Dam, Before and After Rehabilitation

The objective of the South Channel Dam Rehabilitation Project was to replace the six spillway gates and rehabilitate the concrete dam. The project included geotechnical engineering, structural engineering, mechanical engineering, and electrical engineering. The spillway gates and associated hoist mechanism were removed and replaced with six new spillway gates; each were 2.1 meters wide by 4.2 meters high (6.8 feet wide by 13.7 feet high). The new gates are of a modern steel roller-gate design with wire rope hoists. Deteriorated concrete was removed over much of the exposed surfaces and replaced with new concrete. A consolidation grouting program was also included in the dam rehabilitation. The existing mule house was replaced with a new concrete masonry structure that houses a new motor control center and controls for the gate hoists. Figure 1 shows photographs of South Channel Dam before and after the rehabilitation project. Figure 2 shows a general rehabilitated dam section at the spillway gate.

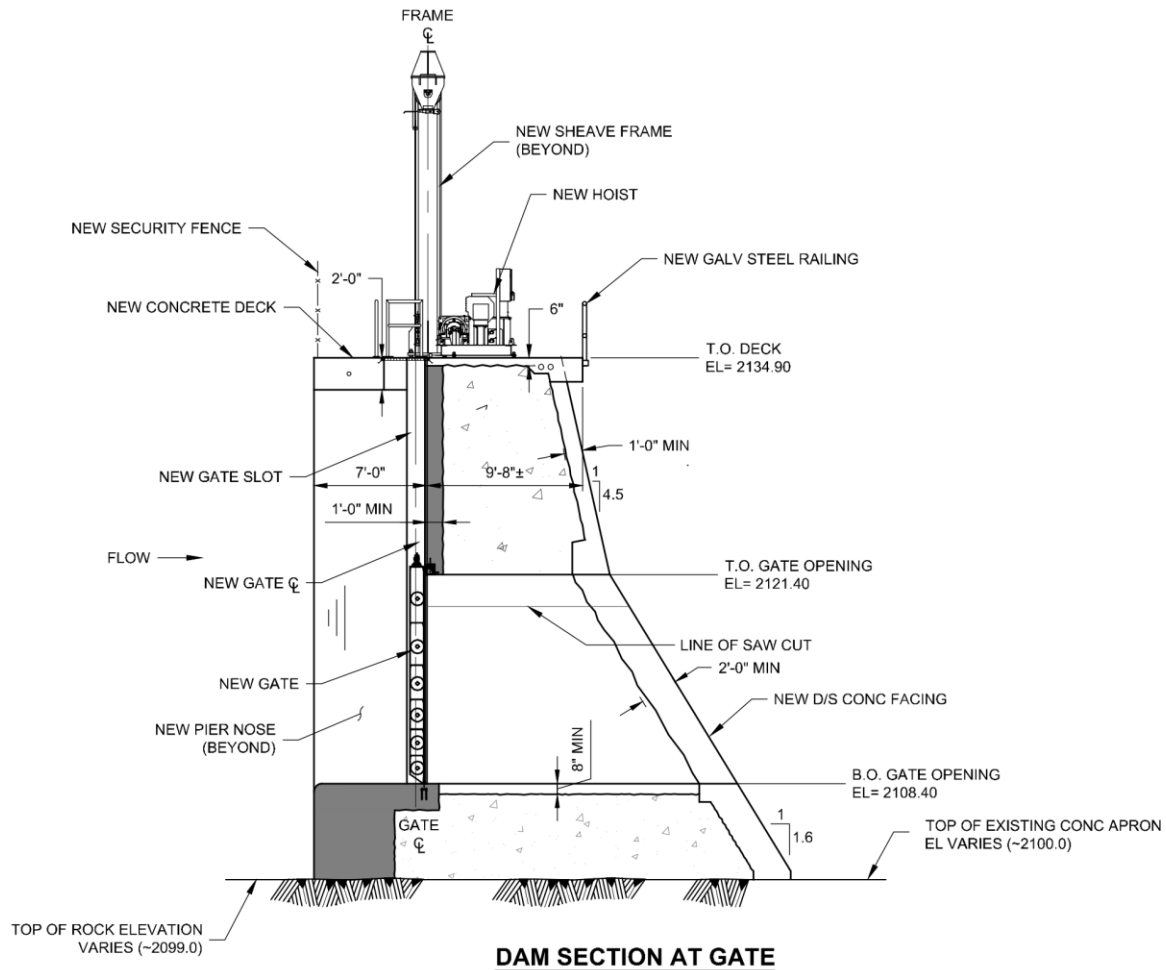
Figure 2. General Dam Rehabilitation Section at Gate

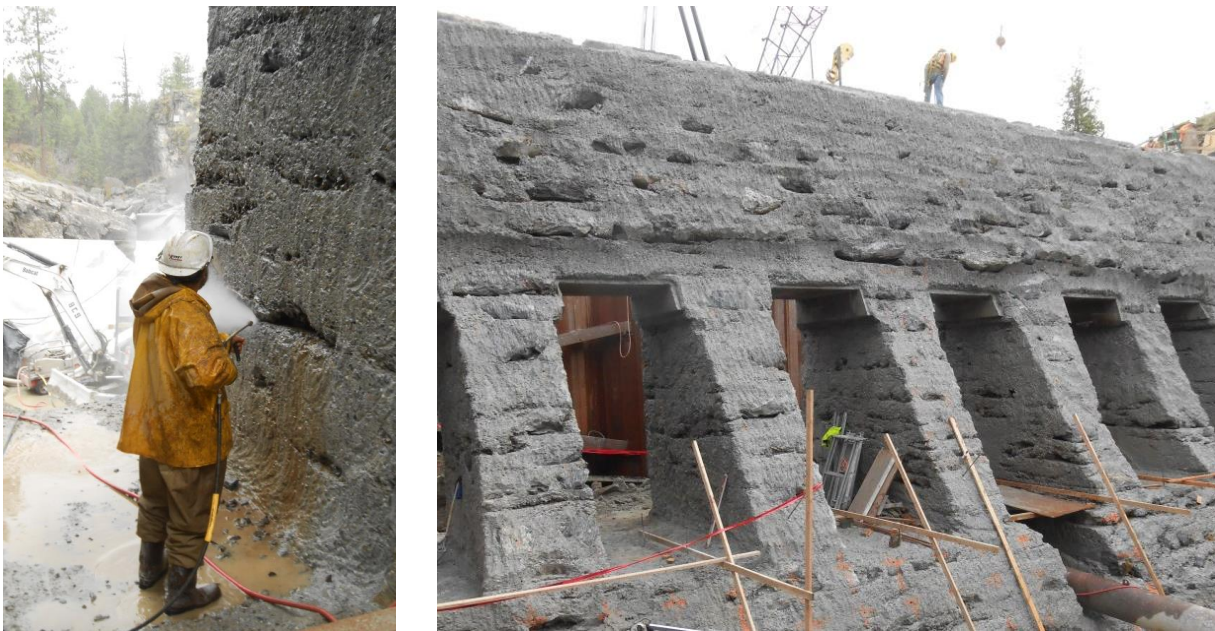
Based on data collected prior to construction, the existing concrete in the historic dam was known to consist of cyclopean concrete with voids, seams, and cold joints. The condition of the existing concrete encountered during construction, however, was worse than expected. Concrete demolition and surface preparation revealed large voids and substantial areas of low strength material. Extending the demolition was not an option because there were no indications that the concrete would improve with depth. The observed condition of the original concrete necessitated adjustments to the design and detailing during the construction phase. The design modifications for the concrete rehabilitation included the following:

Low strength material was observed at several locations in the dam. The following questions were discussed during construction:

Figure 5. Concrete Demolition and Surface Preparation

Ultimately, high-pressure water was used to remove the low strength material. Test sections were performed; the team all agreed to proceed with high-pressure water to remove the areas with low strength material. The extent of low strength material removal was limited to what the high pressure water could remove. Figure 5 shows the concrete surface preparation with high pressure water and the downstream face of the dam after concrete demolition and surface preparation.

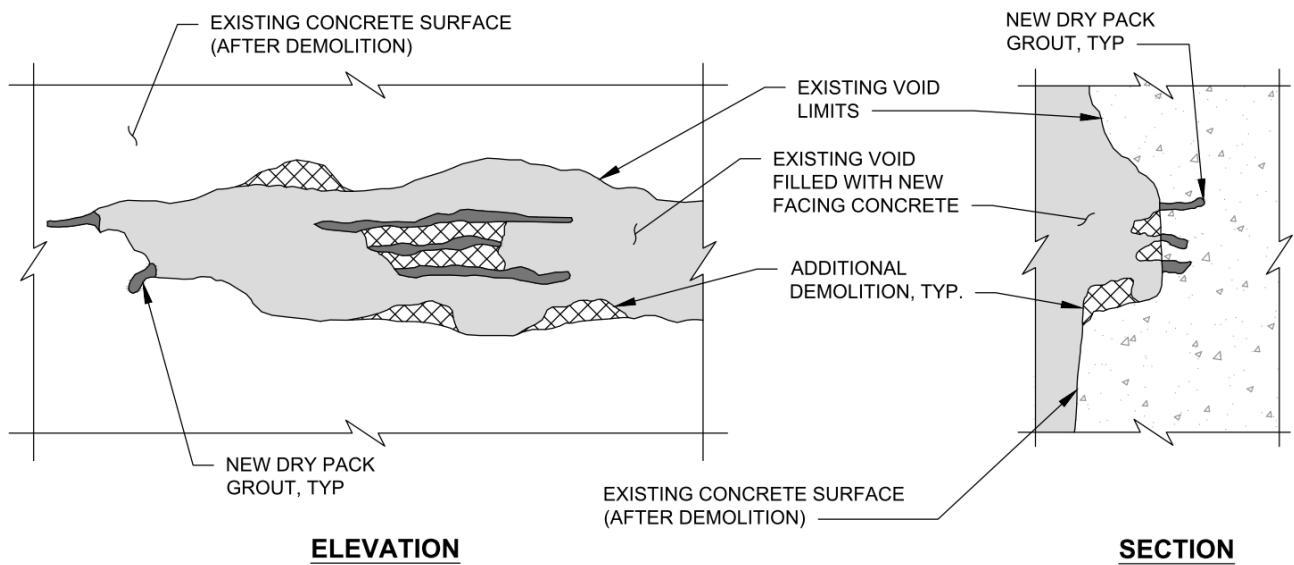
High-pressure washing the concrete surfaces of the dam revealed several concrete voids. The voids ranged in size from 0.15 meters (0.5 feet) wide by 0.15 meters (0.5 feet) deep to up to 1.2 meters (4 feet) wide by 0.6 meters (2 feet) deep. The concrete voids were prepared to ensure that the voids could be filled as part of the facing concrete placement. The facing concrete was a flowable concrete mix with a water-reducing admixture and 19 mm (¾-inch)

Figure 6. Concrete Void Repair Detail

maximum aggregate size. Each void area was inspected, and additional local demolition was performed with hand tools as needed to remove obstructions. Hard to reach deep sections were repaired with dry pack grout (Portland cement and sand) to build the void out to a depth that could be filled as part of the new facing concrete placement. The implemented void repair detail to facilitate filling with the facing concrete is shown in Figure 6.

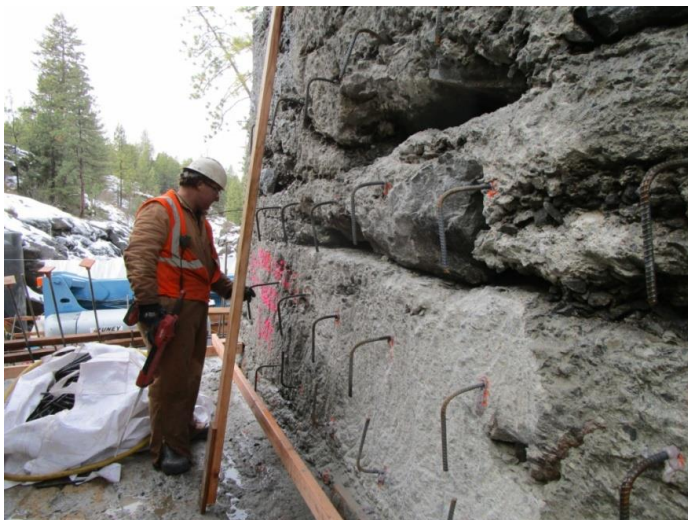
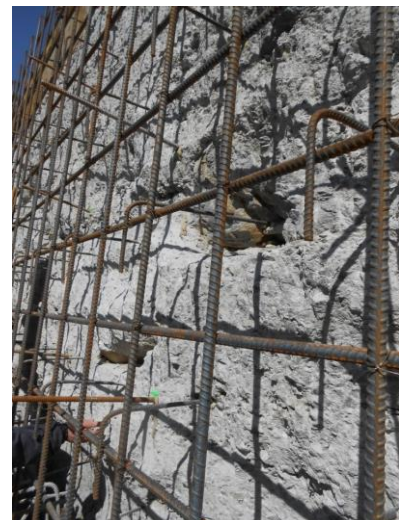
Figure 7. Existing Concrete Voids, Drill and Epoxy Dowel Installation, and Facing Concrete Reinforcement

Due to the extent of the concrete voids and the zones of low strength material, the reinforcement dowl design was revised. The reinforcement dowl size was increased, and the embedment into existing concrete was increased to provide more confidence in the facing concrete anchorage. The grid spacing was also increased to allow for field adjustment in order to properly locate the reinforcement dowels to anchor into the more competent concrete locations and into void areas. The existing concrete voids and the reinforcement dowl installation are shown in Figure 7 below.
