Repair of Failing Spirit Lake Outlet Tunnel at Mount St. Helens

J.P. Britton, PE, PhD¹, S.K. Askelson, PE¹, C.M. Budai, RPG, CEG, PMP¹, and D.H. Scofield, PE, RPG, CEG¹

¹U.S. Army Corps of Engineers
Portland District
Portland, OR 97204
USA

Keywords: Tunnel, heave, steel ribs, shotcrete, Mount St. Helens, Spirit Lake.

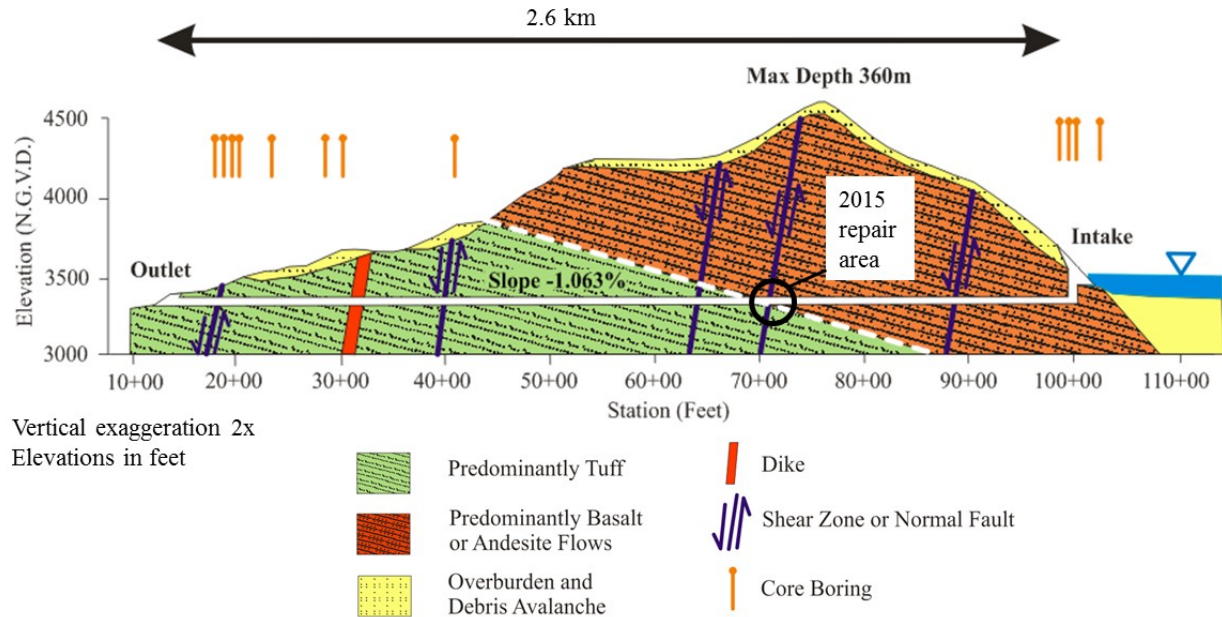
Figure 2. Geologic profile along tunnel (left is west, right is east)

Twelve shear zones and faults were encountered along the tunnel. The affected areas varied from 1 m (3 ft) to upwards of 20 m (66 ft). The primary condition of the shear zones is fractured rock in various stages of decomposition and some plastic to low plasticity fines. Within the shear zones are thin seams of clay gouge. Most of these shears are steeply dipping and cross the tunnel nearly normal to the centerline. The most serious shear zones were the Julie and Kathy L. shear zones, where two zones of about 15 and 20 m (49 and 66 ft) were encountered near the geologic contact and maximum ground cover. The shears were in ashy volcanic tuffs decomposed to weak rock and swelling clays. Spalling and squeezing ground occurred, and the grippers on the tunnel boring machine could not grip the rock. In addition, the soft clay caused significant deviation of the vertical alignment. Hand mining was required in some areas so that steel sets could be placed.

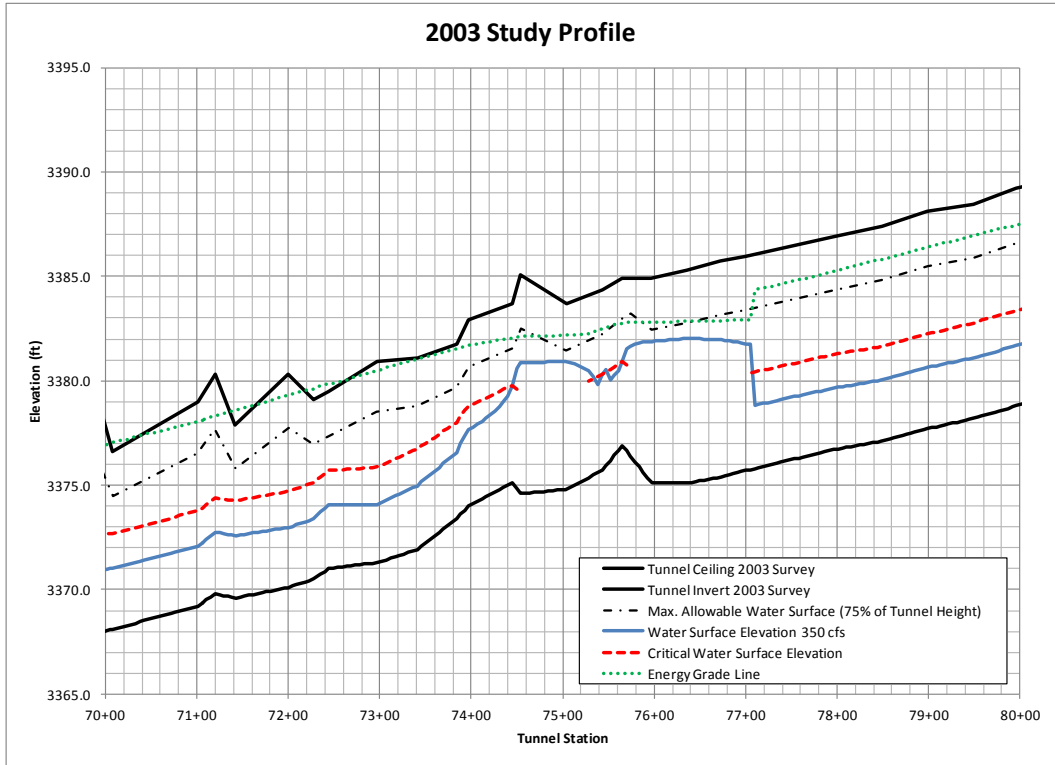
Analyzing model results indicated that the abrupt changes in the invert slope at stations 74+45 and 75+65 (see Figure 3) result in a hydraulic jump forming near station 77+25. The tunnel would not be able to pass the design flow of 15.6 m³/s (550 cfs) without violating the flow depth design criterion. Furthermore, USACE (1980) describes how slug flow can develop when the water surface exceeds 80-85% of the conduit height due to unaccounted-for air bulking, particularly with hydraulic jumps.

Figure 3. Water surface profile for flow of 9.9 m³/s (350 cfs) and 2003 geometry conditions

A HEC-RESSIM model was used to assess the increase in flood risk associated with restricting the Spirit Lake outflow. Flood risk is the risk of the lake elevation exceeding the maximum safe level during a flood event, which could result in debris blockage failure and lake break-out. The minimal increase in flood risk associated with a safe, lower outflow was deemed acceptable compared to the risk associated with pressurization and/or slug flow within the tunnel. A recommendation was made to restrict flow in the tunnel to 9.9 m³/s (350 cfs) by partially closing the intake gate to three-quarters open. Figure 3 shows the water surface profile for this flow.

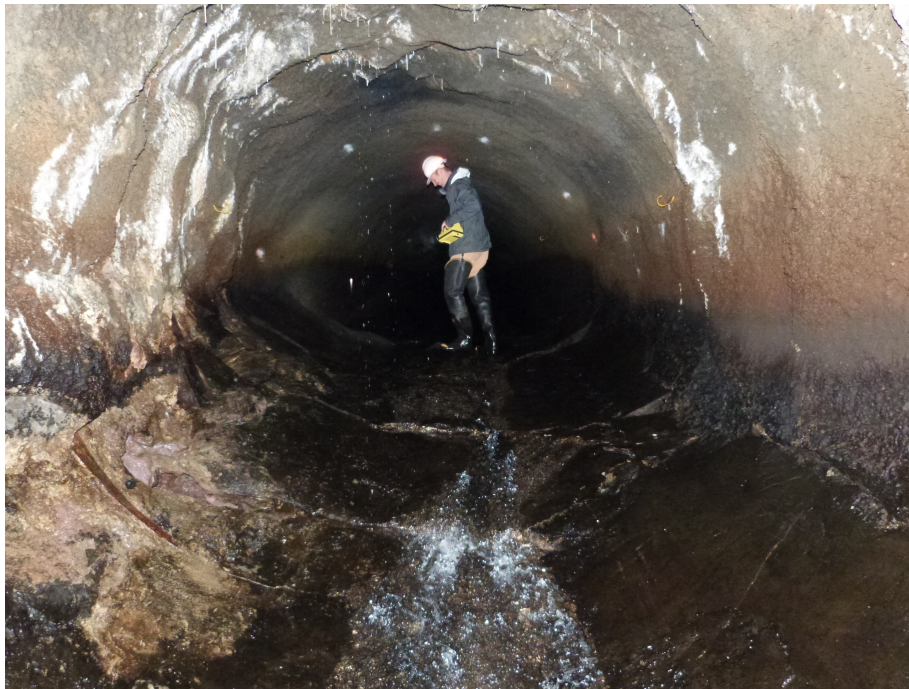
Significant tunnel invert heave was discovered during a routine inspection in October 2014 (See Figure 4). The heave is located at the upstream end of the Julie and Kathy L. shear zone complex, in the vicinity of the geologic contact between volcanic tuffs and lava flows and the high-angle Kathy L. shear zone, which required extensive steel supports during original construction. The heave location is about 30 m (100 ft) upstream of the 1996 repair area. The location is identified in Figure 2 as the 2015 repair area.

Figure 5 shows the geologic mapping from original construction and the approximate extent of heave. The heave began a long time ago due to high ground pressures, the weakness of the sheared tuff dipping beneath the tunnel, the adverse orientation of fractures in the basalt, and the absence of steel rib sets. For several years, the amount of heave remained steady at approximately 61 cm (24 in.). The distress was limited to the tunnel invert; the shotcrete lining on the walls and crown showed no cracking or distress. During the October 2014 inspection, 46 cm (18 in.) of additional heave was measured. Existing cracks in the cast-in-place concrete invert showed severe dilation. Again, the walls and crown showed no distress. A follow-up inspection in April 2015 revealed another 10 cm (4 in.) of heave. The tunnel diameter had now been reduced to approximately 2.1 m (6.8 ft). This segment of the tunnel was in an active state of heave failure.

Figure 4. Photo of heave in tunnel

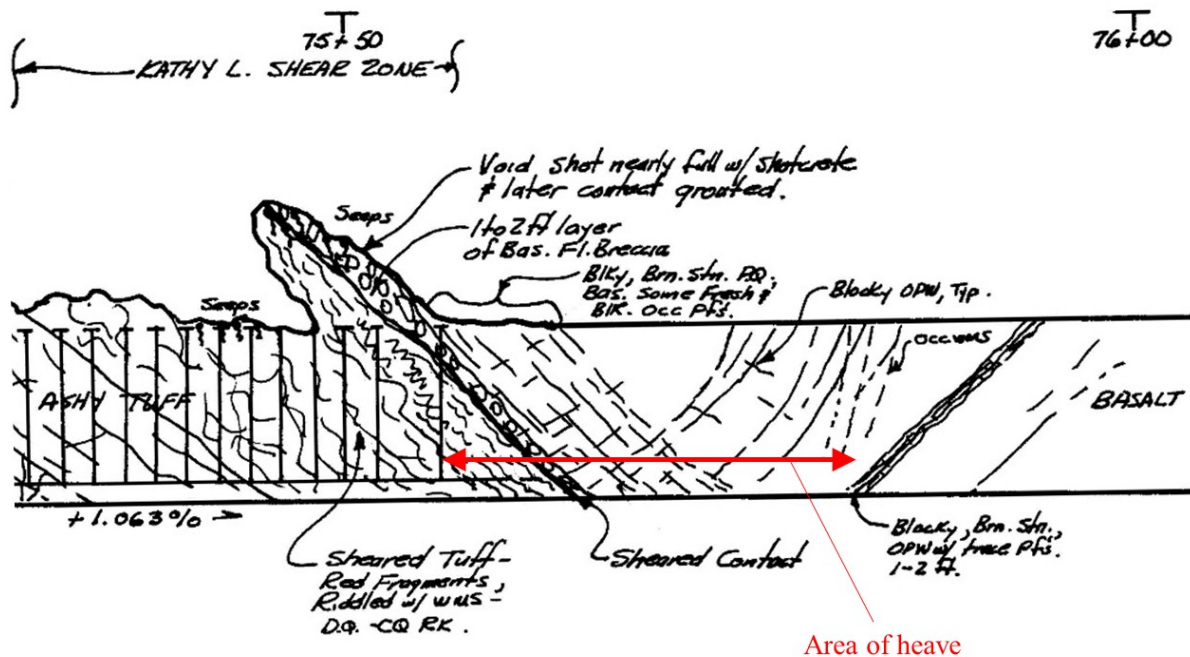
Figure 5. Geology in area of heave (from USACE 1987)

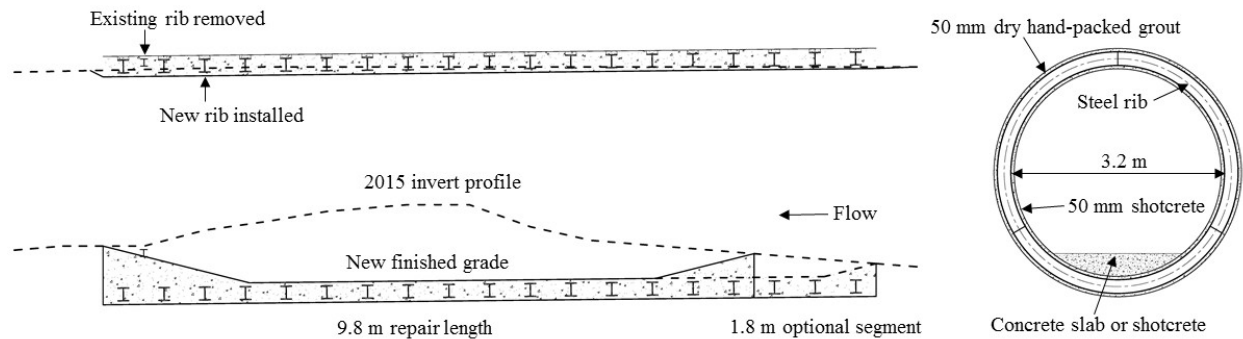
Figure 6. 2015 Repair design profile and section

The loading conditions in the area of the 1996 repair were more severe than the loading conditions in the area of the 2015 repair. In the 1996 repair area, the full tunnel circumference was subjected to squeezing ground conditions. In the 2015 repair area, only the invert was subjected to squeezing ground conditions from the sheared tuff dipping below the fractured basalt. The tunnel walls and crown showed no signs of distress. The 2015 repair design called for the installation of full-circle W200x42 (W8x28) rib sets (with 345 MPa/50 ksi steel) on 0.6 m (2 ft) centers. This was the same rib set design as used in 1996, except no rib sets were spaced at 1.2 m (4 ft). The 2015 repair design then called for the rib sets to be covered with a minimum of 50 mm of steel fiber-reinforced shotcrete.

Figure 6 shows both a profile and section of the 2015 repair design. The heave invert profile was measured in April 2015. The heaved material was assumed to consist of about 0.3 m (1 ft) of cracked concrete overlying blocky basalt and sheared tuff. During inspections, it was difficult to observe the invert conditions near the upstream end of the area due to the pool of water behind the crest of the heave profile. The plan was to assess the need to extend the repair into the “optional segment” shown in Figure 6 after the contractor established a cofferdam upstream of the area. At the downstream end of the repair, the exposed and deformed original rib set at station 75+53 was to be removed.

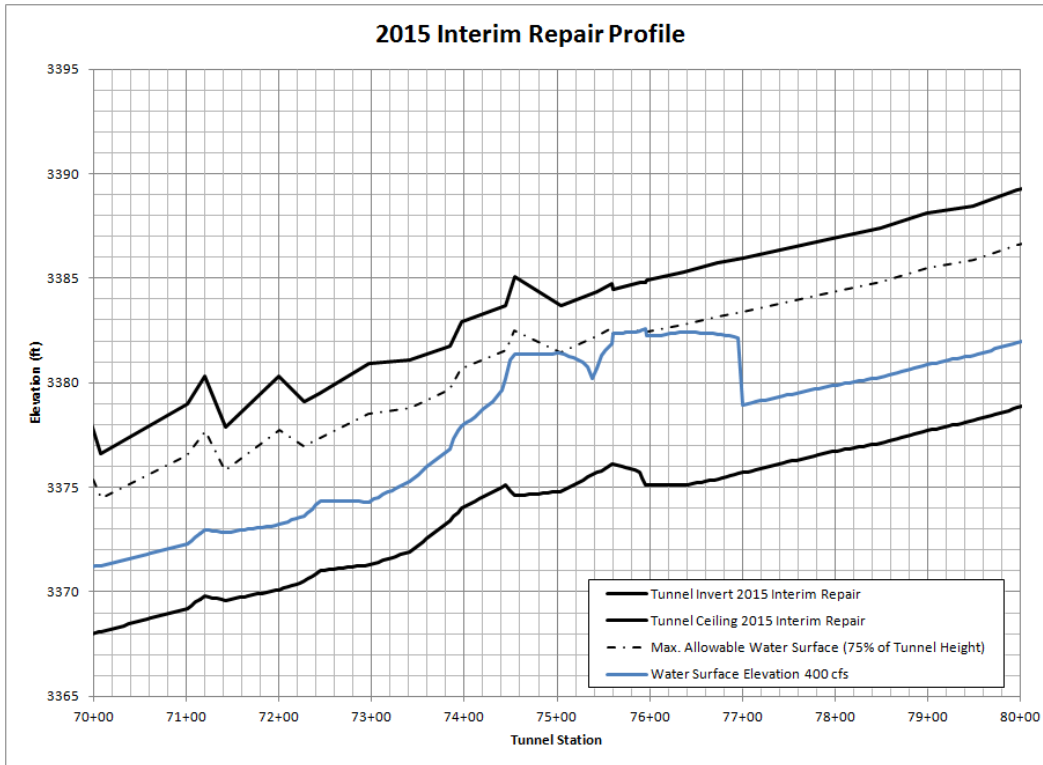
Figure 7. Water surface profile for flow of $11.3 \text{ m}^3/\text{s}$ (400 cfs) and 2015 repair geometry conditions

The 2003 HEC-RAS hydraulic model was updated with the proposed repair geometry. Invert elevations were adjusted to represent the repair cross sectional area with a diameter of 3.1 m (10.2 ft). The results of the hydraulic modelling indicated that the tunnel would pass 11.3 m³/s (400 cfs) without violating the flow depth design criterion (see Figure 7). This flow capacity is greater than the 2003 restricted capacity of 9.9 m³/s (350 cfs). The additional flow capacity will allow for larger gate openings, which will result in lower Spirit Lake elevations. This will decrease the likelihood of exceeding the safe lake elevation. Furthermore, the lower lake elevations will result in less head on the gate, which will reduce the potential of higher flows within the tunnel. This will further decrease the risk of pressurization and/or slug flow within the tunnel.
