Microstructural Effects Regarding Fracture of Clinically Retrieved Dental Sonic and Hand Scalers

H. J. Mueller

MICROSTRUCTURAL EFFECTS REGARDING FRACTURE OF CLINICALLY RETRIEVED DENTAL SONIC AND HAND SCALERS

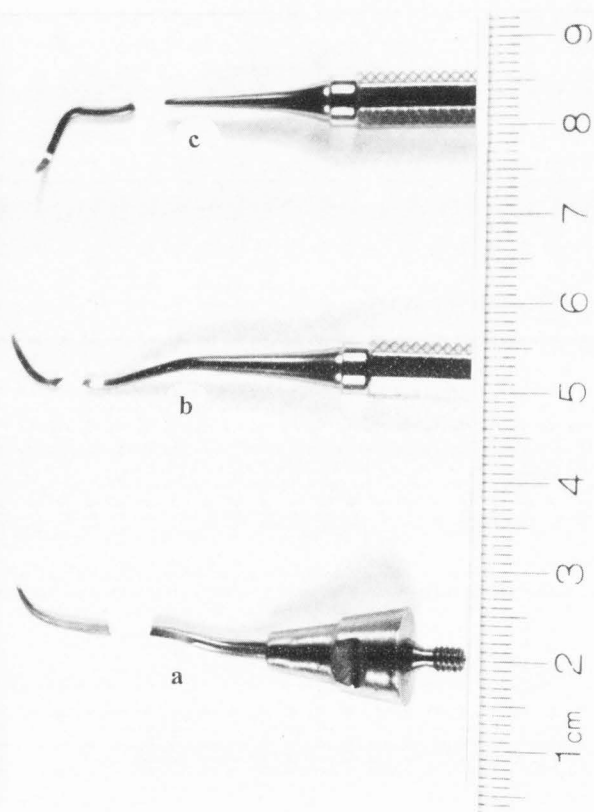
Figure 1. Broken scalers: (a) sonic, (b) SH6/7 hand, (c) S204S hand.

Figure 1 shows broken scaler instruments, including both the main scaler piece and the smaller tip piece. For all of the sonic scalers (Fig. 1a), clinical fracture occurred about 10 mm from their tips. Fractures occurred within the instrument length where the cross-section was still square in configuration. At about 15 mm

from the instrument tip, the square cross-section changed to circular. For the SH6/7 scaler (Fig. 1b), fracture also occurred about 10 mm from its tip, just before the cross-section changed from the four-sided geometry to circular. For the S204S scaler, clinical fracture likewise

occurred about 10 mm from the tip, just before the second bend where a circular cross-section occurred. This scaler type has ground flat sides extending from the tip to just past the first bend. The fracture shown in Figure 1c for an S204S instrument, located about 20 mm from the tip well past the second bend, occurred in a laboratory bend specimen.

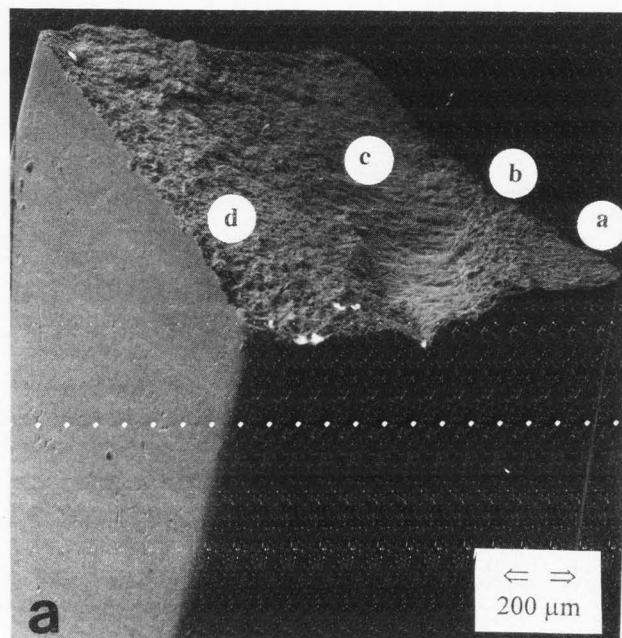
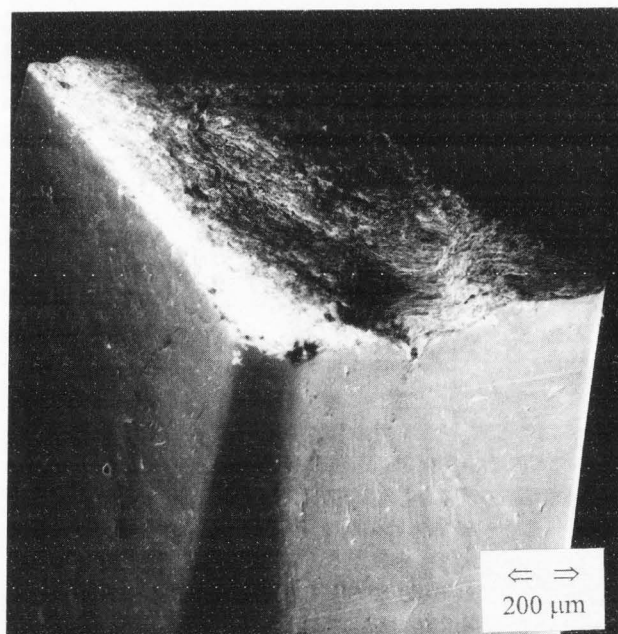
Figure 2. Scanning electron micrographs. (a) Secondary electron image of the fracture surface from a clinically retrieved broken sonic scaler showing regions (a), (b), (c), and (d). (b) Negative voltage bias image, the instrument sides are shown with better clarity than in Figure 2a.

Figures 2a (secondary electron) and 2b (negative voltage bias) present low magnification micrographs of the fracture surface from a clinically retrieved sonic scaler. Figure 2b depicts, with better clarity, the condition of the instrument sides and reveals numerous microcracks running mostly in a longitudinal direction. The fracture surface is distinguished by four regions: (1) region a, the first stage of fracture, represents crack initiation from the bottom corner, positioned on the convex side of the instrument curvature, and extending a short distance inwards; (2) region b corresponds to a halo region extending a short distance beyond region a; region b has a more granular appearance and is partially slanted; (3) region c covers the largest area percent of the fracture surface and contains features running in the direction of fracture; the microscopic flatness of region c is depicted in Figure 3, the crack running lengthwise through the center of the micrograph extends, with reference to Figure 2a or 2b, radially from the deepest depression on the left to almost the mid-length of the right-bottom side; and (4) region d, shown in Figure 4, covers the topmost part of the fracture surface and is characterized by a granular appearance with particles often at the center of dimples.

The fractographic analyses served a useful purpose in providing information about the way the scalers fractured and their stress state at the time of fracture. All three clinically retrieved sonic scalers led to the same conclusion regarding instrument loading and fracture. Fracture initiated at the corner on the convex side of the instrument curvature, suggesting that the scaler tip was being pushed up against an object such as a tooth at the time of failure. The ultrasonic vibrations induced within the instrument tip while under load may also have accelerated the initiation and propagation of cracks from mechanical cycling fatigue. With this scenario, tensile opening stresses, equivalent to mode I loading in fracture mechanics terminology (Anderson, 1991), was applied to the convex corner of the instrument. The presence of stringer inclusions may have resulted in preferred initiation sites. Once initiated, the crack propagated a short distance, as shown by the flat area (region a in Fig. 2), and then radiated outwards and almost perpendicular to the instrument sides. However, as the crack propagated, it soon required an adjustment in its direction in order to accommodate the changing direction of the applied force, which may have been generated by an inward bending and pushing of the instrument, as revealed by the partially slanted surface in region b. Soon thereafter, the conditions for brittle fracture were met, and fracture entered into region c where fast crack propagation occurred until the crack advanced almost to the top edge. Stringers within the microstructure accelerated brittle fracture within region c, as suggested by the presence of surface cracks running perpendicular to the fracture surface (Fig. 2b). Higher magnification of these surface cracks revealed numerous microcracks connected by stringer inclusions. Hence, brittle fracture may have occurred under the conditions imposed on the instrument due to a reduction in yield strength of the steel because of the presence of stringer inclusions. The remaining portion of unfailed material was unable to support any load that was still applied and easily fractured in a ductile manner, resulting in region d, with a shear lip.

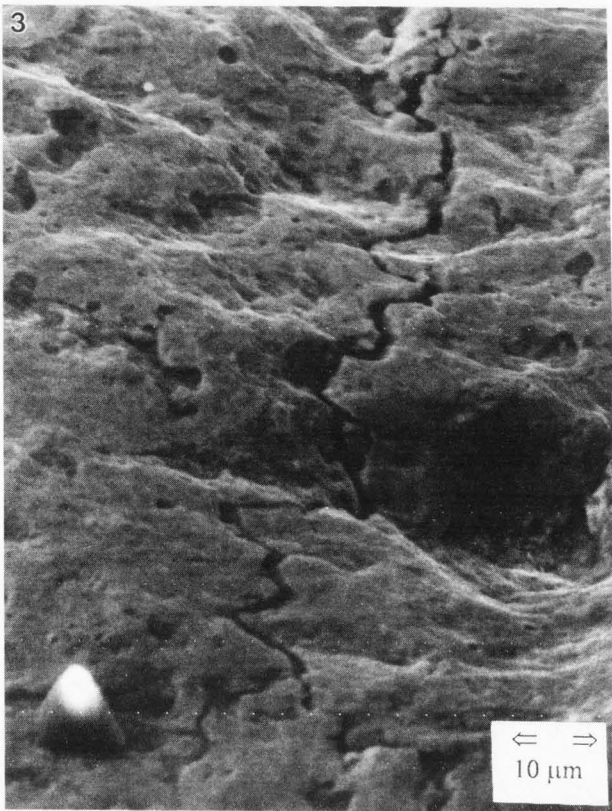
Figure 3. Higher magnification scanning electron micrograph of region c from the fracture surface shown in Figure 2a.

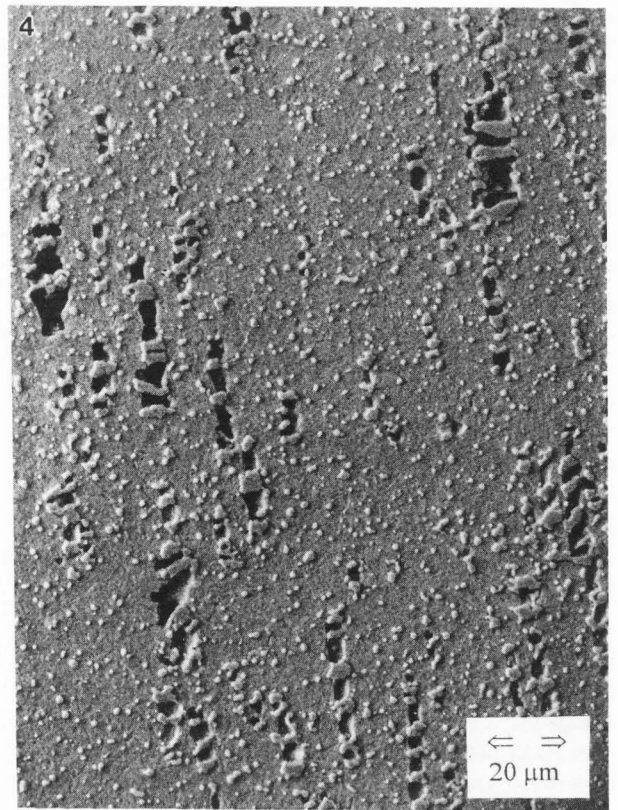
Figure 4. Higher magnification scanning electron micrograph of region d from the fracture surface shown in Figure 2a. Particle: a; dimple: b.

EDS spot analyses for constituents on the fracture surfaces for sonic and hand scalers yielded spectra similar to those for the particles and matrix from the polished and etched surfaces. The particles and surrounding dimples shown in Figure 4 correspond, respectively, to particles and matrix from the etched surface. Analysis of the microscopic flat regions, shown in Figure 3, yielded spectra similar to those for the particles and matrix. Spot analyses of selected particles and regions

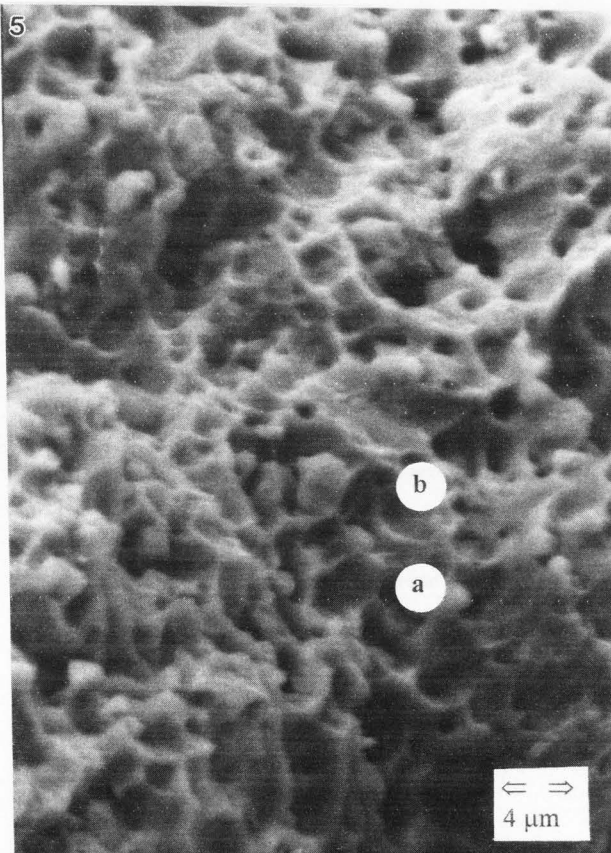
Figure 5. Scanning electron micrograph of polished and etched section of sonic scaler. Longitudinal axis of instrument runs lengthwise. Carbide particles and stringer inclusions (phase removed by etching) in matrix of martensite. Phases are identified in Figure 6.

Figures 5 and 6 present scanning electron micrographs of a polished and etched longitudinal section from the fractured sonic scaler tip shown in Figures 2, 3 and 4. Microstructural characterization of the remaining two

throughout the microstructure, its presence could be overlooked. But because of its widespread occurrence (Fig. 5) throughout all four scalers of this type, reason exists to strongly suspect that an inferior lot of steel was used in making these instruments. While the presence of these foreign inclusions has not been unequivocally linked to degradation in properties such as hardness, caution nevertheless was generated. The mean microhardness of the sonic scaler was found to be about 6% higher than that of two other instruments of different design. Microhardness, however, may be a poor indicator for detecting the effects of inclusions on properties, since random positioning likely placed the Vickers indenter directly over inclusions in only a few measurements out of a total of ten. Because of the ease in dissolving away this phase due to chemical etching, the inclusions may be relatively soft. Furthermore, because of the brittle nature (Kerlins and Phillips, 1987) of the fracture surface, concern must be given to a possible structure-property relationship due to inclusion content. Figure 2b reveals a number of longitudinal microcracks on the sides of the broken sonic scaler that are highly suspected to have propagated between surface imperfections of the stringer type. Subsequent observation of a polished section perpendicular to the fracture surface of the scaler generated additional speculation. It was noticed that microcracks were projected from the fracture surface into the bulk via stringer inclusions, which acted as both crack initiation sites and as sites of facile crack propagation. Therefore, it is highly likely that the presence of a large numbers of stringers within the microstructures of sonic scalers resulted in inferior steel quality, which was a leading cause of the failure experienced by practitioners. Even if stringer inclusions were not the basis of scaler failures, sound metallurgical practice requires elimination of such inclusions or, at least, a substantial reduction in their amount.

- (4). Microhardness requirements alone, which are used in ANSI/ADA specifications for these instruments, are inadequate to prevent the use of inferior quality steel such as that containing stringer inclusions. Recommendation is made that a microscopy requirement or another test also sensitive for the detection of stringer inclusions be added to the appropriate specifications.

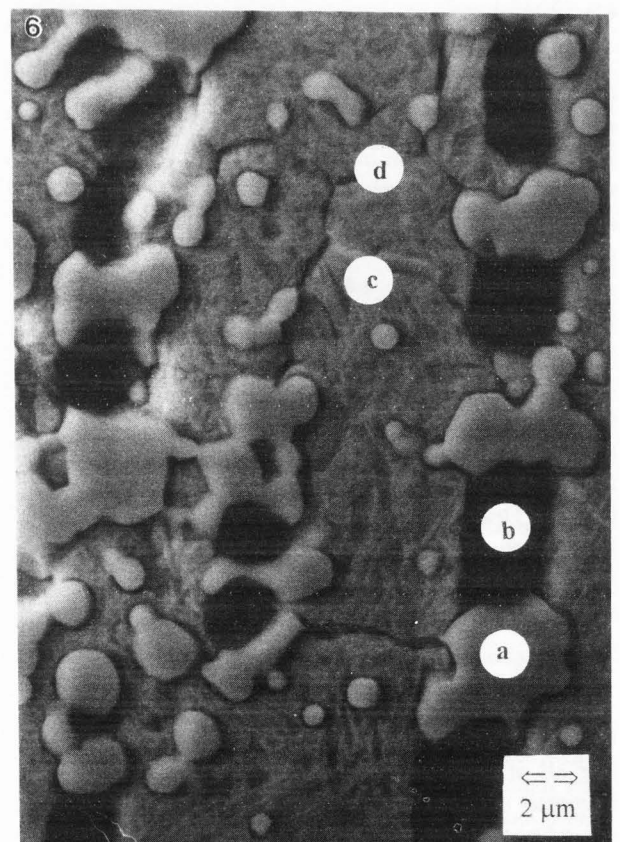
Figure 6. Higher magnification scanning electron micrograph of Figure 5. Carbide particles: a; etched-out stringer inclusions: b; platelets of martensite within grain interiors: c; grain boundaries: d.

quenching the austenite structure from high temperature to room temperature, platelets of martensite formed, giving high hardness to the steel; these martensitic platelets can be observed within the grains of the etched structure in Figures 5 and 6. Reheating the hardened steel to temperatures up to about 480°C has the potential to relieve stresses built-up within the strained martensitic platelets, while reheating in the 540-650°C range tempers the structure by resizing and redistributing the carbide particles so that more desirable properties for useful applications can be obtained. Hence, it is essentially the latter operations that are variable under the control of the manufacturer and crucial in processing instruments with optimum dental performance. The martensitic stainless steels are sensitive to heat treating variables. Rejection rates due to faults in heat treating can be high (ASM, 1981).

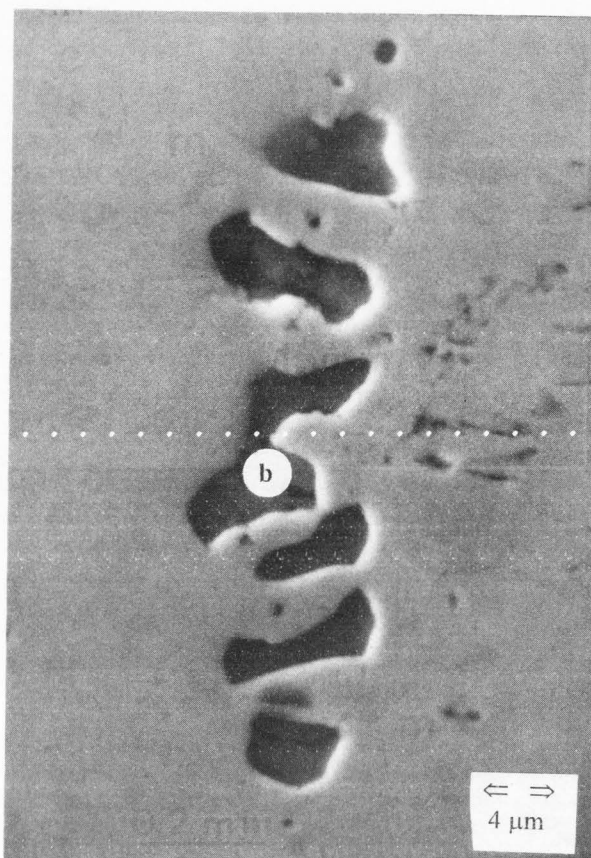
Figure 7. Scanning electron micrograph of polished only section of sonic scaler. Longitudinal axis of instrument runs lengthwise. The darker irregular areas (b) within center of micrograph correspond to material within stringer inclusion. These correspond to the areas that were etched out and shown as dark patches or voids in Figures 4 and 5.

over the entire fracture surface detected, at times, relatively high concentrations of Ca, Si, Al, and, at times, relatively strong concentrations of S, moderate concentrations of Mg and Cl, and relatively weak concentrations of Zn. The detection of Ca, Al, and Si qualitatively agreed with the spectra obtained from the as-polished section for inclusions shown in Figure 7.

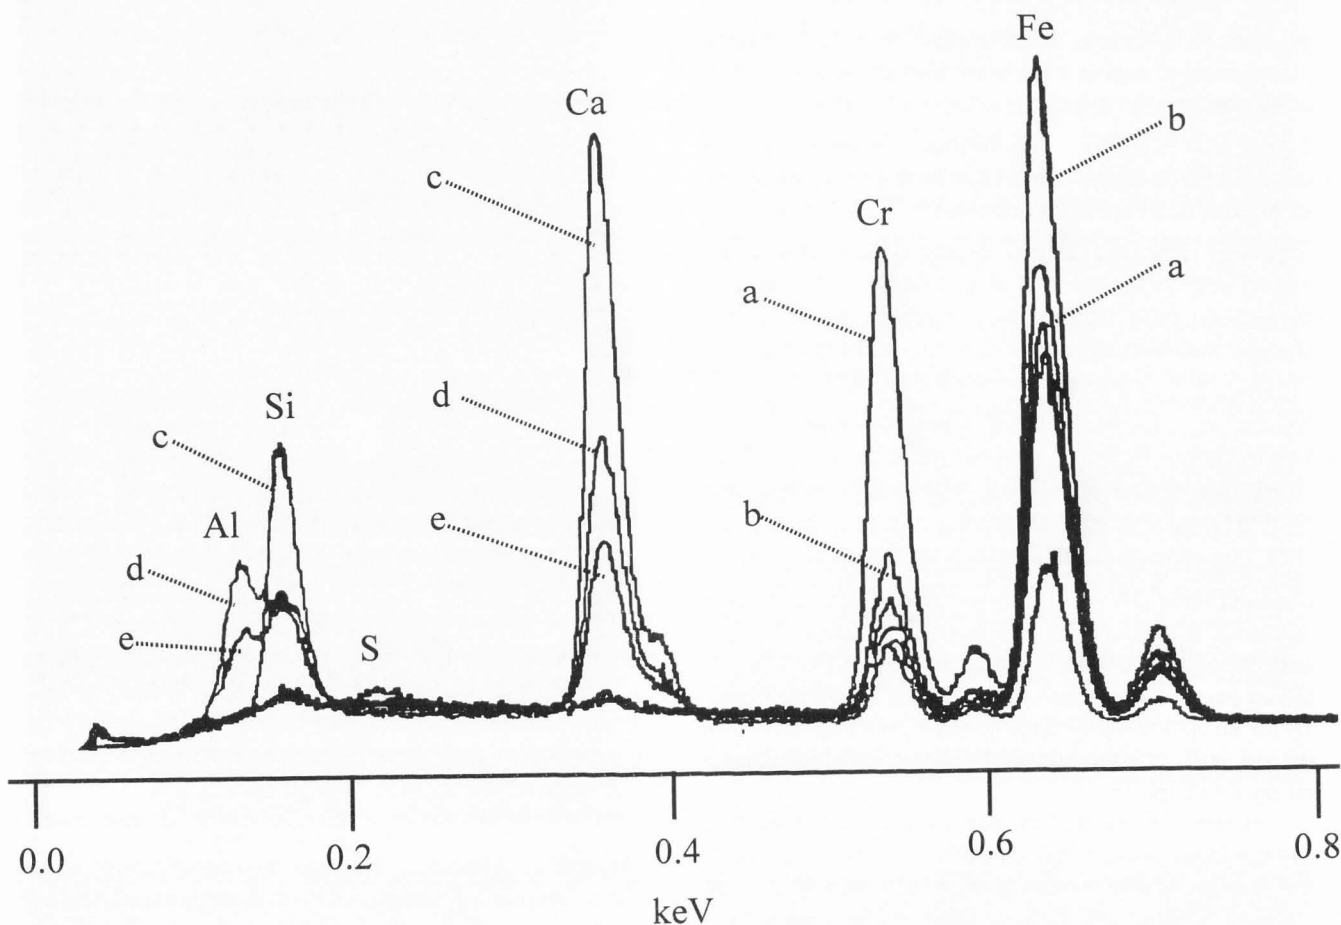
EDS spot analyses (Fig. 8) of the microstructural constituents, shown in Figures 5 and 6, revealed the particles to be rich in Cr, with lower Fe, and with a small but detectable amount of S, while the matrix was rich in Fe but with lower Cr. Semi-quantitative analysis with a software program utilizing ZAF corrections revealed

Figure 8. EDS spectra of carbide (a) and matrix (b) phases of polished and etched section from sonic scaler (Figure 5) and three spectra (c, d, e) from different spots of stringer material (Fig. 6). Full scale equals 3900 counts.

the composition of the particles by mass fraction to be 55-60% Cr, 40-45% Fe, and 0.5-1.0% S, and the matrix to be 15.5-16.0% Cr with the balance Fe. No distinctions were found in composition between the larger and smaller particles. EDS spot analyses of the inclusions shown in Figure 7 are also presented in Figure 8. Since variations in spectra occurred depending upon spot location in the stringer, a number of representative spectra are presented. Besides detection of Cr and Fe, the inclusions also contained Ca (at times, high levels) and low to moderate levels of Si and/or Al.

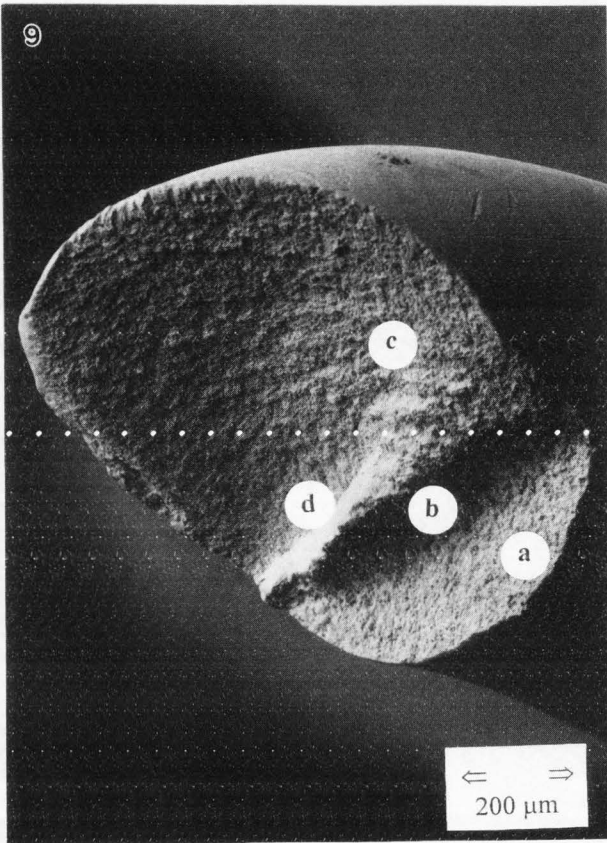
Figure 9. Scanning electron micrograph of fracture surface from clinically retrieved S204S hand scaler showing regions (a), (b), (c), and (d).

Figures 9, 10, 11 and 12 present micrographs of the fracture surface from the clinically fractured S204S scaler. The surface topography contained a pronounced discontinuity. The surface is divided into four regions. Region a (Fig. 9) extends from the lower circular edge, where crack initiation occurred and corresponds to concave part of the instrument curvature, to where the surface became partially slanted upward. Region b, which is slanted upward, extends for only a short distance before region c commences. Figure 10 shows the granular appearance of region b compared to the dimpled appearance of region c. Fracture in region c initiated from the right side of the instrument and progressed in a circular fashion from the right side to the left side of the instrument (Fig. 9). Higher magnification of region c above

Fractographic analysis of the S204S clinically retrieved scaler revealed more complexity in its loading pattern. Since crack initiation occurred on the concave side of the instrument curvature, it was inferred that the scaler was being pulled in bending, as might occur by

hooking the tip around an object while being pulled. In this manner, tensile opening stresses were applied to the concave surface, initiating a crack that propagated a short distance inwards (region a in Fig. 9). Both tensile (mode I) and in-plane shear stresses (mode II) were required to characterize the stress state of the system, since both pulling and bending took place. Hence the fracture plane was required to become slanted (region b) in order to accommodate both types of stresses. Shortly thereafter, however, the scaler must also have been subjected to a twisting motion that included out-of-plane shear stresses (mode III). At this point, the fracture entered region c, where crack propagation continued radially from the right to left side. As the crack was completing its semicircular path to the left side, the position of the crack generated in region c did not exactly meet the crack that had propagated on that side in region b. Hence, the last part of the instrument to fracture was the remaining small portion characterized by a flat step (region d). The shear lip existing on the upper left edge of the circular geometry supports the mechanism for region c.

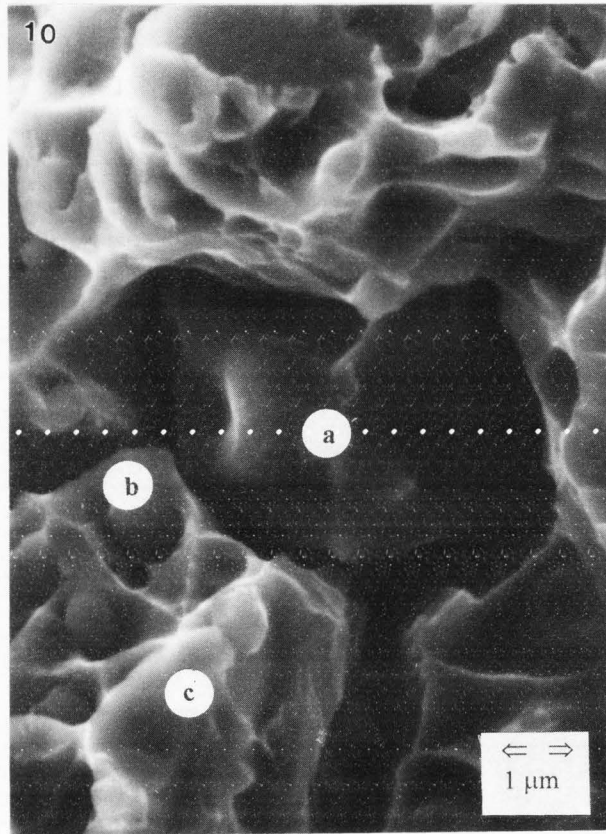
Figure 10. Higher magnification scanning electron micrograph between regions b and c from the fracture surface shown in Figure 9.

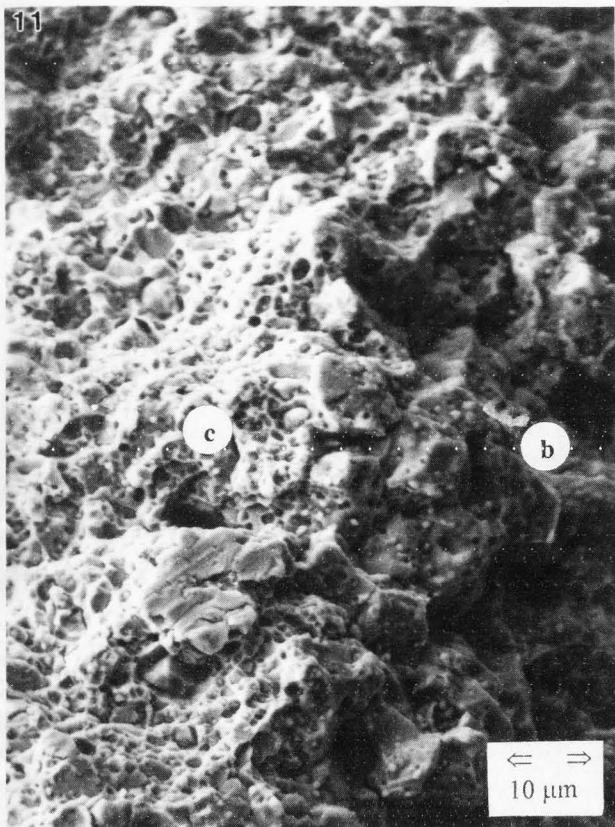
Figure 11. Higher magnification scanning electron micrograph of region c from the fracture surface shown in Figure 9. Primary carbide (a), secondary carbide with small dimple (b), and left side of dimple surface emanating from primary carbide (c).

the step is characterized by features shown in Figure 11. Here particles, both larger and smaller, are located at the bottoms of dimples. Finally, region d (Fig. 9), characterized by the flat surface of the step, is shown at higher magnification in Figure 12. The relatively flat step contained narrow and shallow grooves, observed as lines, running across its width. EDS analyses often yielded spectra across most of the fracture surface representative of particles and matrix, as detected on the etched surface shown in Figures 4, 5 and 6 for the sonic scaler.

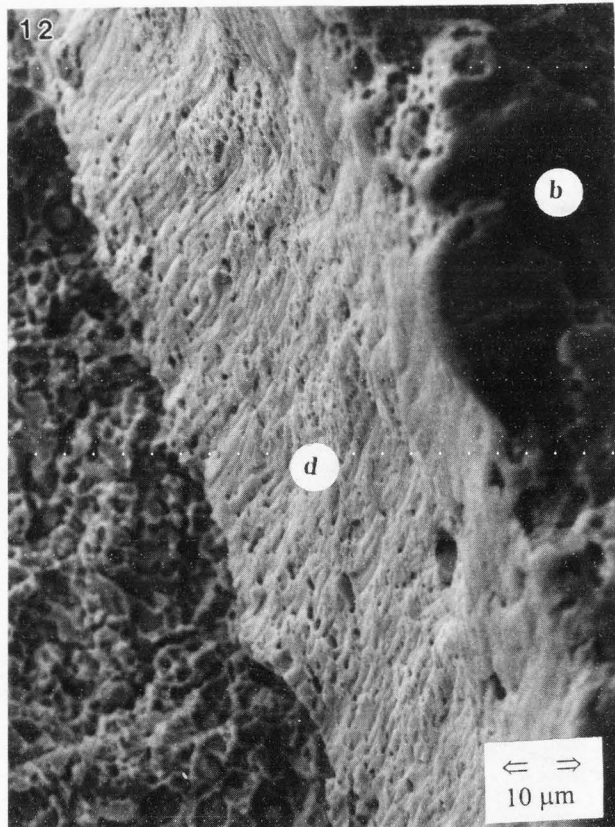
Figure 12. Higher magnification scanning electron micrograph of region d from the fracture surface shown in Figure 9.

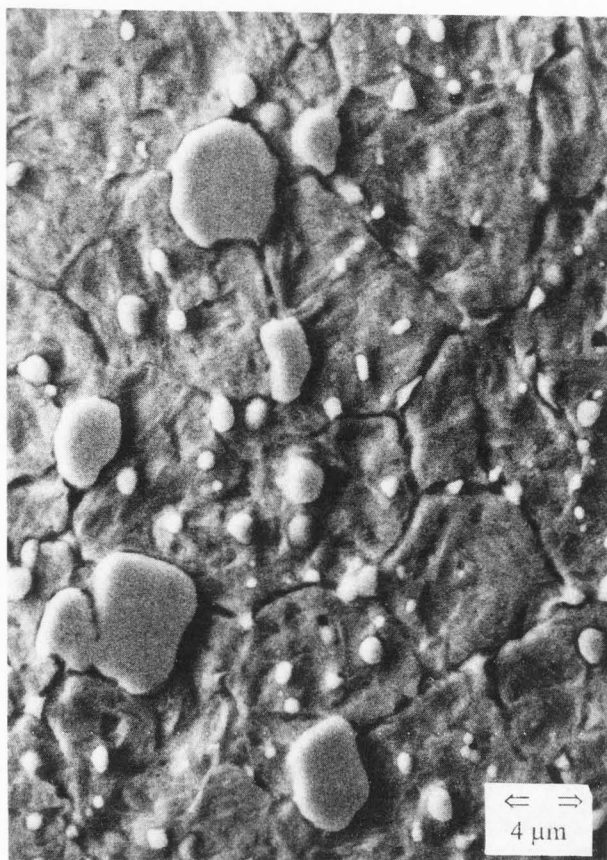
Figure 13. Scanning electron micrograph of polished and etched section of S204S hand scaler. Microstructure similar to Figures 5 and 6 for sonic scalers except for the absence of stringer inclusions.

Figure 13 presents the polished and etched microstructure for a section from the S204S broken scaler. Except for the absence of dark patches of longitudinal stringers, the microstructure is similar to that of the sonic scalers shown in Figures 4, 5 and 6. Characterization of the polished and etched SH6/7 scaler revealed similarities to S204S. The larger particles from SH6/7, however, were only about one-half the size of those from S204S. Both of the non-sonic scalers revealed no stringer inclusions.

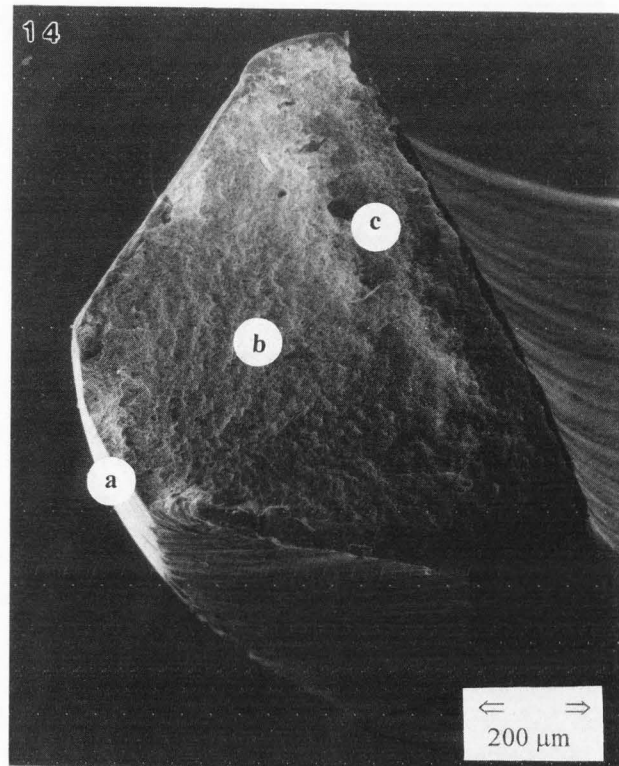
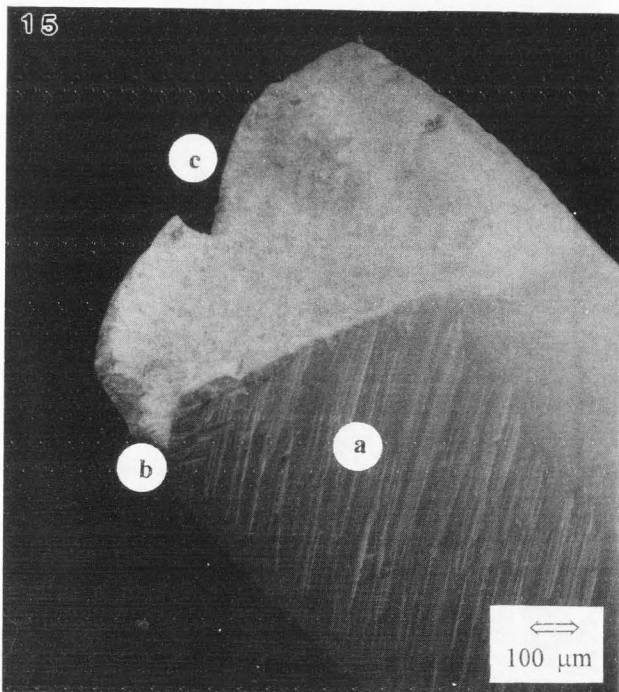
Figures 14 and 15. Scanning electron micrographs of fracture surface from clinically retrieved SH6/7 hand scaler. Regions a, b, and c are identified in Figure 14. Figure 15 is taken at an optimum angle to reveal grinding grooves and their effects upon crack initiation and propagation: grinding grooves: a; crack initiation site: b; effects upon crack propagation: c.

Figures 14 and 15 present low magnification micrographs of the fracture surface from the clinically retrieved SH6/7 scaler. Three regions characterize this surface. Region a represents the left part of the upper circular edge (Fig. 14) where crack initiation occurred.

Figure 15 shows that rough grinding grooves, occurring on the instrument sides, influenced the direction of fracture at initiation. Region b covers most of the fracture surface and includes the area where the crack radiated outwards and downwards from region a. Again, on the right instrument side, the occurrence of grinding grooves influenced crack propagation, as evidenced by the slanted edge over part of its length. Region c, corresponding to the bottom portion of the fracture surface just before the widest part of the instrument, is characterized by a slight elevation in surface and by a more granular appearance.

For the clinically broken SH6/7 scaler, fractographic analysis revealed that the instrument was stressed by being pushed inwards since crack initiation occurred on the convex surface. The stress state consisted mainly of a tensile opening mode. Since the fracture propagated almost perpendicularly through the instrument, very little, if any, in-plane shear stresses occurred. Further, as the SH6/7 was pushed inwards, an inward rotation, also favoring this stress state, may have occurred. Moreover, since crack propagation occurred almost vertically from the top to the bottom edge, very little, if any, out-of-plane or twisting occurred. This scaler was the only example where the coarse grooves from grinding, still easily detected on the sides of the instrument, partially influenced the fracture direction. Since crack initiation occurred at a site influenced by grinding grooves (Fig. 15), it may be that fracture of this scaler was affected due to the concentration of stress at the site of the grinding grooves.

- (7). The presence of coarse grinding grooves on the instrument sides is discouraged since crack initiation and propagation can be affected.
