Development and Evaluation of the Midwest Guardrail System Placed Adjacent to a 2:1 Fill Slope

*Midwest States Regional Pooled Fund Research Program
Fiscal Year 2004-2005 (Year 15)
Research Project Number SPR-3(017)
NDOR Sponsoring Agency Code RFPF-05-09*

DEVELOPMENT AND EVALUATION OF THE MIDWEST GUARDRAIL SYSTEM (MGS) PLACED ADJACENT TO A 2:1 FILL SLOPE

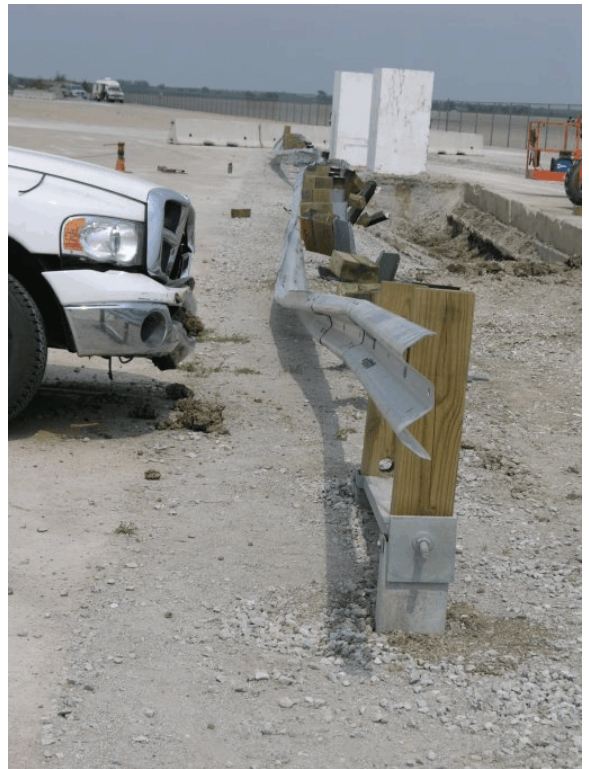
Figure 33. System Damage, Test No. MGS221-1

Damage to the barrier was moderate, as shown in Figures 33 through 41. Barrier damage consisted of deformed guardrail posts, disengaged wooden blockouts, contact marks on a guardrail section and posts, and deformed and fractured W-beam rail. The length of the vehicle contact along the MGS system was approximately 8.8 m (29 ft - 1½ in.), which spanned from 305 mm (12 in.) upstream from the centerline of post no. 13 through the midspan between post nos. 17 and 18.

Moderate deformation and flattening of the impacted section of W-beam rail occurred between post nos. 13 through 17. Contact marks were found on the guardrail between post nos. 12 and 18 and on the backside of the W-beam between post nos. 23 and 26. A 686-mm (27-in.) long diagonal tear in the rail occurred 127 mm (5 in.) downstream of post no. 5. A 25-mm (1-in.) long

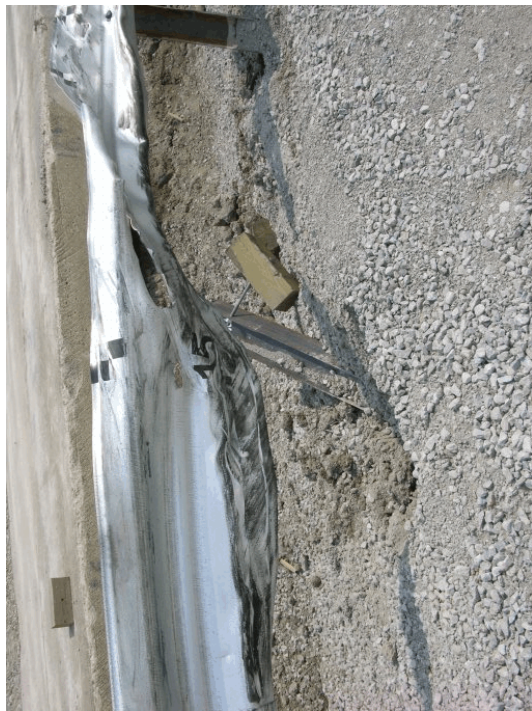
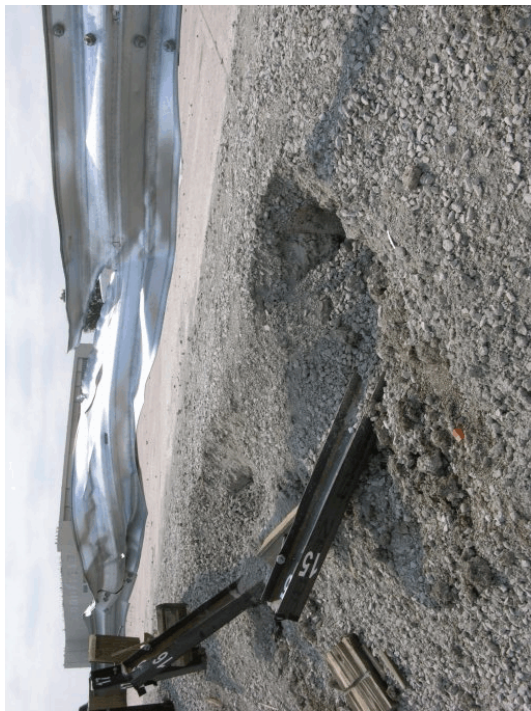
Figure 37. Post Nos. 15 through 17 Damage, Test No. MGS221-1

Steel post nos. 3 through 12 encountered minor twisting. Steel post nos. 13 through 17 twisted and rotated backward with major soil failure visible at the ground level. Steel post nos. 18 through 20 were undamaged. Steel post nos. 21 and 22 bent slightly, while post no. 23 bent downstream and rotated clockwise. The rear flange of post no. 23 was bent toward the web due to vehicle contact. Steel post nos. 24 through 26 bent downstream and backward and twisted counter-clockwise. The front and back flanges were bent backward at the top of steel post nos. 24 and 25. The upstream and downstream anchorage systems moved longitudinally. For the upstream anchorage, soil gaps of 102 mm (4 in.) and 38 mm (1½ in.) were found on the upstream and downstream sides of post no. 1, respectively, and for post no. 2, soil gaps of 64 mm (2½ in.) and 51 mm (2 in.) were found on the upstream and downstream sides, respectively. For the downstream anchorage, soil gaps of 13 mm (½ in.) and 51 mm (2 in.) were found on the downstream side of post nos. 28 and 29, respectively, while no soil gaps were found on the upstream sides of these posts. In addition, post no. 28 and 29 were uplifted out of the ground 102 mm (4 in.) and 229 mm (9 in.), respectively. However, the wooden posts in both anchorage systems were not damaged.

The wooden blockout at post no. 14 encountered damage on the front face, but it remained attached. The wooden blockouts at post nos. 15 through 17 were fractured and mostly removed from the post. All other wooden blockouts remained undamaged.

The vehicle override was attributed to the slow release of post no. 15 from the guardrail, thus causing the W-beam to be pulled downward. In addition, the vehicle override was also attributed to the failure of the vehicle's front suspension shortly after impact, thus preventing the guardrail from capturing the pickup truck's left-front tire.

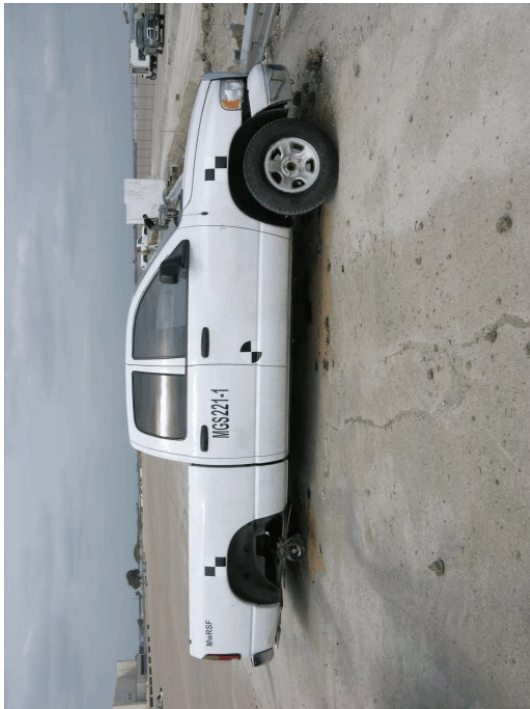
Figure 42. Vehicle Damage, Test No. MGS221-1

Exterior vehicle damage was moderate, as shown in Figures 42 through 44. Occupant compartment deformations to the left side and center of the floor pan were judged insufficient to cause serious injury to the vehicle occupants, as shown in Figure 45. Maximum longitudinal deflections of 6 mm (¹/₄ in.) were located throughout the left-side floor pan. Maximum lateral deflections of 13 mm (¹/₂ in.) were located at the rear-center of the left-side floor pan. Maximum vertical deflections of 13 mm (¹/₂ in.) were located on the floor pan near the left-side door. Complete occupant compartment deformations and the corresponding locations are provided in Appendix E.

Damage was concentrated on the left-front corner of the vehicle. The left-front corner was deformed inward toward the engine compartment. The left side of the grill was fractured and removed. The center of the front bumper buckled. The left-front, left-rear, and right-rear tires disengaged from the vehicle. Sheet metal tearing and major deformations were found along the lower portion of the left-side doors and the left-rear fender. The left side of the rear bumper was deformed upward. The left-side taillight was fractured, while the right-side taillight was slightly dislodged. The left-front, right-front, and right-rear brake lines were severed. The left-rear and right-rear shocks were fractured. The left-front upper control arm and left-front tie rod were fractured. The drive shaft was fractured and separated at the transmission yoke. The left-front sway bar linkage was

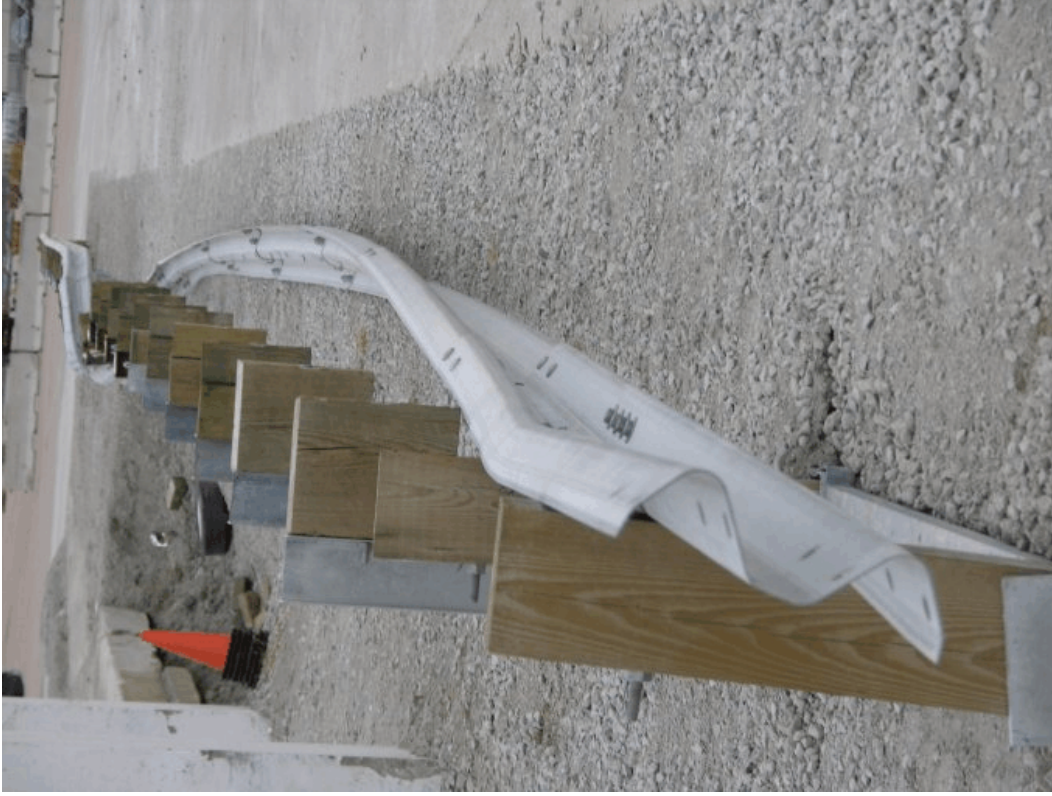
Figure 58. System Damage, Test No. MGS221-2

Damage to the barrier was moderate, as shown in Figures 58 through 64. Barrier damage consisted of deformed W-beam and guardrail posts, disengaged wooden blockouts, and contact marks on a guardrail section and posts. The length of the vehicle contact along the MGS system was approximately 12.42 m (40 ft - 9 in.), which spanned from 394 mm (15½ in.) upstream of the centerline of post no. 13 through 597 mm (23½ in.) downstream from the centerline of post no. 19.

Moderate deformation and flattening of the impacted section of W-beam rail occurred between post nos. 14 through 17. Contact marks were found on the guardrail between post nos. 12 and 20. Buckling in the rail occurred around the upstream cable anchor bracket. The guardrail buckled at post nos. 12 through 18. Rail buckle points also occurred at the midspans between post nos. 13 and 14, 14 and 15, and 15 and 16, at 229 mm (9 in.) and 508 mm (20 in.) downstream from post no. 15, at 330 mm (13 in.) downstream from post no. 16, and at 508 mm (20 in.) upstream from post no. 19. The W-beam rail sustained yielding around the post bolt slots at post nos. 2 through 19. The W-beam was pulled off post nos. 2 through 18.

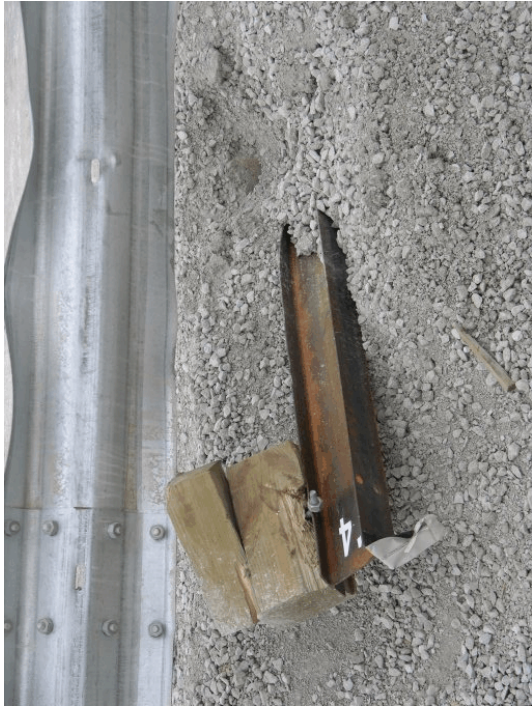
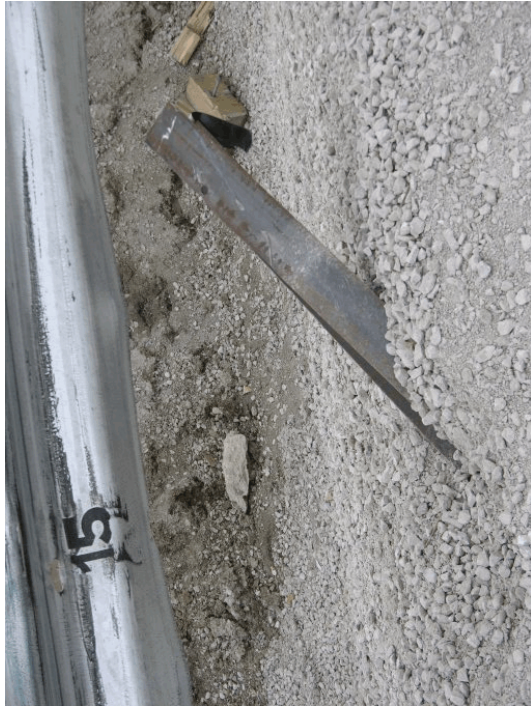
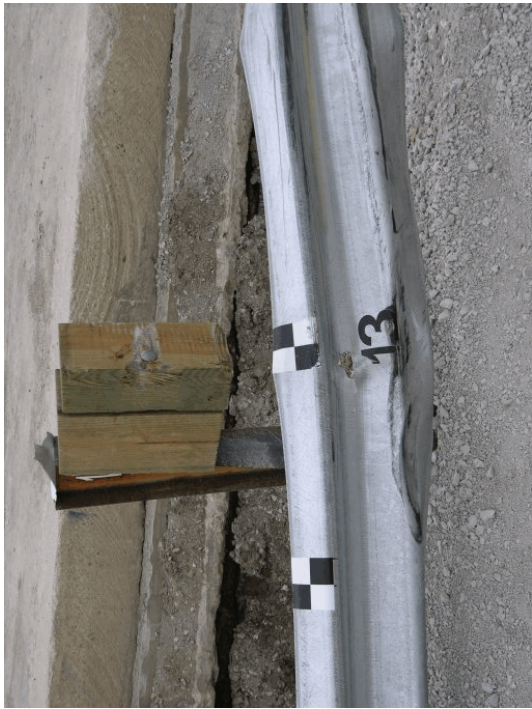
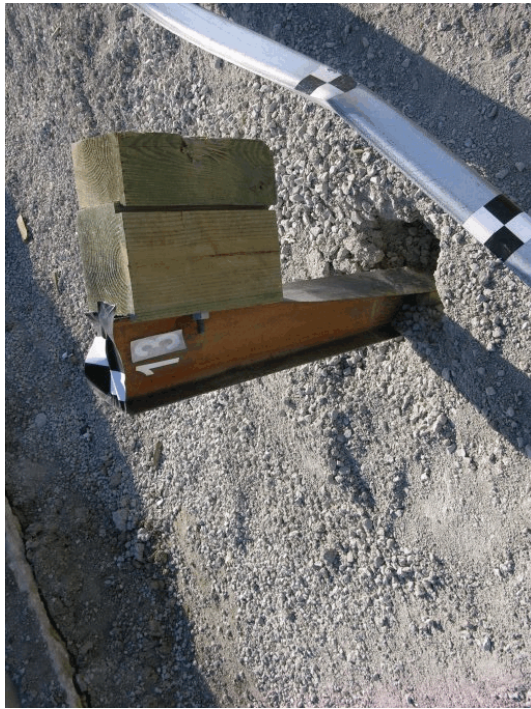
Figure 61. Post Nos. 13 through 15 Damage, Test No. MGS221-2

Steel post nos. 12 through 14 twisted and rotated backward. Post no. 14 also bent downstream to the ground. Post nos. 15 through 18 are bent and twisted downstream in the soil. Post no. 15 also encountered minor scraping and denting on the traffic face of the post. Post no. 16 encountered tearing in the flange at the bolt hole. The upstream and downstream anchorage systems moved slightly longitudinally. For the upstream anchorage, soil gaps of 121 mm (4¾ in.) and 89 mm (3½ in.) were found on the upstream sides of post nos. 1 and 2, respectively. For the downstream anchorage, a soil gap of 25 mm (1 in.) was found on the downstream side of post no. 29. However, the wooden posts in both anchorage systems were not damaged.
