# Midwest Guardrail System With Southern Yellow Pine Posts

TESTING CERT # 2937.01

*Midwest States Regional Pooled Fund Research Program  
Fiscal Year 2011 (Year 21)  
Research Project Number TPF-5(193) Supplemental #31  
NDOR Sponsoring Agency Code RFP-11-MGS-1*

# **MIDWEST GUARDRAIL SYSTEM (MGS) WITH SOUTHERN YELLOW PINE POSTS**

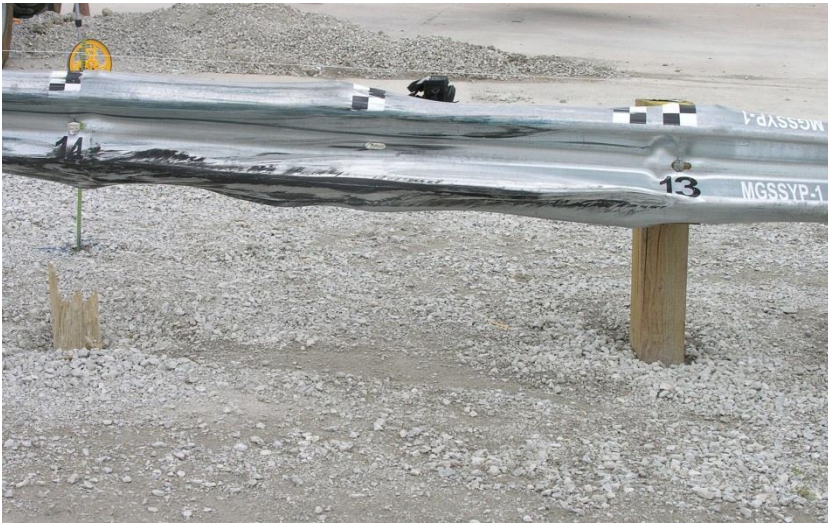
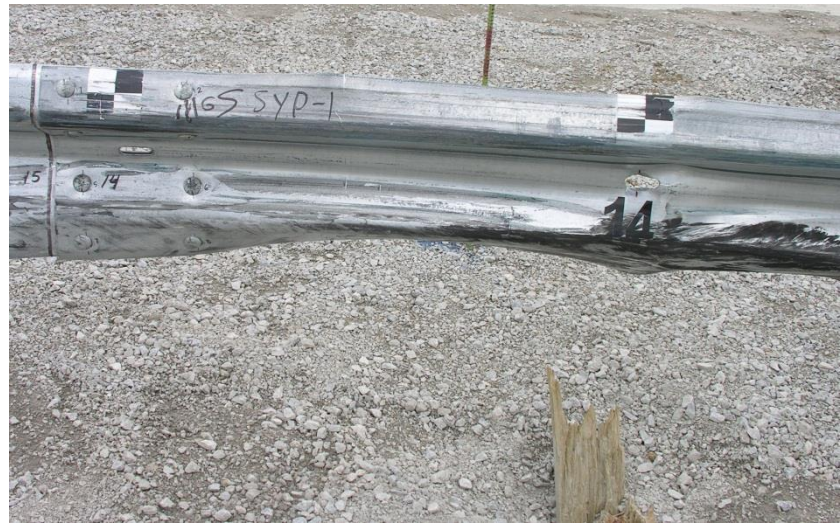
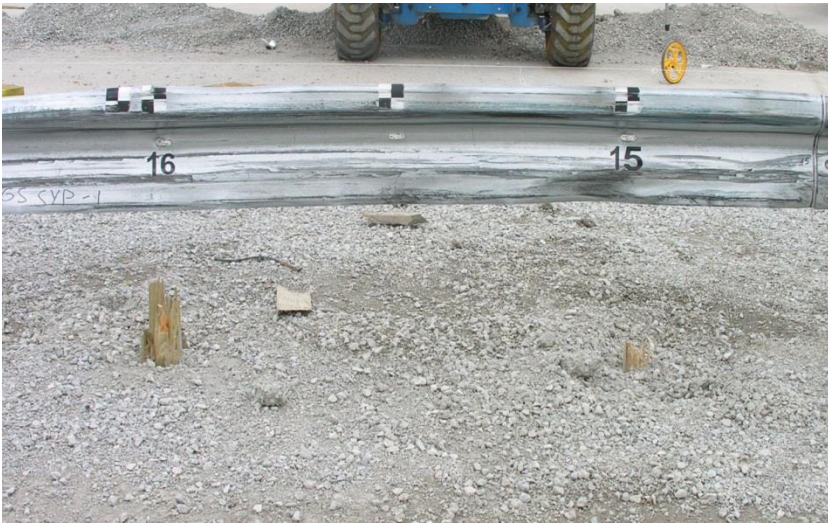
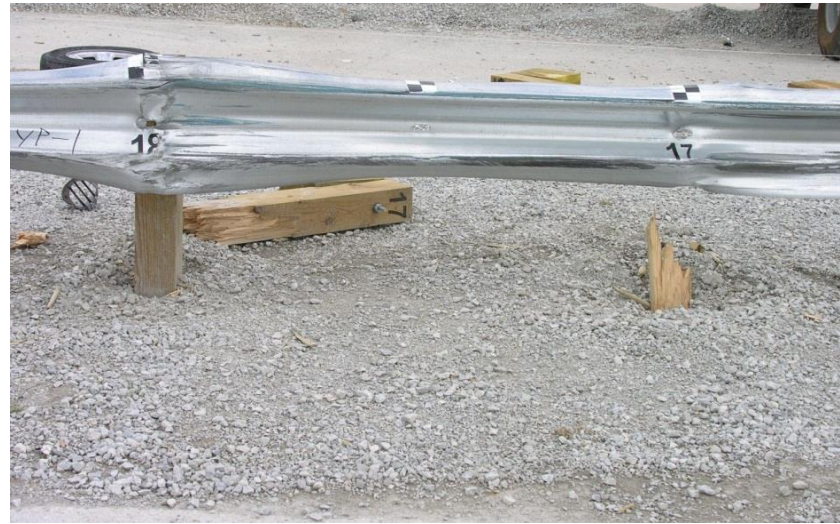
Figure 37. System Damage, Test No. MGSSYP-1

Damage to the barrier was moderate, as shown in Figures 37 through 38 . Barrier damage consisted of deformed guardrail, fractured posts, and contact marks on the front face of the W-beam guardrail. The length of vehicle contact along the barrier was approximately 34 ft – 4 in. (10.5 m) which spanned from 4 in. (102 mm) upstream of the centerline of post no. 13 and extended to 33 in. (838 mm) downstream of post no. 18.

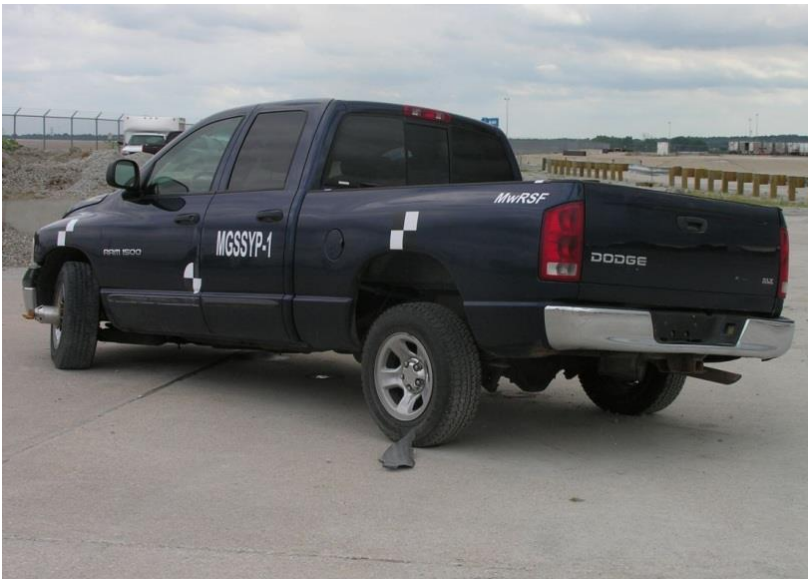
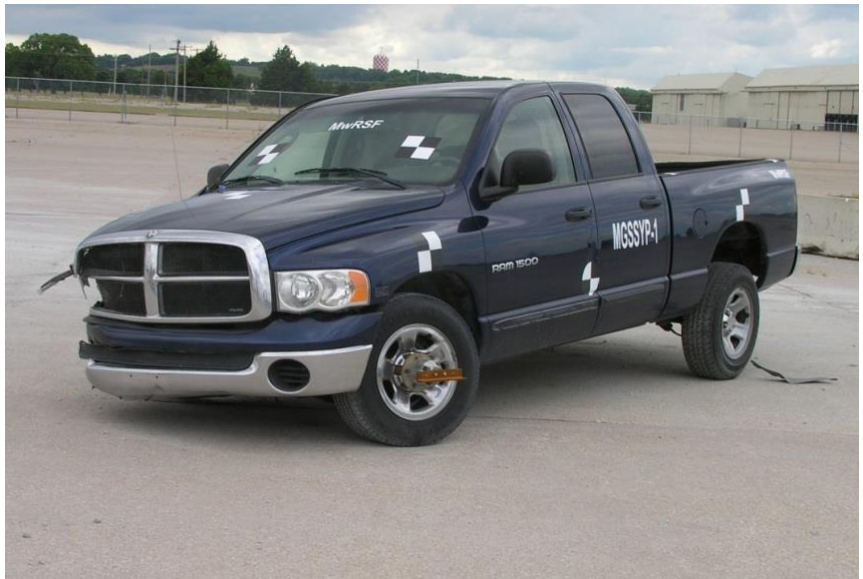
Figure 47. Vehicle Damage, Test No. MGSSYP-1

The damage to the vehicle was minimal, as shown in Figures 47 and 48. The maximum occupant compartment deformations are listed in Table 6 along with the deformation limits established in MASH for various areas of the occupant compartment. Note that none of the MASH established deformation limits were violated. Complete occupant compartment and vehicle deformations and the corresponding locations are provided in Appendix D.

The majority of the damage was concentrated on the right-front corner and right side of the vehicle where the impact occurred. The front bumper was bent on the right lower side approximately 8 in. (203 mm) from the centerline of the vehicle. There was also a kink on the top of the front bumper approximately 19 in. (483 mm) from the centerline of the vehicle. There were contact marks on the right side of the front bumper cover. The front bumper cover also had a 5-in. (127-mm) tear along the right quarter panel. The grill of the vehicle was deformed backward 2½ in. (64 mm) on the bottom right side. The right quarter panel was folded inward 7 in. (178 mm). The right headlight fractured, and the right-front tire detached from the vehicle at the wheel bearing. The right-front upper control arm and disc brake assembly detached. Contact marks extended the entire length of the right side of the vehicle. Both of the doors on the right side were slightly ajar. The top of the right-front door separated 1 in. (25 mm) from the cab of the vehicle, while the bottom of the right rear door separated ¾ in. (19 mm) from the cab. The right-front door also had flattening that extended the entire length of the door 17 in. (432 mm) up from the bottom of the door. The right-rear door had contact marks that extended the length of the door. Flattening occurred at the bottom of the door and at the rear corner of the cab. The right

side of the rear bumper was flattened and had a kink 12 in. (305 mm) from the right fender. The right-rear taillight separated approximately 2½ in. (64) mm from the fender. A 35 in. (889 mm) long crack was found down the center of the windshield.
