Evaluation of a Non-Proprietary, High-Tension, Four-Cable Median Barrier on Level Terrain

TESTING CERT # 2937.01

Midwest States Regional Pooled Fund Research Program

EVALUATION OF A NON-PROPRIETARY, HIGH-TENSION, FOUR-CABLE MEDIAN BARRIER ON LEVEL TERRAIN

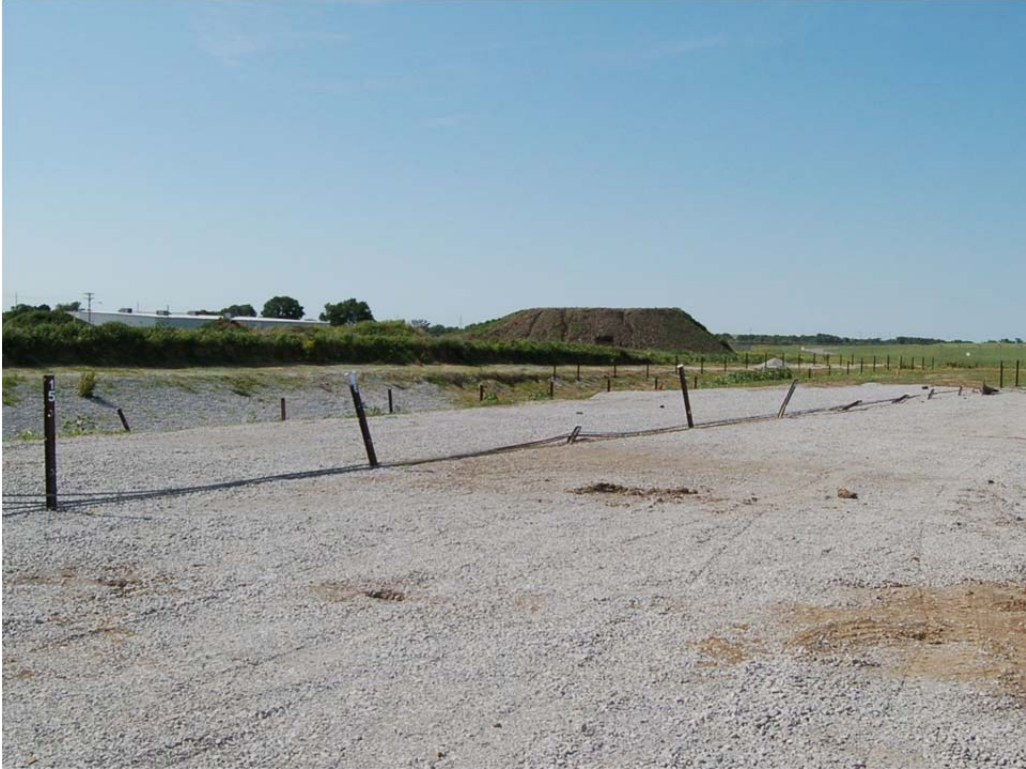
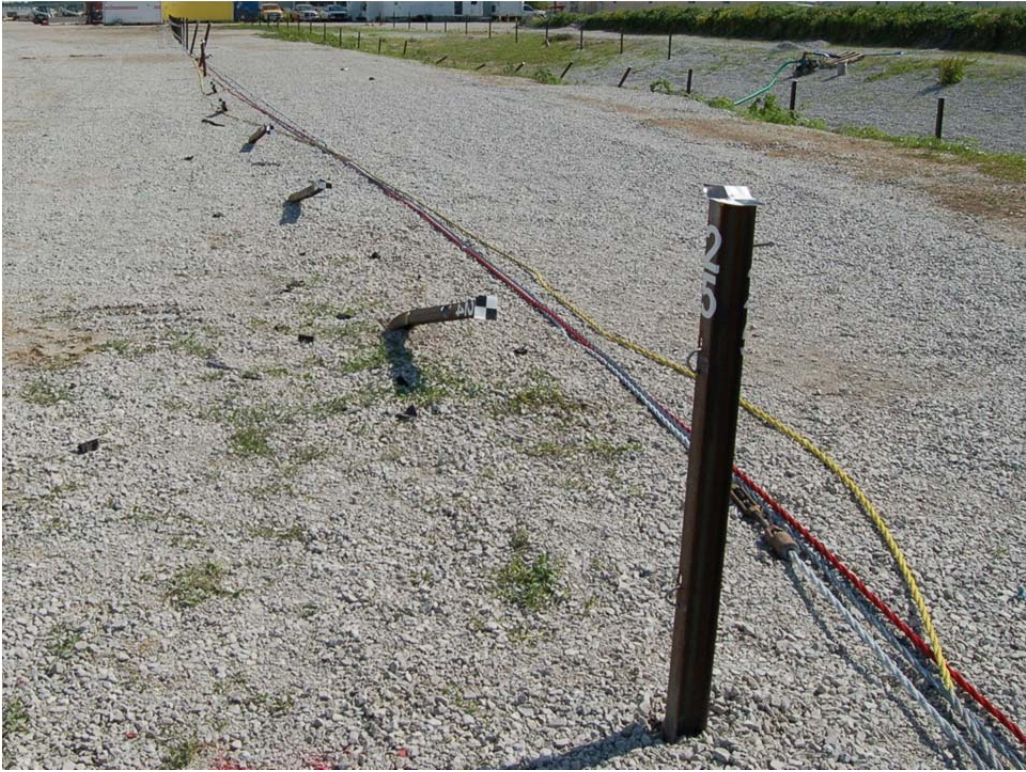
Figure 36. System Damage, Test No. 4CMBLT-1

Damage to the barrier was moderate, as shown in Figures 36 through 49. Barrier damage consisted of detached cables and bent and rotated posts. The length of vehicle contact along the barrier was approximately 123 ft (37.5 m), which spanned from 5 ft – 4 in. (1.6 m) upstream

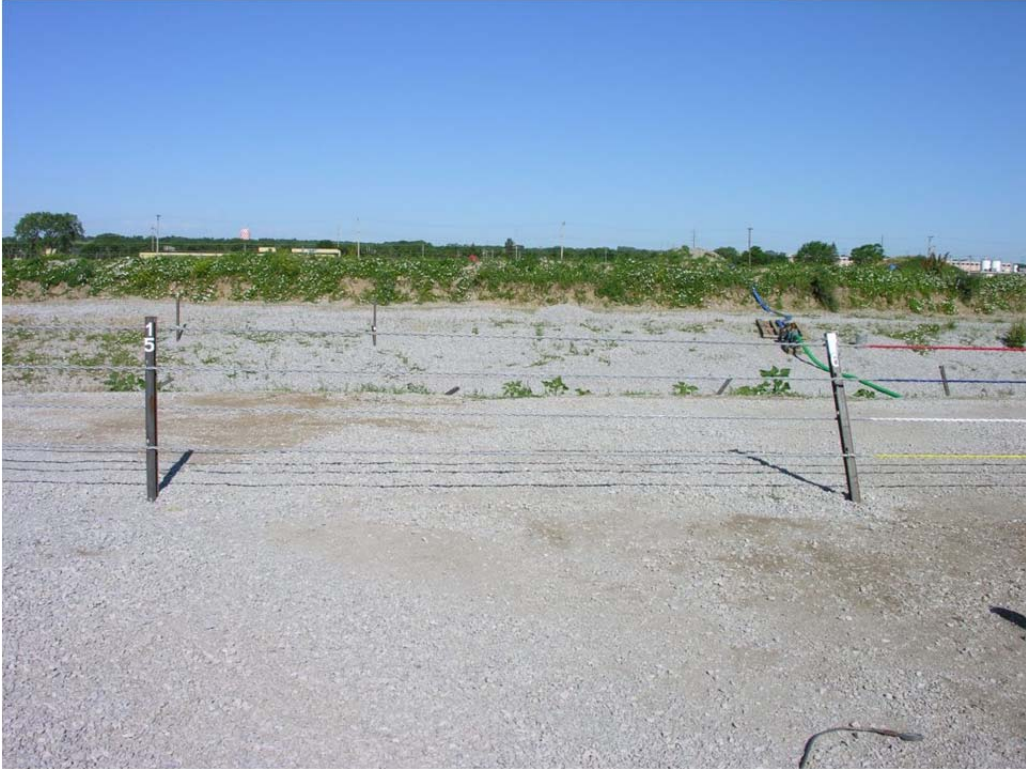
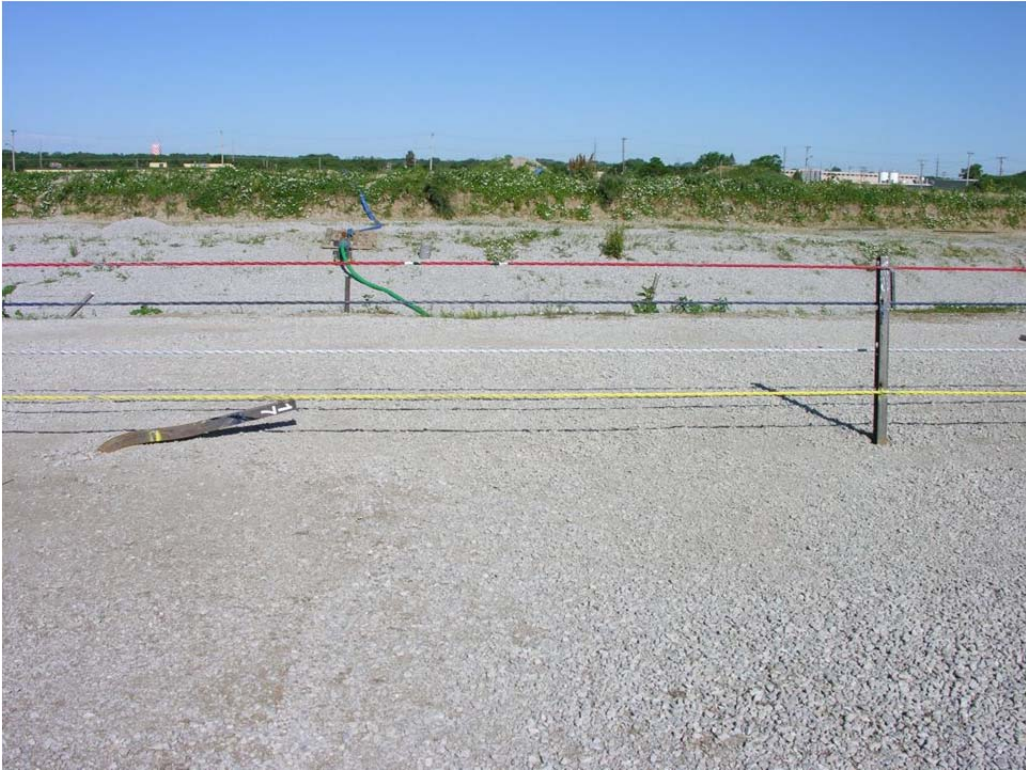
Figure 37. Post Nos. 15 through 18 System Damage, Test No. 4CMBLT-1

The button head of cable no. 2 keyway bolt on post no. 16 released from the keyway, but the bolt remained attached to the post. The button head of cable nos. 1 and 2 keyway bolts on post no. 17 released from the keyway and deformed. The keyway bolt for cable no. 3 on post no. 17 fractured through the shank, while the keyway bolt for cable no. 4 fractured through the threads and disengaged. The button head of the keyway bolts for cable nos. 1 and 2 on post nos. 18 and 19 disengaged from the keyway and deformed. Cable no. 3 keyway bolt on post nos. 18 and 19 disengaged. The keyway bolts for cable nos. 1 and 2 on post no. 20 released from the keyway and deformed, the keyway bolt for cable no. 3 fractured through the threads, and the keyway bolt for cable no. 4 disengaged. The keyway bolts for cable nos. 1, 2, and 3 on post nos. 21 and 23 disengaged and deformed, and the keyway bolt for cable no. 4 disengaged. Keyway bolts for cable nos. 1 and 4 on post no. 22 fractured through the shank. The keyway bolt for cable no. 2 on post no. 22 disengaged and flattened, while the keyway bolt for cable no. 3 disengaged. The keyway bolts for cable nos. 1 and 2 on post no. 24 disengaged and flattened, while the keyway bolts for cable nos. 3 and 4 on post no. 24 disengaged. The keyway bolt for cable no. 1 on post no. 25 disengaged and flattened, while the keyway bolt for cable no. 2 on post no. 25 pushed upward and began to disengage.

The maximum permanent set of the post was 20¼ in. (514 mm), which occurred at post no. 17, as measured in the field. The maximum lateral dynamic deflection of the post and rail was 24.0 in. (610 mm) and 94.5 in. (2,400 mm), respectively, at post no. 20 as determined from high-speed digital video analysis. The working width of the system was found to be 111.2 in. (2,824 mm), also determined from high-speed digital video analysis.

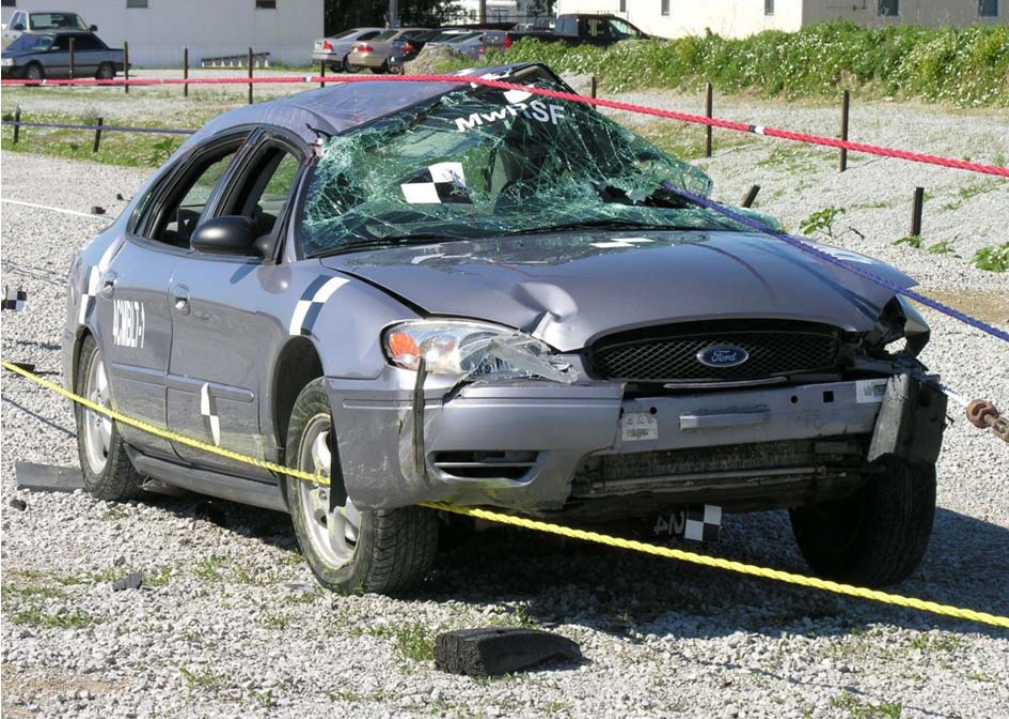
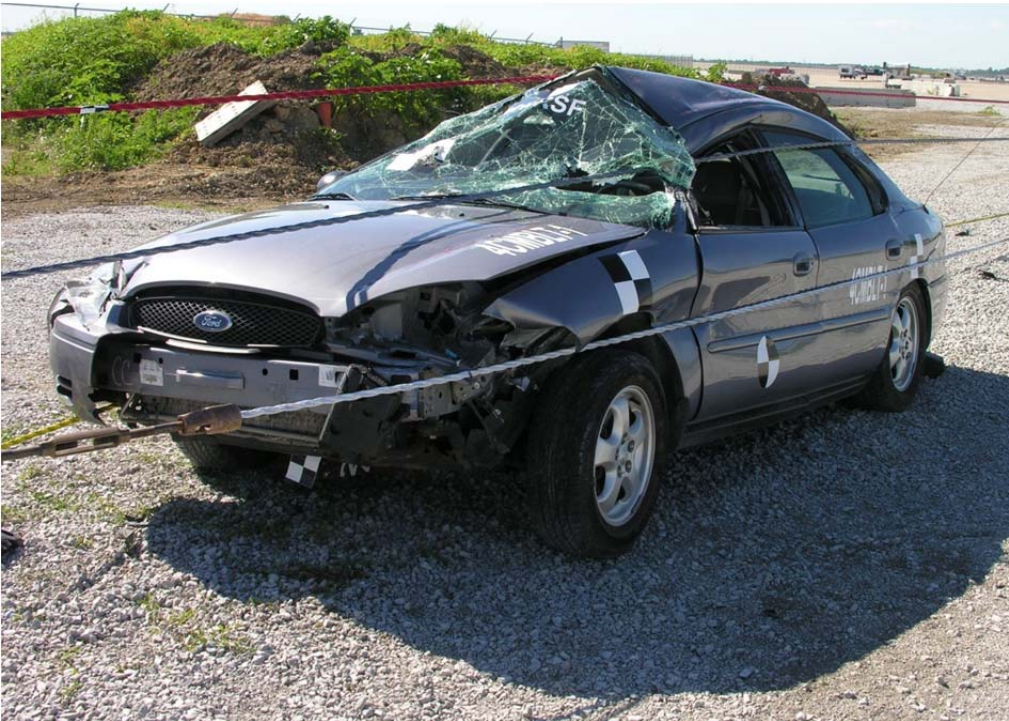
Figure 50. Vehicle Damage, Test No. 4CMBLT-1

The damage to the vehicle was extensive, as shown in Figures 50 through 52. The maximum occupant compartment deformations are listed in Table 7 along with the deformation limits established in MASH for various areas of the occupant compartment. Complete occupant compartment and vehicle deformations and the corresponding locations are provided in Appendix D.

The damage to the vehicle was concentrated on the left-front corner with substantial damage to the sides and roof of the vehicle. The windshield experienced extensive damage with spider-web cracking throughout. The windshield disengaged from the roof near the middle of the vehicle spanning approximately 16 in. (406 mm). A 6-in. vertical by 15-in. horizontal (152-mm by 381-mm) tear occurred to the bottom left corner of the windshield where cable no. 2 laid on the vehicle. The front bumper cover fractured and disengaged, except for an 18-in. (457-mm) segment attached to the right-front corner. Foam from the front bumper disengaged and came to rest 127 ft (38.7 m) downstream and 3 ft (0.9 m) in front of the impact location. The left side of the engine hood sustained contact marks from cable nos. 1 and 2.

After reviewing the high-speed video of test no. 4CMBLT-1, it was determined that the excessive damage to the roof, windshield, and A-pillar was caused by cable no. 2. While the vehicle was redirecting, this cable was in contact with the A-pillar and did not slide up and over the top of the vehicle as anticipated. The cable also did not release away from post no. 18 (the second post downstream from initial impact) as early as predicted. These two phenomena

resulted in a high lateral load being imparted to the vehicle's A-pillar, which eventually caused it to crush along with the windshield and roof.

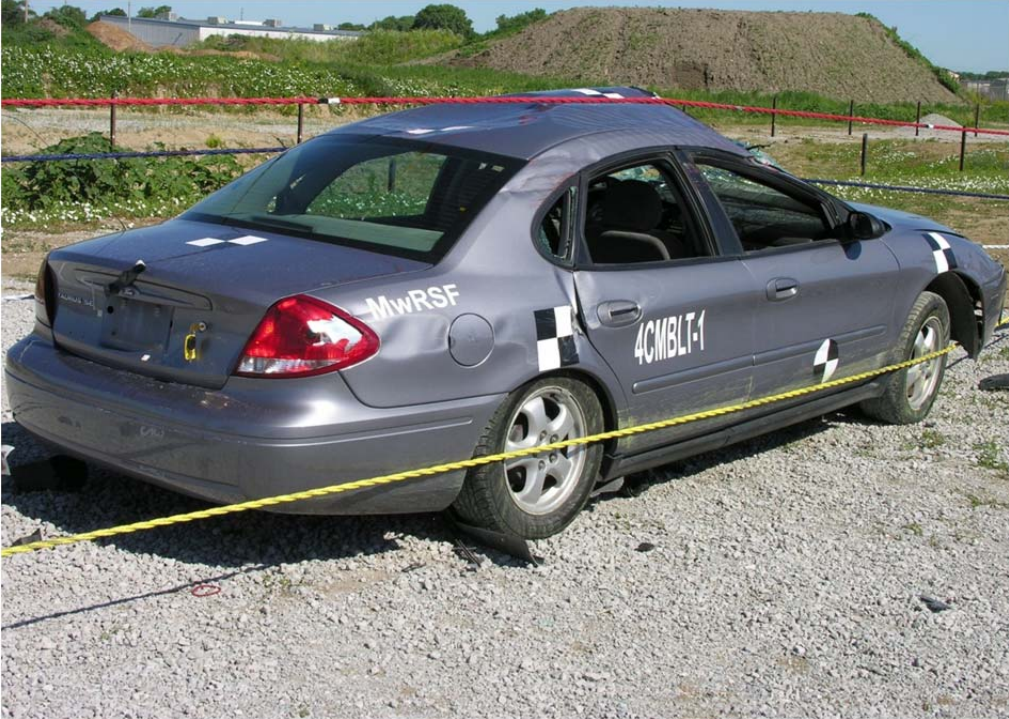
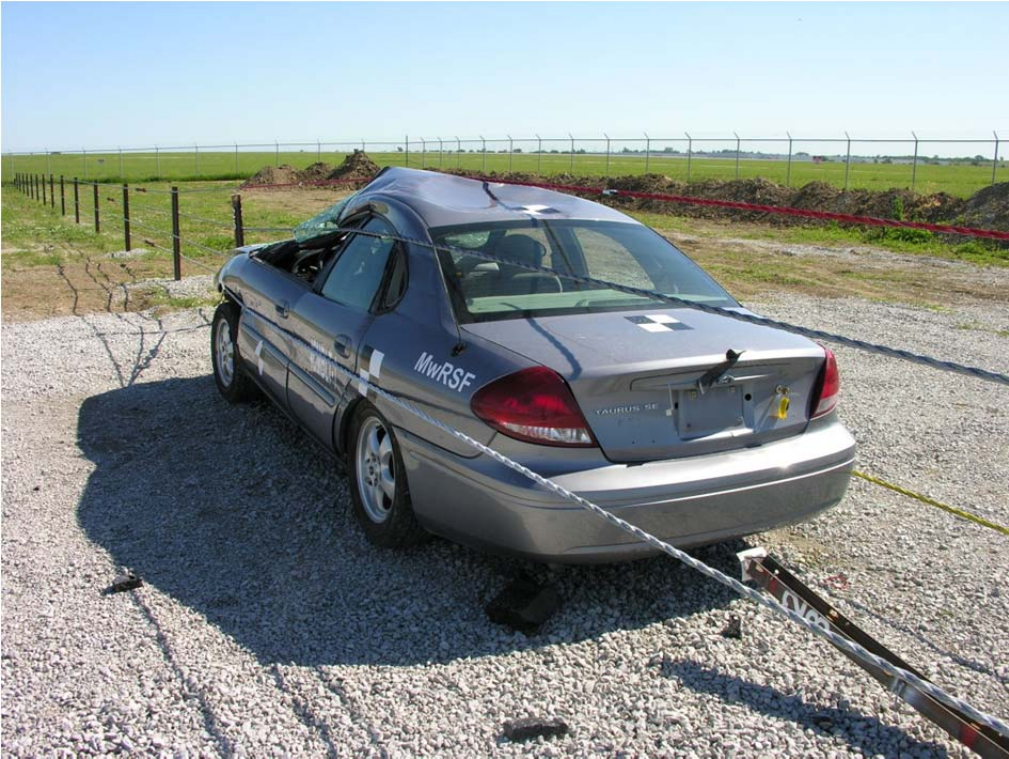
Figure 51. Vehicle Damage, Test No. 4CMBLT-1

The left-front headlight disengaged and came to rest 129 ft (39.3 m) downstream and 57 ft (17.4 m) behind the impact location. The left-front quarter panel folded behind itself and encountered a 4-in. (102-mm) long tear. The left-front wheel well liner sustained a 12-in. (305-mm) long tear. The left-front steel rim encountered contact marks from cable nos. 3 and 4. A gouge was found along the entire left side with cable no. 3 in contact with the left side of the vehicle. Contact marks from the cable no. 2 were located on the left-side A-pillar, the left-side B-pillar, the left-rear door window, and the left-side C-pillar. The left-side A-pillar was crushed inward and the left-side C-pillar was flattened. The left-side mirror disengaged from the vehicle. The left-side of the roof was kinked above the B-pillar. The left-front and left-rear window glass were shattered. The left-rear door panel bowed away from the window, and the bottom of the door bent outward. Contact marks from cable no. 3 were found on the left-rear tire and the left portion of the rear bumper cover.

The right-rear tail light shattered. The right-rear quarter panel encountered contact marks from cable no. 4, 2- and 3-in. (51- and 76-mm) diameter dents, and folding near the right-rear door. Contact marks from cable no. 4 and a 2-in. (51-mm) diameter dent were found on the right-rear door. The right-front, and rear, windows were shattered. Contact marks from cable no. 4 were found on the right-rear tire. Contact marks from cable no. 1 were found on the right-side A-pillar, B-pillar, and C-pillar. The right-side A-pillar was crushed inward. Contact marks from cable no. 4 extended the length of the right side of the vehicle. The right-front steel rim sustained contact marks from cable no. 4 and 4-in (102-mm) gouge. The right-front wheel well liner was partially disengaged. The right-front bumper cover bent and sustained a 5- and 8-in. (127- and 203-mm) tear. The right-front headlight cracked. The right-front corner of the hood kinked above the right-front headlight. The entire roof sustained contact marks from cable no. 1, and it buckled upward at the midpoint of the windshield. The right-side of the roof bent downward from the front to approximately the B-pillar. A 2.5-ft (0.8-m) diameter dent was located near the right-side of the roof. A 2-in. (51-mm) long tear with an 8-in. (203-mm) crease was found in the left-side floor pan.
