# Phase I Development of a Non-Proprietary, Four-Cable, High Tension Median Barrier

TESTING CERT # 2937.01

Midwest States Regional Pooled Fund Research Program  
Fiscal Year 2003-2004 (Year 14), 2005-2006 (Year 16), 2007-2008 (Year 18)  
Research Project Number SPR-3(017)  
NDOR Sponsoring Agency Code RFPF-04-01, RFPF-08-02

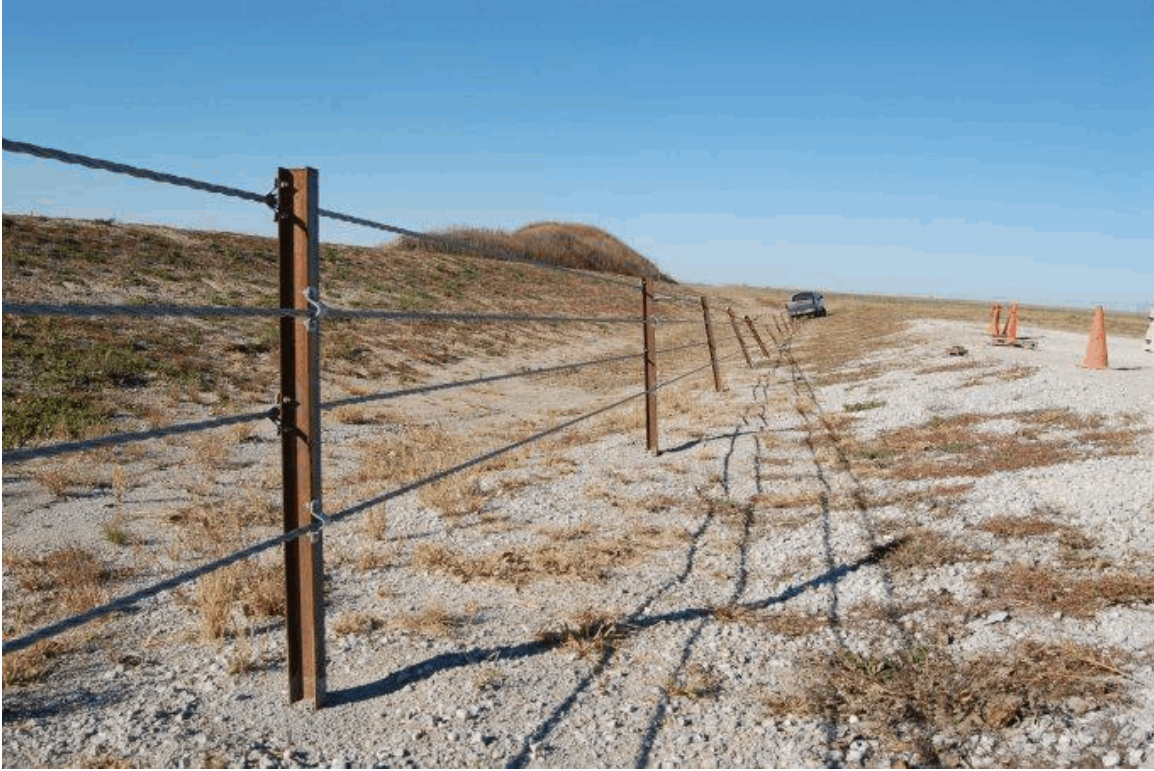
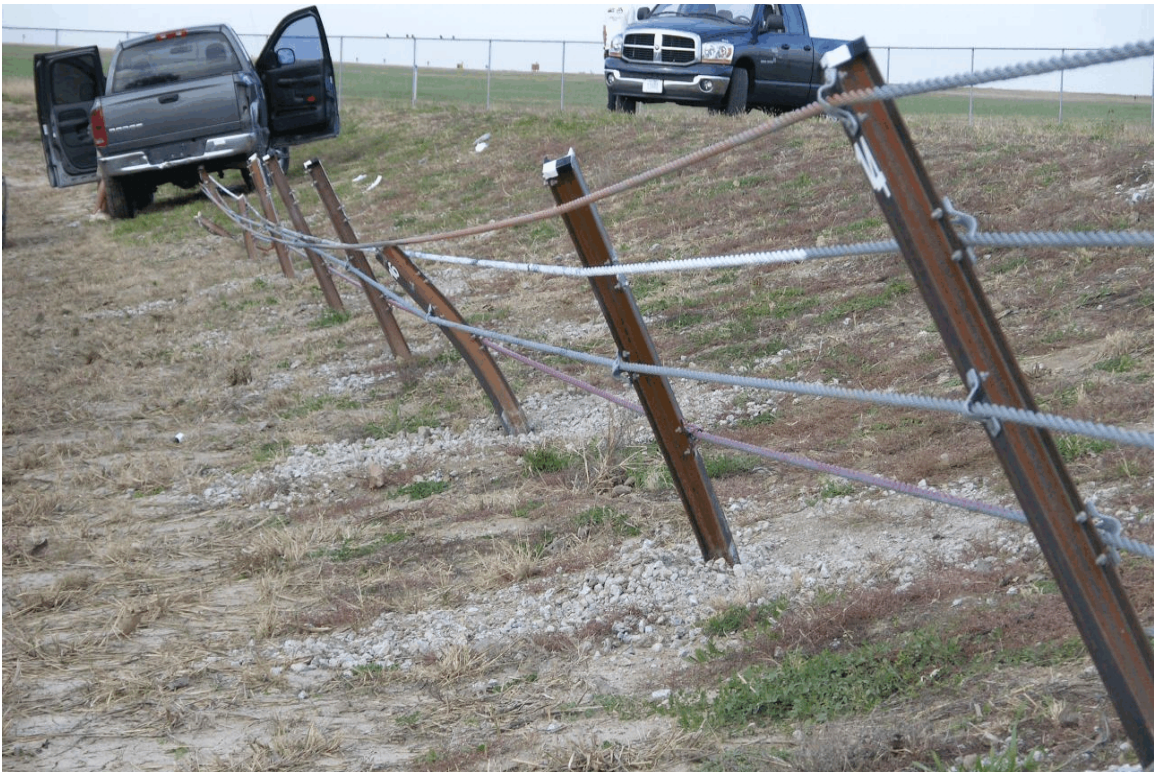
Figure 40. System Damage, Test No. 4CMB-1

Damage to the barrier was moderate, as shown in Figures 40 through 43. Barrier damage consisted of bent and rotated guardrail posts and detached cables. During the test, the vehicle was in contact with the cable median barrier for 143 ft (43.6 m), which spanned from the point of impact to post no. 24. After the test, the vehicle remained in contact with the system.

The top cable bracket on post no. 3 was removed. The cable and brackets were still attached for post nos. 4 through 14. The top two cable brackets on post no. 15 were removed, and the bottom two cable brackets were slightly bent. The top two cable brackets on post no. 16 were also removed, and the bottom two brackets were deformed. The top two cable brackets on post no. 17 were removed, and the bottom two brackets were slightly bent. The top two cable brackets on post no. 18 were removed, the third bracket from the top was slightly bent, and the bottom bracket showed no visible damage. The top two cable brackets on post no. 19 were also removed, and the bottom two brackets were bent. The top three cable brackets on post no. 20 were removed, the lower bolt for the third bracket was also missing, and the bottom bracket was deformed. All cable brackets for post nos. 21 through 24 were removed, with the exception of the top bracket on post no. 22. The top bracket on post no. 38 was also removed.

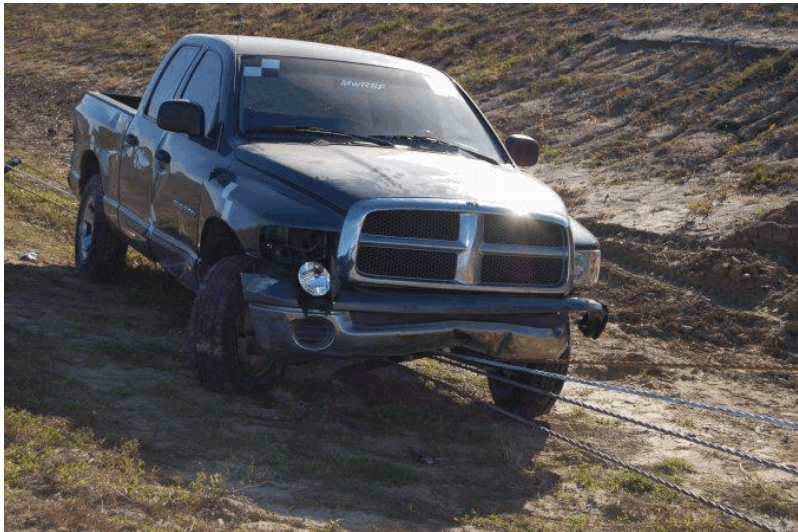
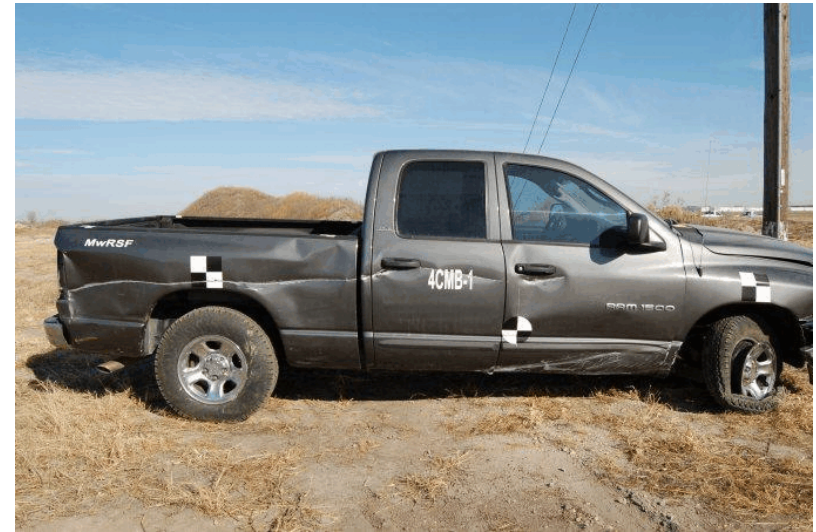
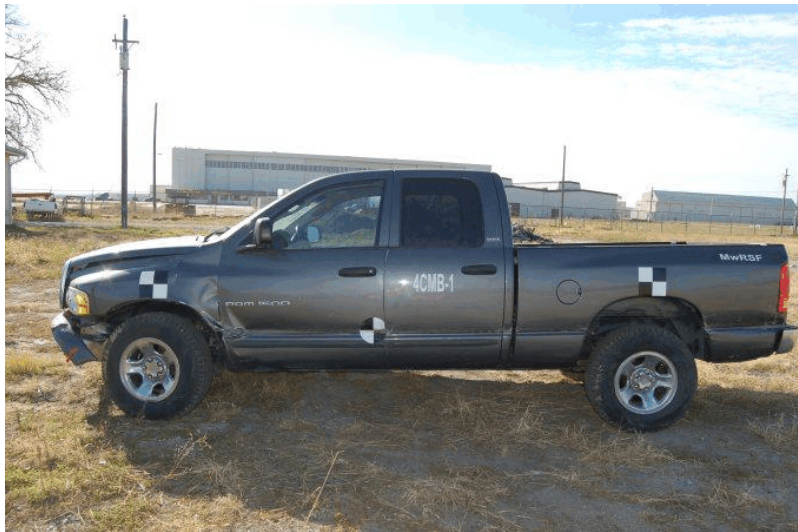
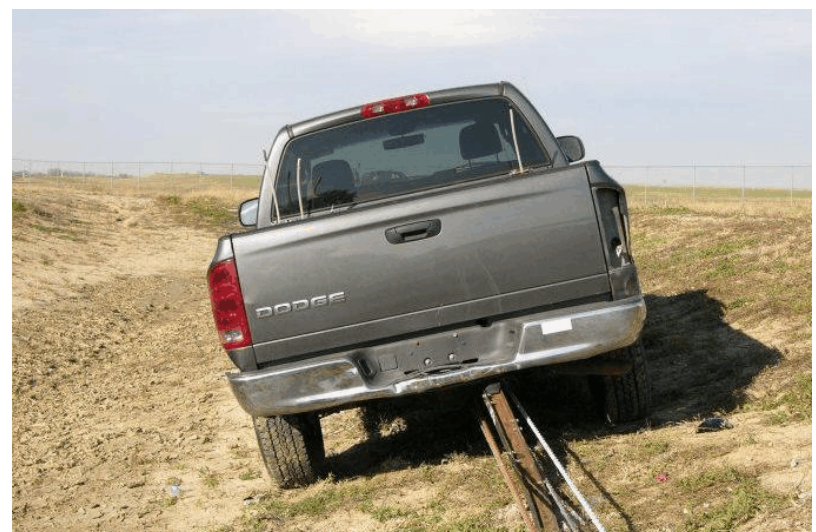
Figure 44. Vehicle Damage, Test No. 4CMB-1

Exterior vehicle damage was moderate, as shown in Figures 44 through 46 and Figure 48. Occupant compartment deformation was minimal and did not exceed  $\frac{1}{2}$  in. (13 mm) of deformation, as shown in Figure 47.

Driver's side damage consisted of a creased fender near the front door joint; a broken headlight lens cover; major cable scrapes and marks 12 in. (305 mm) up from the bottom of the door; gouging through the sheet metal, fender, and door approximately 6 in. (152 mm) long; and more cable scrapes and marks along the entire length of vehicle at approximately the c.g. height. The passenger side damage consisted of the rear tail light cover removed; scrapes along the entire length of the box, continuing up to the front door handle; smaller scrapes and deformations along the bottom of the door; 3-in. (76-mm) long tears near both door handles; right-front tire disengagement from the rim; and a 1-in. (25 mm) long tear along the tire sidewall. The front of the vehicle received major deformation on the bumper, primarily on the left side. The plastic bumper cover was also removed. The undercarriage showed slight scraping on the right lower control arm, the lower tie rod

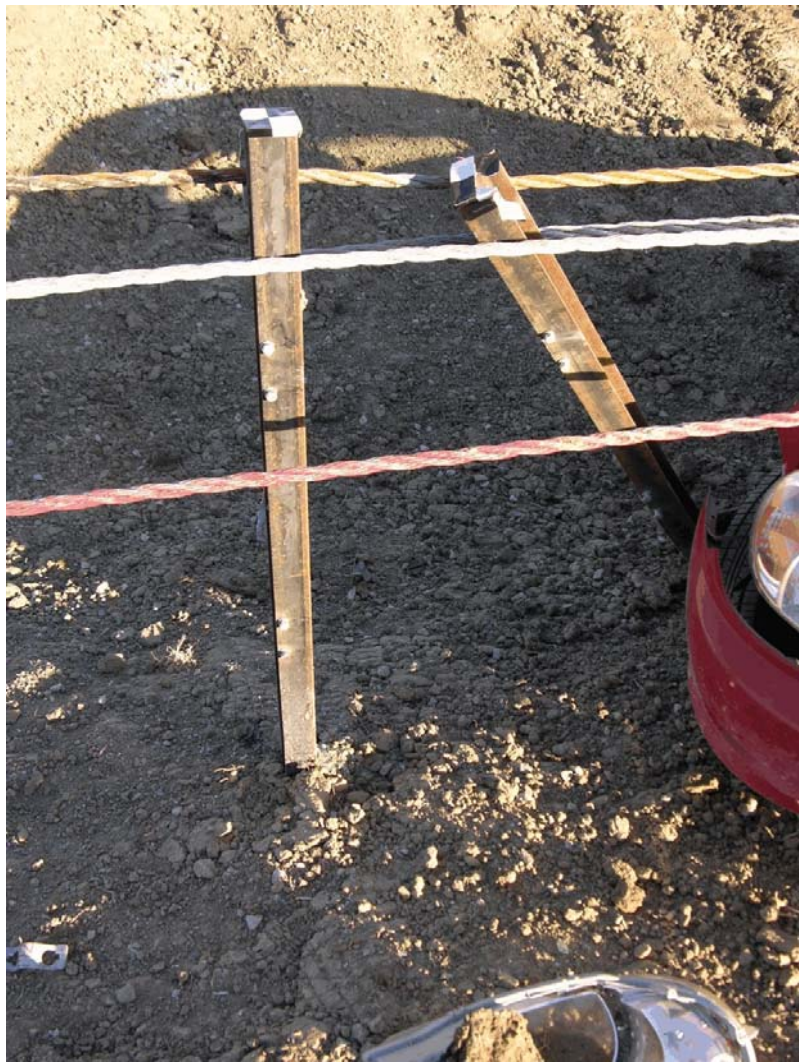
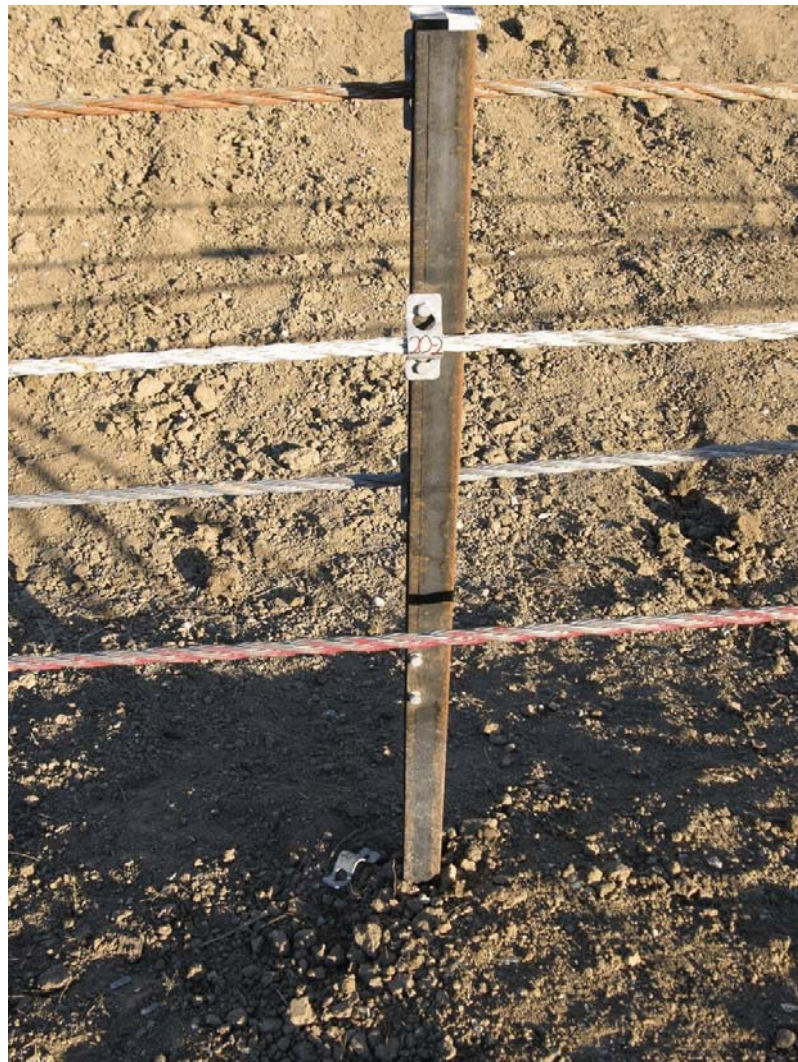
Figure 72. System Damage, Test No. 4CMB-2

Damage to the barrier was minimal, as shown in Figures 72 through 74. Barrier damage consisted of bent and twisted guardrail posts and detached cables. The length of vehicle contact along the cable median barrier system was about 24 ft (7.3 m) which spanned from post nos. 17 to 19.

Several cable brackets were detached from posts. The cable brackets are numbered from top to bottom with no. 1 corresponding to the top cable and no. 4 corresponding to the bottom cable. For post no. 18, the 2<sup>nd</sup>, 3<sup>rd</sup>, and 4<sup>th</sup> cable brackets were detached, but the 1<sup>st</sup> bracket was still attached. The 2<sup>nd</sup> bracket was found 8 ft - 10 in. (2.7 m) downstream of post no. 19 and 6 in. (152 mm) in front of the system. The 3<sup>rd</sup> bracket was found 7 ft - 6 in. (2.3 m) upstream of post no. 19 and 3½ ft (1.1 m) behind the system. The 4<sup>th</sup> bracket was found 2 ft (0.6 m) downstream of post no. 20 and 9 ft - 4 in. (2.8 m) behind the system. For post no. 19, the 2<sup>nd</sup> and 4<sup>th</sup> cable brackets were detached. The 2<sup>nd</sup> bracket was found 19 in. (483 mm) downstream of post no. 19 and 15 in. (381 mm) behind the system. The 4<sup>th</sup> bracket was found 20 in. (508 mm) downstream of post no. 19 and 2 in. (51 mm) in front of the system. For post no. 20, the 4<sup>th</sup> cable bracket was missing, and it was found 4 in. (102 mm) downstream of post no. 20 and on the longitudinal centerline of the system.

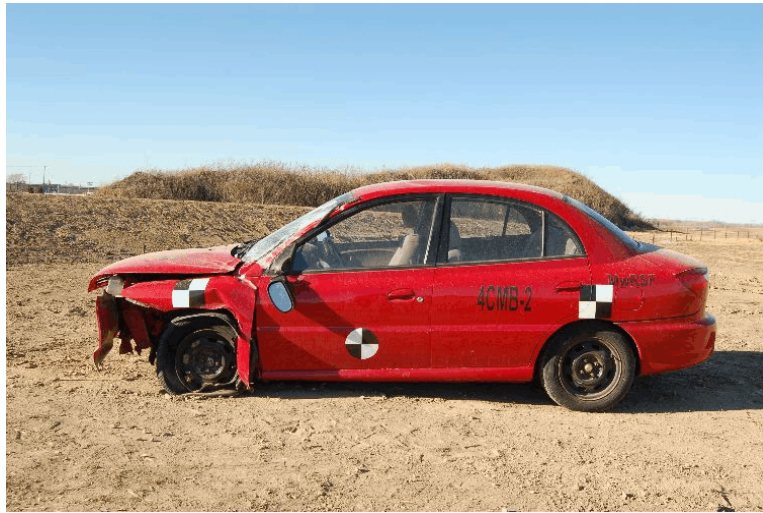
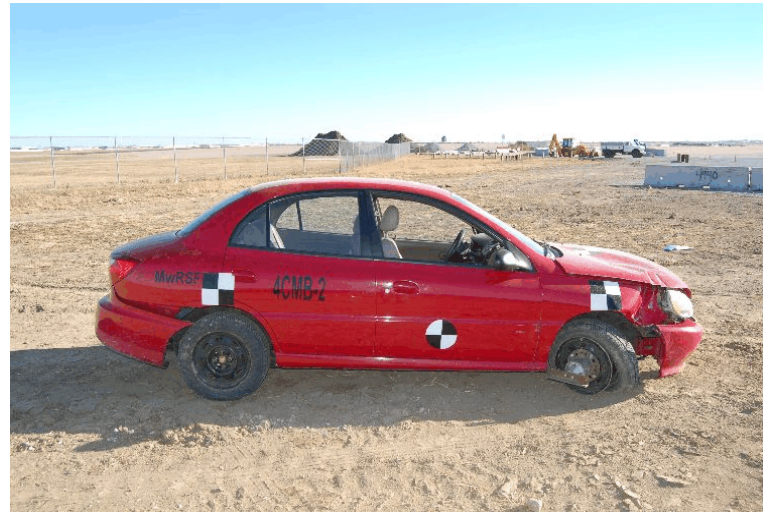
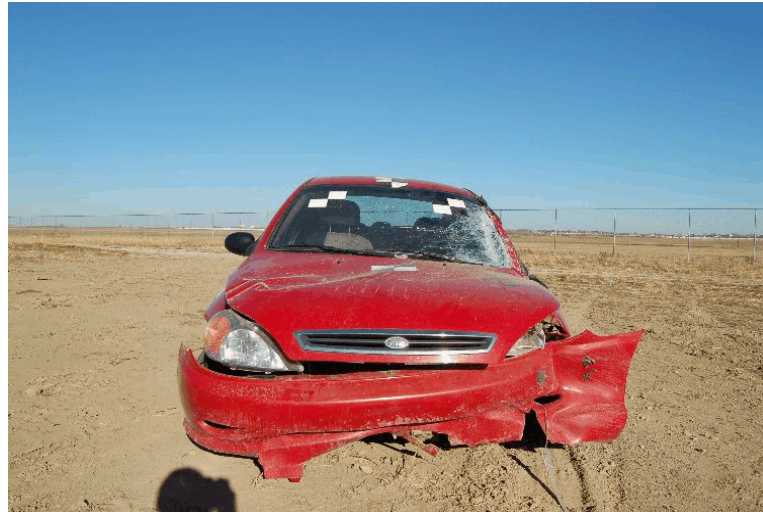
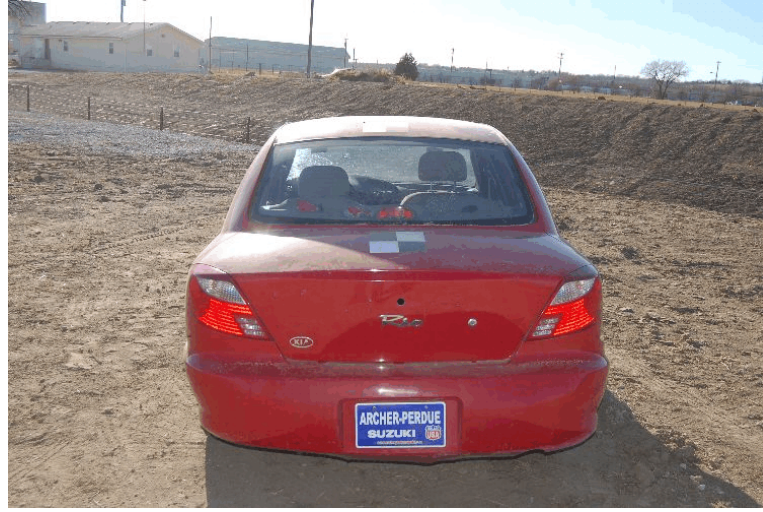
Figure 75. Vehicle Damage, Test No. 4CMB-2

Exterior vehicle damage was moderate, as shown in Figures 75 through 77. Minimal damage was observed in the interior occupant compartment of the vehicle, as shown in Figure 78.

The left-front fender was severely damaged and heavily creased toward the front of the car. It was also torn near the door joint. There was heavy cable contact and loading damage at the bottom of the A-pillar, and scrapes from the cables continued along the entire length of the pillar to the roof line. The left-front steel rim had an 8 in. (203 mm) long by 3 in. (76 mm) deep indent, and the tire was completely disengaged from the rim. The right-rear bumper cover attachment was pulled off, and there was heavy damage to the right-front fender. The right-front window was also broken out. The right-front steel rim was slightly dented, and the tire was deflated and disengaged. There were minor contact marks on the right-front quarter panel, and the entire wheel assembly was pushed in toward the engine.

The face of the front bumper was heavily damaged from cable contact. The radiator support brackets were buckled, crushing other components in the engine compartment. The hood was also deformed on the front end and buckled toward the center. There was major damage along the bottom-left side of the windshield and along the A-pillar where it had disengaged from the frame. Interior damage included a buckled and broken dash. On the left-front suspension, the vertical

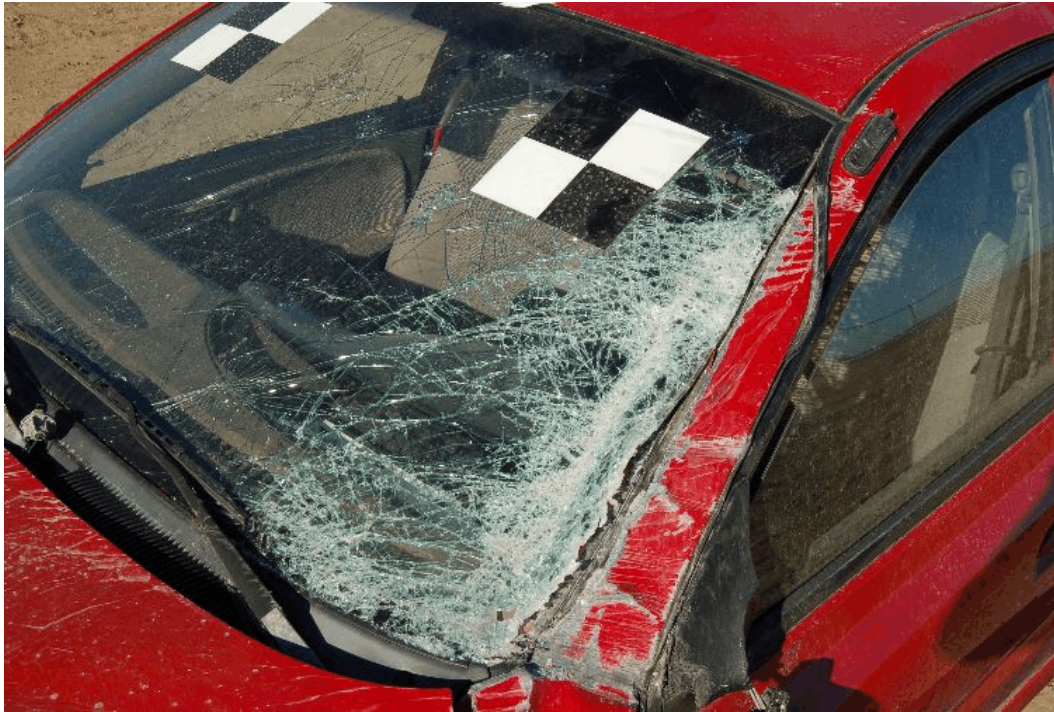
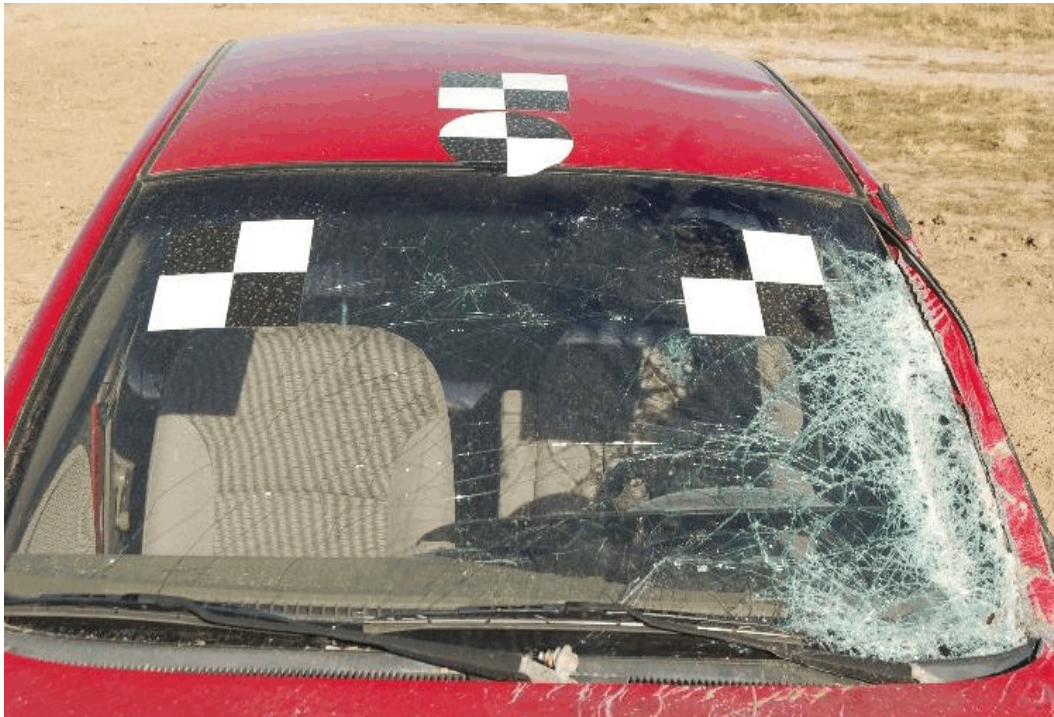
Figure 76. Windshield Damage, Test No. 4CMB-2

0.282	Vehicle overrode post no. 18.
0.348	Top, upper-middle, and lower-middle cables continued to wrap around the front of the windshield, causing it to crack.

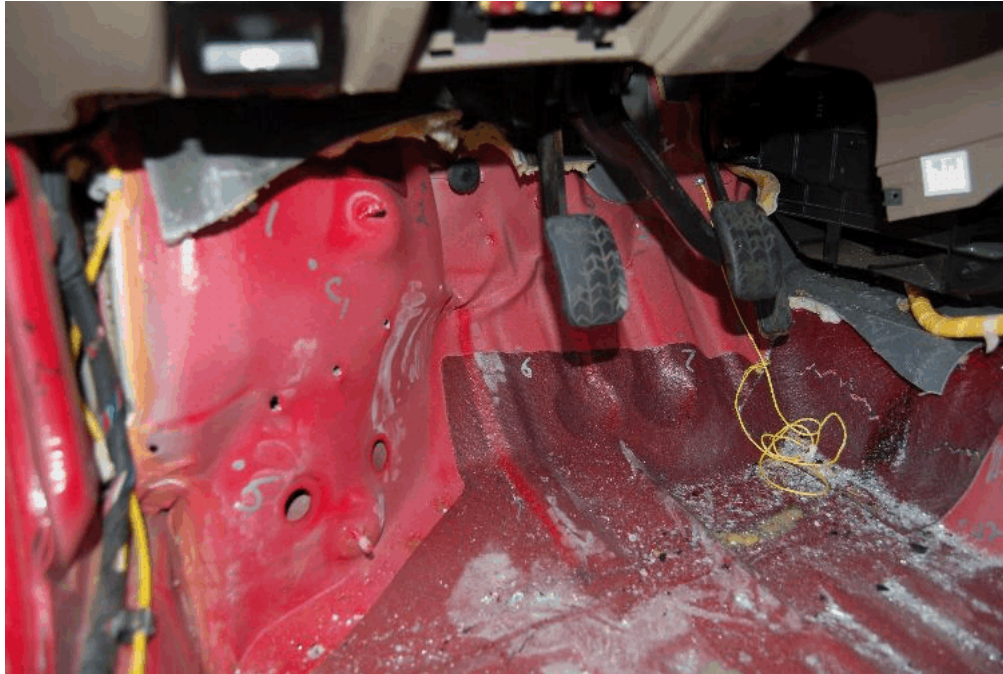
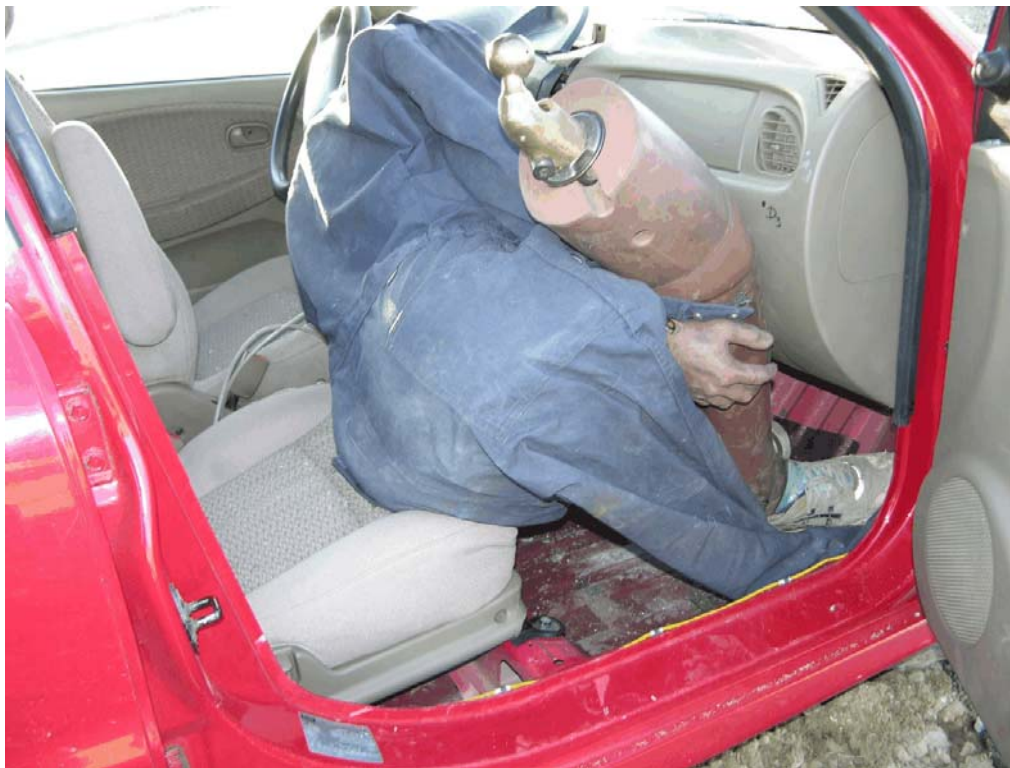
Figure 78. Occupant Compartment Damage, Test No. 4CMB-2

stabilizer was disengaged at the lower ball joint, the lower A-frame component was bent, and the front wheel drive line component was bent backward. There was also left-front occupant compartment damage on the firewall and floor pan. The maximum deformation of the occupant compartment was 3 in. (76 mm), located at the right-front corner of the left toe pan.
