# Development and Evaluation of the Midwest Guardrail System (MGS) Placed Adjacent to A 2:1 Fill Slope

TESTING CERT # 2937.01

*Midwest States Regional Pooled Fund Research Program  
Fiscal Year 2004-2005 (Year 15)  
Research Project Number SPR-3(017)  
NDOR Sponsoring Agency Code RFPF-05-09*

# **DEVELOPMENT AND EVALUATION OF THE MIDWEST GUARDRAIL SYSTEM (MGS) PLACED ADJACENT TO A 2:1 FILL SLOPE**

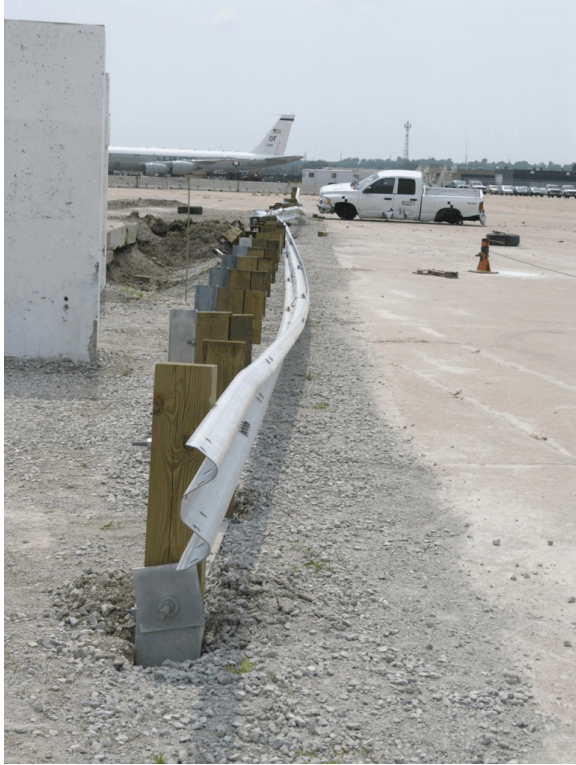
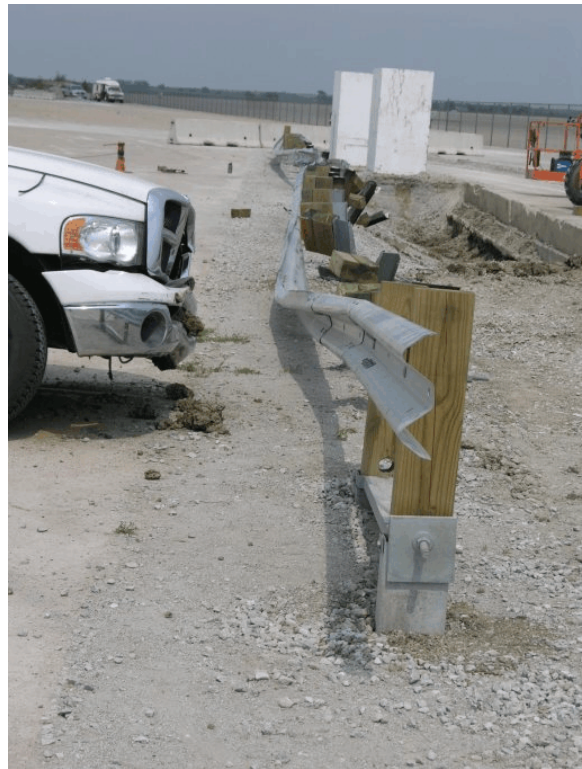
Figure 33. System Damage, Test No. MGS221-1

Damage to the barrier was moderate, as shown in Figures 33 through 41. Barrier damage consisted of deformed guardrail posts, disengaged wooden blockouts, contact marks on a guardrail section and posts, and deformed and fractured W-beam rail. The length of the vehicle contact along the MGS system was approximately 8.8 m (29 ft - 1½ in.), which spanned from 305 mm (12 in.) upstream from the centerline of post no. 13 through the midspan between post nos. 17 and 18.

Moderate deformation and flattening of the impacted section of W-beam rail occurred between post nos. 13 through 17. Contact marks were found on the guardrail between post nos. 12 and 18 and on the backside of the W-beam between post nos. 23 and 26. A 686-mm (27-in.) long diagonal tear in the rail occurred 127 mm (5 in.) downstream of post no. 5. A 25-mm (1-in.) long

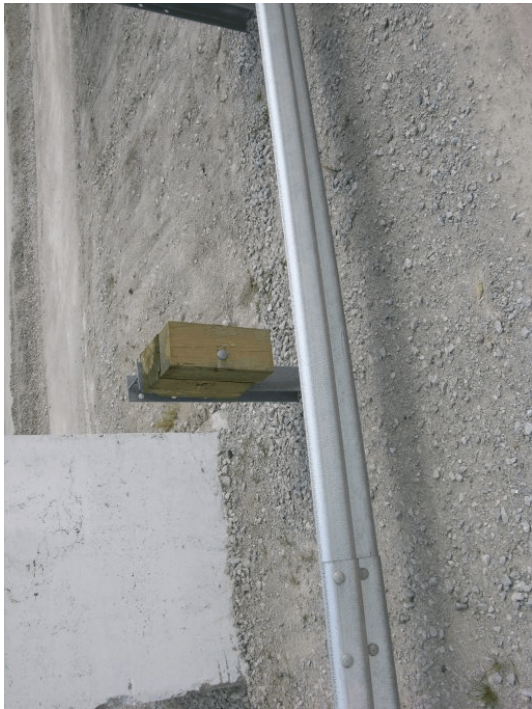
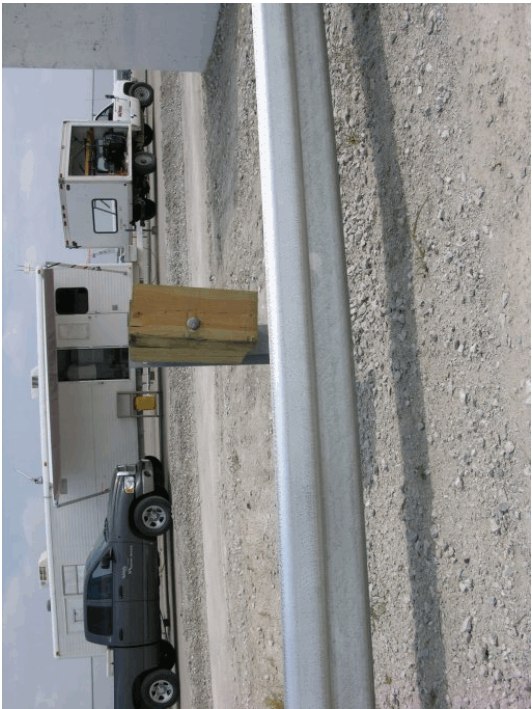
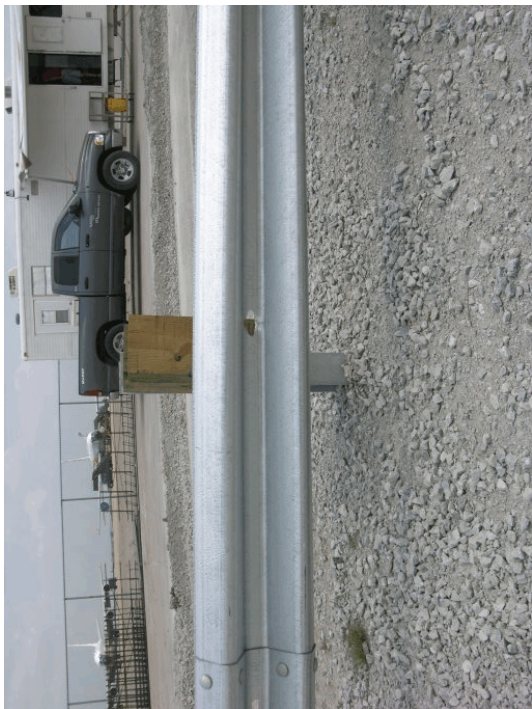
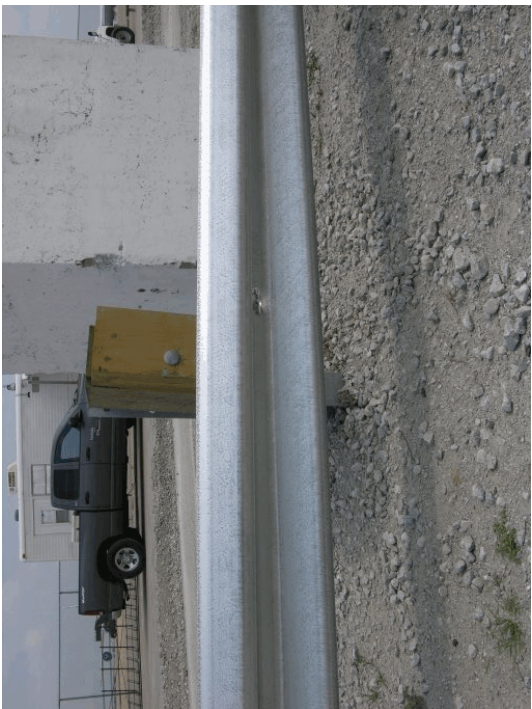
Figure 34. Post Nos. 3 through 6 Damage, Test No. MGS221-1

Steel post nos. 3 through 12 encountered minor twisting. Steel post nos. 13 through 17 twisted and rotated backward with major soil failure visible at the ground level. Steel post nos. 18 through 20 were undamaged. Steel post nos. 21 and 22 bent slightly, while post no. 23 bent downstream and rotated clockwise. The rear flange of post no. 23 was bent toward the web due to vehicle contact. Steel post nos. 24 through 26 bent downstream and backward and twisted counter-clockwise. The front and back flanges were bent backward at the top of steel post nos. 24 and 25. The upstream and downstream anchorage systems moved longitudinally. For the upstream anchorage, soil gaps of 102 mm (4 in.) and 38 mm (1½ in.) were found on the upstream and downstream sides of post no. 1, respectively, and for post no. 2, soil gaps of 64 mm (2½ in.) and 51 mm (2 in.) were found on the upstream and downstream sides, respectively. For the downstream anchorage, soil gaps of 13 mm (½ in.) and 51 mm (2 in.) were found on the downstream side of post nos. 28 and 29, respectively, while no soil gaps were found on the upstream sides of these posts. In addition, post no. 28 and 29 were uplifted out of the ground 102 mm (4 in.) and 229 mm (9 in.), respectively. However, the wooden posts in both anchorage systems were not damaged.

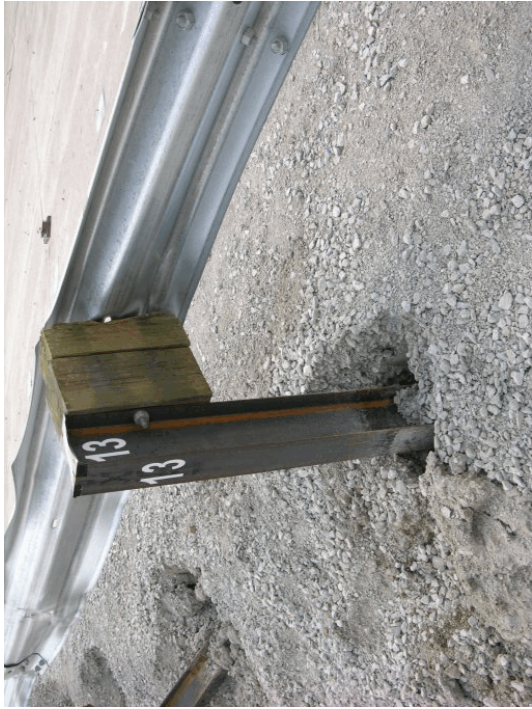
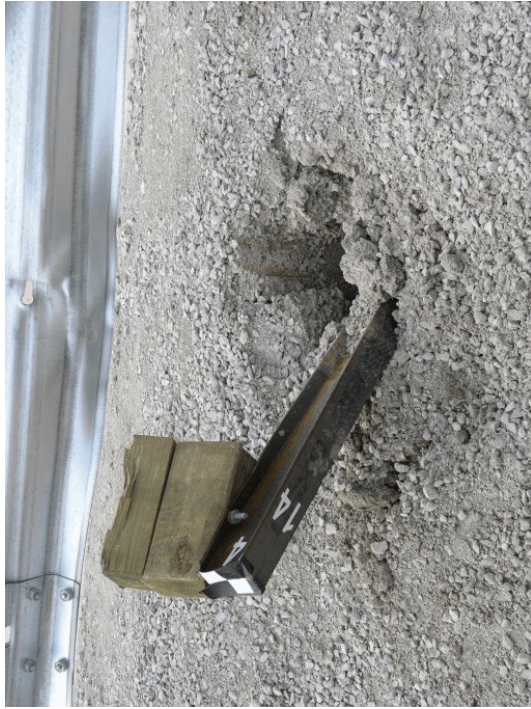
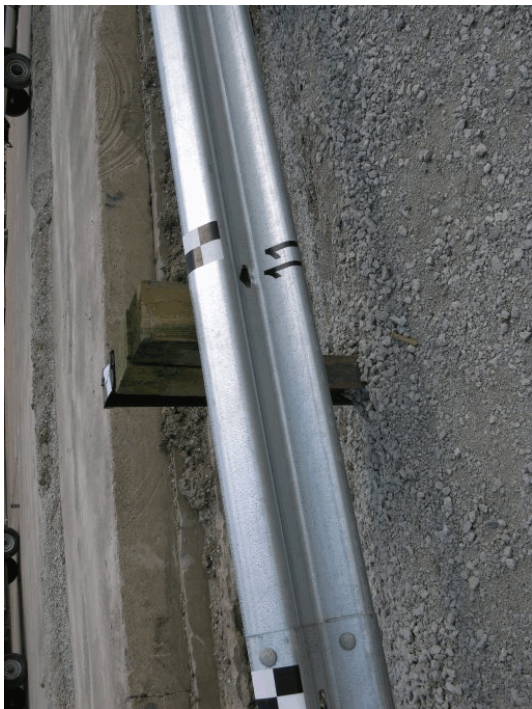
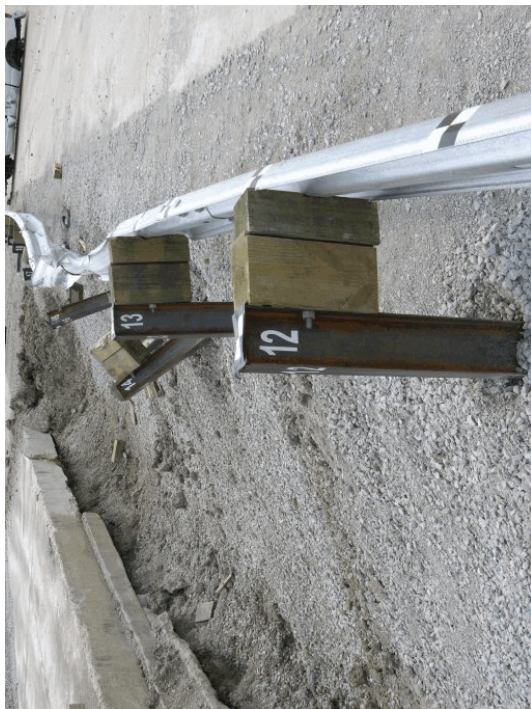
Figure 36. Post Nos. 11 through 14 Damage, Test No. MGS221-1

The wooden blockout at post no. 14 encountered damage on the front face, but it remained attached. The wooden blockouts at post nos. 15 through 17 were fractured and mostly removed from the post. All other wooden blockouts remained undamaged.

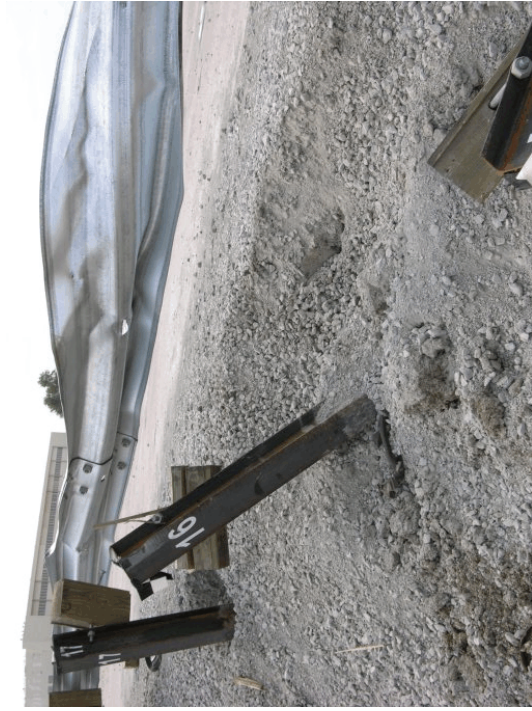
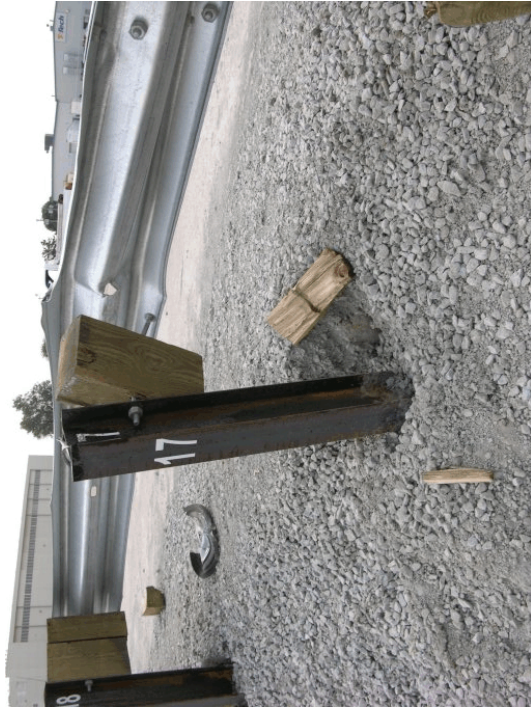
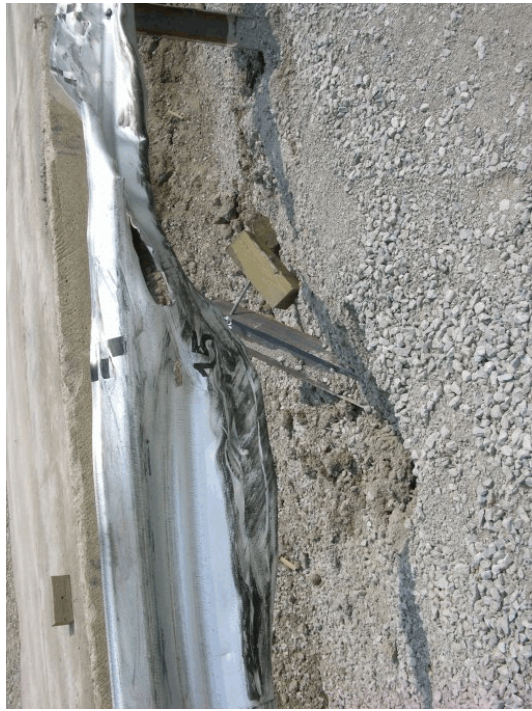
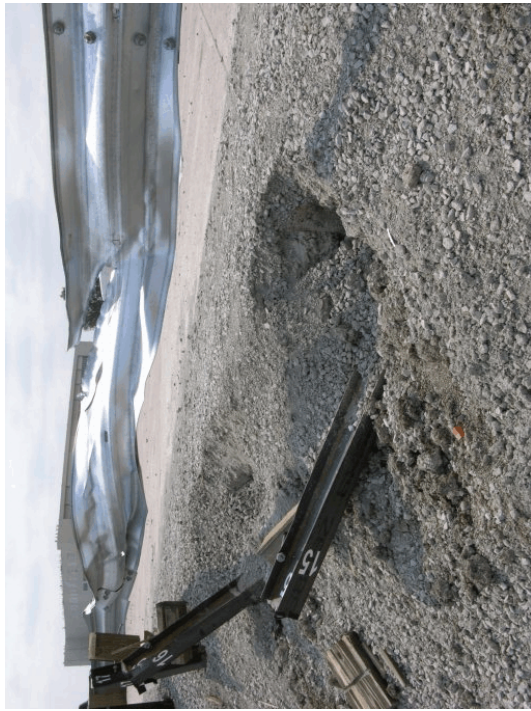
Figure 37. Post Nos. 15 through 17 Damage, Test No. MGS221-1

The vehicle override was attributed to the slow release of post no. 15 from the guardrail, thus causing the W-beam to be pulled downward. In addition, the vehicle override was also attributed to the failure of the vehicle's front suspension shortly after impact, thus preventing the guardrail from capturing the pickup truck's left-front tire.

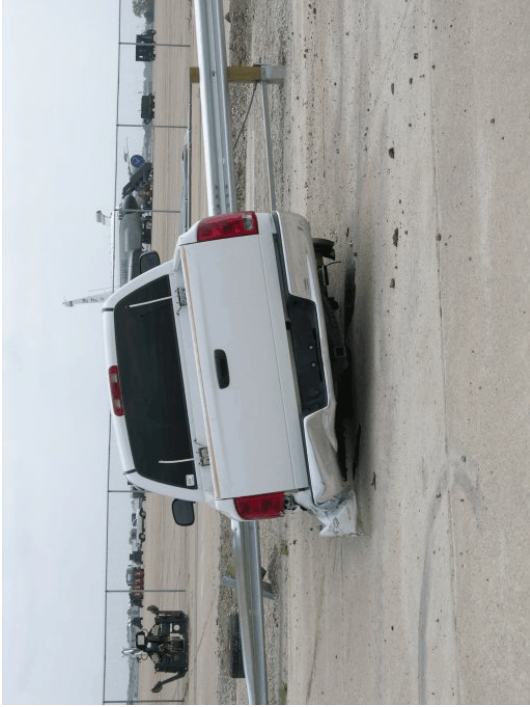
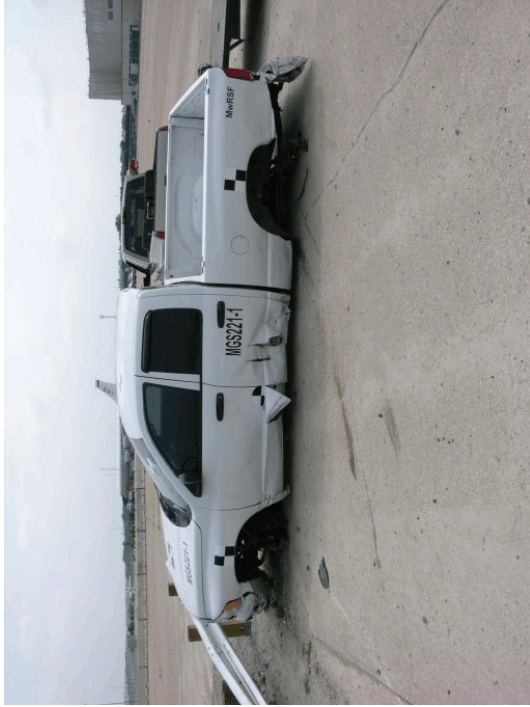
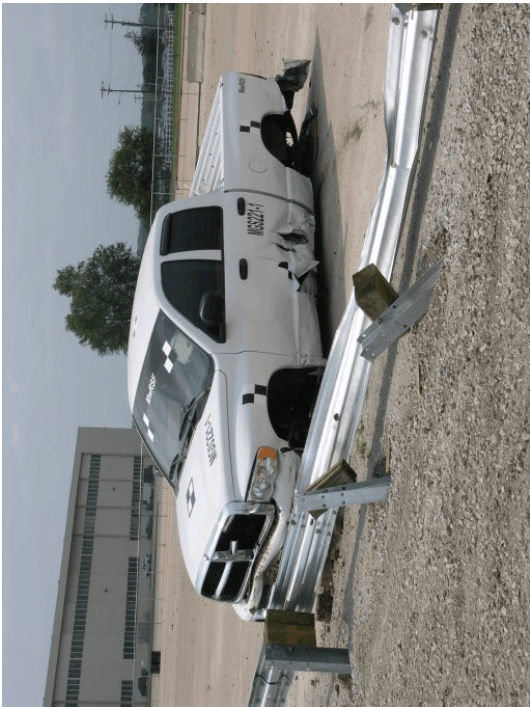
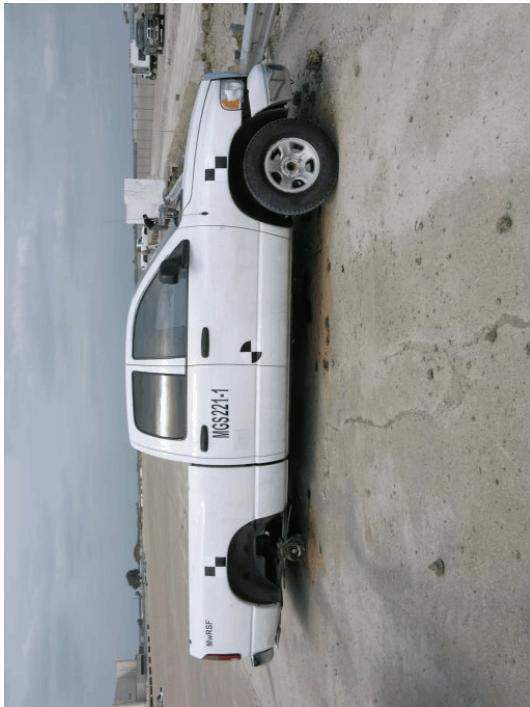
Figure 42. Vehicle Damage, Test No. MGS221-1

Exterior vehicle damage was moderate, as shown in Figures 42 through 44. Occupant compartment deformations to the left side and center of the floor pan were judged insufficient to cause serious injury to the vehicle occupants, as shown in Figure 45. Maximum longitudinal deflections of 6 mm (<sup>1</sup>/<sub>4</sub> in.) were located throughout the left-side floor pan. Maximum lateral deflections of 13 mm (<sup>1</sup>/<sub>2</sub> in.) were located at the rear-center of the left-side floor pan. Maximum vertical deflections of 13 mm (<sup>1</sup>/<sub>2</sub> in.) were located on the floor pan near the left-side door. Complete occupant compartment deformations and the corresponding locations are provided in Appendix E.

Damage was concentrated on the left-front corner of the vehicle. The left-front corner was deformed inward toward the engine compartment. The left side of the grill was fractured and removed. The center of the front bumper buckled. The left-front, left-rear, and right-rear tires disengaged from the vehicle. Sheet metal tearing and major deformations were found along the lower portion of the left-side doors and the left-rear fender. The left side of the rear bumper was deformed upward. The left-side taillight was fractured, while the right-side taillight was slightly dislodged. The left-front, right-front, and right-rear brake lines were severed. The left-rear and right-rear shocks were fractured. The left-front upper control arm and left-front tie rod were fractured. The drive shaft was fractured and separated at the transmission yoke. The left-front sway bar linkage was

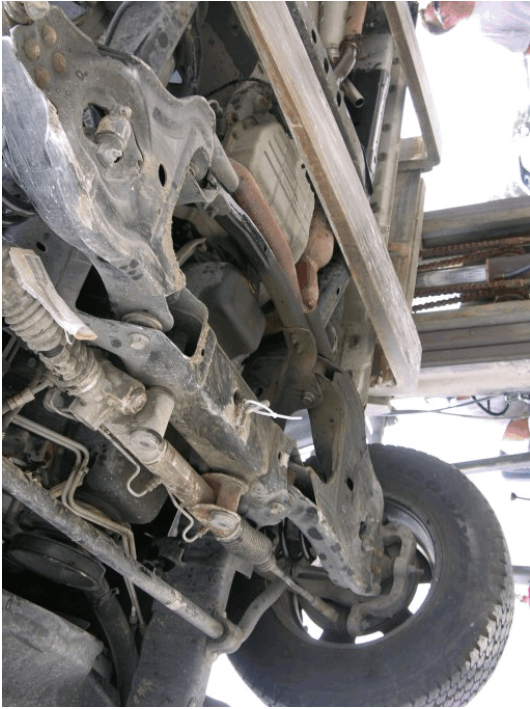
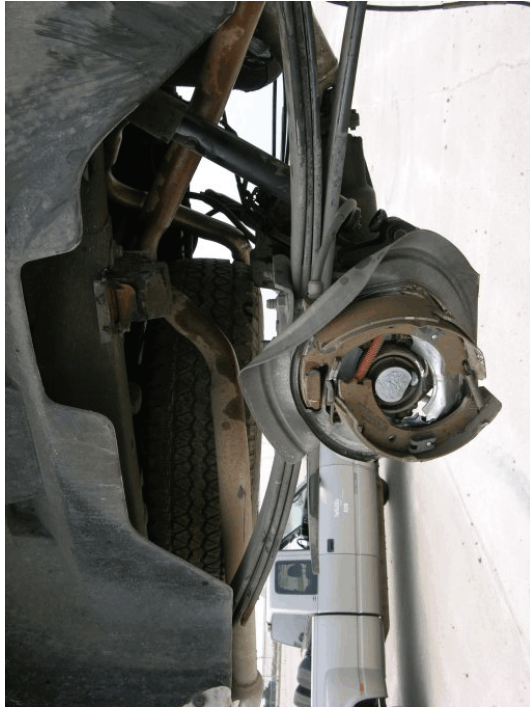
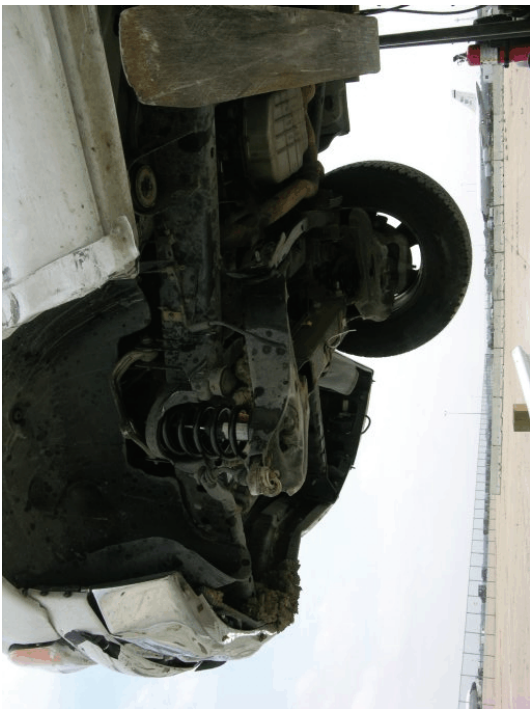
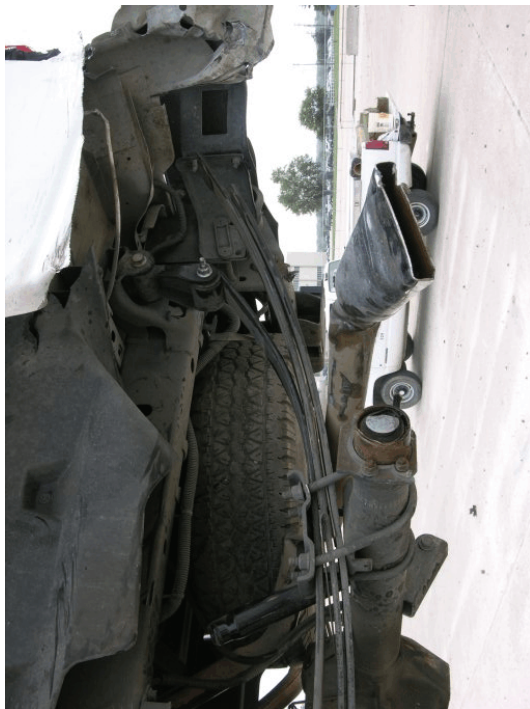
Figure 44. Undercarriage Damage, Test No. MGS221-1

bent. Both ends of the rear axle fractured before the brake housing. The gas tank heat shield was deformed and bent. The roof, hood, and right side of the vehicle and all window glass remained undamaged.
