Development of the Midwest Guardrail System (MGS) W-beam to Thrie Beam Transition Element

*Midwest States' Regional Pooled Fund Research Program
Fiscal Years 2000-2002, 2005-2006 (Years 11-12, 16)
Research Project Number SPR-3(017)
NDOR Sponsoring Agency Codes RFPF-01-04, RFPF-02-05, RFPF-06-04*

DEVELOPMENT OF THE MIDWEST GUARDRAIL SYSTEM (MGS) W-BEAM TO THRIE BEAM TRANSITION ELEMENT

7.1 Test MWT-3	52
7.2 Test Description	52
7.3 Barrier Damage	53
7.4 Vehicle Damage	55
7.5 Occupant Risk Values	56
7.6 Discussion	57
8 ANALYSIS AND DISCUSSION OF TEST NO. MWT-3	77
9 DESIGN MODIFICATIONS (DESIGN NO. 2)	79
10 CRASH TEST NO. 2	94

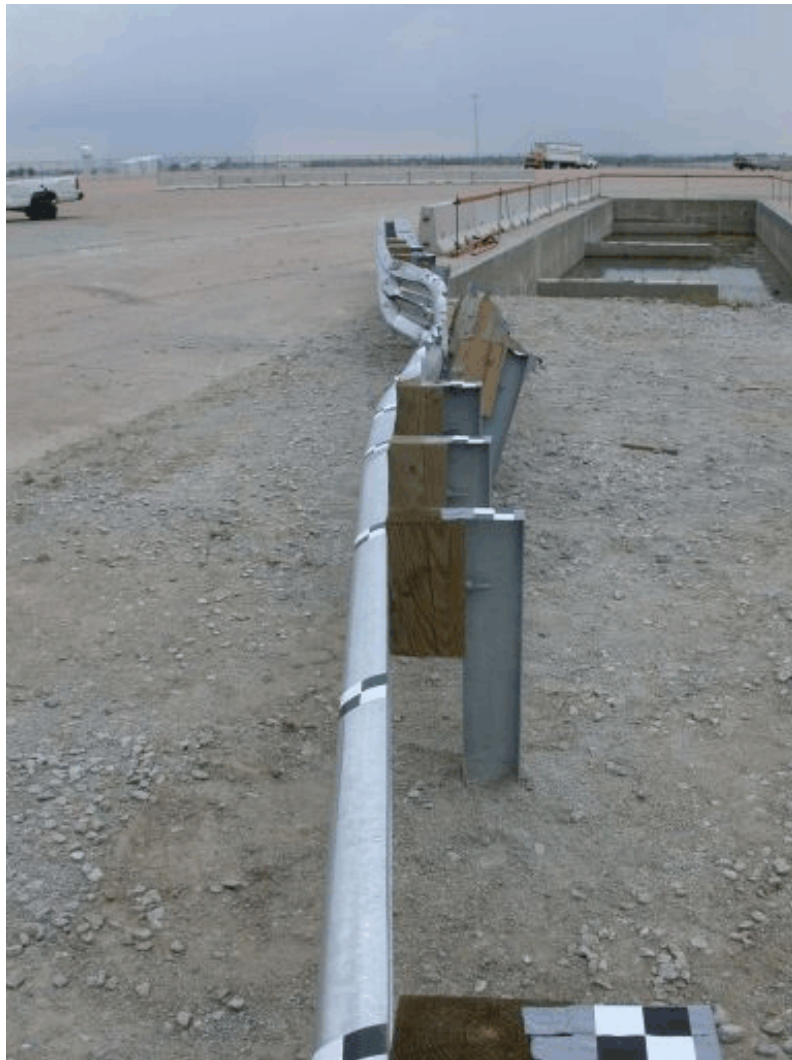
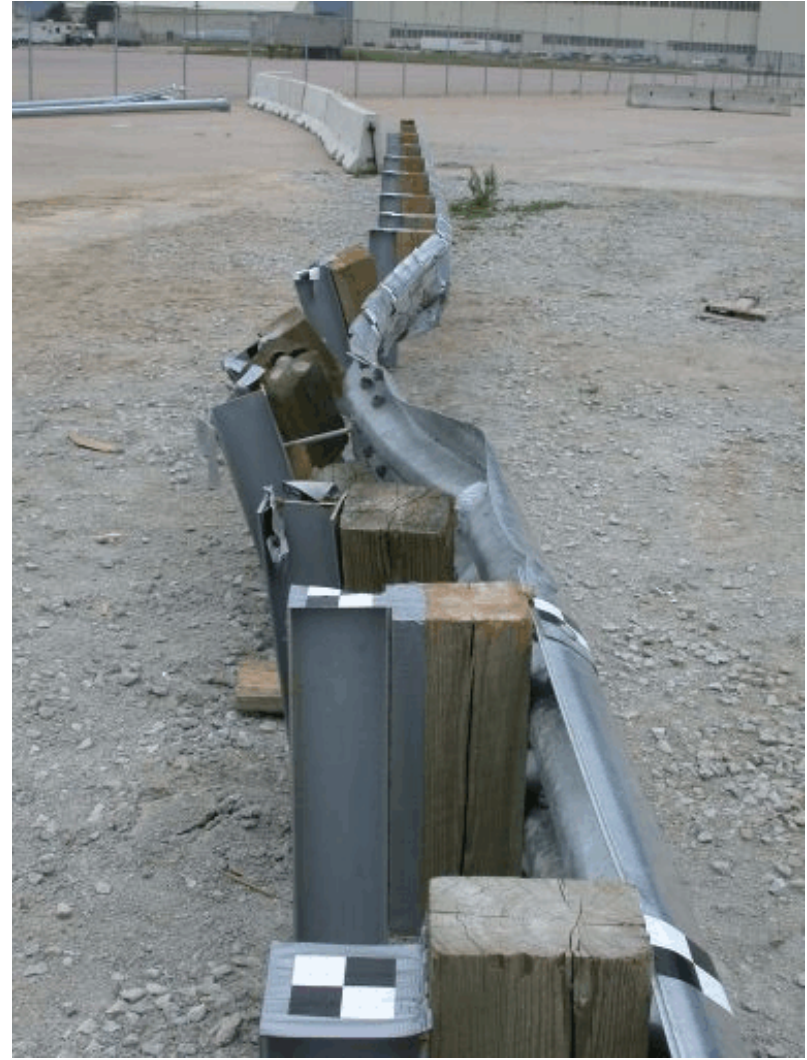
Figure 39. System Damage, Test MWT-3

Damage to the barrier was moderate, as shown in Figures 39 through 45. Barrier damage consisted of deformed guardrail and posts, contact marks on a guardrail section, and fractured wooden spacer blockouts. The length of vehicle contact along the approach guardrail system was approximately 5.7 m (18.75 ft), which spanned from 203 mm (8 in.) upstream from the centerline of post no. 9 through 203 mm (8 in.) upstream from the centerline of post no. 15.

Buckling in the upper and lower portions of the rail was found 102 mm (4 in.) upstream of post no. 8. Two buckle points were evident on the top portion of the rail at the leading edges of the blockouts at post nos. 16 and 17. Between post nos. 9 and 12, the bottom portion of the W-beam was

The permanent set of the barrier system is shown in Figure 39. The maximum lateral permanent set rail and post deflections were 389 mm (15.3 in.) at the centerline of post no. 12 and 556 mm (21.9 in.) at the centerline of post no. 11, respectively, as measured in the field. The maximum lateral dynamic rail and post deflections were 620 mm (24.4 in.) at the centerline of post no. 12 and 649 mm (25.5 in.) at the centerline of post no. 11, respectively, as determined from the high-speed film analysis. The working width of the system was found to be 785 mm (30.9 in.).

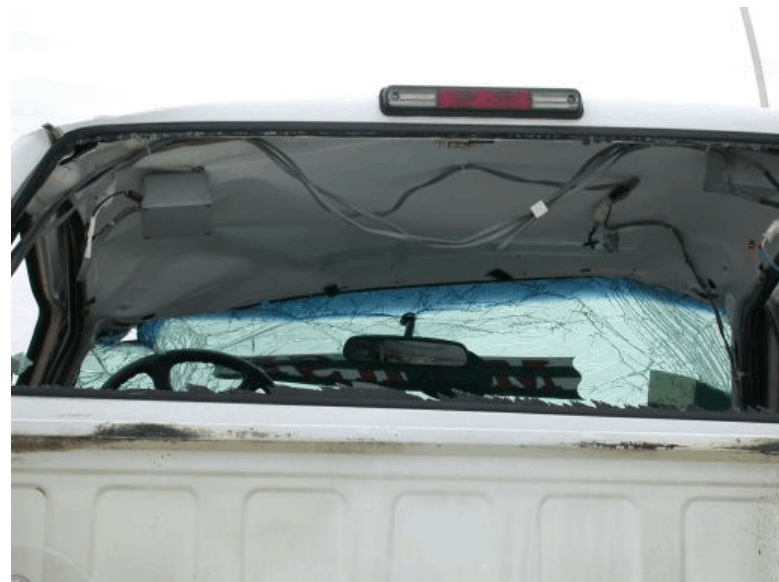
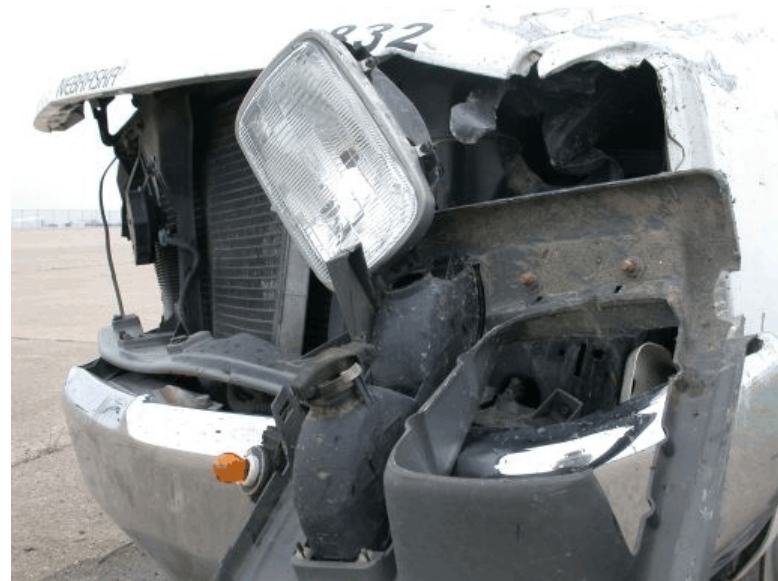
Figure 47. Vehicle Damage, Test MWT-3

Most of the damage was concentrated on the front, both the left and right sides, and the roof of the vehicle due to rollover, as shown in Figure 46. The right-front corner of the vehicle was

crushed inward toward the engine with the bumper buckling near its center. The roof of the vehicle was crushed downwards due to vehicle roll. The right-front tire was deflated and removed from the steel rim, and the inside of the steel rim encountered deformations. The right-front outer tie rod was disengaged, while the ball joints, stabilizer bar, and shock mount remained intact. The right-side A-frame was deformed. The right-rear fender behind the tire, the right-side end of the rear bumper, and the tail pipe encountered significant damage.

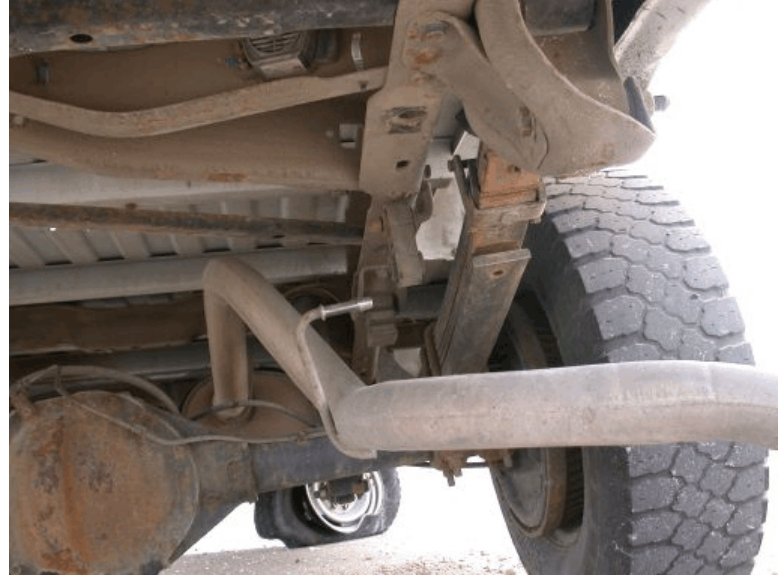
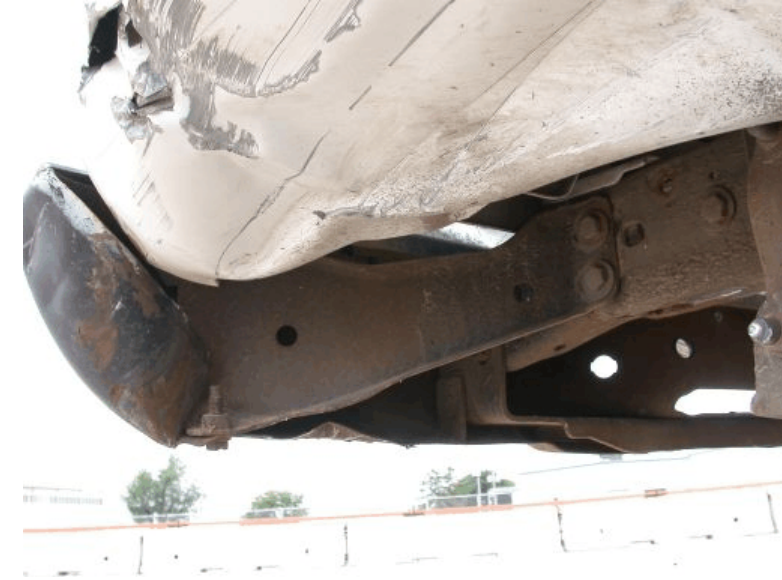
Figure 48. Vehicle Damage, Test MWT-3

The damage to the frame was minimal and focused mainly around the bumper bracket and frame horns. Deformations to the vehicle's body were evident on the right side in the shape of the guardrail. Left-side damage was limited to light scraping and box deformations due to rollover. The windshield was shattered but remained intact due to the safety layer, as shown in Figure 48. All other window glass shattered and was removed from the system.

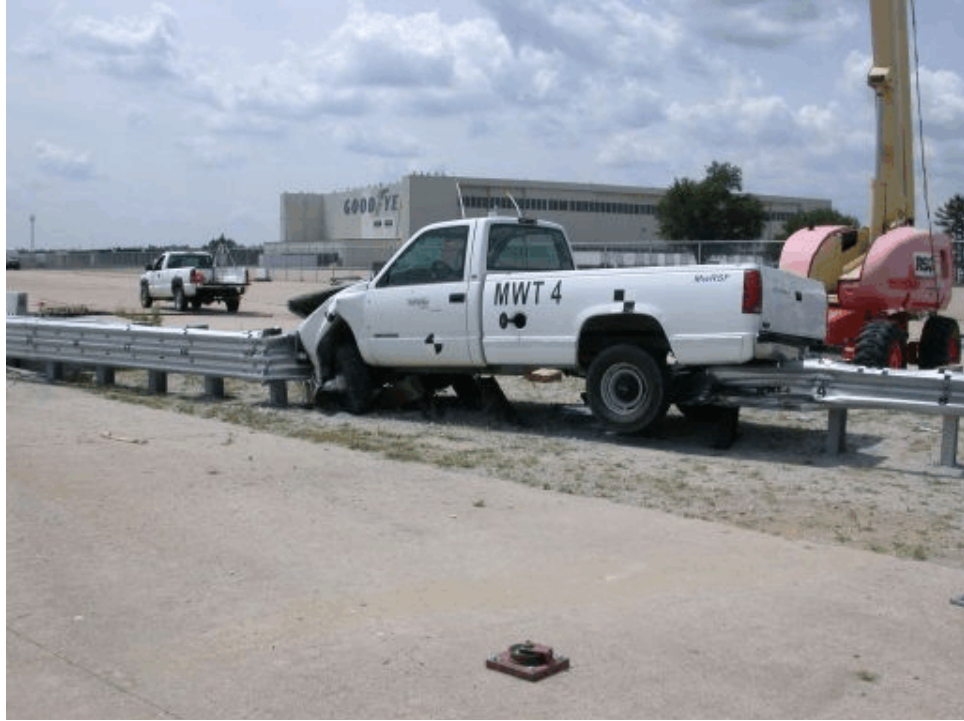
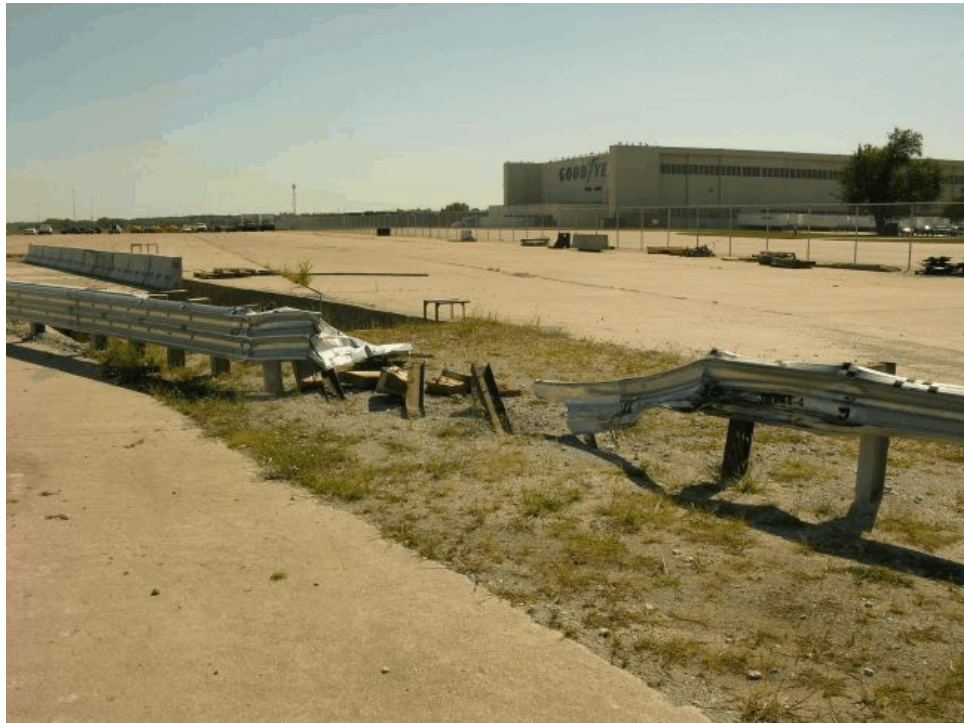
Figure 70. System Damage, Test MWT-4

Barrier damage was extensive as shown in Figures 70 through 76. Barrier damage consisted of deformed guardrail and posts, ruptured guardrail, fractured blockouts, and contact marks on a guardrail section. The length of vehicle contact along the approach guardrail system was approximately 5.9 m (19.5 ft), which spanned from 229 mm (9 in.) upstream from the centerline of post no. 9 through the centerline of post no. 15.

The guardrail damage consisted of significant contact marks and moderate deformation and flattening of the impacted section of W-beam and thrie beam rail between post nos. 9 and 14. The guardrail buckled at post nos. 8, 9, 14, 15, and 16 and 89 mm (3.5 in.) downstream of post no. 10. The guardrail bent around the blockouts at post nos. 9 and 10. The W-beam guardrail was torn

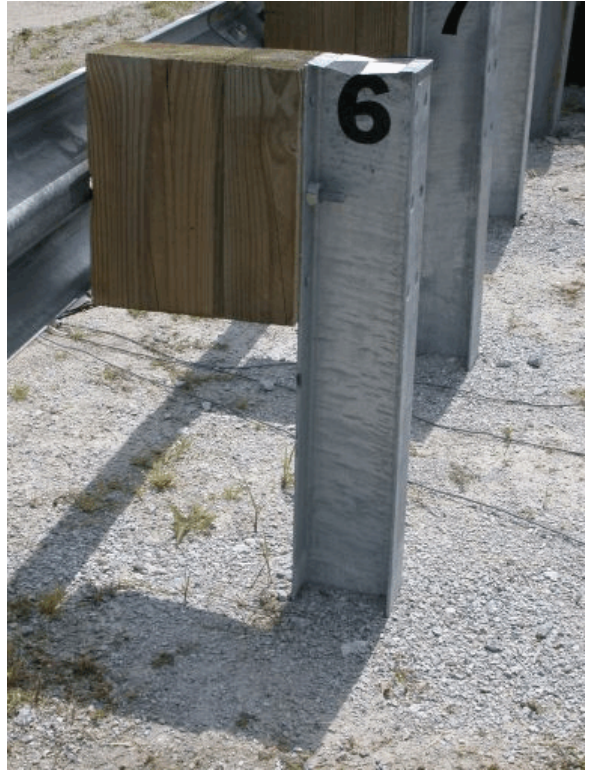
Figure 73. Post Nos. 1, 2, 5, and 6 Damage, Test MWT-4

Steel post nos. 3 through 7 twisted and rotated slightly downstream. Post nos. 8 through 10 rotated backward slightly and bent longitudinally downstream. Post nos. 11 through 14 rotated backwards and bent longitudinally downstream. Post nos. 11 and 12 also encountered contact marks on the upstream front flange and rear flange, respectively. Post nos. 15 through 21 bent slightly downstream, and post nos. 15 through 18 also rotated backward slightly. The upstream anchorage system moved slightly longitudinally, but the posts were not damaged.

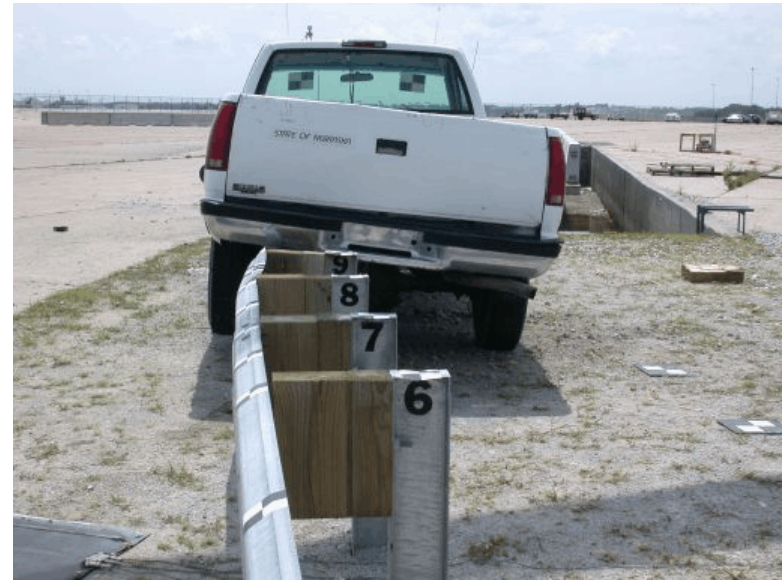
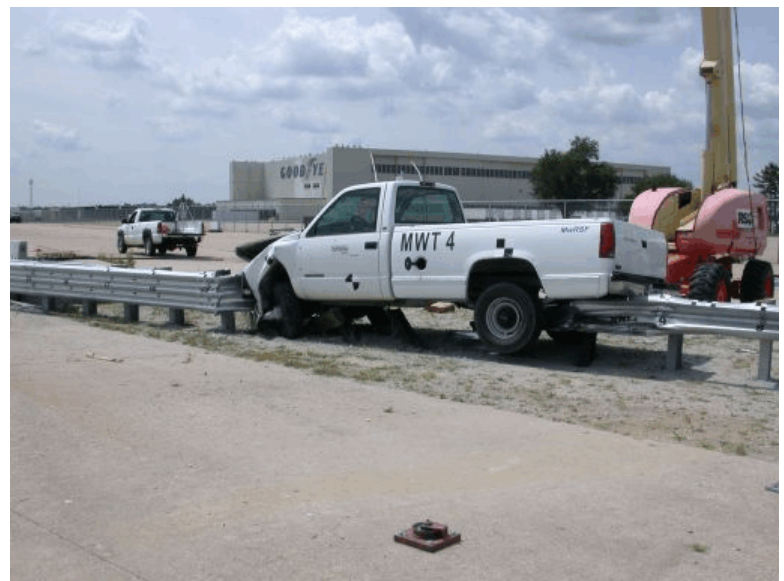
Figure 77. Vehicle Damage, Test MWT-4

Exterior vehicle damage was moderate, as shown in Figures 77 and 80. Extensive occupant compartment deformations occurred with the penetration of the center of the floorboard, as shown in Figure 80. The drive shaft U-joint penetrated through and caused a 178-mm (7-in.) slice in the floorboard. A 64-mm (2.5-in.) dent was also found in the floorboard. Complete occupant compartment deformations and the corresponding locations are provided in Appendix C.

Damage was concentrated on the front third of the vehicle. The front of the vehicle through the front quarter panels buckled inward. The right-front and left-front quarter panels and right-side door encountered significant contact and scratch marks along with buckling and numerous dents. The right-side frame rail buckled near the cab portion. The hood deformed downward and inward under itself. The front bumper encountered significant tears, dents, and buckling. The front grill was fractured and removed from the vehicle. The radiator encountered contact marks and was punctured. Contact marks were visible on the right side of the rear bumper. The right-front and left-front wheel wells sustained contact and scratch marks, and the right-front wheel well also encountered significant dents. Both of the front wheel assemblies were severely deformed and damaged.
