## Investigating the Use of a New Universal Breakaway Steel Post -- Phase III

TESTING CERT # 2937.01

*Research Project Number TPF-5(193), Suppl. #35*

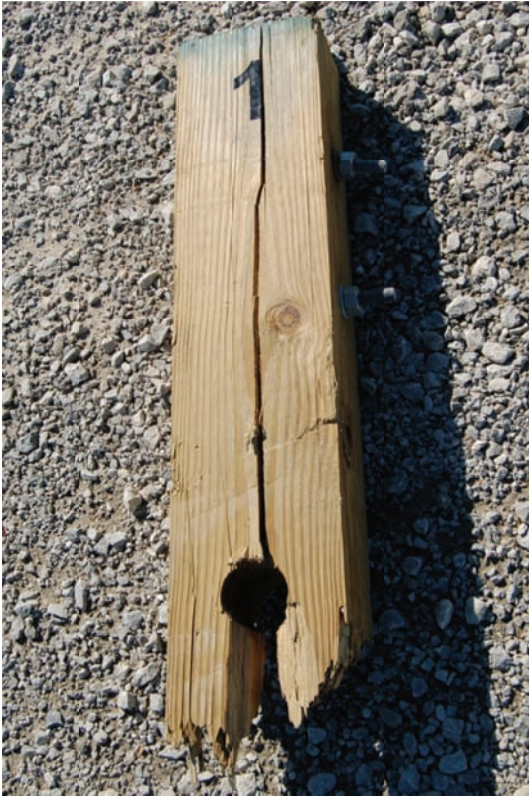
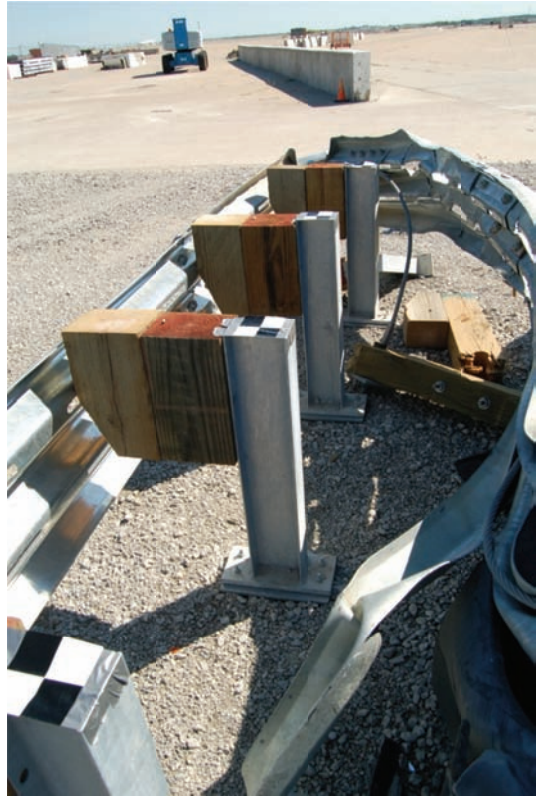
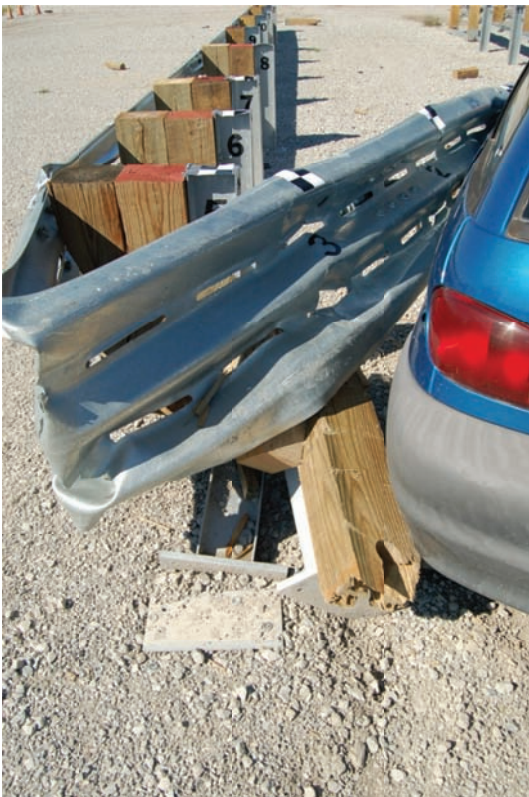
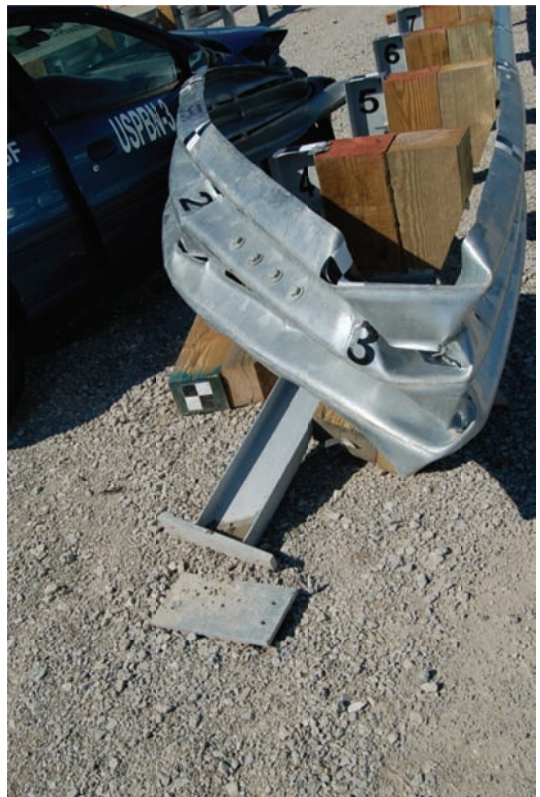
Figure 40. System Damage, Test No. USPBN-3

Damage to the barrier was severe, as shown in Figures 40 through 42. Barrier damage consisted of guardrail buckling and flattening, deformation of the guardrail around the front of the car, and post fracture and disengagement on both sides of the bullnose. Deformation to the rail occurred from 11 in. (279 mm) downstream of post no. 3 on Side A to 7½ in. (191 mm) downstream of post no. 5 on Side B.

The first three posts on Side A were fractured and disengaged. BCT post nos. 1 and 2 fractured through the hole at ground level. The universal steel breakaway post no. 3 disengaged from the foundation tube and lower base plate when the bolts fractured. Post no. 3 was slightly twisted downstream in relation to the upper base plate, and there was some slight chipping on the blockout. Post no. 4 was slightly twisted upstream in relation to the upper base plate. Post nos. 1 and 3 had a ¼-in. (6-mm) soil gap and a ½-in. (13-mm) soil gap on the front side of the bases, respectively. There was no visible damage to post nos. 5 through 14 on Side A.

The first four posts on Side B were fractured and disengaged. BCT post nos. 1 and 2 fractured through the hole at ground level. Post no. 1 was split on the upstream face, and the cable bearing sleeve disengaged. UBSP nos. 3 and 4 were slightly twisted upstream in relation to their upper base plates and were disengaged from the foundation tube and lower base plate when the bolts fractured. The blockouts on post no. 5 were rotated downstream. A ½-in. (13-mm) soil gap was found on the downstream side of post no. 3 with an approximate 12-in. (30-mm) diameter by 2-in. (51-mm) high soil heave. The rail-to-post bolt was pulled out at post no. 6. There was no visible damage to post nos. 7 through 14 on Side B. There was no visible damage to the foundation tubes or lower base plates on either side of the system.

The damage to the thrie beam guardrail consisted of buckling, tearing, and flattening of the guardrail. Flattening occurred in the thrie beam from post no. 3 on Side A to post no. 4 on Side B. The Side B cable end anchorage threads fractured at the post no. 1 BCT anchorage. A buckle formed 11 in. (279 mm) downstream of post no. 3 on Side A with an 8-in. (203-mm) long horizontal tear in the upper slot. Another buckle formed at post no. 3 on Side A. A 2¼-in. (57-mm) long vertical tear was located 9 in. (229 mm) upstream of the Side A quarter point in rail section no. 1. The guardrail buckled 19 in. downstream of the center of the system towards Side A. Rail section no. 1 at the lower slot was torn completely through from 18½ in. (470 mm)

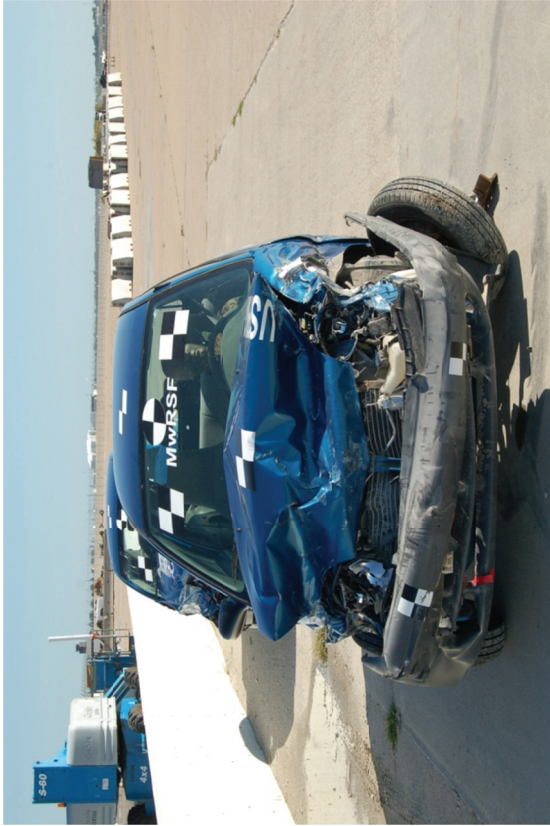
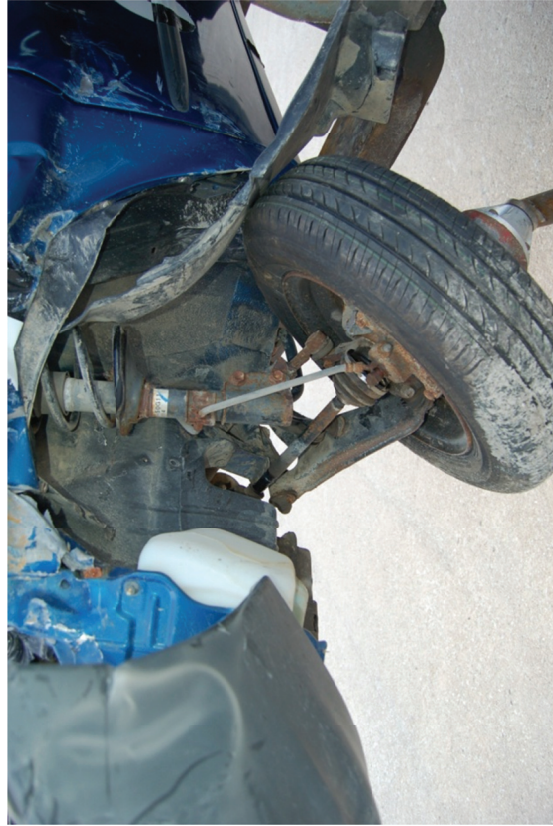
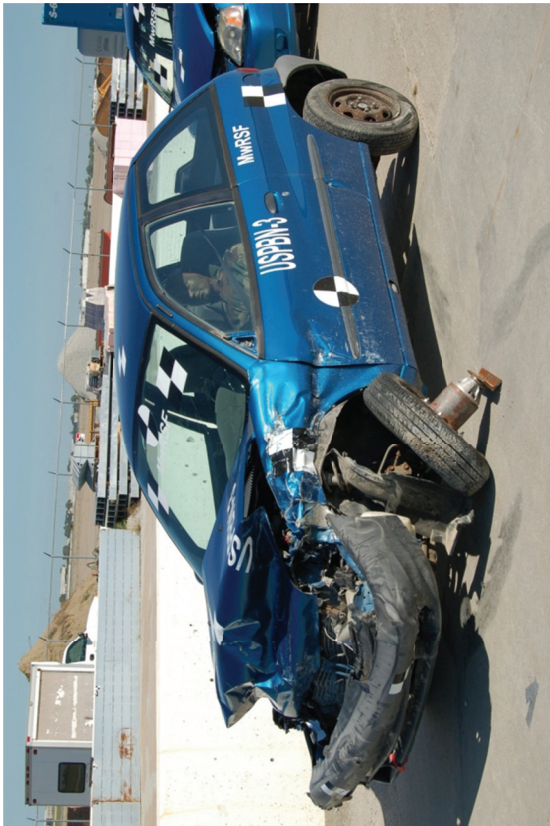
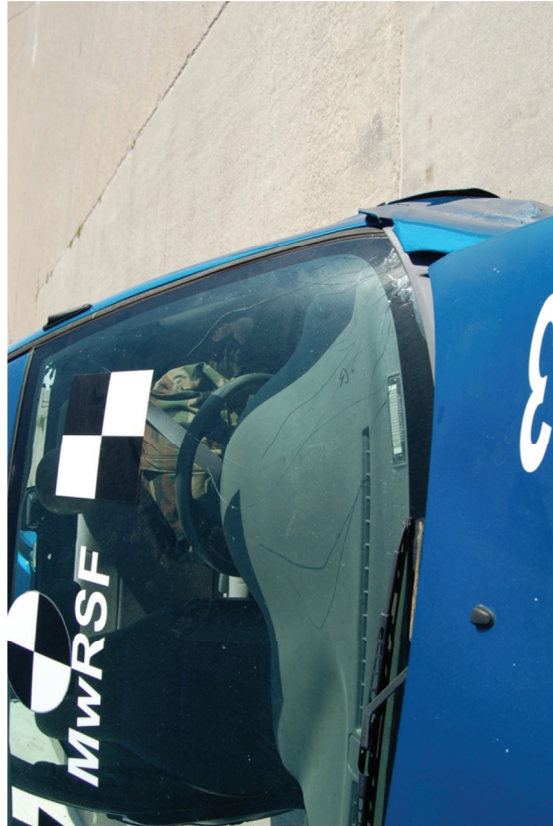
Figure 45. Vehicle Damage, Test No. USBN-3

The damage to the vehicle was moderate, as shown in Figure 45. Deformations to the vehicle's floorboard were relatively minor, with maximum longitudinal and vertical deflections of ½ in. (13 mm) and ¼ in. (6 mm), respectively. Complete occupant compartment and vehicle deformations and the corresponding locations are provided in Appendix C.

The left door was dented and crushed. A dent was found between the left door and quarter panel. The left-fender was crushed inward and backward. The left-front strut attachment was fractured and the steering rod was bent. The left-front CV joint was pulled out, and both ends of the half shaft were damaged or pulled out. A dent was found in the left-front rim. The left mirror was disengaged. The radiator was crushed inward and shifted to the right. Both headlights were fractured. The left bumper mount was fractured. The bumper fractured near its

center. Minor cracking occurred in the lower left windshield in an area approximately 15 in. (381 mm) by 13 in. (330 mm). The hood was crushed backward and upward. The right side of the bumper cover was dented and torn. The right fender was crushed inward. The front of the right door was crushed and dented, and the door was ajar. The fuel tank was punctured, and small scrapes were found on the rear lower control arms. The roof and window glass remained undamaged.

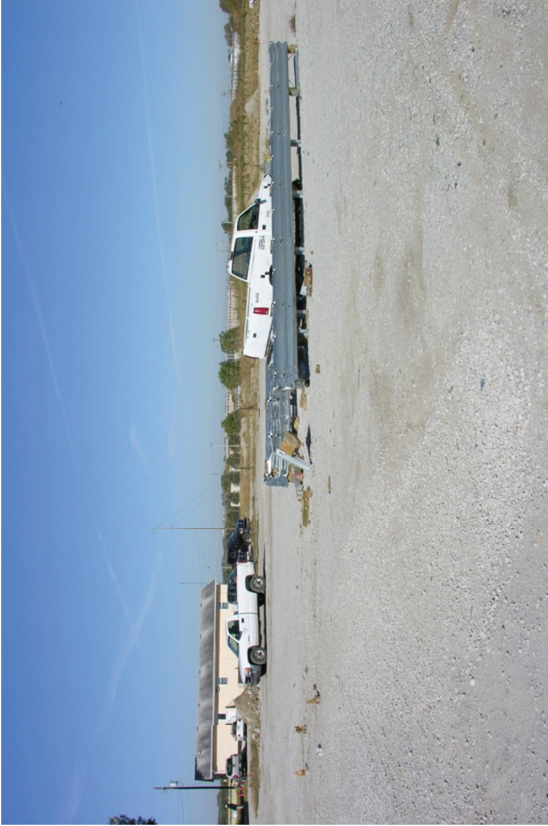
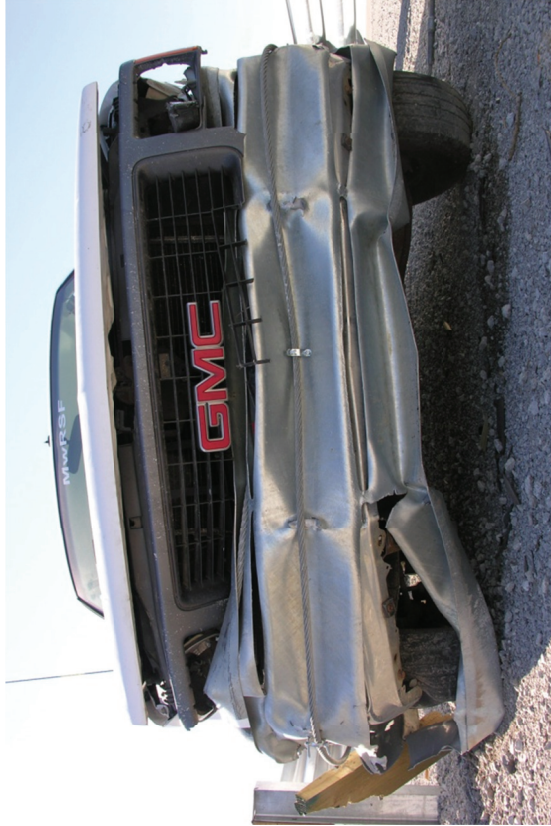
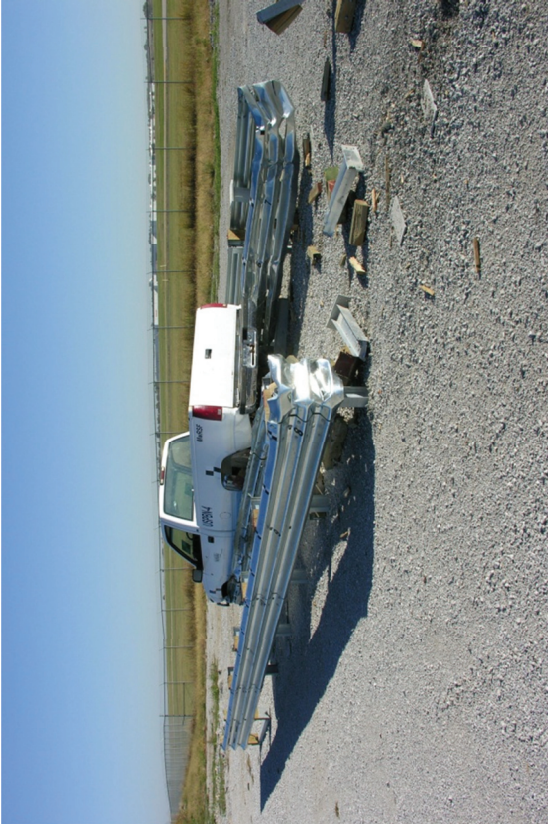
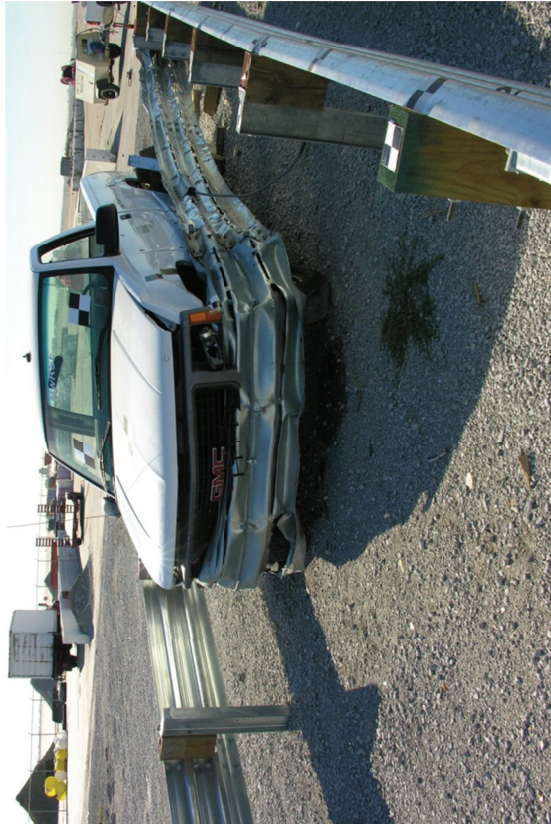
Figure 51. System Damage, Test No. USPB4-4

Damage to the barrier was severe, as shown in Figures 51 through 53. Barrier damage consisted of guardrail buckling and flattening, deformation of the guardrail around the front of the pickup truck, and post fracture and disengagement on both sides of the bullnose. Deformation to the rail occurred from 13 in. (330 mm) upstream of post no. 8 on Side A to 15 in. (381 mm) upstream of post no. 8 on Side B.

The damage to the Side A thrie beam guardrail consisted of buckling and tearing of the guardrail. A buckle formed 13 in. (330 mm) upstream of post no. 8. A 1½-in. (38-mm) long vertical tear was located in the upper slot 13 in. (330 mm) downstream of post no. 7 on the Side A. Another 2-in. (51-mm) long tear was located in the upper slot 21 in. (533 mm) downstream of post no. 6. The bottom corrugation had a 6-in. (152-mm) long vertical tear 17 in. (432 mm) upstream of post no. 5. The lower slot had a small vertical tear 43 in. (1,092 mm) upstream of post no. 5. Major folding and a buckle occurred in the thrie beam guardrail at the Side A quarter-point cable clip on rail section no. 1. The lower slots were torn completely through from post no. 1 through 13 in. (330 mm) downstream of the center of the nose on Side A. A 4-in. (102-mm) long vertical tear and an 8-in. (203-mm) long vertical tear were located 12 in. (305 mm) and 9 in. (229 mm) upstream from post no. 1, respectively. Another 4-in. (102-mm) long vertical tear was located in the bottom corrugation 13 in. (330 mm) downstream of the center of the nose on Side A.

The damage to the Side B thrie beam guardrail consisted of buckling, tearing and flattening of the guardrail. Folding and flattening occurred downstream of the center of the nose on Side B. A 2-in. (51-mm) long vertical tear was located 20 in. (508 mm) upstream of post no. 1. A 3-in. (76-mm) long vertical tear and a 4-in. (102-mm) long vertical tear were located at the

lower slot 13 in. (330 mm) and 11 in. (279 mm) upstream of post no. 1, respectively. The guardrail was torn completely through at the lower slots 17 in. (432 mm) downstream of post no. 1. A 2-in. (51-mm) long vertical tear was found 7 in. (178 mm) upstream of post no. 2 at the upper slot. Another 1-in. (25-mm) long tear was found 4 in. (102 mm) downstream of post no. 3. A 3-in. (76-mm) long horizontal tear was located 43 in. (1,092 mm) downstream of post no. 7. The guardrail was buckled 15 in. (381 mm) upstream of post no. 8.

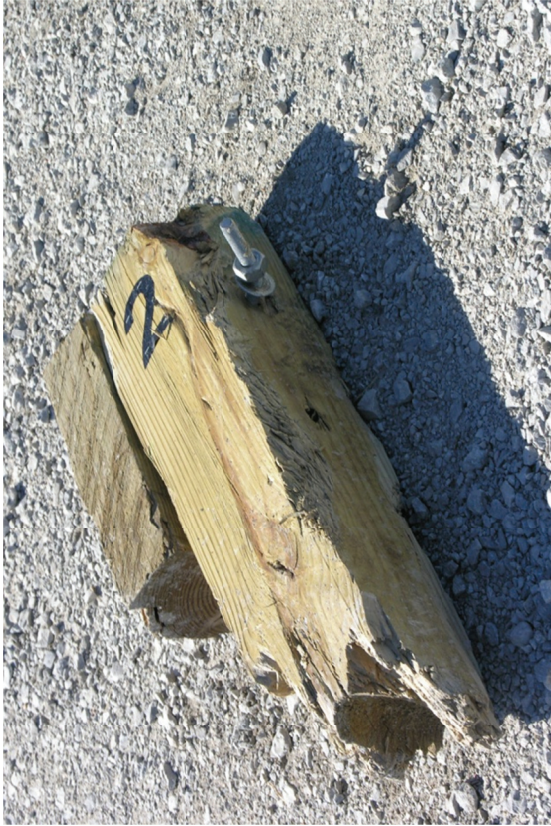
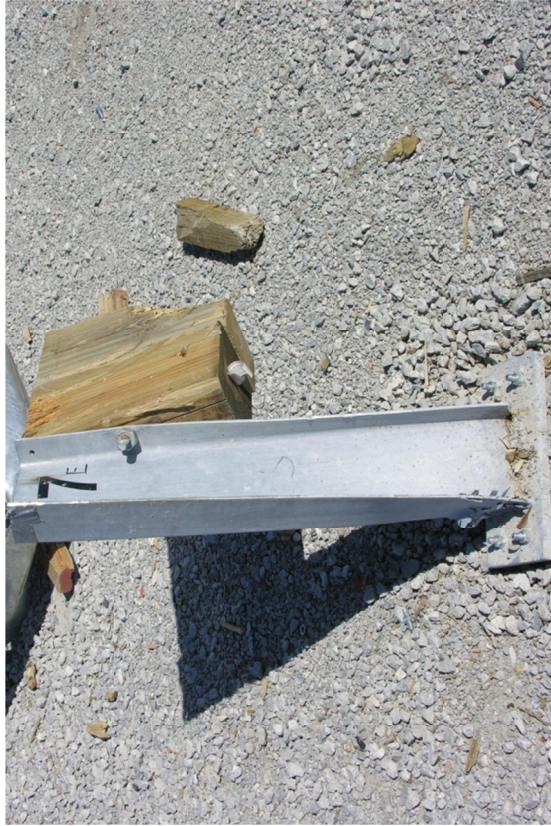
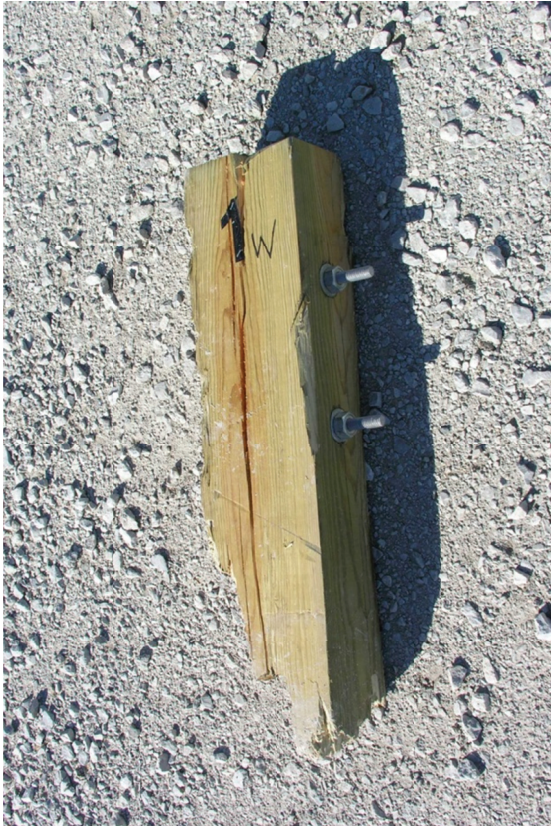
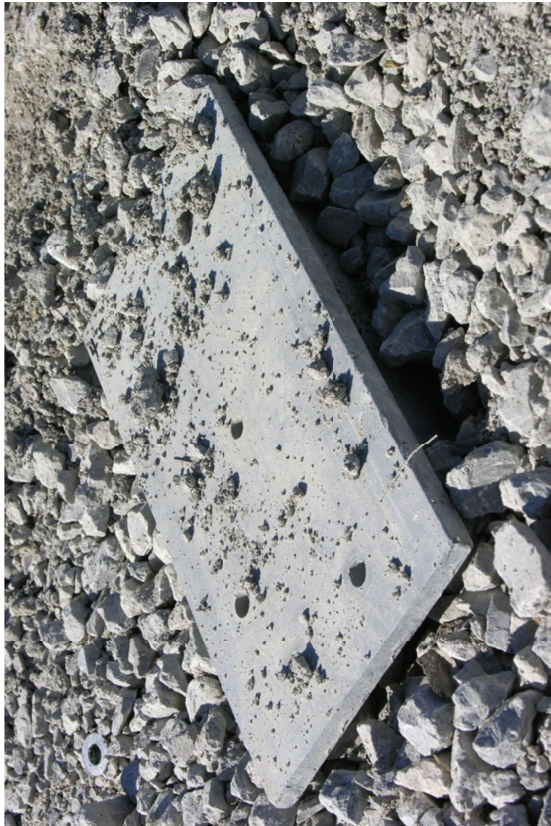
Figure 53. Post Damage, Test No. USPBN-4

Post nos. 1 through 6 and post no. 8 on Side A were fractured and disengaged. BCT post nos. 1 and 2 fractured through the hole at ground level. The majority of post no. 1 remained attached to the guardrail connected through the bottom bolt. The universal steel breakaway post nos. 3 through 6 and post no. 8 disengaged from the foundation tube and lower base plate when the bolts fractured. The top portion of post no. 3 was slightly twisted in relation to the upper base plate. The back blockout was disengaged from post no. 4 and the front flange was bent. The back blockout was disengaged from post no. 5, and the front blockout was partially disengaged. The weld at the base plate of post no. 7 fractured at the front flange on the upstream side. Post no. 7 was also bent and twisted downstream in relation to the upper base plate with the rear flange buckled 2 in. (51 mm) at the lower portion of the post. There was also a  $\frac{3}{8}$ -in. (10-mm) soil gap on the upstream face of the foundation tube at post no. 7. Post no. 8 was twisted upstream in relation to the upper base plate, and the back flange and web were bent at the top of the post. Post nos. 9 and 10 had  $\frac{1}{2}$ -in. (13-mm) soil gaps on the backside and frontside of the foundation tubes, respectively. There was no visible damage to post nos. 11 through 14 on Side A.

The first seven posts on Side B were fractured and disengaged. BCT post nos. 1 and 2 fractured through the hole at ground level. Post no. 1 was split on the upstream face. The universal steel breakaway post nos. 3 through 7 disengaged from the foundation tubes and lower base plates as the bolts fractured. Post no. 3 was slightly twisted downstream in relation to the

upper base plate, and the back flange was bent and gouged. Post no. 4 was wedged underneath the left-rear tire. The front blockout on post no. 5 was fractured. The back flange was bent and the front blockout was split on post no. 7. A ½-in. (13-mm) soil gap was found on the upstream side of the foundation tube of post no. 8. The two upstream base plate bolts fractured on post no. 8, and the post was bent slightly downstream but still in its original location. There was no visible damage to post nos. 9 through 14 on Side B. There was no visible damage to the foundation tubes or lower base plates on either side of the system.

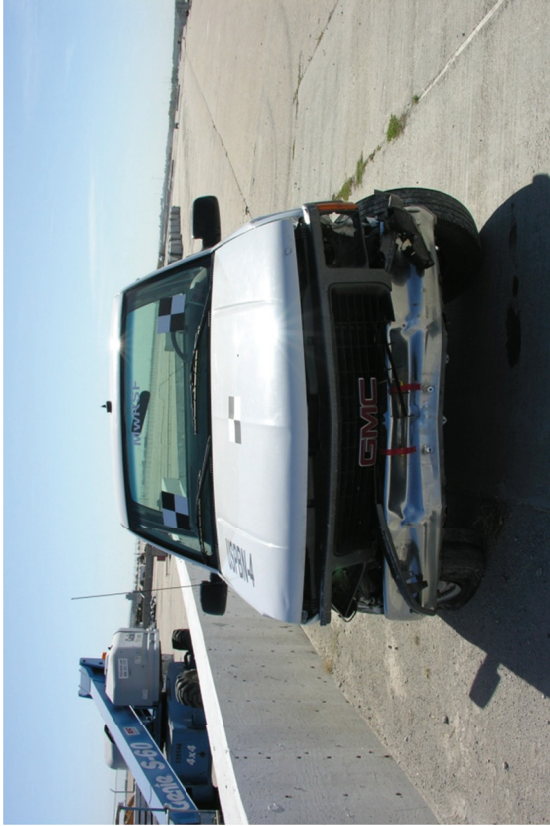
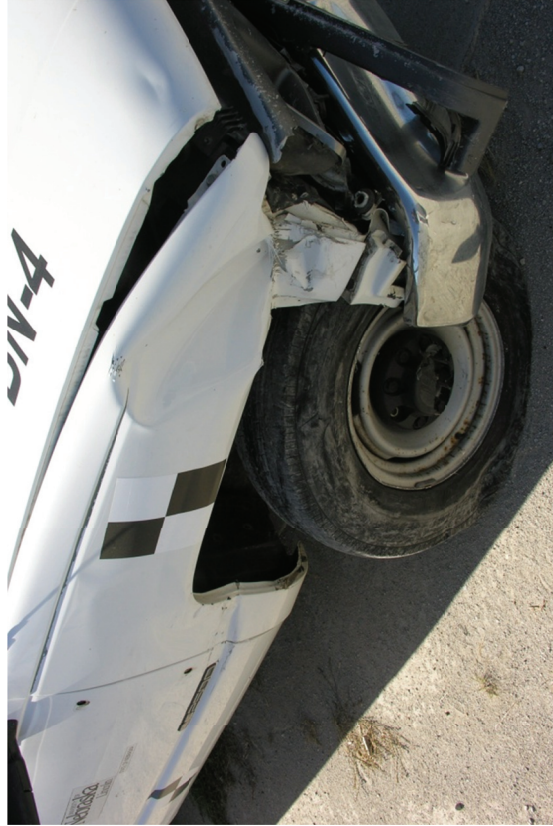
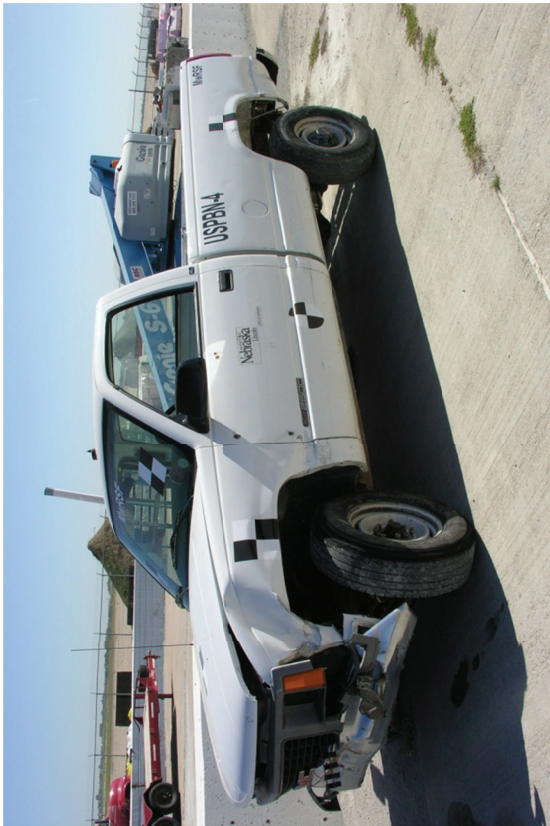
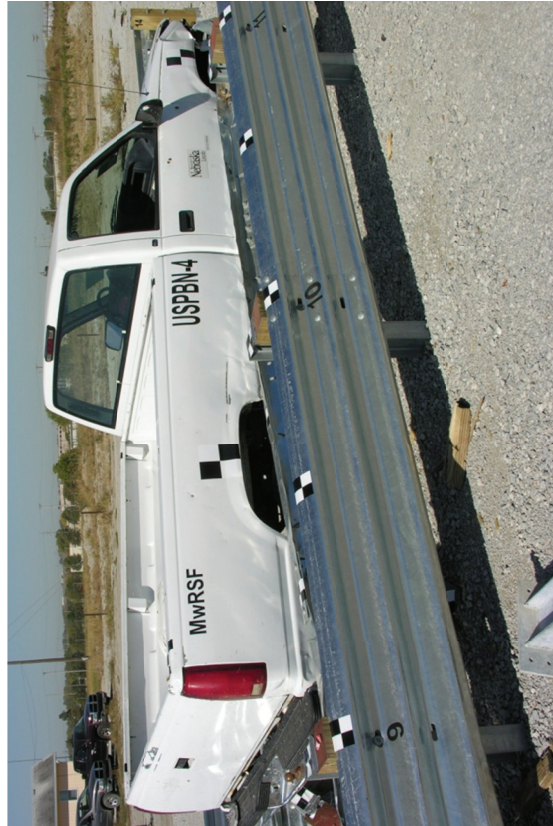
Figure 55. Vehicle Damage, Test No. USPBN-4

The damage to the vehicle was moderate, as shown in Figure 55. Deformations to the vehicle's floorboard were relatively minor, with maximum longitudinal, lateral, and vertical deflections of ½ in. (13 mm) located at the right side of the right-side floorboard near the dashboard, ½ in. (13 mm) located near the middle of the left-side floorboard, and ½ in. (13 mm) located at the right side of the right-side floorboard near the dashboard, respectively. Complete occupant compartment and vehicle deformations and the corresponding locations are provided in Appendix C.
