Landslide Investigation and Correction

WILLIAM J. SISILIANO

PHIL JONES

Seymour District Area Engineer
Indiana State Highway Commission

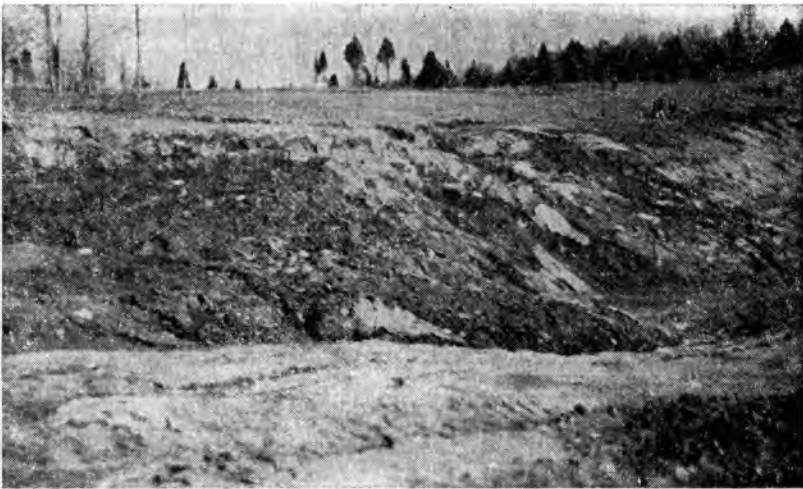
These cut slopes failed during construction. Photograph 1* was on contract R-8828, where the cut slope failed at the interface between soil and shale; photograph 2 was on contract R-8742 where the cut slope failure was in soil.

The cut backslopes were constructed on 2:1 slopes which proved to be too steep for the strength of the soils encountered, the dip of the underlying shale and the ground water conditions encountered.

Photo 1. Cut backslope failure on I-64.

The correction of these slides was to flatten the slope and to provide backslope interceptor drains.

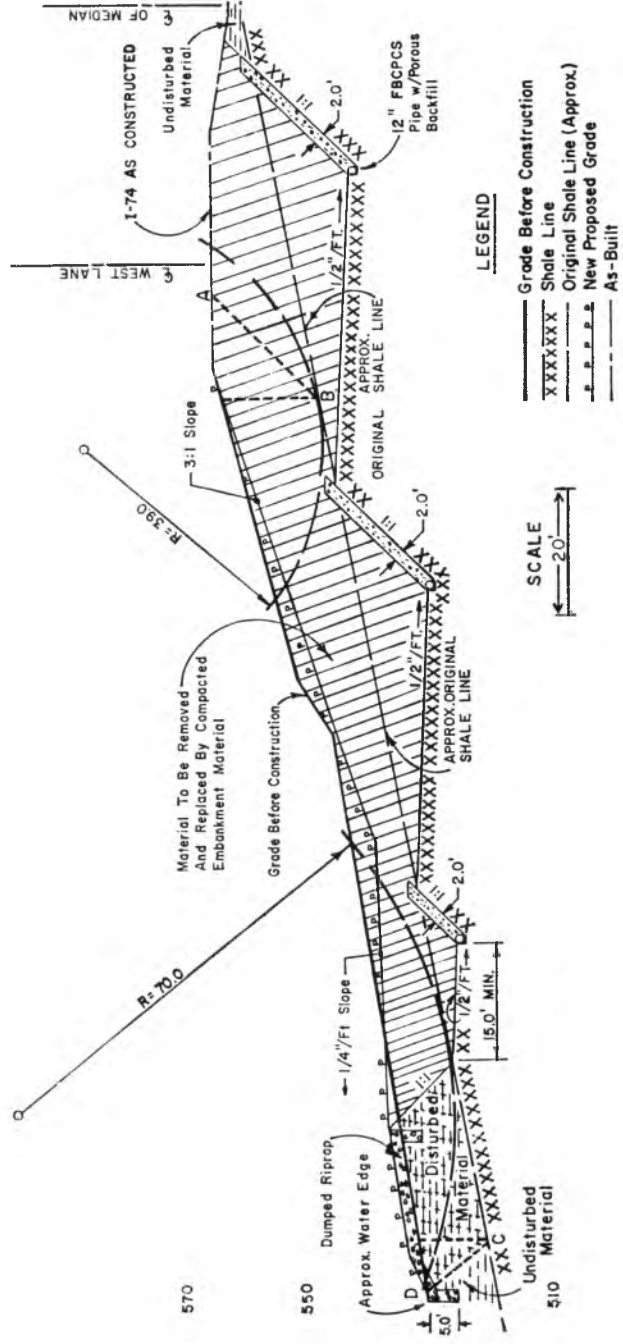
Fig. 8. Typical landslide correction—River Slide.

The embankment making up the westbound lane failed at the interface between the soil overburden and the underlying shale. The slide correction which proved to be the most economical was complete removal of the sliding mass, deep benching into the underlying shale, installation of a positive subsurface drainage system and reconstruction of the embankment with soil and shaley material compacted to more stringent requirements than used previously. The typical slide correction is shown in Figure 8 Photograph 3, showing the benching operation during construction, has been included along with photograph 4 of the basic filing operation.

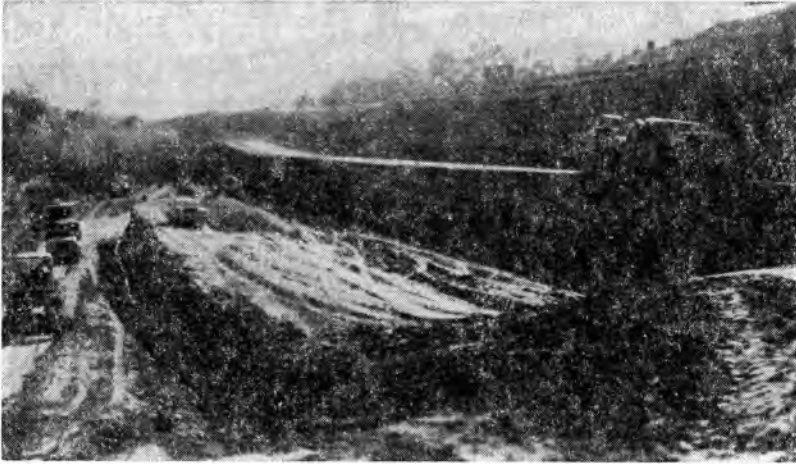
Photo 3. Construction benching operation on I-74 River Slide.

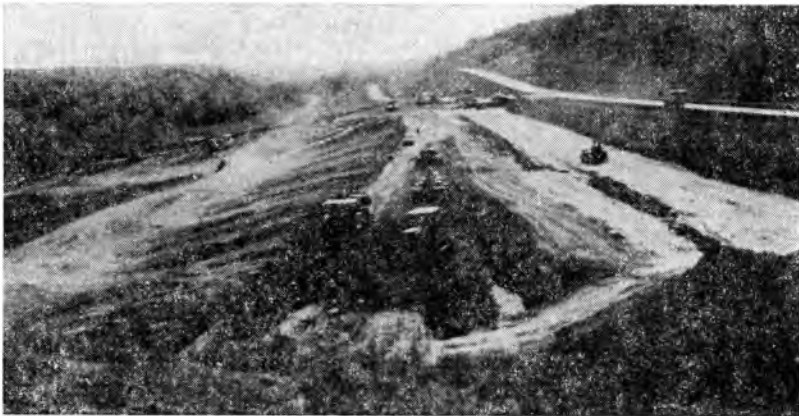
Photo 4. Embankment construction operations on I-74 River Slide.

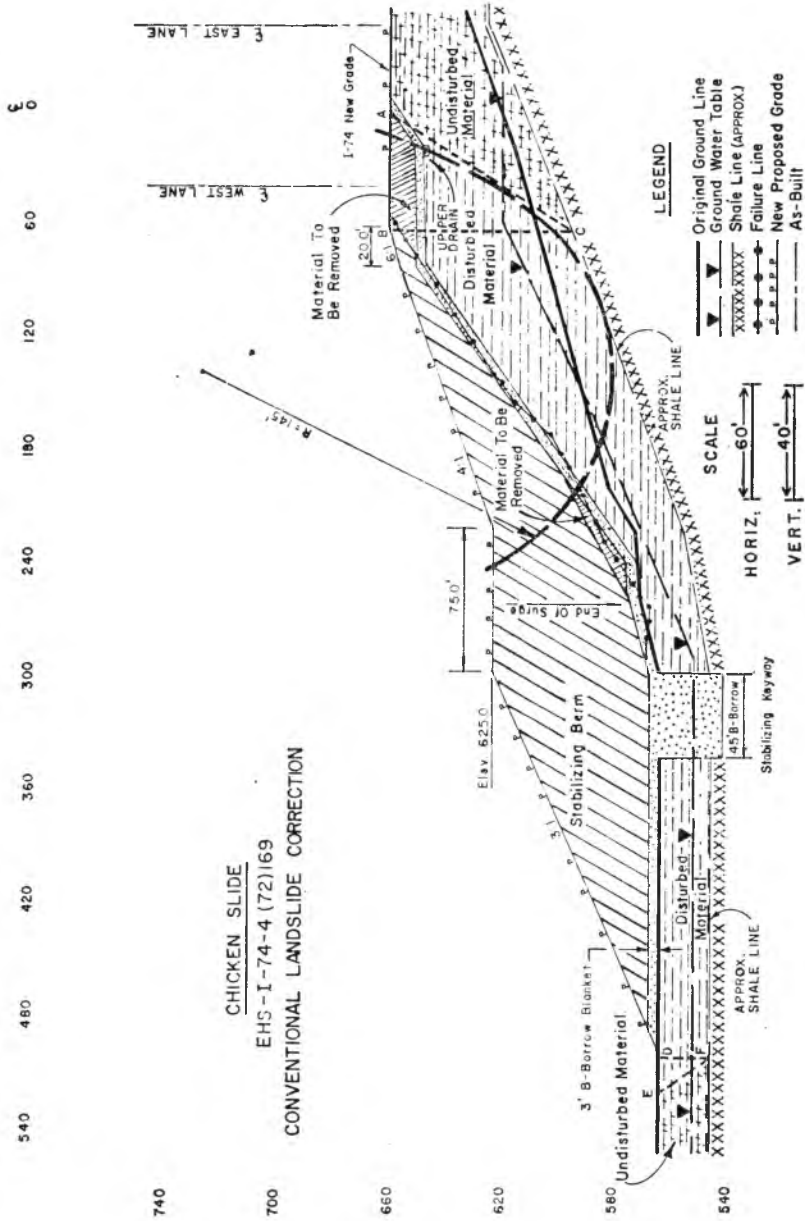
Fig. 9. Conventional landslide correction—Chicken Slide.

1. Embankment slopes were designed too steeply for the height of embankment involved.
2. Benches into foundation material were not deep enough to be effective.
3. Drains were not installed on benches, to intercept water flowing in the foundation materials.
4. Shale-limestone material used in the embankment was placed as a rock fill instead of being compacted, etc., like an earth fill, thus allowing breakdown of the shaley materials and excessive settlement of the fill to occur. Then drainage structures and pavement edge drains probably mal-functioned.
5. Eventually saturated zones in the fill sloughed out and the landslide developed.

The failure was considered to occur between the soil overburden and the shale. This conventional slide correction, as shown in Figure 9, consisted of the following:

1. Unloading upper portion of the embankment.
2. Construction of a stabilizing keyway near the toe of sideslope.
3. Installation of horizontal drains to intercept water in the foundation material. This is the first project in Indiana in which horizontal drains were installed. Photograph 5 shows the horizontal drains being installed and photograph 6 shows the drains after installation.
4. Spreading a 3-ft thick B borrow blanket over the entire slide correction area.
5. Construction of a stabilizing berm system, with a shale-placement special provision.
6. Reconstruction of the pavement.

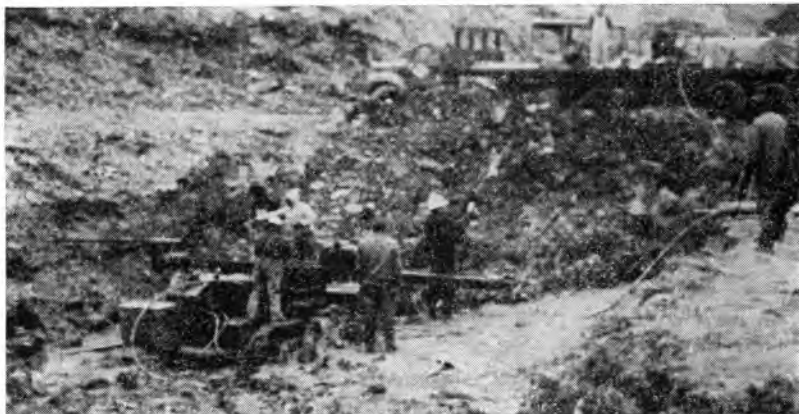
Photo 5. Horizontal drains being installed in I-74 Chicken Slide.

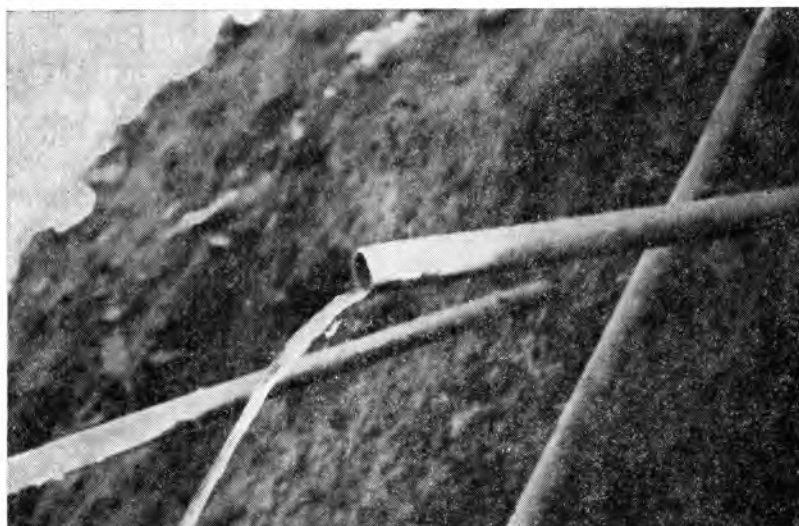
Photo 6. Horizontal drains after installation on I-74 Chicken Slide.

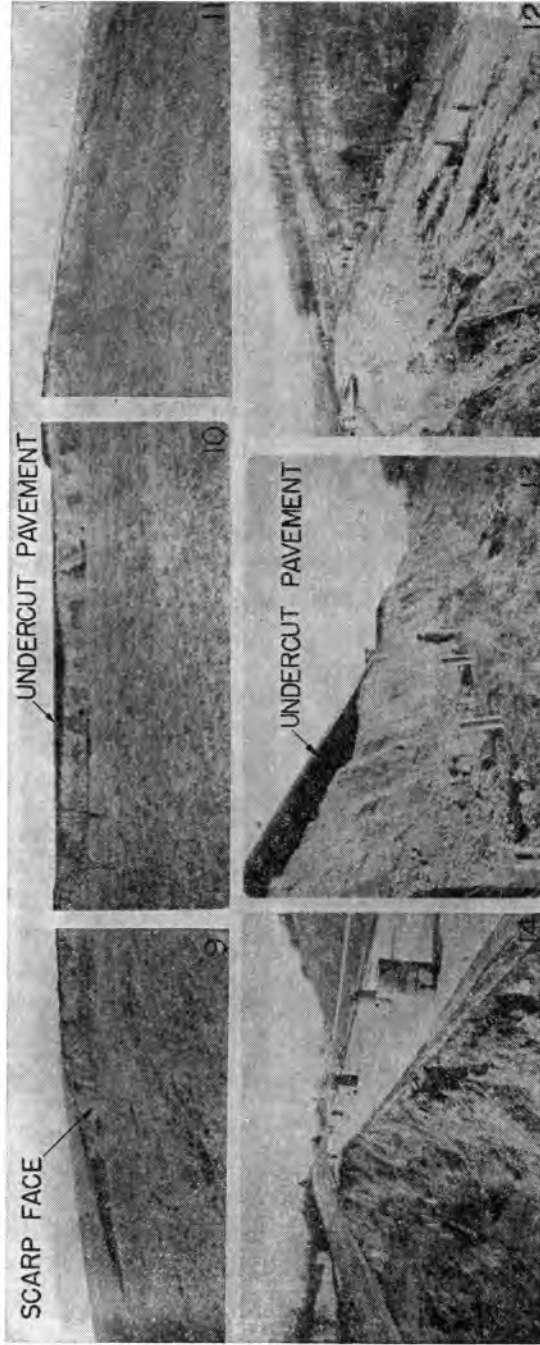
Photo 9. West side of failure scarp on I-74 Big Slide.

Photo 11. East side of failure scarp on I-74 Big Slide.

Photo 13. Failure scarp facing west on I-74 Big Slide.

Photo 10. Center of failure scarp on I-74 Big Slide.

Photo 12. Failed sideslope facing east on I-74 Big Slide.

Photo 14. Failure scarp facing west on I-74 Big Slide.

1. Erosion occurred at the toe of embankment and water in foundation soils entering from cut to the north.
2. Slopes were designed too steeply for the height of embankment involved.
3. Benches were not deep enough and drains were not provided.
4. Embankment material used was not compacted adequately, settlement occurred and drainage structures mal-functioned.
5. Saturated zones sloughed and eventually the landslide occurred.

investigation was completed, based on preliminary stability analyses and slide correction. It was recommended that granular materials be dumped over the shoulder with a conveyor to prevent the slide from enlarging under the pavement toward the centerline of the roadway by retaining the vertical failed face.

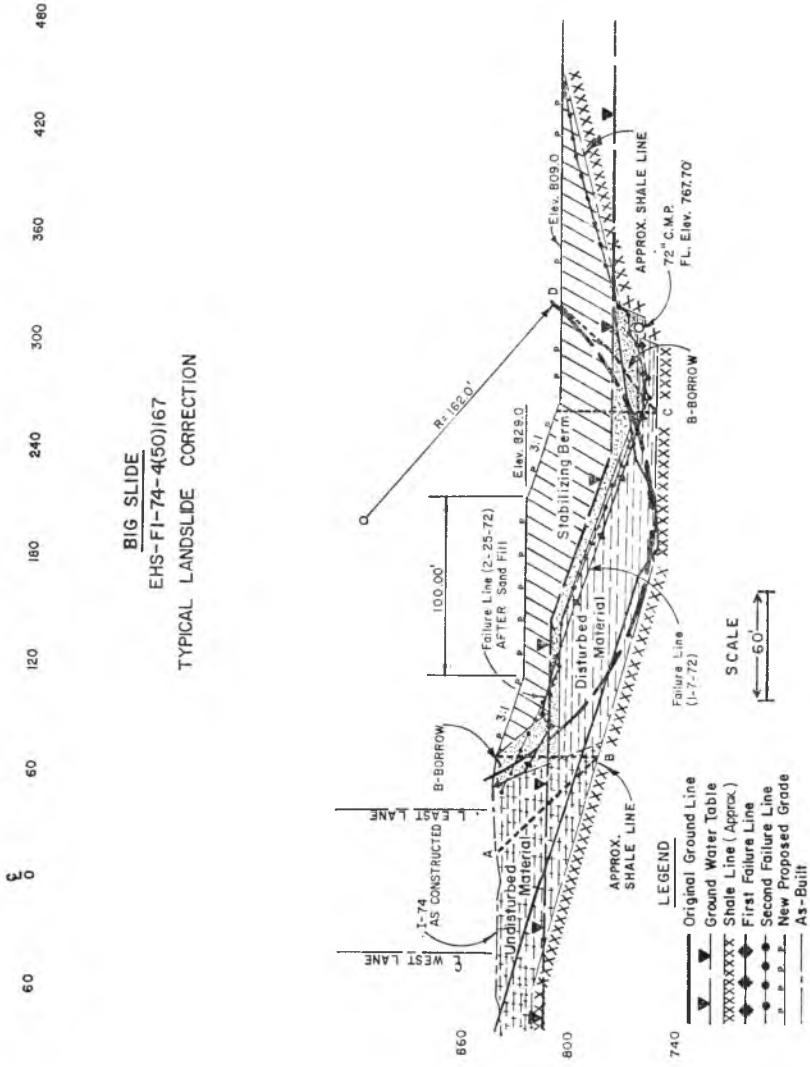
Fig. 11. Typical landslide correction—Big Slide.

This failure was considered to occur at the interface between the soil overburden and the shale. The correction as shown in Figure 11 consisted of the following:

1. Relocation of stream through 72 in. culvert placed in the shale cut located to the south.
2. Placing a select granular material blanket over the entire landslide correction area.
3. Construction of a stabilizing berm system.

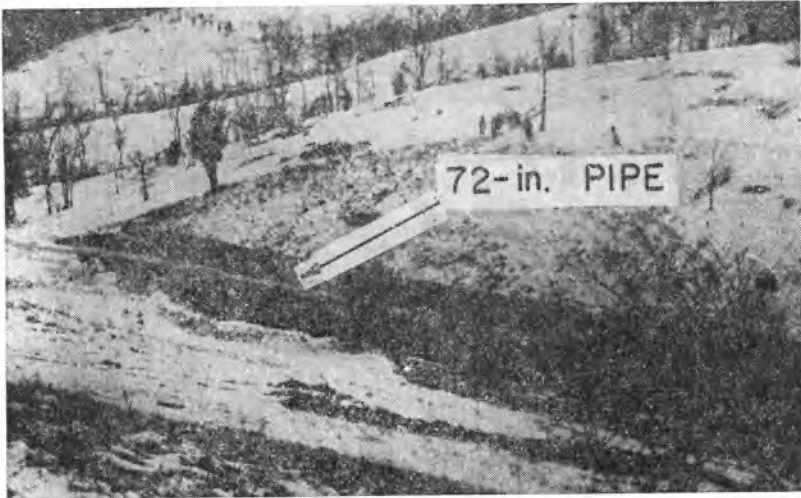
Photo 15. Stream relocation through 72-in. culvert on I-74 Big Slide.

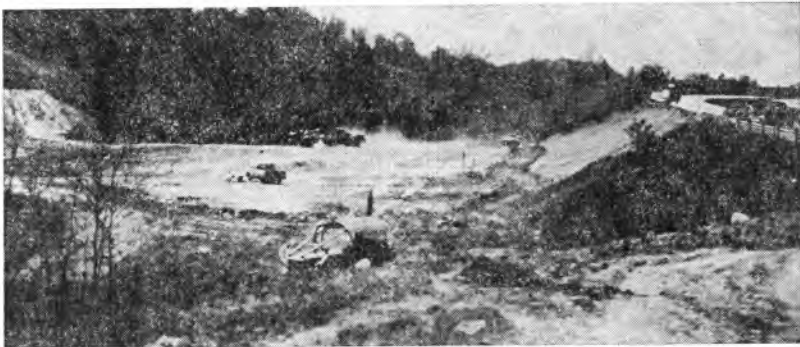
Photo 16. Construction of stabilizing berm on I-74 Big Slide.

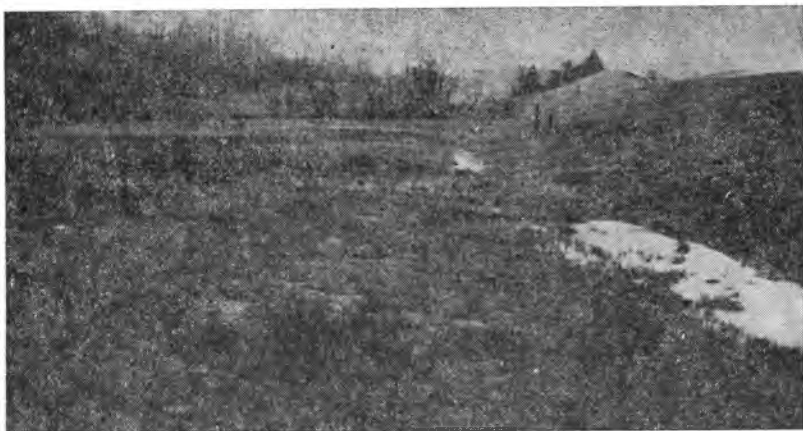
Photo 17. Completed landslide correction on I-74 Big Slide.
