Use of Road Fabrics in Resurfacing and Reconstruction

KENNETH P. HERCEG

President, Herceg-Peirce Associates
South Bend, Indiana

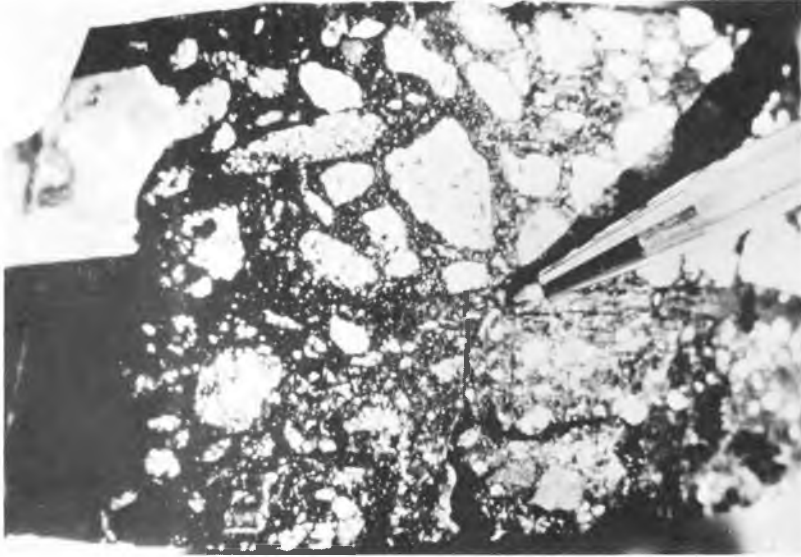
Figure 1.

Most of our experience in St. Joseph County has been in the area of asphalt membrane interlayers in resurfacing and widening projects. Figure 1 is a picture of a core sample which shows what the fabric membrane interlayer is suppose to do. The lower portion is the existing pavement, including its crack, which was overlaid. The upper portion is the new HAC overlay, and the pen point is at the location of the asphalt impregnated fabric membrane layer. As stated earlier, I don't think that anything is going to stop our pavements from cracking either through contraction or reflection of underlying pavement cracks, but this membrane layer will retard reflective cracking simply because it is a somewhat lubricative layer (i.e. it will relieve some of the friction bond between pavements as the lower pavement moves horizontally).

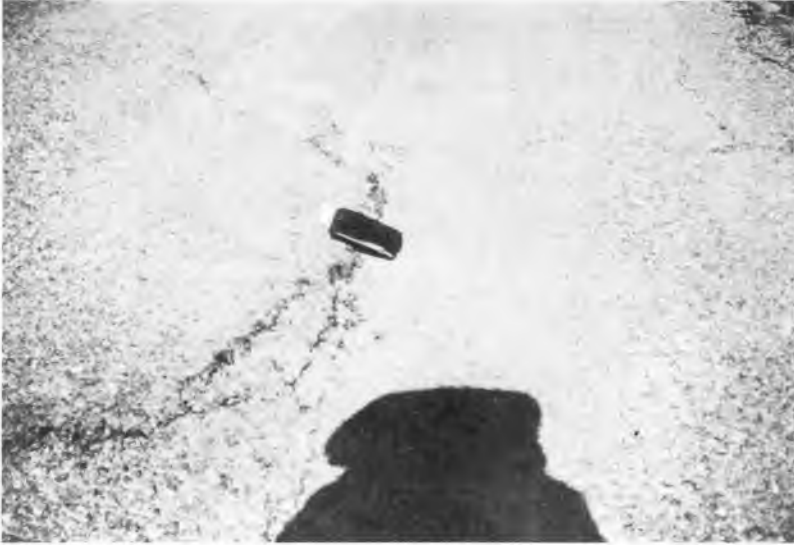
Figure 2.

Figure 2 shows a section of concrete pavement which has been covered with chip & seal in the last year. The wallet was placed at this crack

to show the magnitude of the displacement that had to be dealt with along this length of roadway. The concrete was placed about 50 years ago directly on top of very poorly drained clay soils.

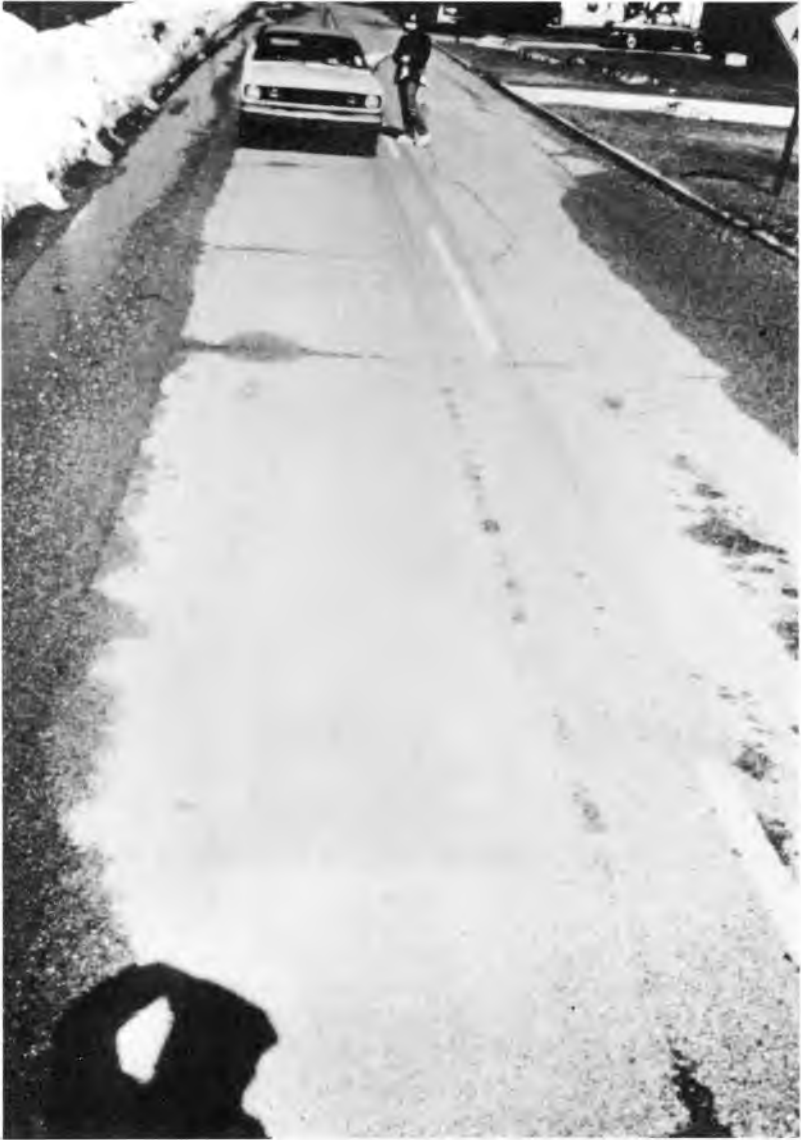
Figure 3.

This section of Dogwood was paved without the fabric membrane interlayer. Figure 3 is a picture taken a week ago which shows the lateral and transverse crack patterns which have reflected through the 200 lb/sq yd binder and the 650 lb/sq yd widening each side of it. This pavement was widened about 4 ft on the left side of the picture and 2 ft on the right. Before this section of road was chip and sealed two years ago, it was bumpy and loaded with potholes. Also, the widening cracks on both sides had reflected through for almost the entire length.

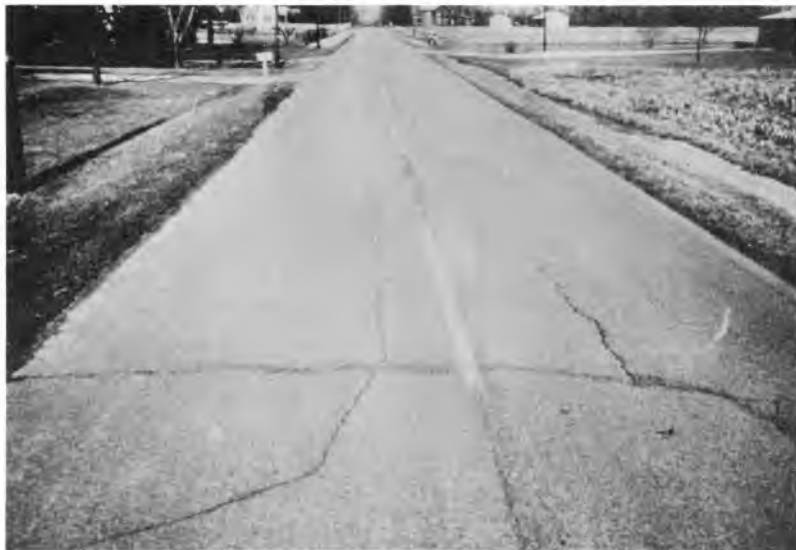
Figure 4.

The results, as shown in Figure 4, were interesting and somewhat impressive. The cracks from the severely displaced slabs began to reflect

through during the following year. I don't think that anyone expected that these severe cracks could be prevented from reflecting through. But, the impressive result was that hardly any (less than 2%) of the widening cracks had reflected through to the surface even after several years. This was the most impressive result of this use of fabric membrane interlayer, because it had been our experience that widening cracks almost always reflected through within the first year to two years.

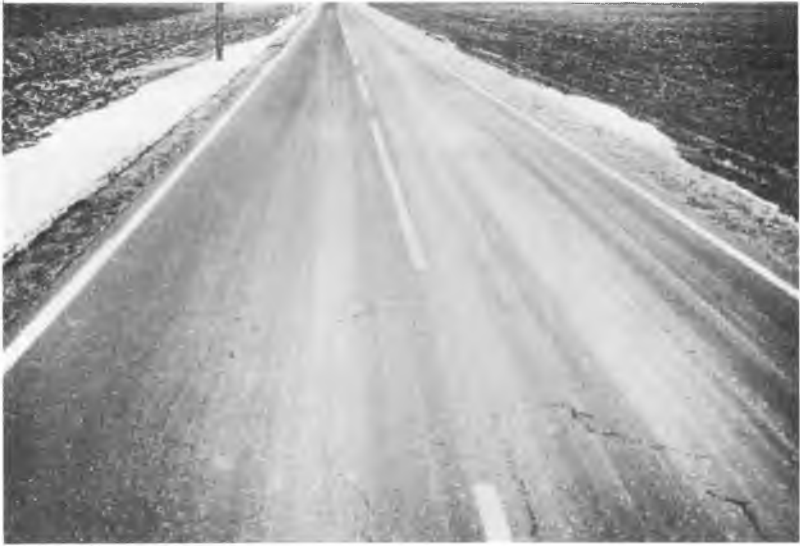
Figure 5.

Because we were impressed with some of the results of the earlier section laid with fabric membrane interlayer, we constructed the next section with the membrane interlayer also. The procedure was improved on this section of roadway by adding a scratch coarse of #9 binder at an average of 100 lb/sq yd to level and rebuild the crown. The asphalt cement and fabric membrane was then placed over this leveling coarse. The membrane was then overlaid with 250 lb/sq yd of HAC Base and 100 lb/sq yd of HAC Surface. This section had held up quite well considering the instability of the concrete slabs prior to resurfacing. Again, as shown in Figure 5, less than 2% of the edge widening cracks have come through in the eight years since reconstruction.

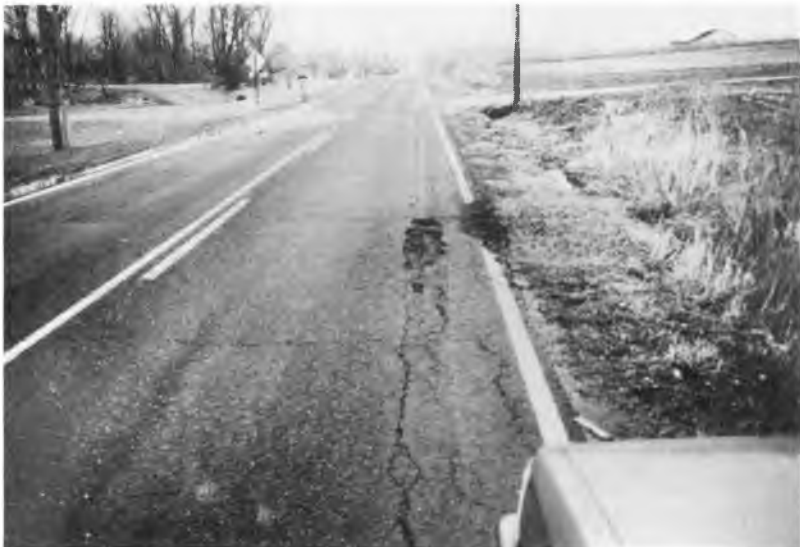
Figure 6.

Compare Figure 5 (Dogwood Rd. with fabric membrane—1979) to Figure 6 (Beech Rd.: Kern Rd. to Dragoon Tr. with no fabric membrane—1979) which is of a road paved with almost the identical

asphalt section and within four miles of the Dogwood Road projects. Basically, the only difference was that no fabric membrane was used on the Beech Road project. Virtually 100% of the widening cracks had reflected through this no fabric overlay within the first two years along with the accompanying pothole problems. Potholes are almost nonexistent on the fabric membrane sections of Dogwood Road; even in the sections older than this section of Beech Road.

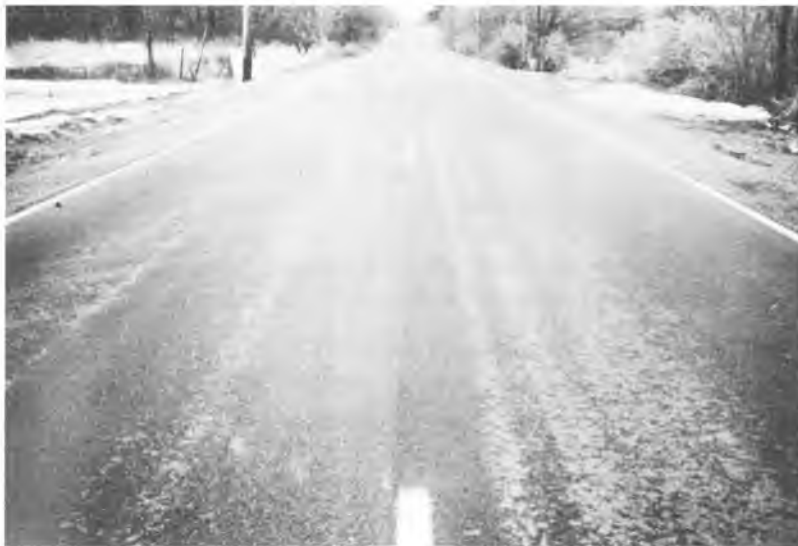
Figure 7.

Probably the most effective test section placed to date in St. Joseph County was placed after I left the county. This section of Edison Road was widened and overlaid originally in 1970. Within two years of its reconstruction, the widening crack had reflected through for the entire length. In 1984, the county paved half of the project length with full width fabric membrane and the other half with no fabric membrane at all. Figure 7 is a picture of the section with fabric membrane. A wheel

survey indicated that less than 5% of the widening cracks had reflected through the membraned length since resurfacing. For Figure 8, the camera was turned 180 degrees from Figure 7 and moved to the edge to show the section which had no fabric membrane placed. A wheel survey indicated that about 60% of the widening cracks had reflected through this identical asphalt section with no fabric in less than eight months.

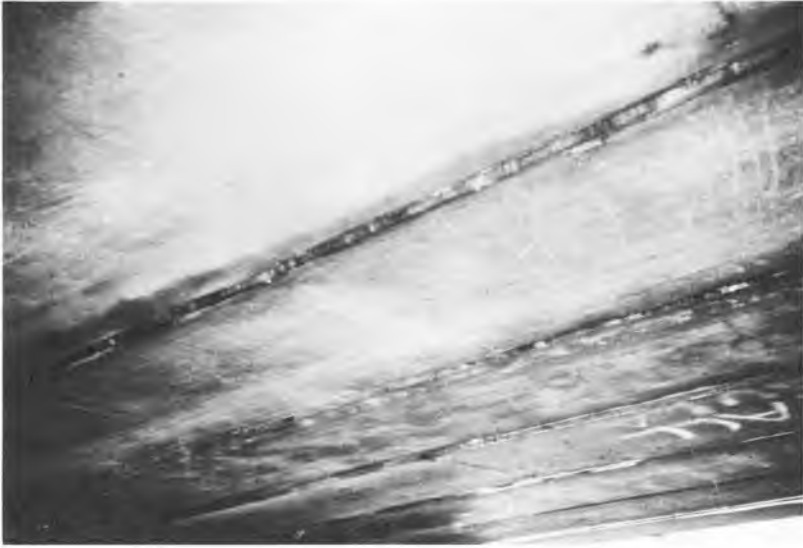
Figure 9.

For instance compare Figure 9 (Washington St Bridge with concrete deck and no membrane) with Figure 10 (Elm Road bridge with asphalt deck and fabric membrane). Both were inspected and photographed shortly after a rain. The water can be seen coming through every joint of the bridge with no membrane, while the vast majority of beam interfaces with the membrane above were dry as in Figure 10.

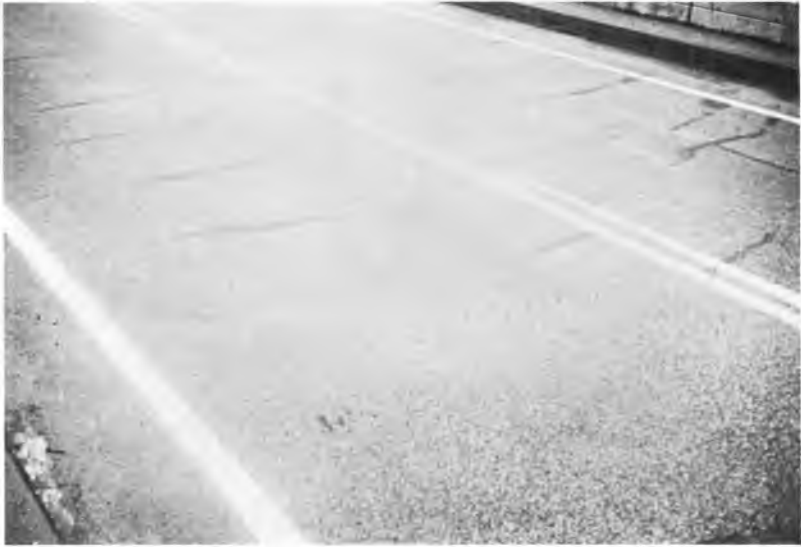
Figure 11.

This bridge's deck was beginning to deteriorate and water penetration was threatening to do even further damage. The county rebuilt all of the joints of each span and included a 1 in overlay dam at each joint. Then the deck was repaired in the usual fashion and overlaid with a fabric membrane interlayer and HAC Surface at 110 lb/sq yd. The end product still developed cracks (Figure 11) as would be expected with a

steel structure which oscillates under heavy loads. Again, the key to the success of the fabric membrane is that, even though the top of the asphalt bridge deck is cracked, the membrane is not broken as indicated when inspecting under the structure after a rain. All of the old cracks which were leaking prior to the redecking still were marked with efflorescence

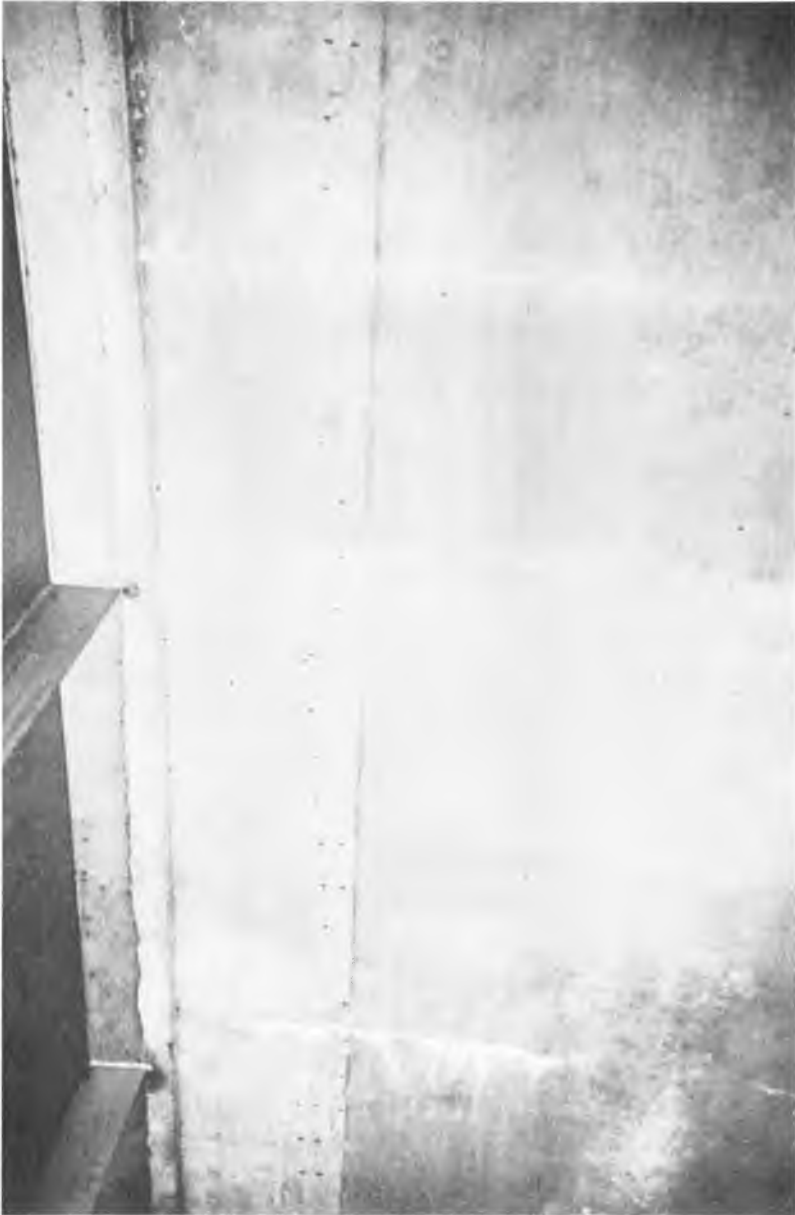
Figure 12.

from when they used to leak (see Figure 12). But over 95% of these cracks showed no sign of water immediately following a long period of saturation. Figure 13 shows what it looked like under the sidewalk of the same bridge at the same time as Figure 12 was photographed.

Figures 12 and 13 are dramatic proof that the fabric membrane interlayer consisting of AC and non-woven fabric is doing exactly what we in St. Joseph County wanted it to do. It is effectively waterproofing the pavement (or, as in this case, the bridgedeck) beneath itself.
