Material Evaluation: Self Damping Wire SD/ACSR Conductor Failures

A THESIS

For the Degree of Master of Science
Major: Mechanical Engineering and Applied Mechanics

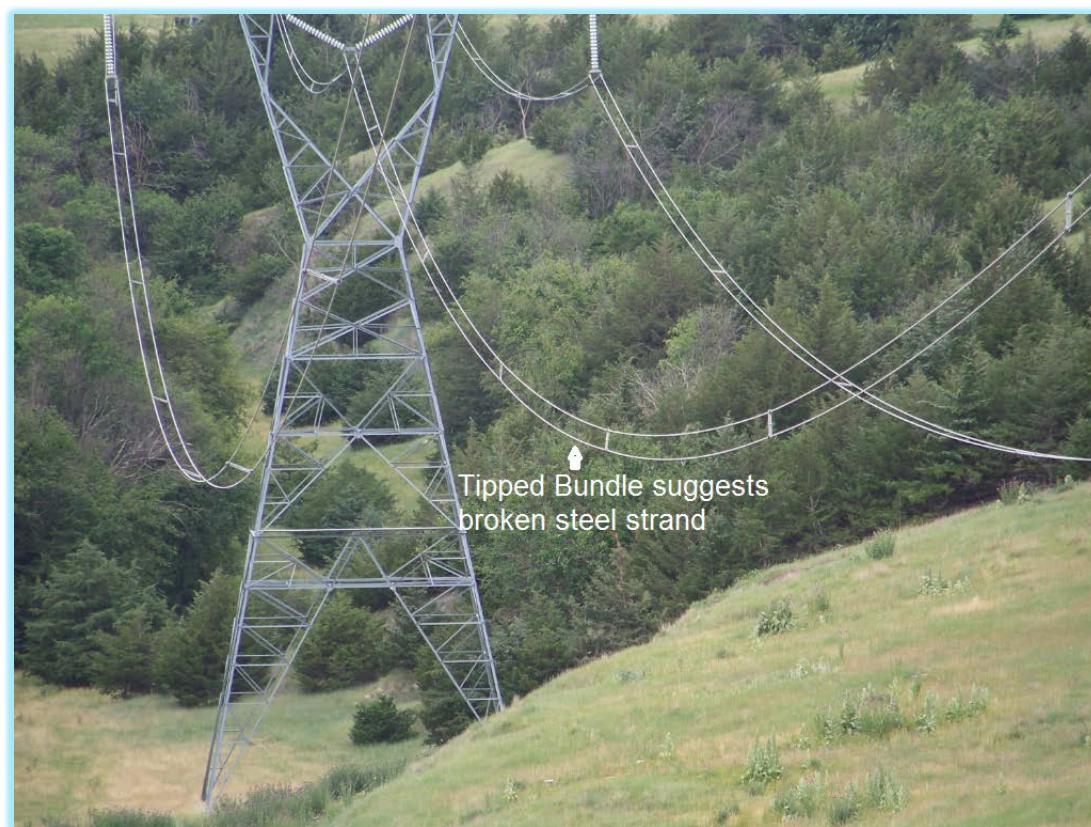
Throughout line patrol inspections in 2012, more than 4 additional miles of corroded/failed conductor were identified (Figure 6). All of these locations were ACSR/SD type conductor with failed transmission conductor being placed in service during the late 1970's and early 1980's. Steel core conductor failed transmission lines were constructed with final design tensions of 5,000 pounds; two-piece transmission line splices connect the two ACSR/SD conductor reels during the original construction.

Figure 6 –The bundled conductor being tipped demonstrates the visual identification for a failed steel core due to loss of tension

Prior to removal of the failed sections of conductor, a rare earth magnet test is used to find the ferrous steel beneath the aluminum; this is performed to determine the steel core contraction within the conductor bundle following a break for repair of the composite conductor. Once this is determined, the damaged portion of the conductor is removed and replaced to return the transmission line to service.

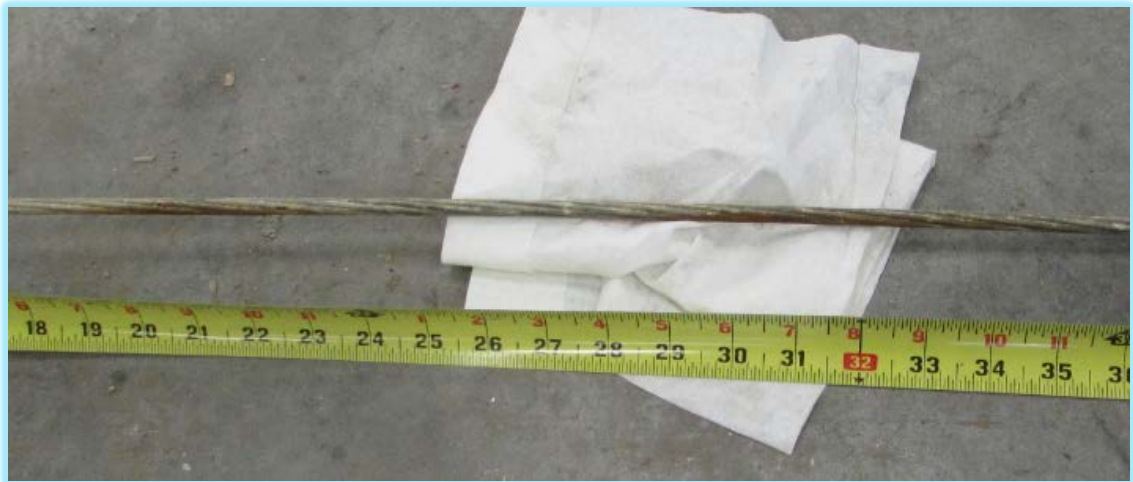
Figure 7 – Steel wire corrosion with the galvanization layer attacked in 8 to 10 inch intervals

galvanization layer on the steel wire has a thickness of around 0.002 inches. From multiple dissections it has been observed that the abrasion intensifies approximately every 8 to 10 inches as shown in Figure 7, which is roughly the same as the lay (or rotation spiral) of the interior steel wire.

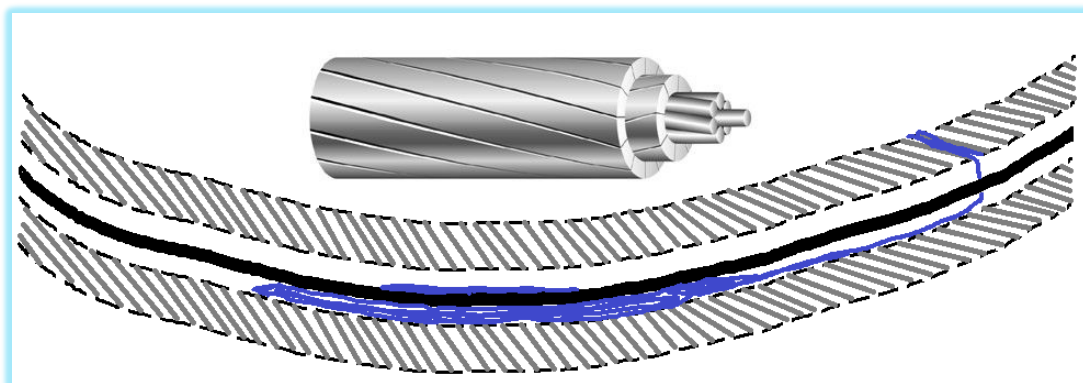
Removal of the galvanization layer is the first phase of the steel wire corrosion and resulting failure, while the next phase appears to be ingress of moisture. The water tightness of the aluminum is compromised near a compression splice as the outer aluminum layer is deformed, resulting in a “birdcaging” effect where the aluminum layer is uncoiled. This deformation allows moisture to seep into the annular gap which was designed for damping. As shown in Figure 8, the moisture collects at the low point (i.e. belly) of the span which is more tightly sealed as it is further from the splice and more uniform. This hypothesis has been detected, as water has been “drained” in the past while lowering the conductor down to the ground for repair or replacement.

Figure 8 – ACSR/SD conductor moisture ingress/entrapment within self-damping gap provided in conductor design

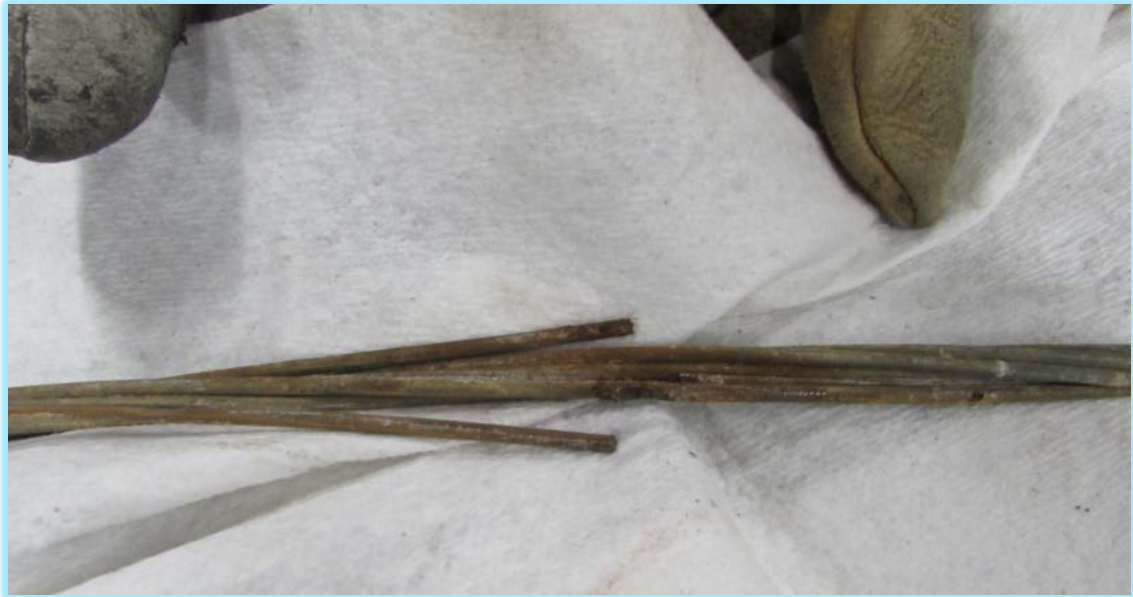
Broken steel wire(s) such as those in Figure 9 were found on a span with a splice installed. The outer layers of aluminum are quite homogeneous for many miles along

the conductor, but the connection points appear to indicate a likely failure point. Once the protective zinc layer has been eroded from the steel and an electrolyte has been introduced, a galvanic corrosion cell may occur.

Figure 9 – ACSR/SD broken steel strands due to localized corrosion

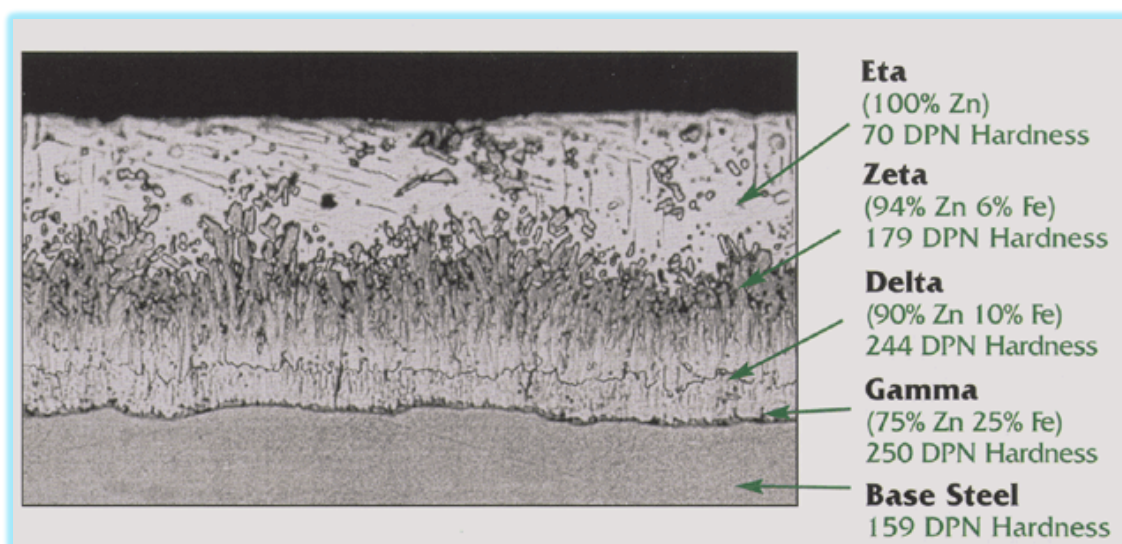
EPRI performed a microscopic examination shown in Figure 10 for the core strands; although it is unclear which layer of the galvanizing is exposed[12]. Trace amounts of zinc and zinc oxide with outer steel sections showing signs of iron oxide deposits. These surface anomalies include no less than four iron oxide deposit types along with heavy localized corrosion contributing to the indication of trapped moisture.

Figure 10 – Microscopic examination of broken ACSR/SD Conductor performed at EPRI

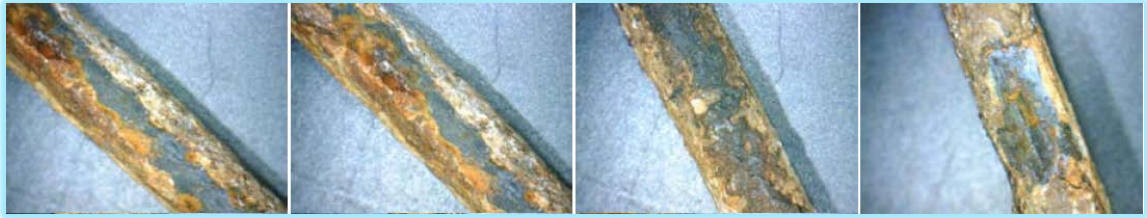
According to the EPRI report[12], surface anomalies were noted throughout the steel core sample and many different iron oxide deposit types which show heavy localized corrosion (Figure 11). Film thickness in samples ranged from 5-7 microns for the steel strand diameter of 0.0971 inches. The oxide film types observed were; red/black powder Iron Oxide (Magnetite Fe_3O_4), brown Iron Hydroxide (Goethite $\text{FeO}(\text{OH})$), white Iron Hydroxide II ($\text{Fe}(\text{OH})_2$), and red/brown Iron Oxide III (Hematite Fe_2O_3).

Figure 11 - Localized corrosion, iron oxide deposit shown through microscope

Initial pitting of the steel wire was likely due to mechanical damage and/or localized stresses near the compression splice, while vibration following installation could damage the passive film to expose the metal surface. Free ends of the ACSR conductor stored on reels have increased vulnerability to environmental conditions to introduce reactive products.

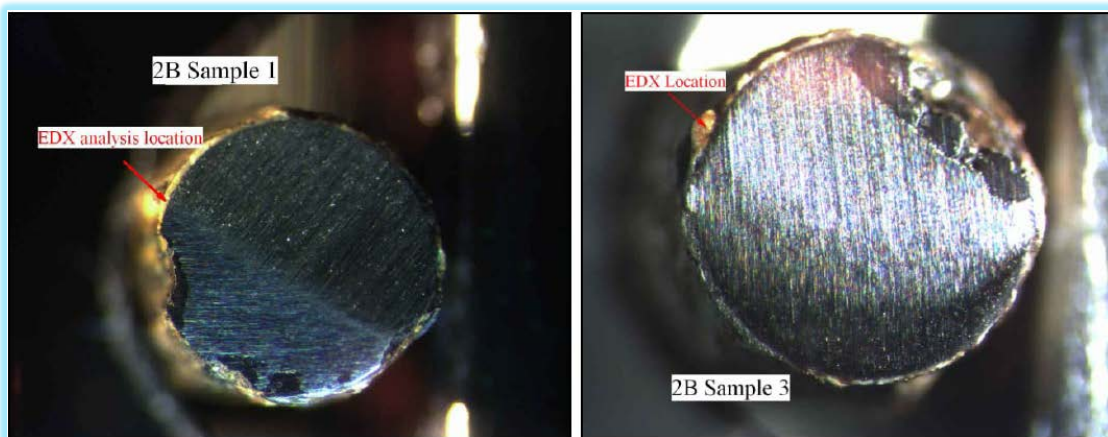
EDX analyses resulted in chlorides and sulfates being found within the oxide formations. The concentrations were found to be 2,400 ppm for chlorides and 2,200 ppm for sulfates. The heightened sulfur and chloride anion levels within the steel strands influences corrosion. Both chlorides and sulfates are electron acceptors and depolarization changes the interaction within the corrosion cell. Cathodic cells lose electrons, essentially accelerating the oxidation process.

Figure 12 - EDX analysis locations for corroded steel wire of samples 2B1 and 2B3

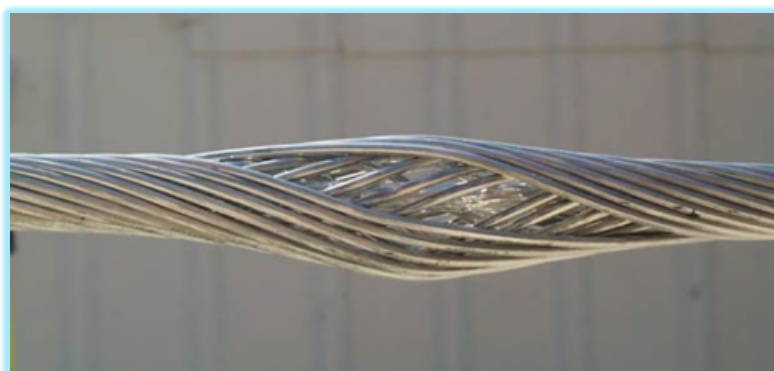
Figure 13 - Extreme example of conductor birdcaging by uncoiling/deformation of the outer aluminum conductor wire strands

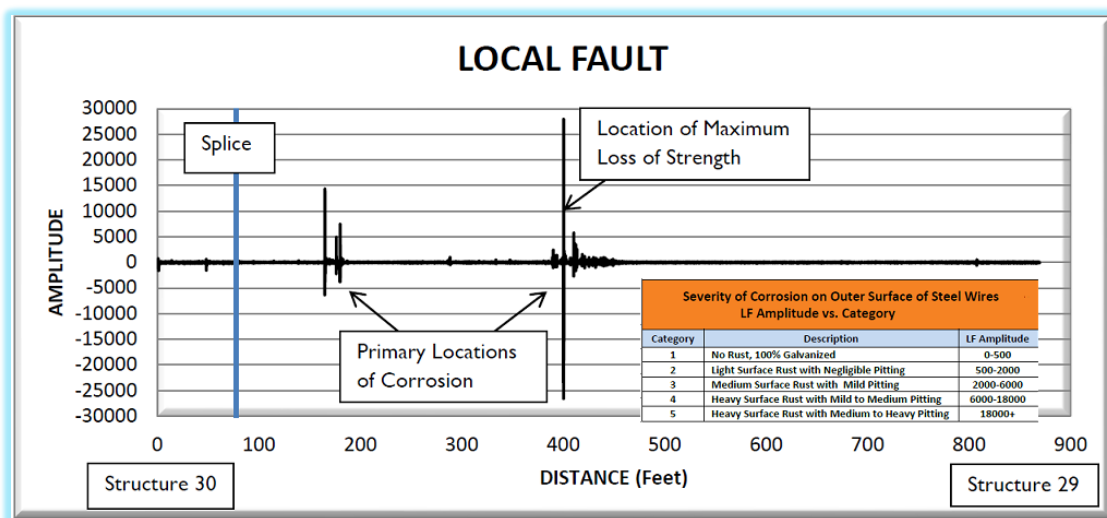
Figure 20 - Line 2309 results showing LF level throughout the conductor span length

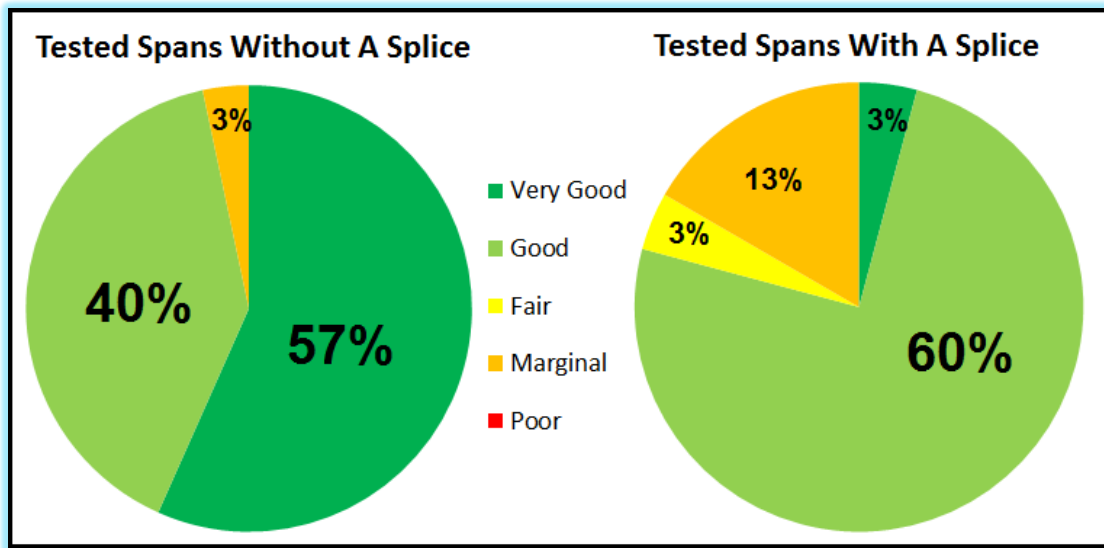
Figure 21 - Comparison of Spliced & Un-spliced Spans

Repair by removal of a section wire exhibiting corrosion will likely compound the problem, since the single splice will be replaced with a length of the redesigned ACSR 954 46 Al - 7 Steel conductor and two splices. Performing this sort of testing biannually or annually could provide for follow-up testing for borderline results, as well as identifying other susceptible spans.

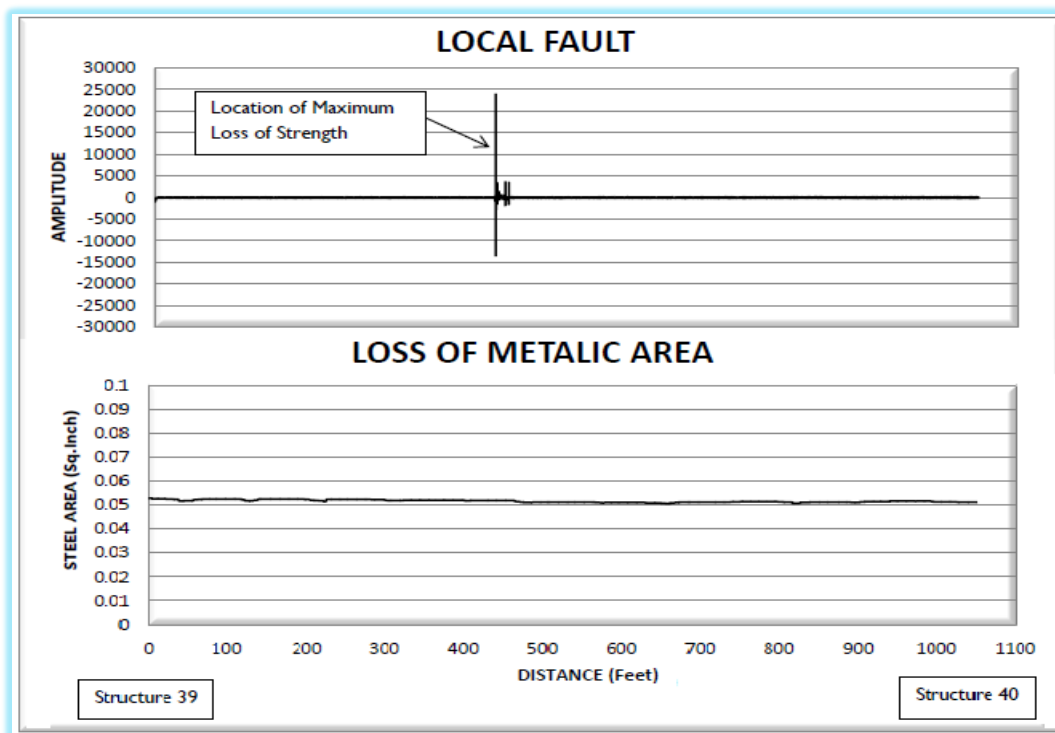
Figure 22 - Line 2312 results showing LF/LMA level throughout the conductor span length

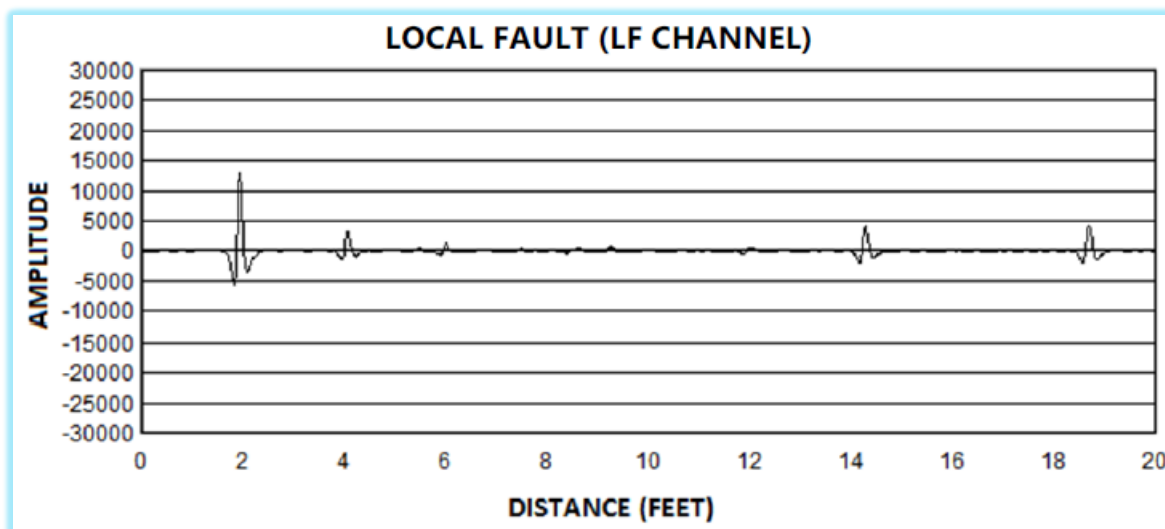
galvanized new section of the steel wires in the conductor. This is due to either a very deep corrosion pit or a broken steel wire strand recognized by the LF coil sensor[16].

Figure 23 - Line 2312 results showing LF level throughout 20 feet of the conductor detail

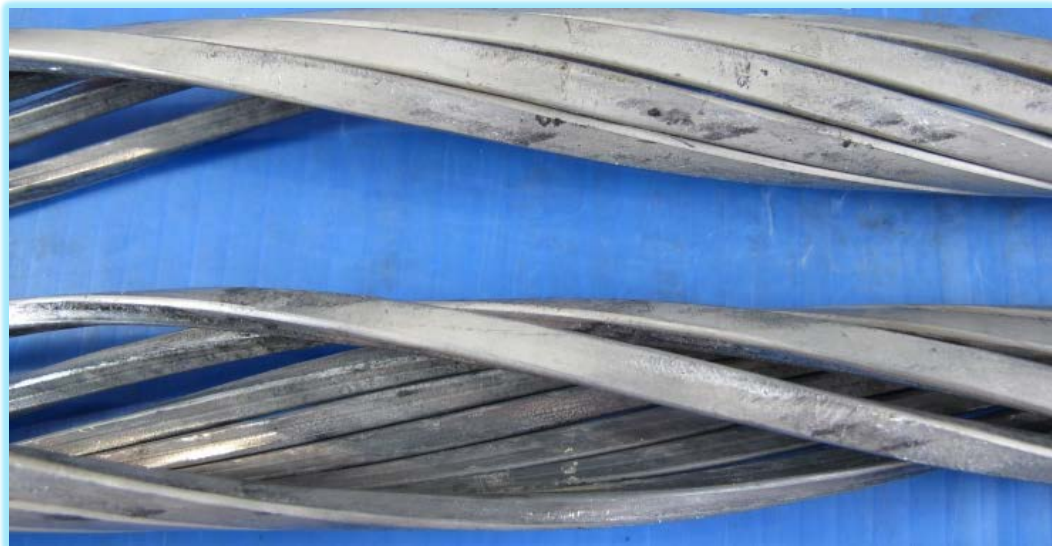
Figure 24 - L2312, Str. 39-40, Middle Phase – Outer Aluminum Layer

During dissection, first the outer aluminum layer was observed to be grey in color with many handling mark on the outside surface shown in Figure 24. It is likely that many of the handling marks were caused by compression wire grips installed for removal and or initial installation 40 years ago. Removed conductor is often subject to being slid on coarse or jagged surfaces which will wear the relatively soft aluminum. The inner surface of the outer aluminum wire had a light grease coating containing some corrosion products.

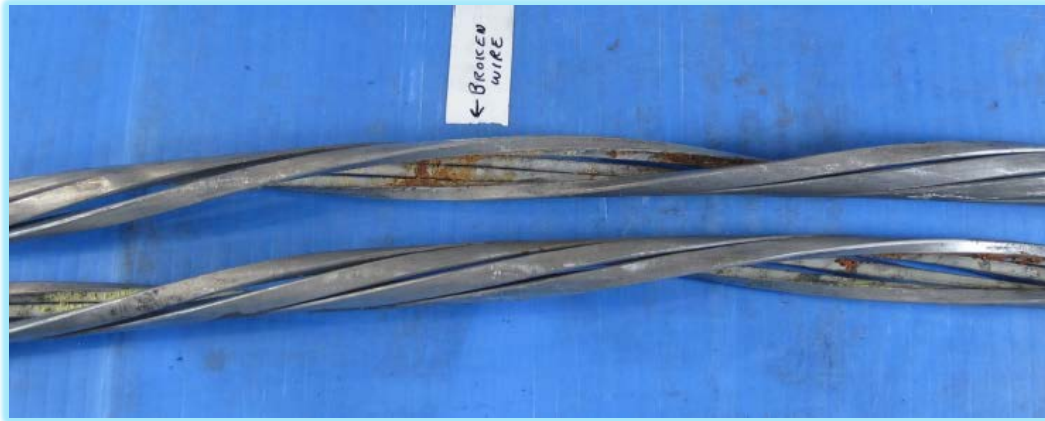
Figure 25 - L2312, Str. 39-40, Middle Phase – Inner Aluminum Layer

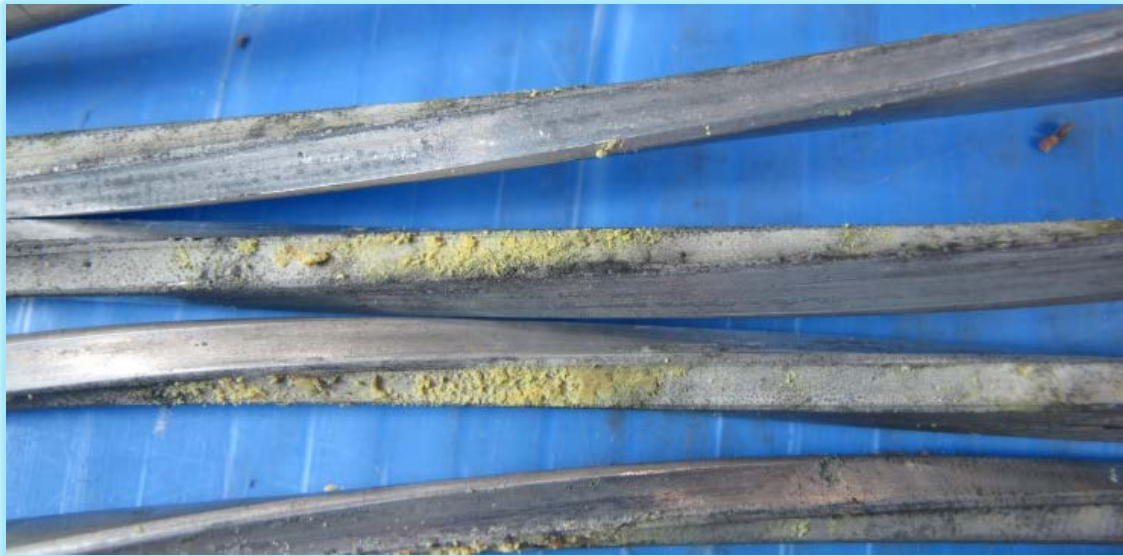
products. Removal of the grease found that the surface was etched with light corrosion. A few of the areas examined had brown grease with rust corrosion product along with transfer of brown/red rust to the aluminum surface.

Figure 26 - L2312, Str. 39-40, Inner Aluminum Layer yellow corrosion products

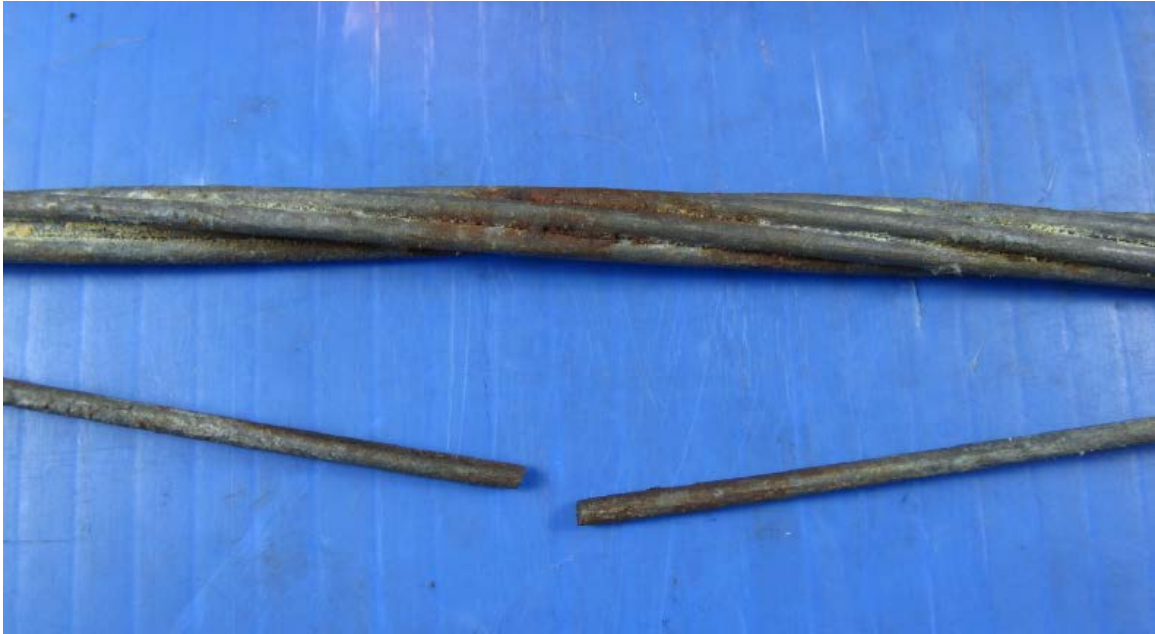
layers must be crushed due to the annulus designed for the self-damping ACSR. Gaps are introduced through the permanent deformation of the trapezoidal aluminum wire, which could allow for an electrolyte to be introduced into the annulus near a conductor splice.

Figure 27 - L2312, Str. 39-40, Galvanized Steel Wires

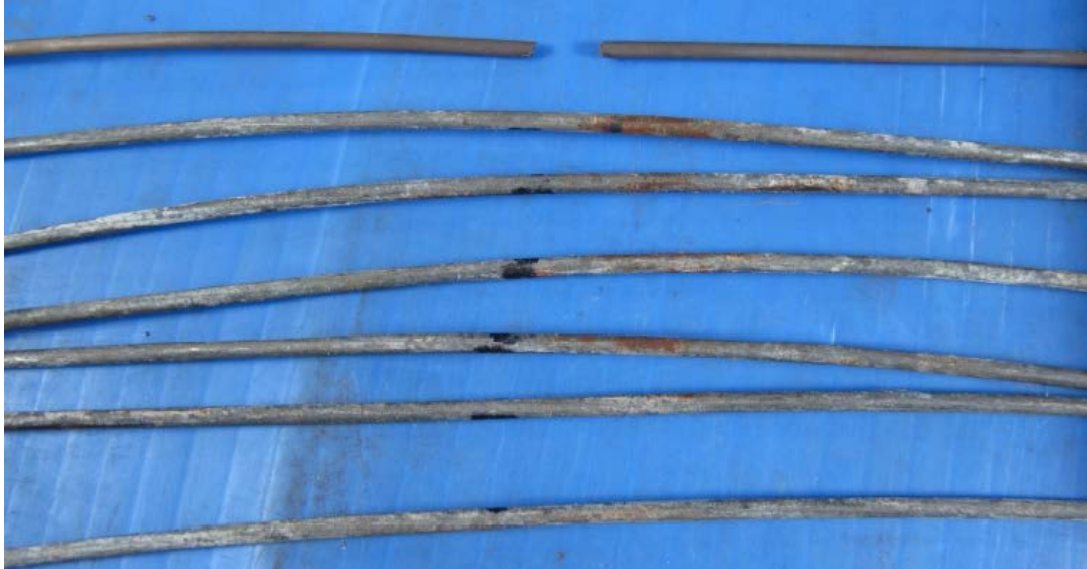
wire had grease and white corrosion products removed and were found to have no corrosion on the surface.

Figure 28 - L2312, Str. 39-40, Galvanized Steel Wires (unstranded)

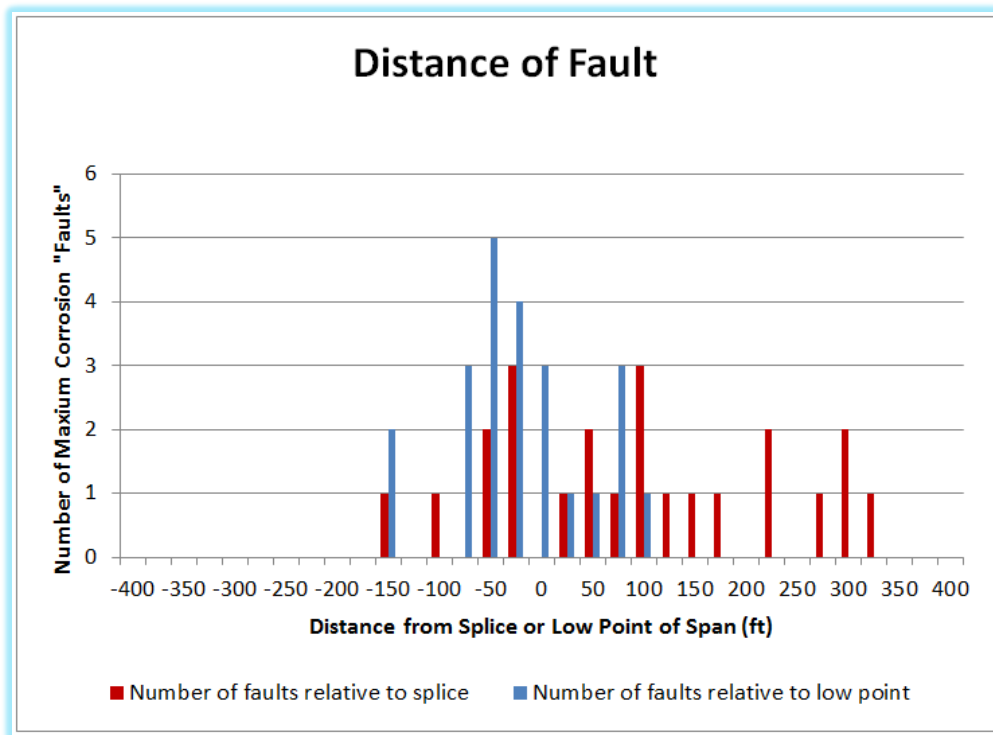
- 96% of spans with compression sleeve splices have corrosion present in various stages. 83% of these spans were considered “Good” or “Very Good”.
- 42% of spans without compression sleeves have corrosion present in various stages. 91% of these spans were considered “Good” or “Very Good”
- About 40% of the spans in the system have localized areas of corrosion that are Category 3 or worse.
- 33 of 36 maximum corrosion locations (91%) occurred within 150 ft. of the low point of the span.

Figure 30 - Analysis of fault data based on the location in span for the corrosion locations identified
