Storm Damage – Floating Culverts & Other Inlet Issues

Mark Bailey, PE - Hydraulic Manager, INDOT
Dale Sedler, PE - Sr. Hydraulic Engineer, INDOT

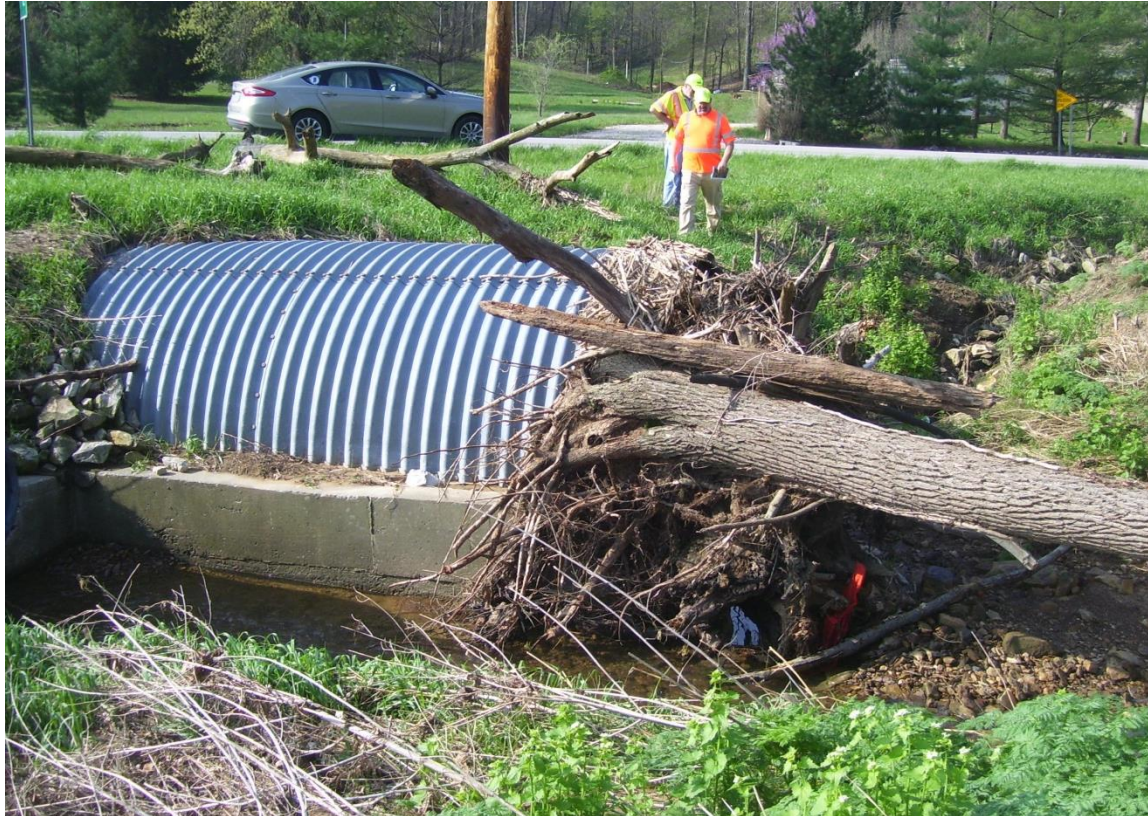
SR 56 Dubois @ RP 54.2
April 2015

Debris at inlet.

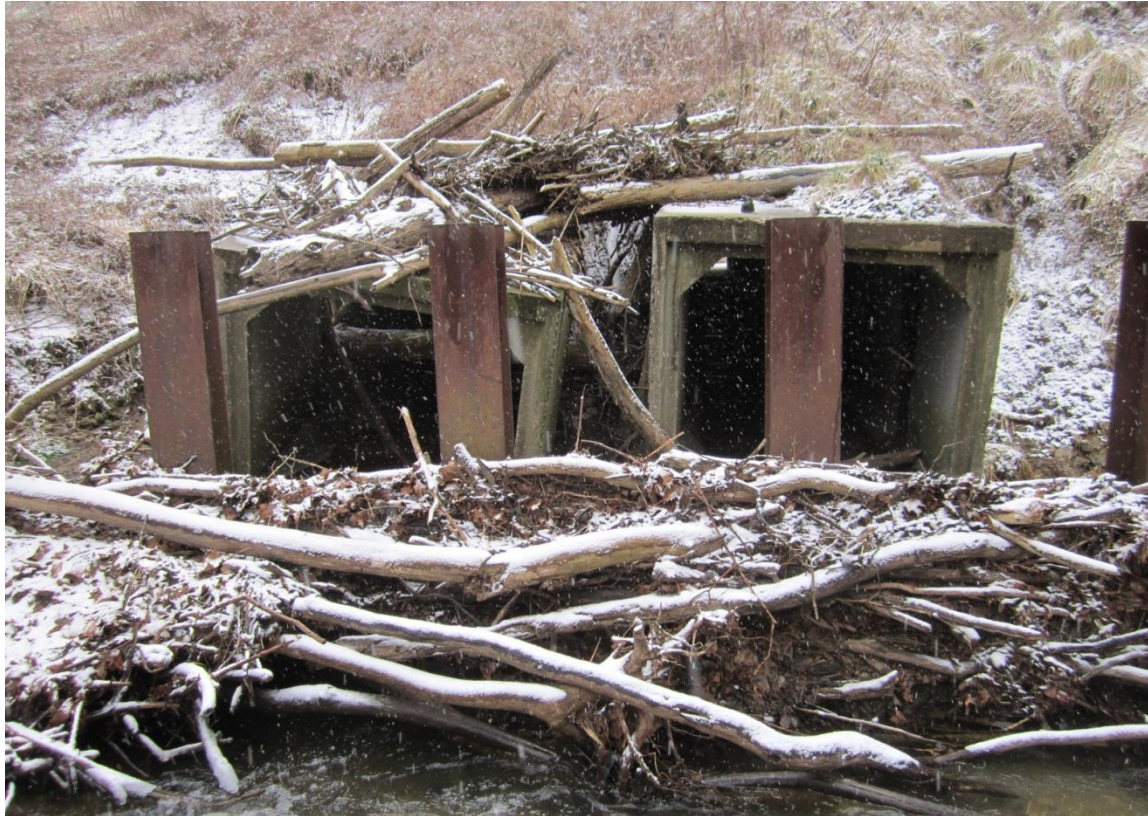
SR 26 Tippecanoe Co. @ RP 28.10
March 2012

Debris accumulation on collector and on top of structures.

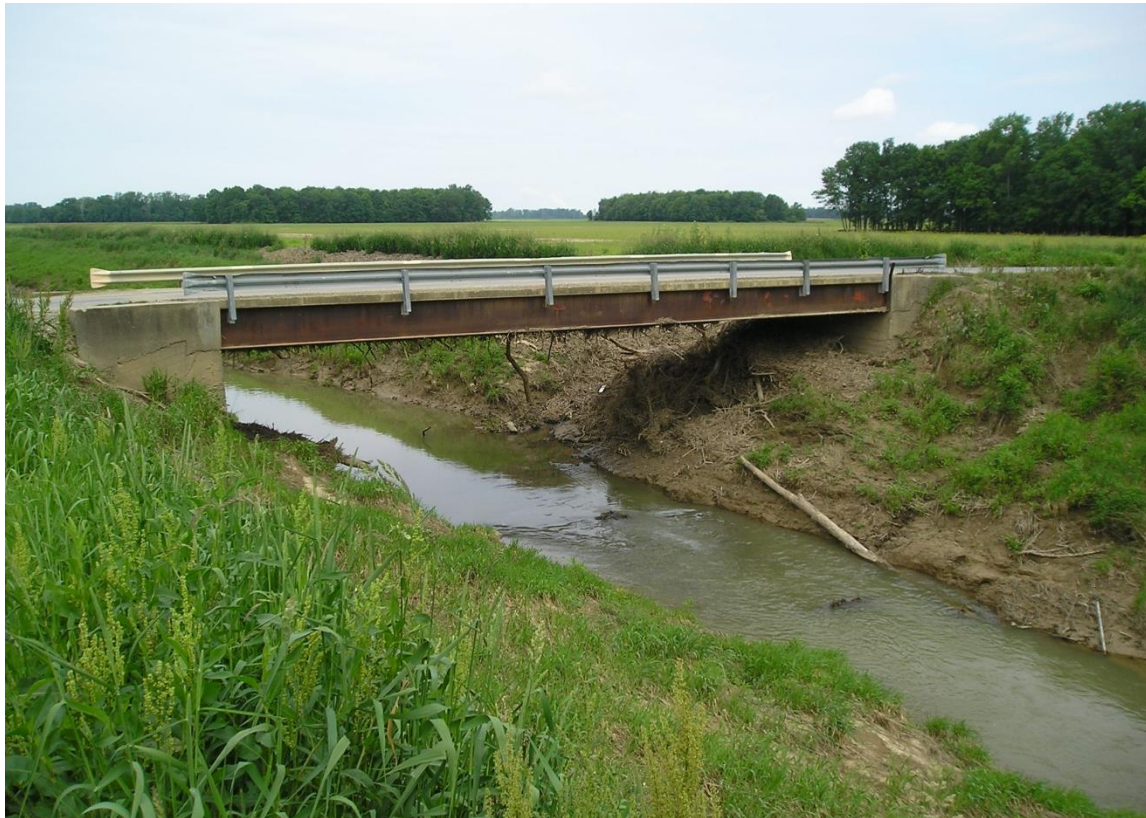
CO Rd 550 E Gibson Co @ Pigeon Creek **May 2011**

This 60 ft. bridge is immediately upstream of I-69 Bridge and was plugged by debris, mainly branches and corn stalks. A local farmer unplugged it using a tractor with a backhoe attachment.

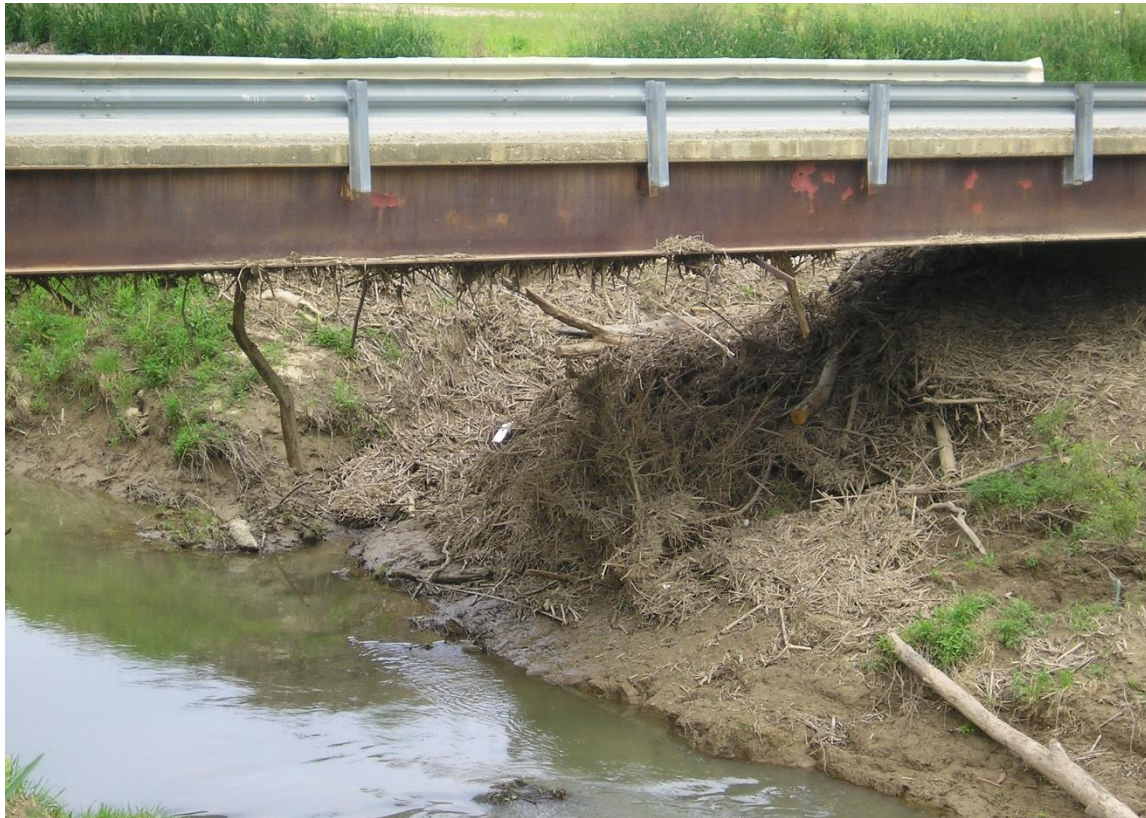
CO Rd 550 E Gibson Co @ Pigeon Creek
May 2011

Note the branches and corn stalks.

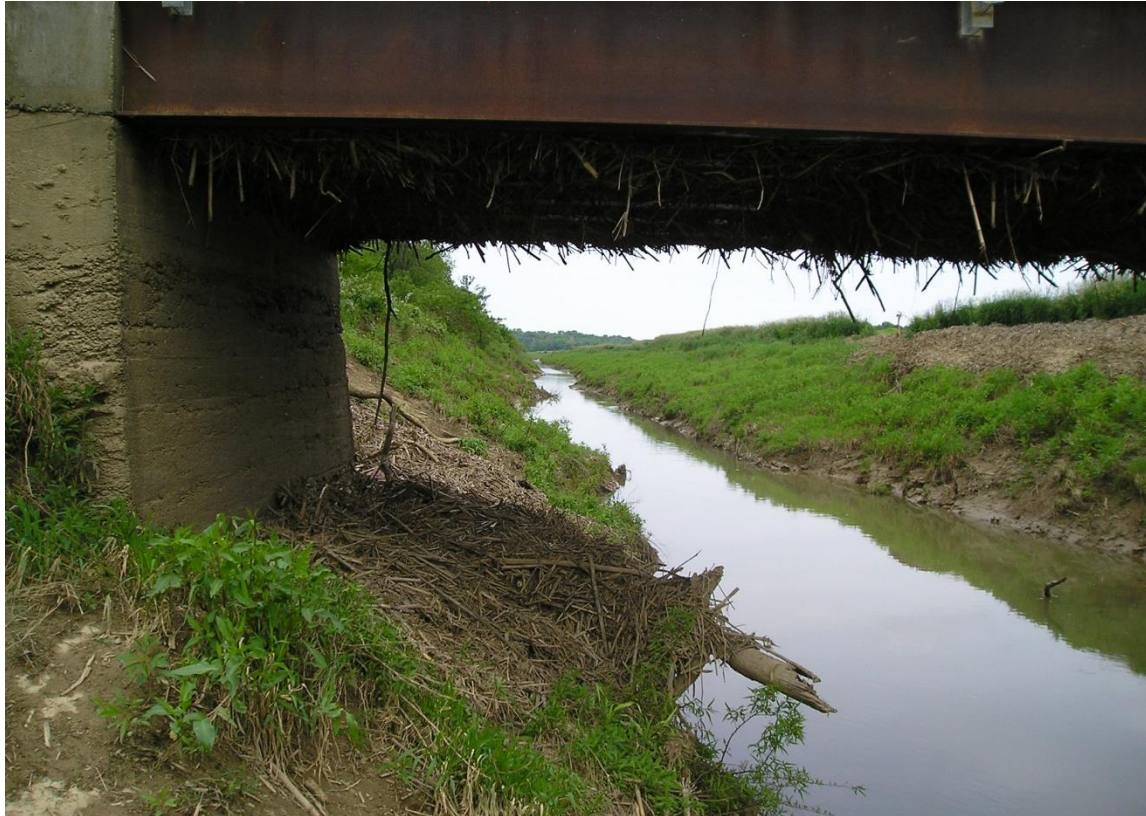
CO Rd 550 E Gibson Co @ Pigeon Creek
May 2011

Note the corn stalks jammed in between the beams.

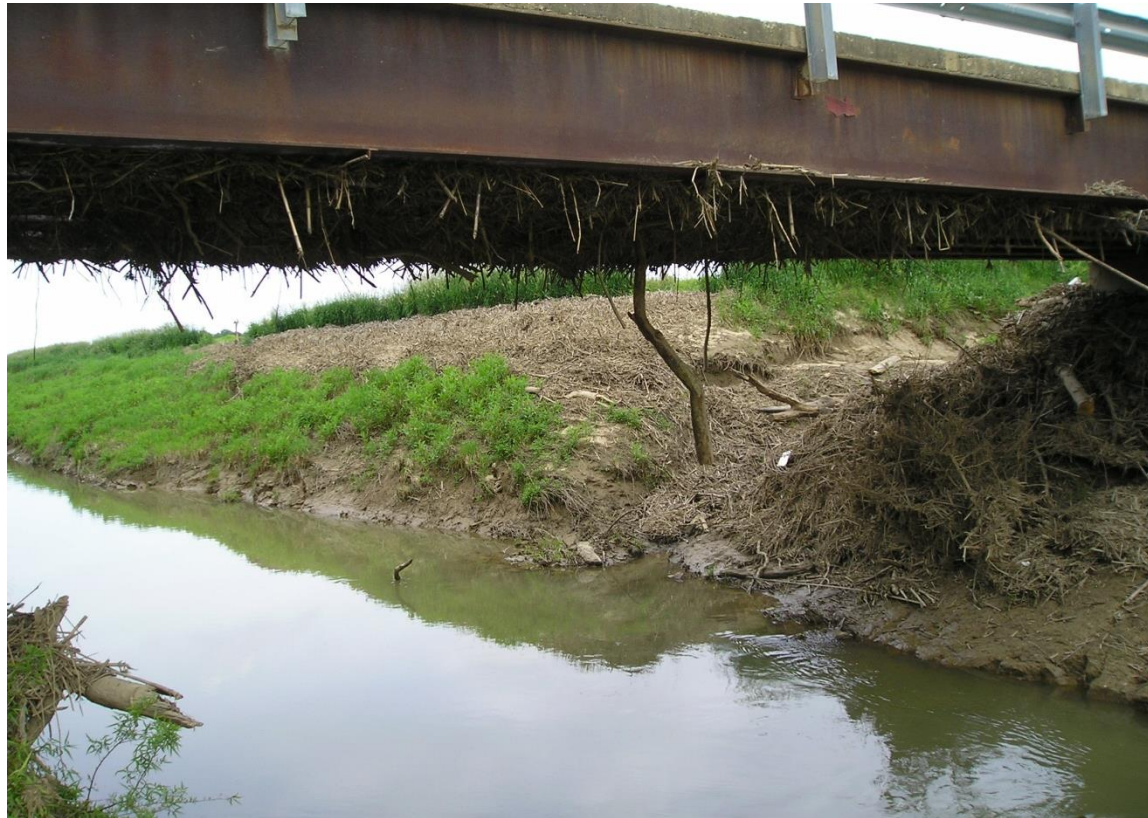
CO Rd 550 E Gibson Co @ Pigeon Creek **May 2011**

More of the corn stalks and branches in the beams. Note the corn stalks on the bank upstream of the bridge.

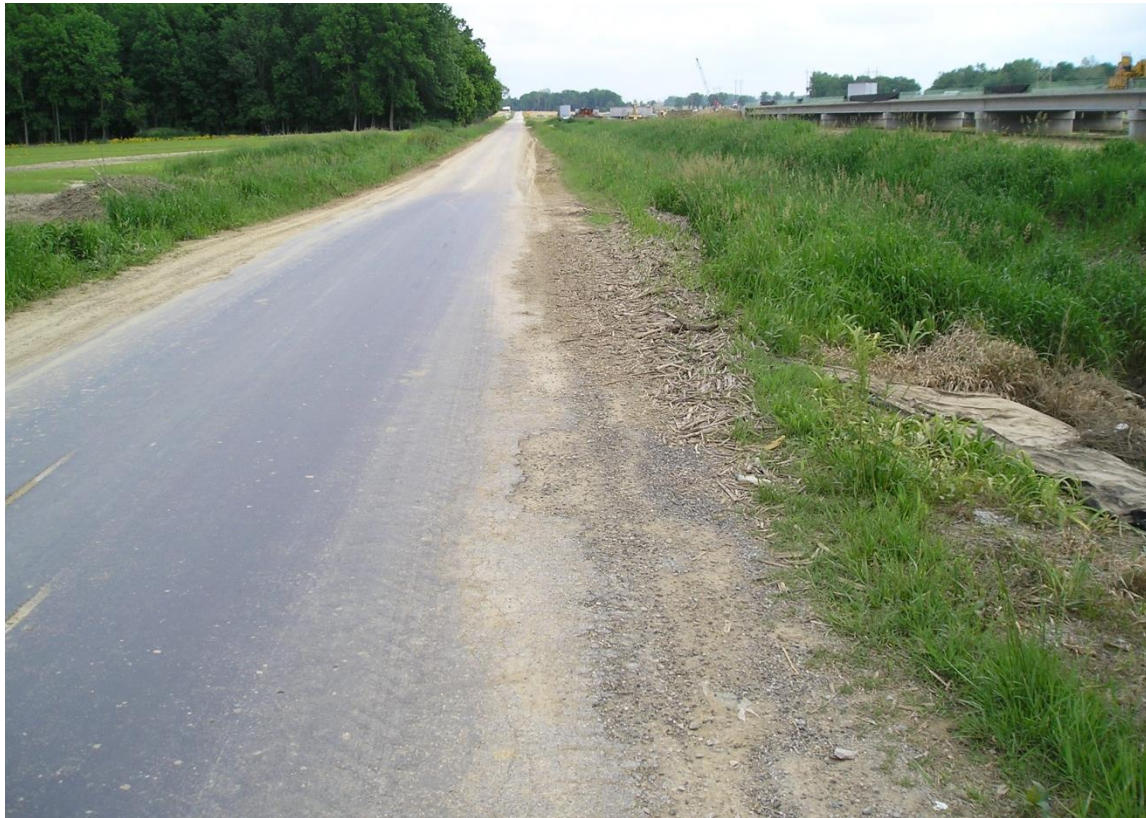
CO Rd 550 E Gibson Co @ Pigeon Creek **May 2011**

Looking N from bridge. Note the stains on the County Road due to overtopping, as well as the corn stalks. Also, note how the I-69 bridge extends far onto the flood plain. Br is > 1,300 ft long.

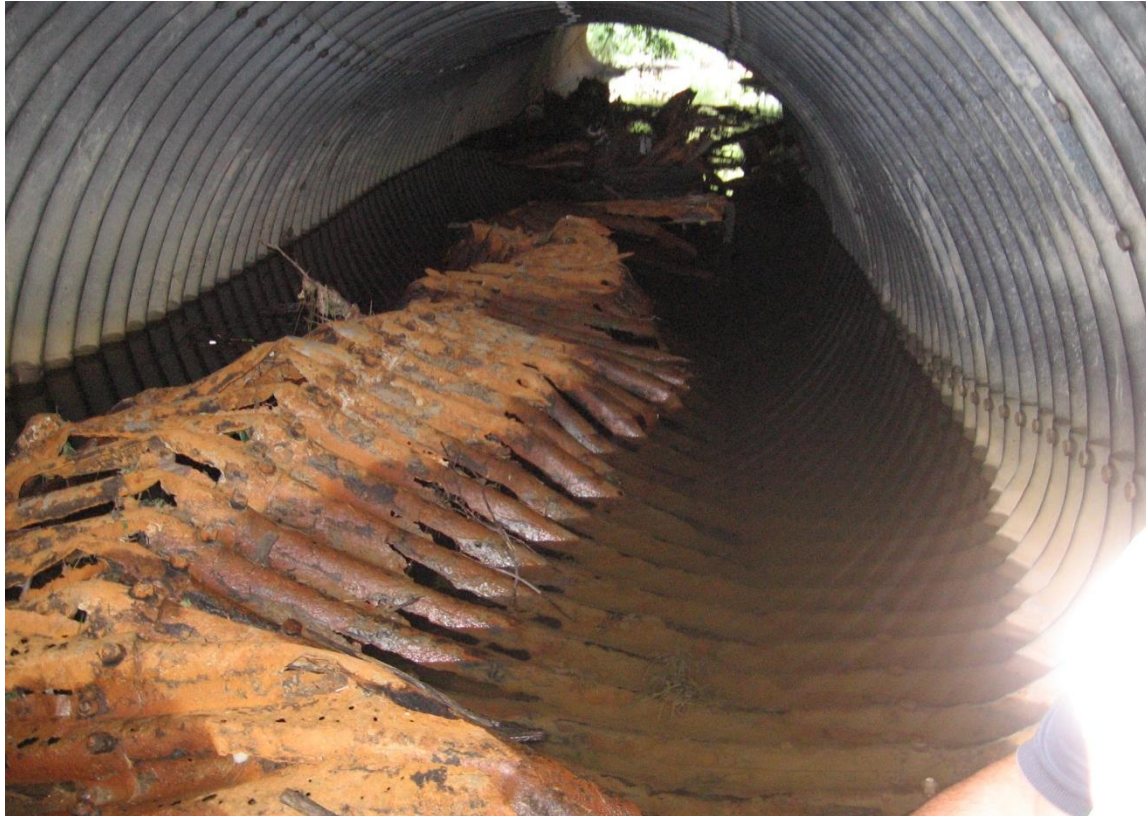
SR-60, Clark Co., July 2006, 11.40 x 7.24 SPPA
7-16-2006

Items to observe: 1. Culvert bottom was in poor shape prior to event. 2. Note upwards bending of culvert (looking in inlet direction).

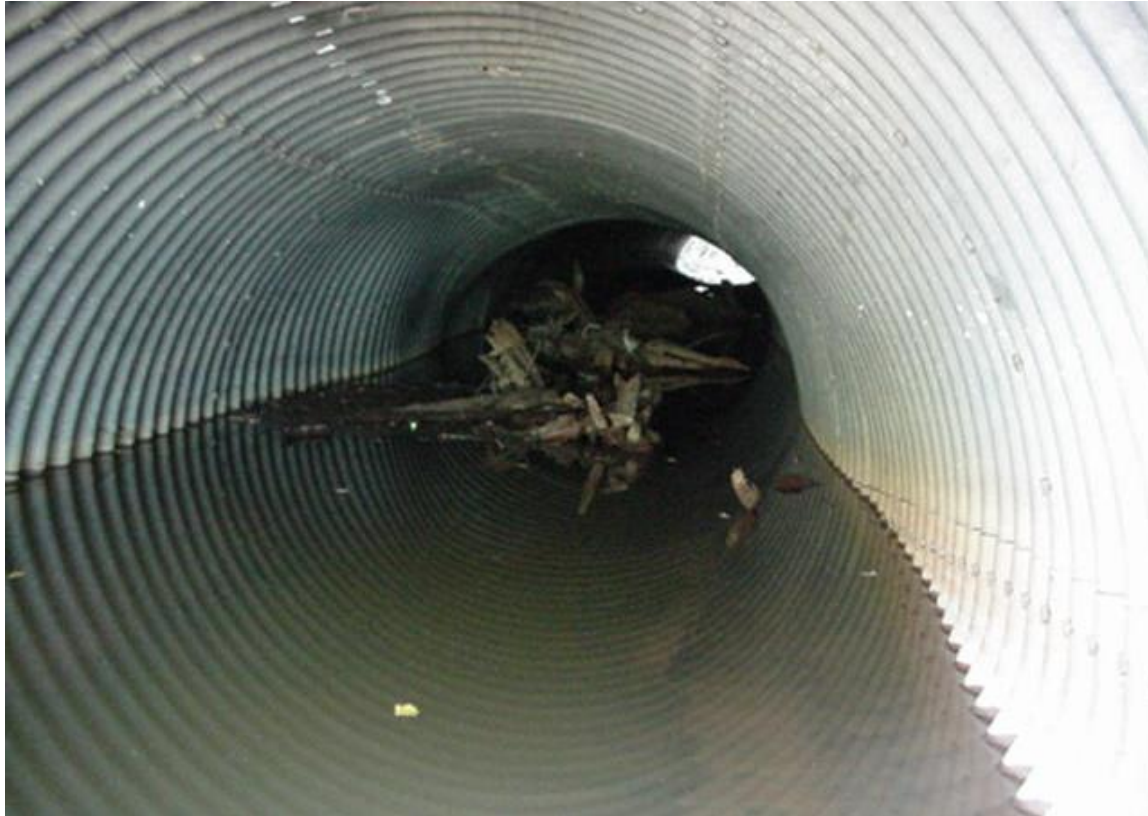
SR-60, Clark Co., July 2006, 11.40 x 7.24 SPPA
7-26-2006

Residual debris in culvert (looking towards inlet)

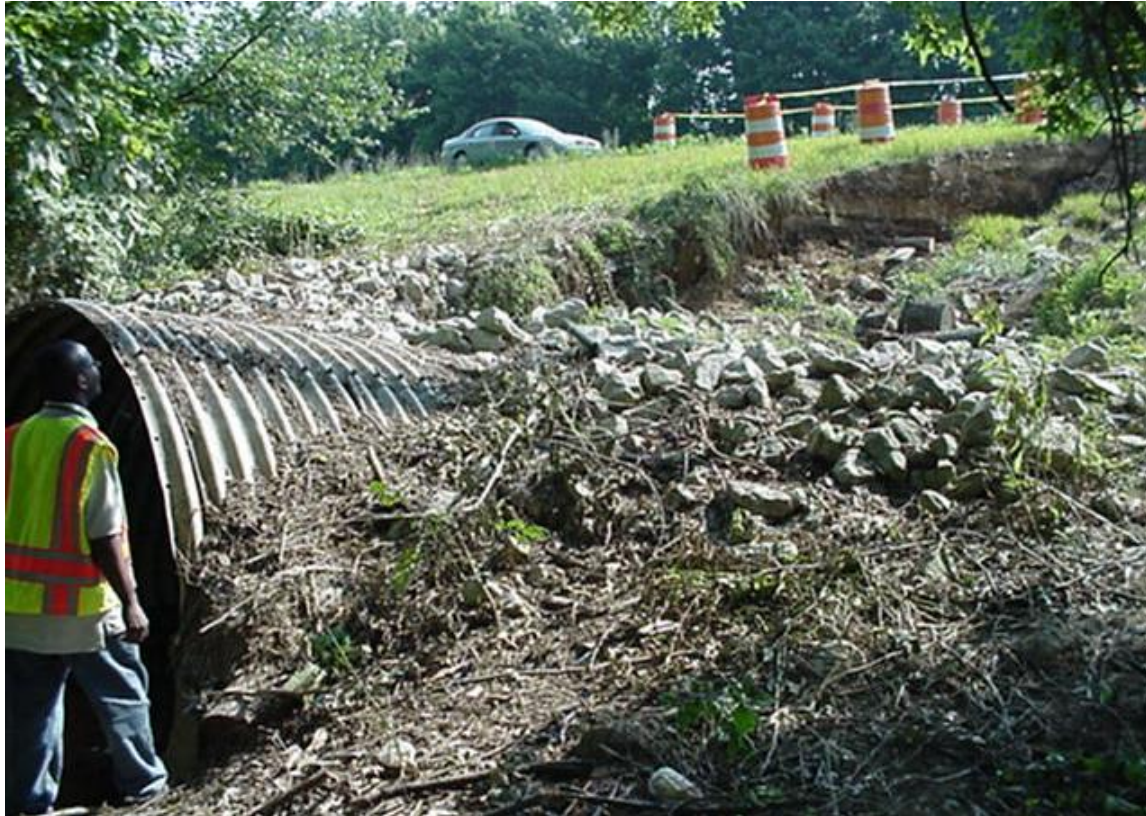
SR-60, Clark Co., July 2006, 11.40 x 7.24 SPPA
7-26-2006

Disturbed embankment at inlet. Again note the upwards bend of the culvert.

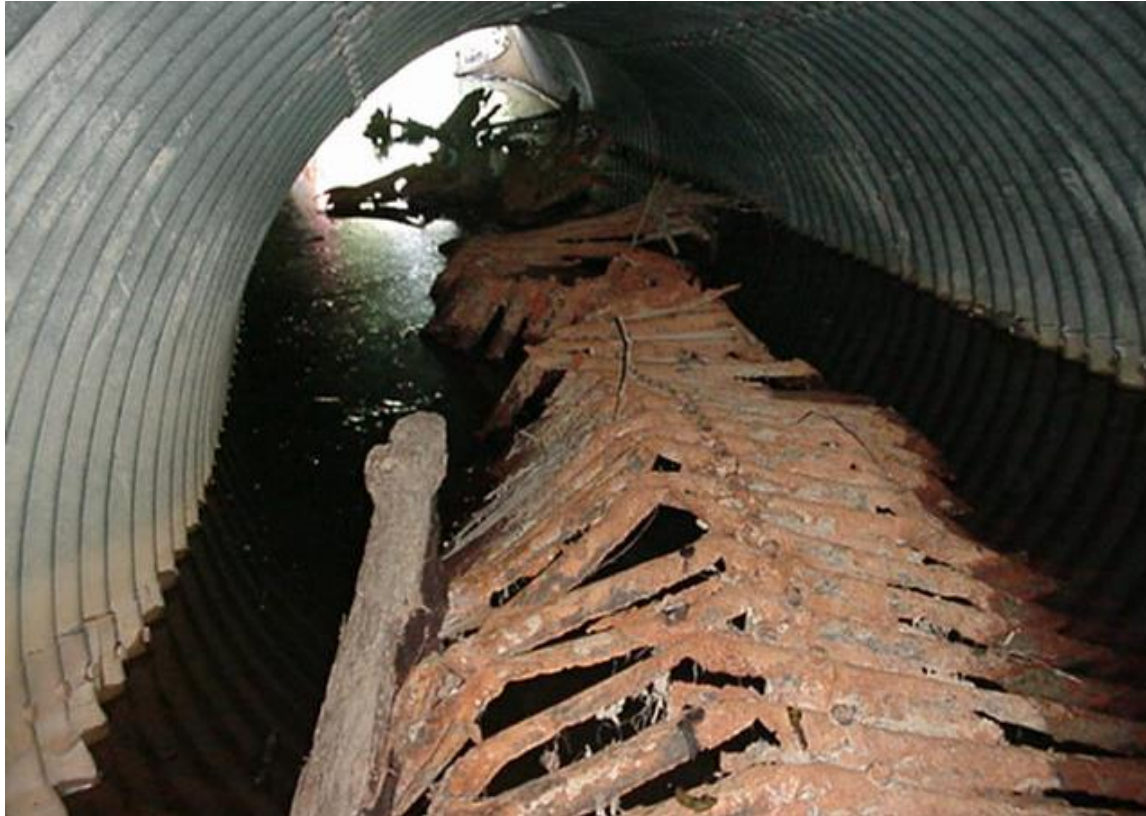
SR-60, Clark Co., July 2006, 11.40 x 7.24 SPPA
8-4-2006

Interior bottom damage to culvert near inlet. Again, note the bending of the culvert and debris.

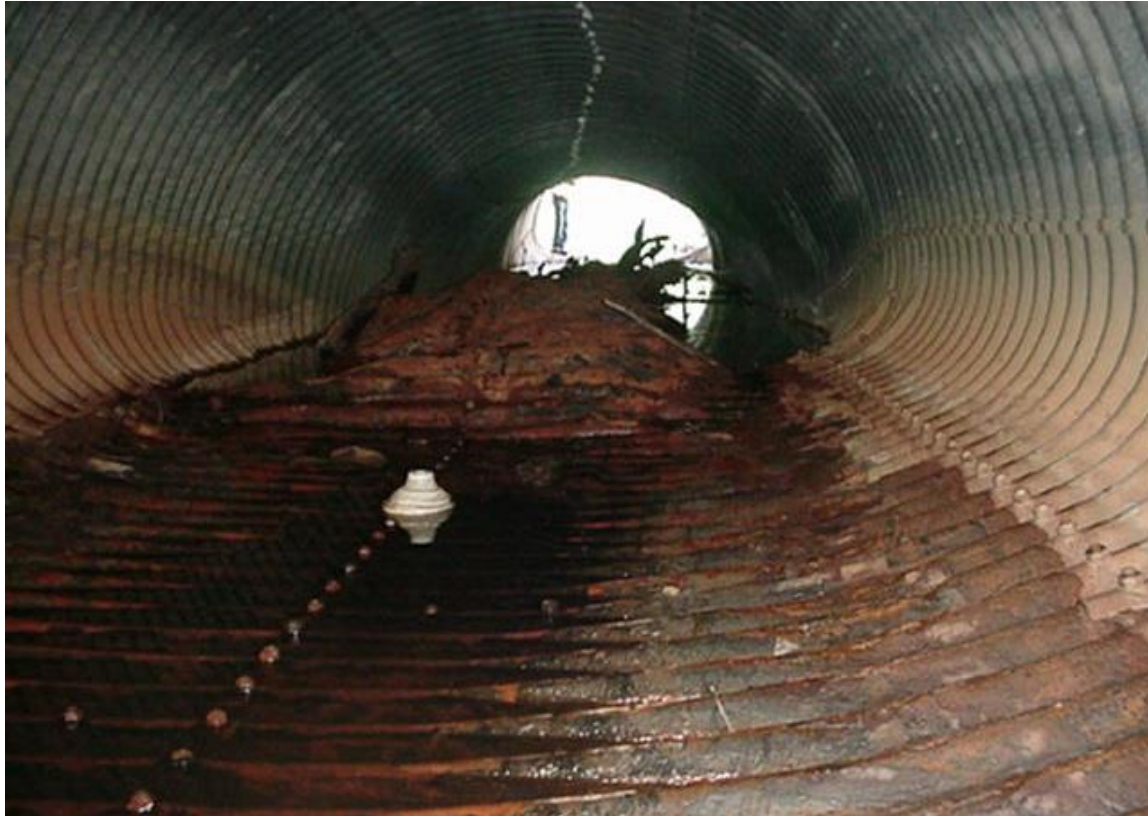
SR-60, Clark Co., July 2006, 11.40 x 7.24 SPPA
8-4-2006

Culvert bottom damage.

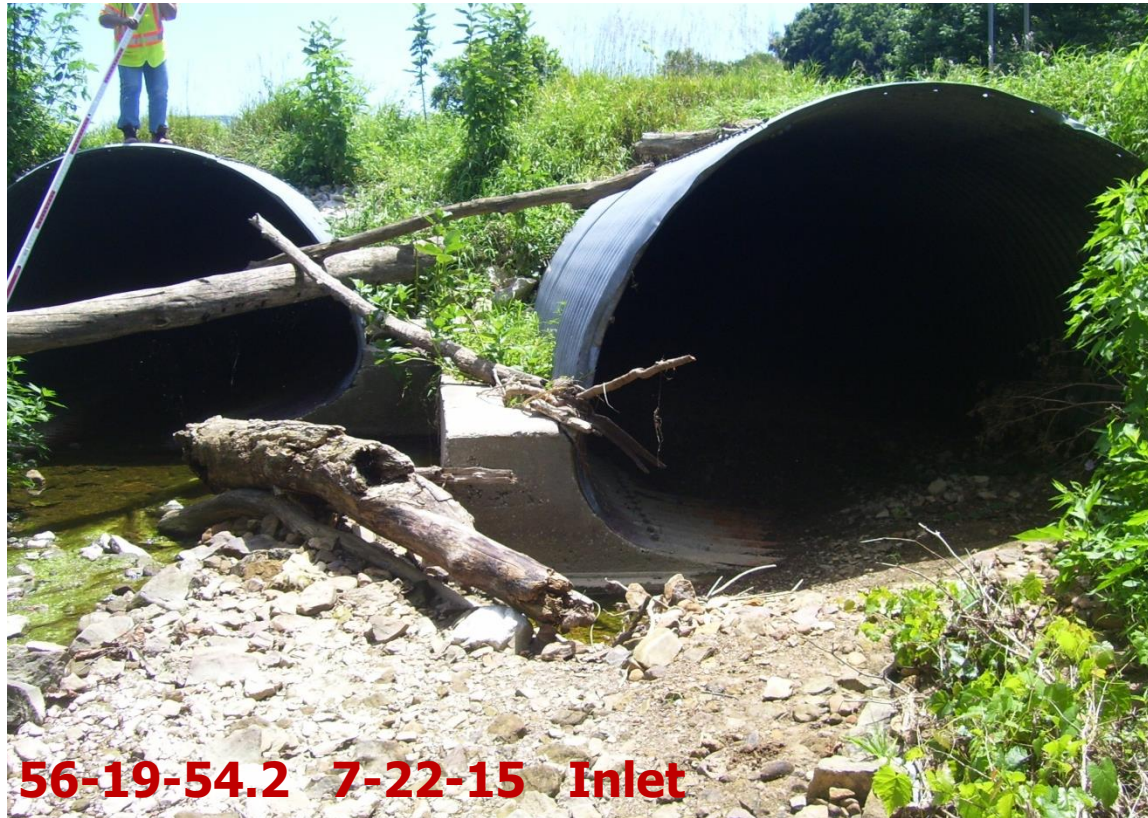
Multiple culvert problems

Note that one culvert tends to become the streams choice, and the other may experience sediment accumulation. And, the one the stream chooses to use, also collects floating debris.

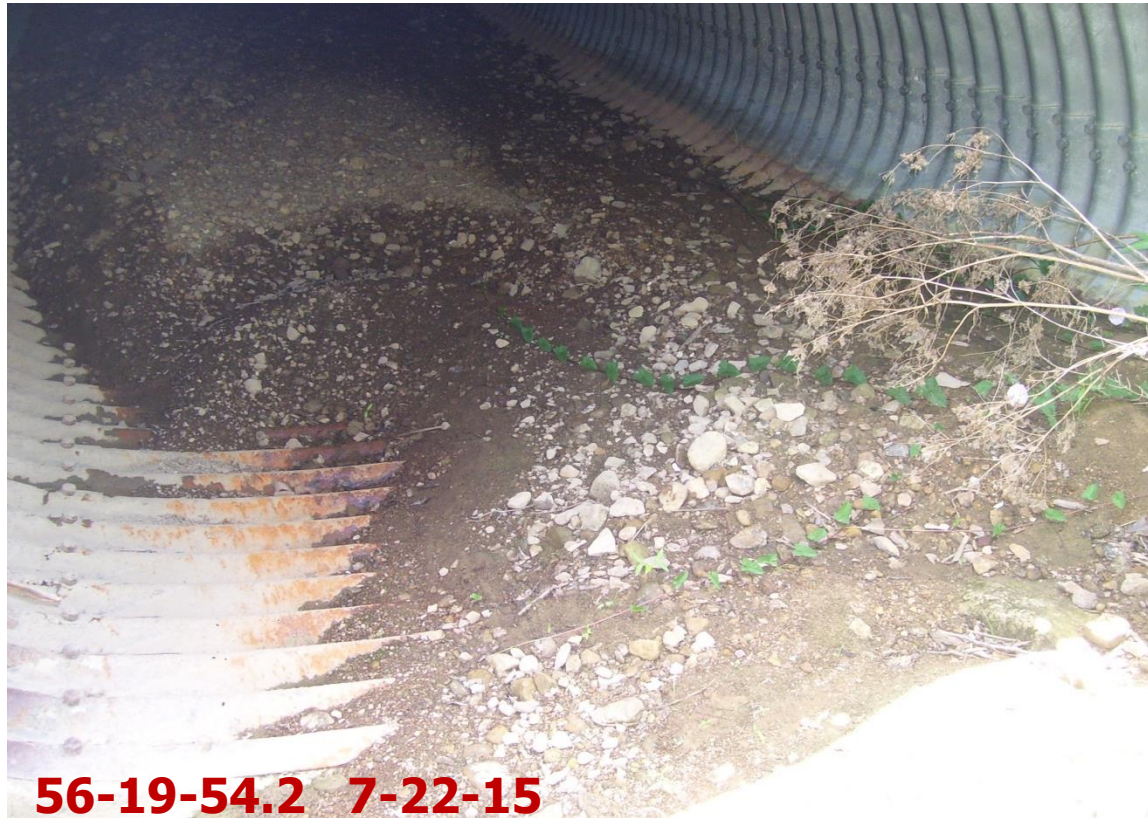
56-19-54.2 7-22-15

Accumulating sediment

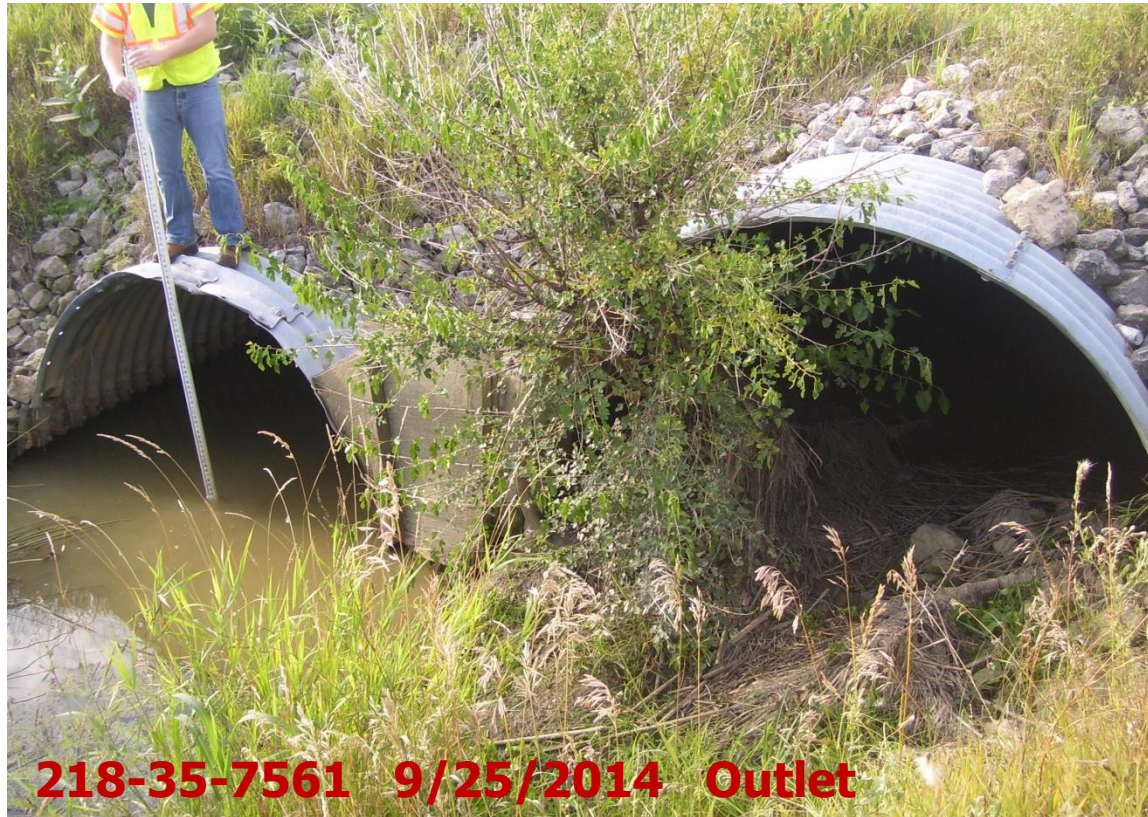
Multiple culvert problems

At the higher culvert outlet sediment and debris accumulation is visible, as well as a tree starting to grow.

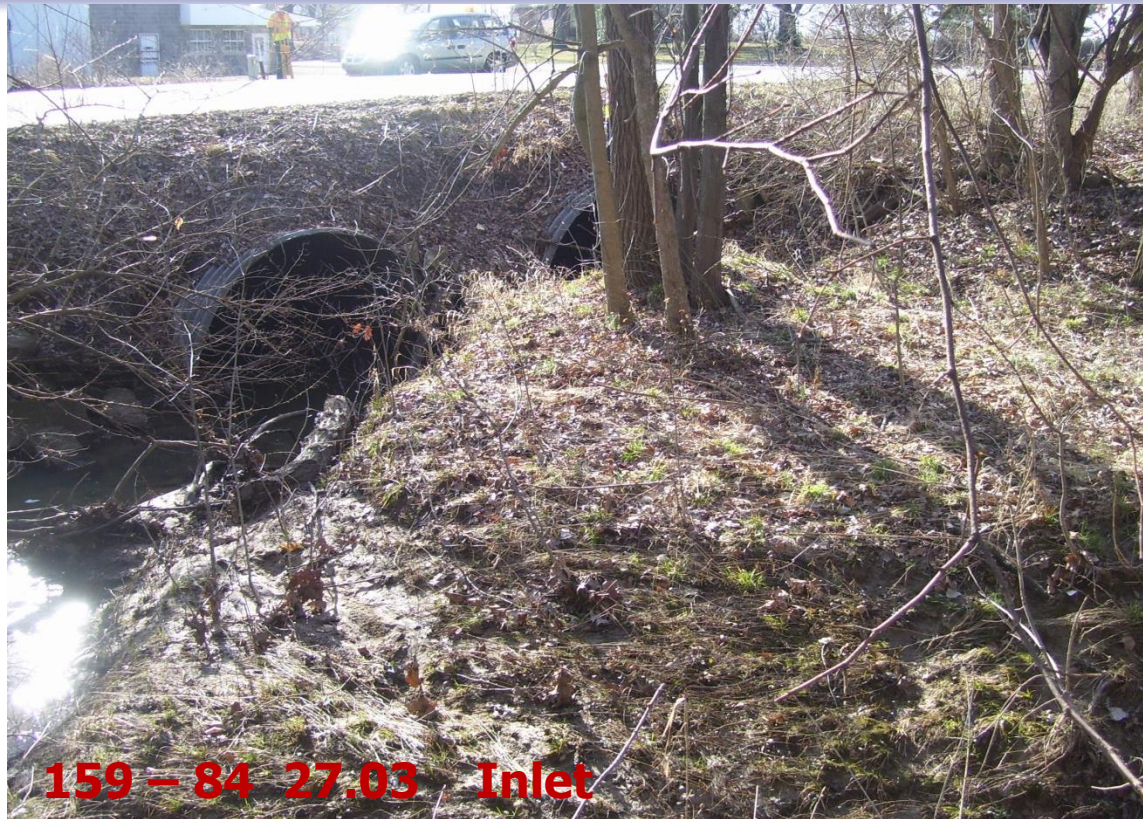
Multiple culvert problems

Double culvert where the stream has shifted and abandoned the other culvert, which now has a ridge of soil with trees growing immediately upstream of the inlet.

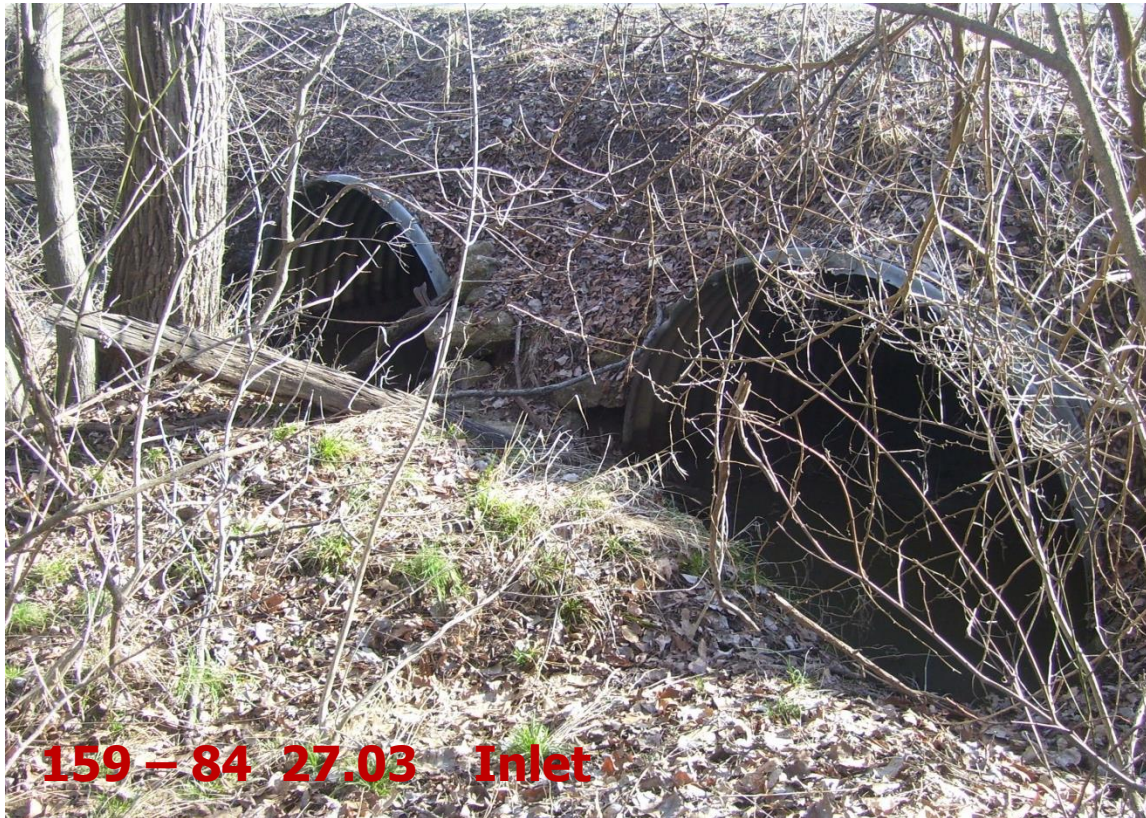
159 - 84 27.03 Inlet

Close-up of the same culverts showing how water has to be very deep to get into the second culvert.

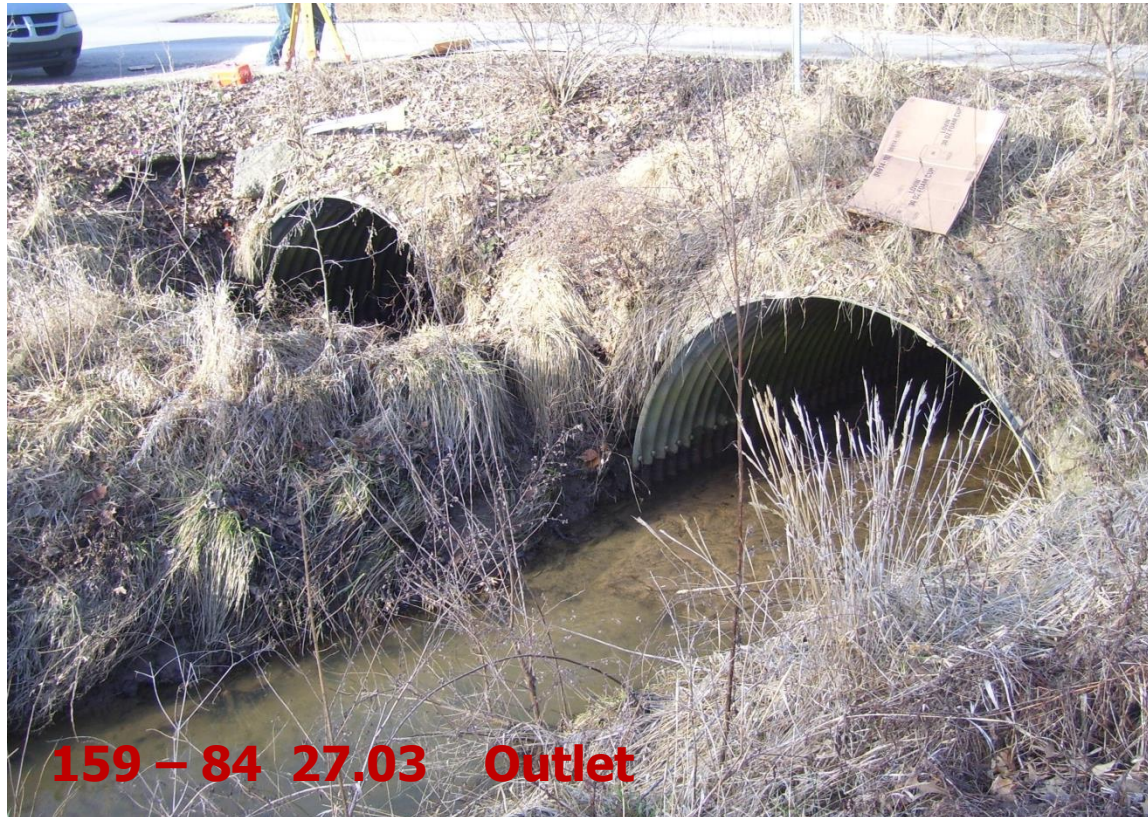
Multiple culvert problems

At the outlets it is apparent that the other culvert has been abandoned by the stream.

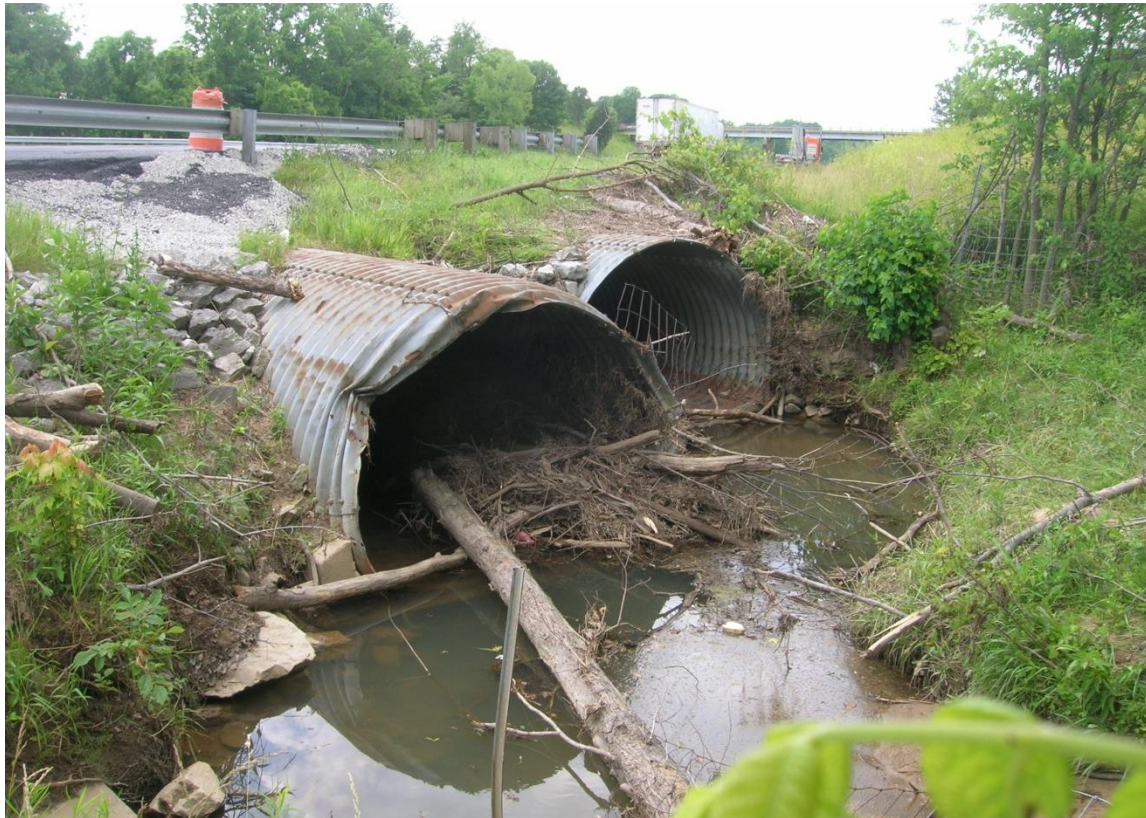
I-70, Putnam Co., June 2008, Twin 9.5 x 6.0 SPPA

Culvert inlets. Closest one was blocked and floated, popping up through the pavement of westbound I-70.

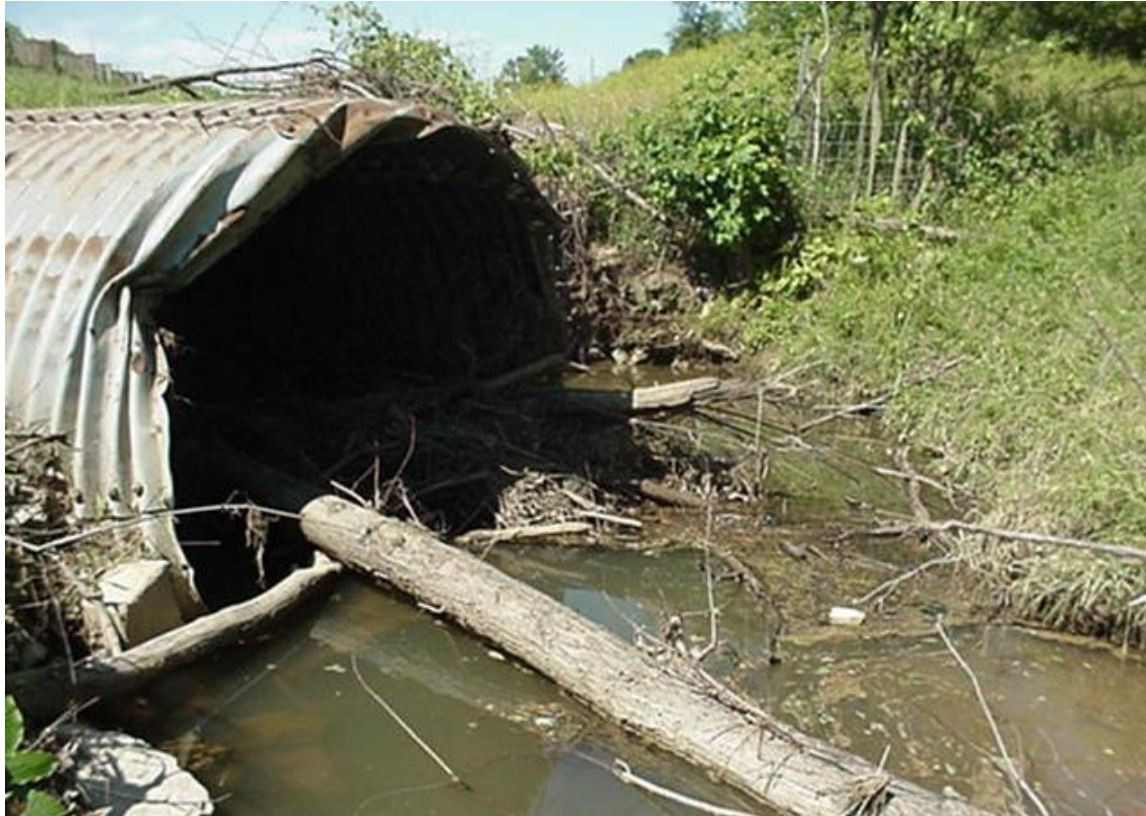
I-70, Putnam Co., June 2008, Twin 9.5 x 6.0 SPPA

East pipe inlet. Note large dent and debris, including a tree.

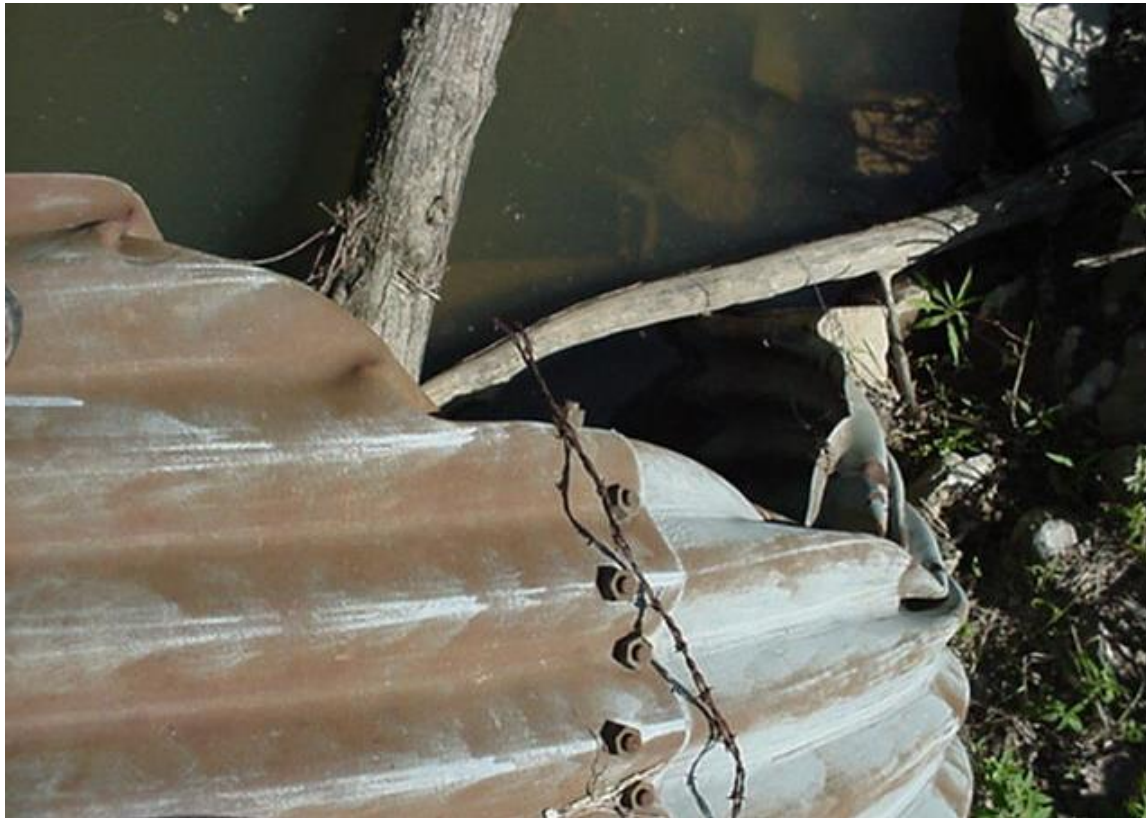
I-70, Putnam Co., June 2008, Twin 9.5 x 6.0 SPPA

Dent on eastern side of east culvert inlet.

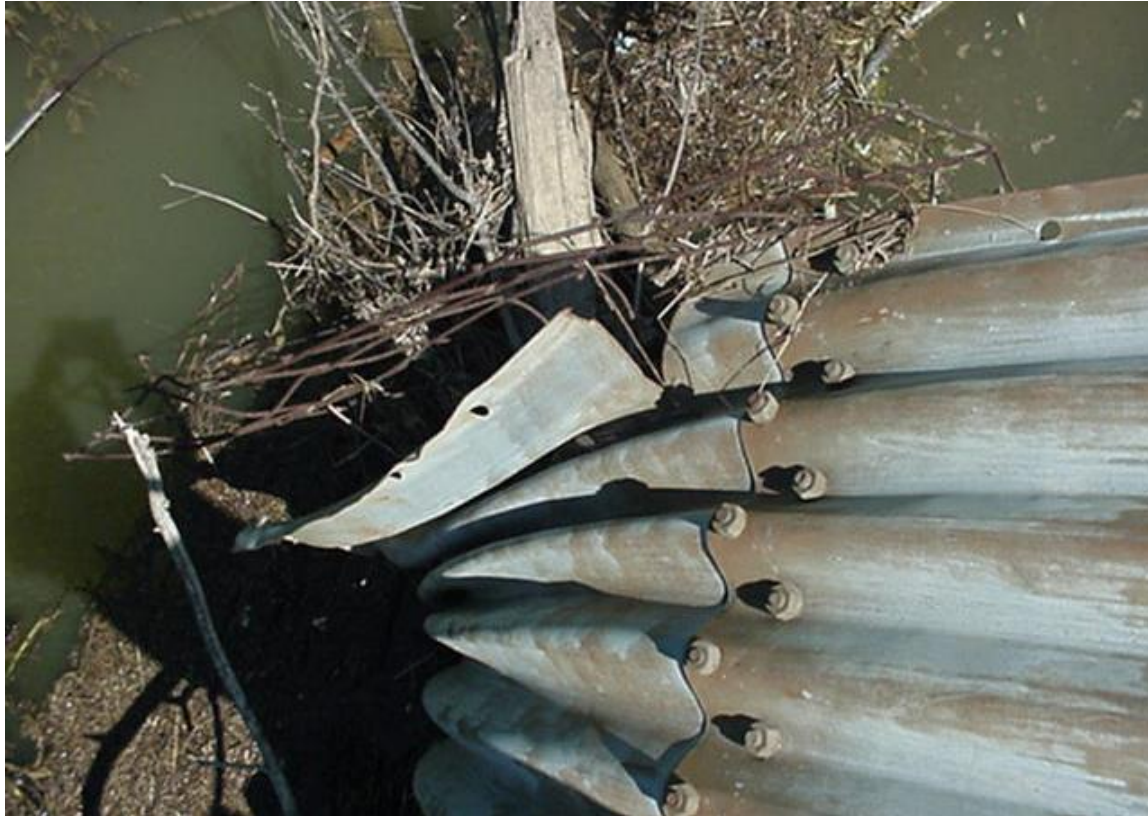
I-70, Putnam Co., June 2008, Twin 9.5 x 6.0 SPPA

Dent on western side of east culvert inlet.

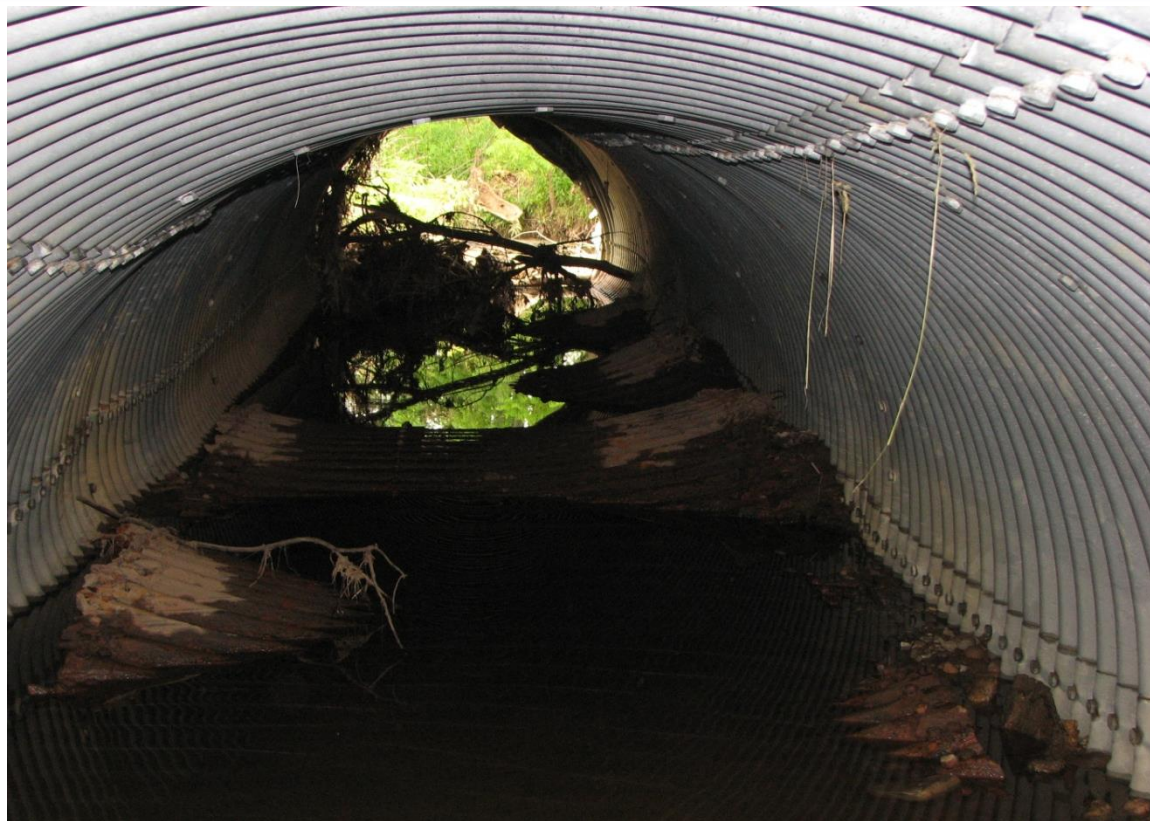
I-70, Putnam Co., June 2008, Twin 9.5 x 6.0 SPPA

East pipe, bottom damage, looking towards inlet. Note upwards bend in culvert top.

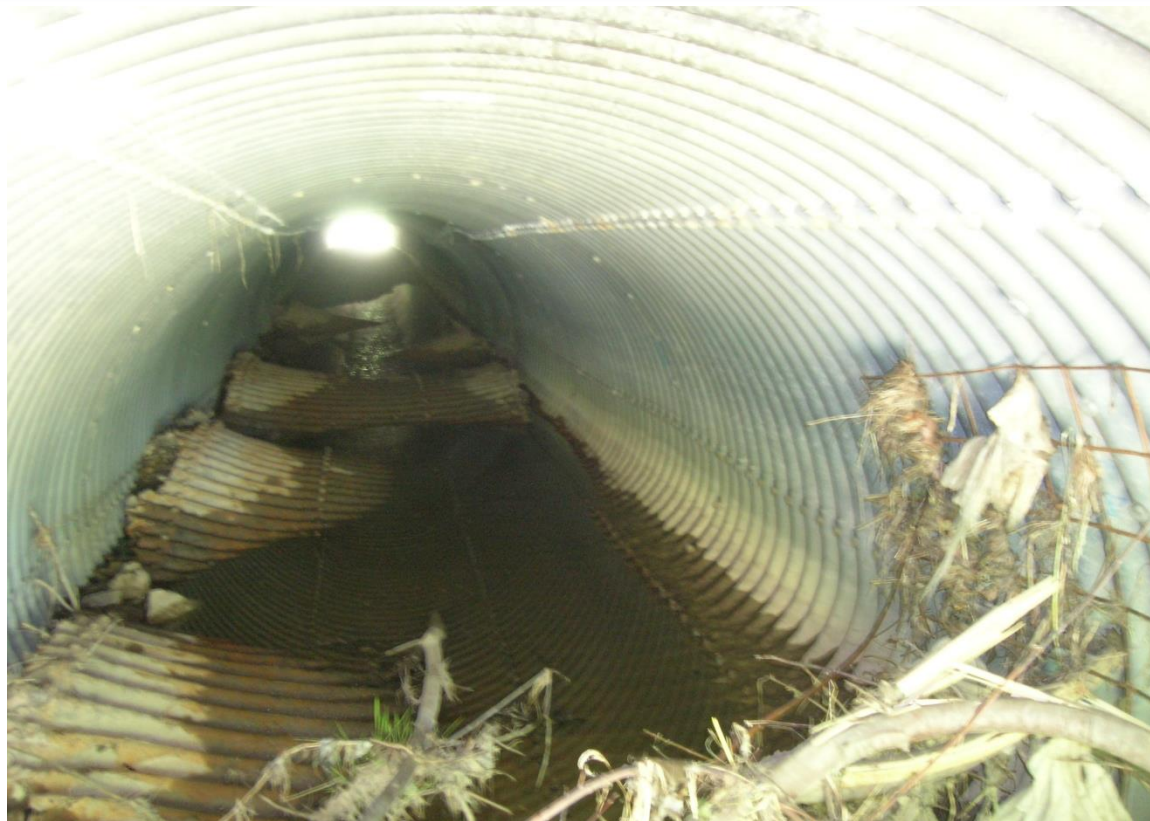
I-70, Putnam Co., June 2008, Twin 9.5 x 6.0 SPPA

East pipe, bottom damage, looking towards inlet
