Storm Damage – Floating Culverts & Other Inlet Issues

Mark Bailey, PE - Hydraulic Manager, INDOT
Dale Sedler, PE - Sr. Hydraulic Engineer, INDOT

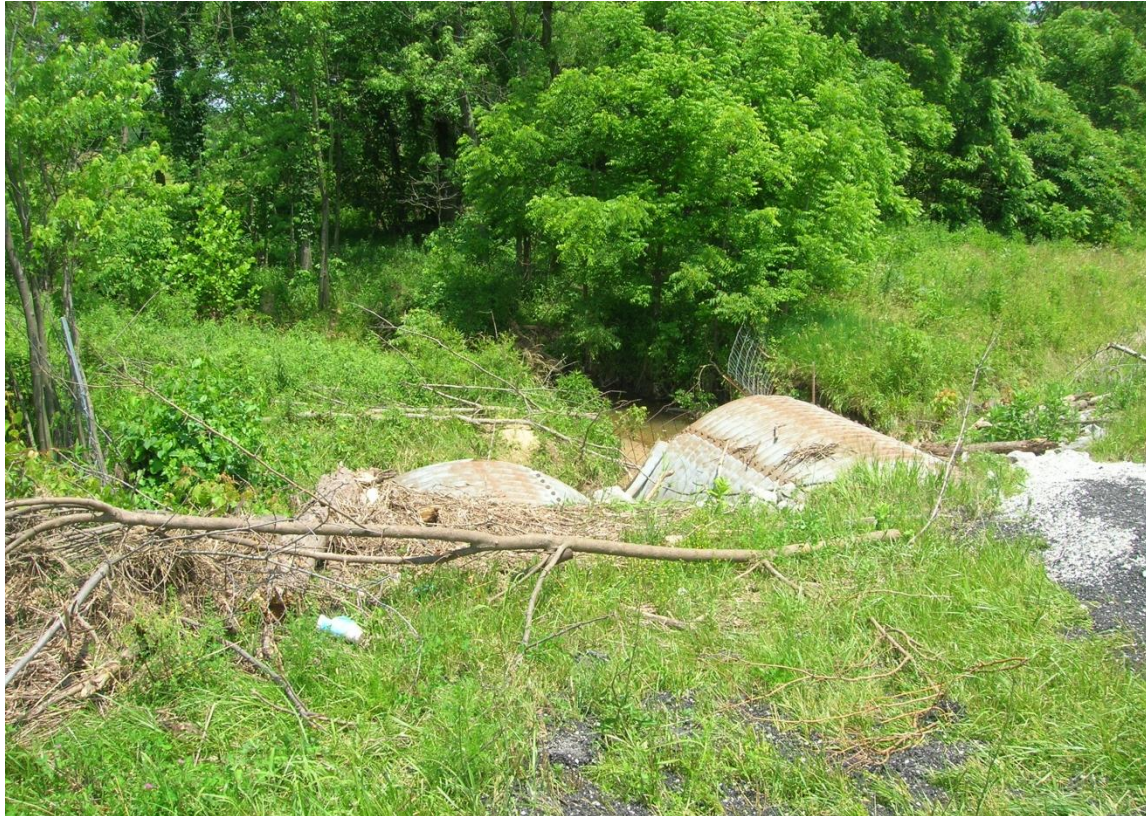
I-70, Putnam Co., June 2008, Twin 9.5 x 6.0 SPPA

Looking upstream at inlets. Note debris deposits above culverts. And stream has chosen one culvert and abandoned the other resulting in sediment is collecting in the abandoned one.

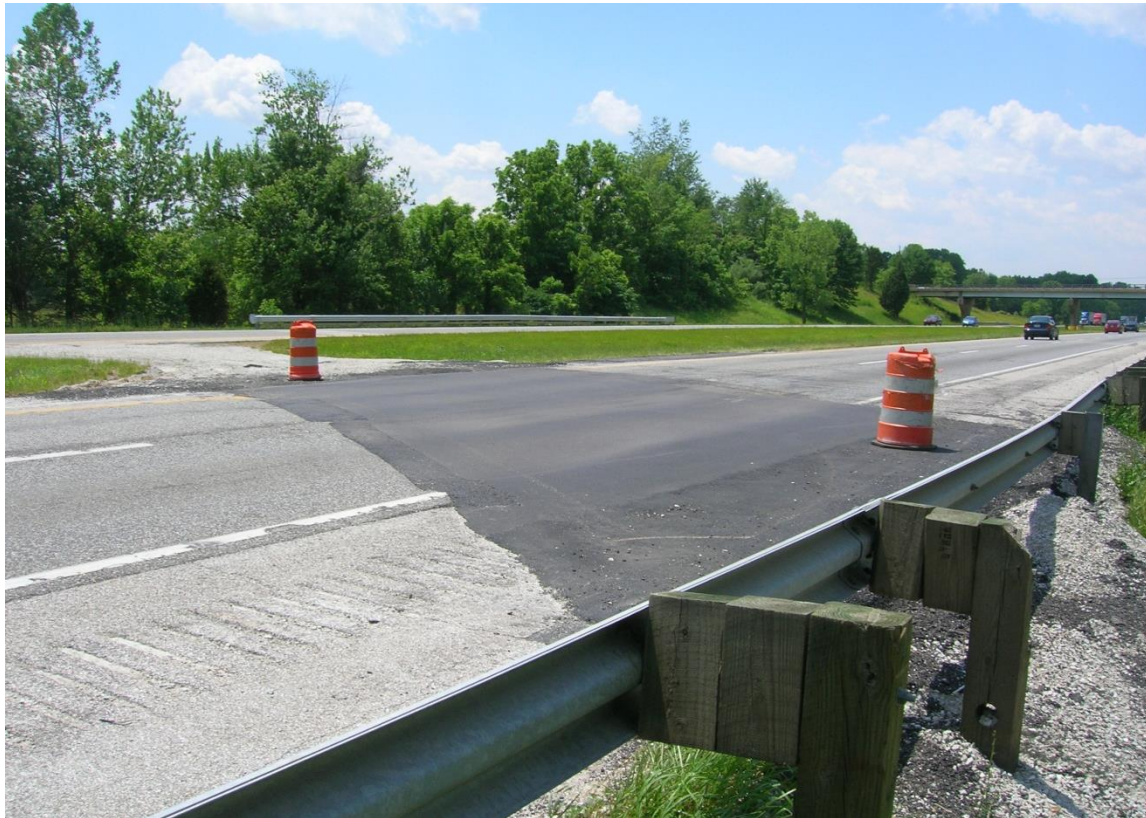
I-70, Putnam Co., June 2008, Twin 9.5 x 6.0 SPPA

Temporary patching where culvert popped up through the westbound lane of I-70.

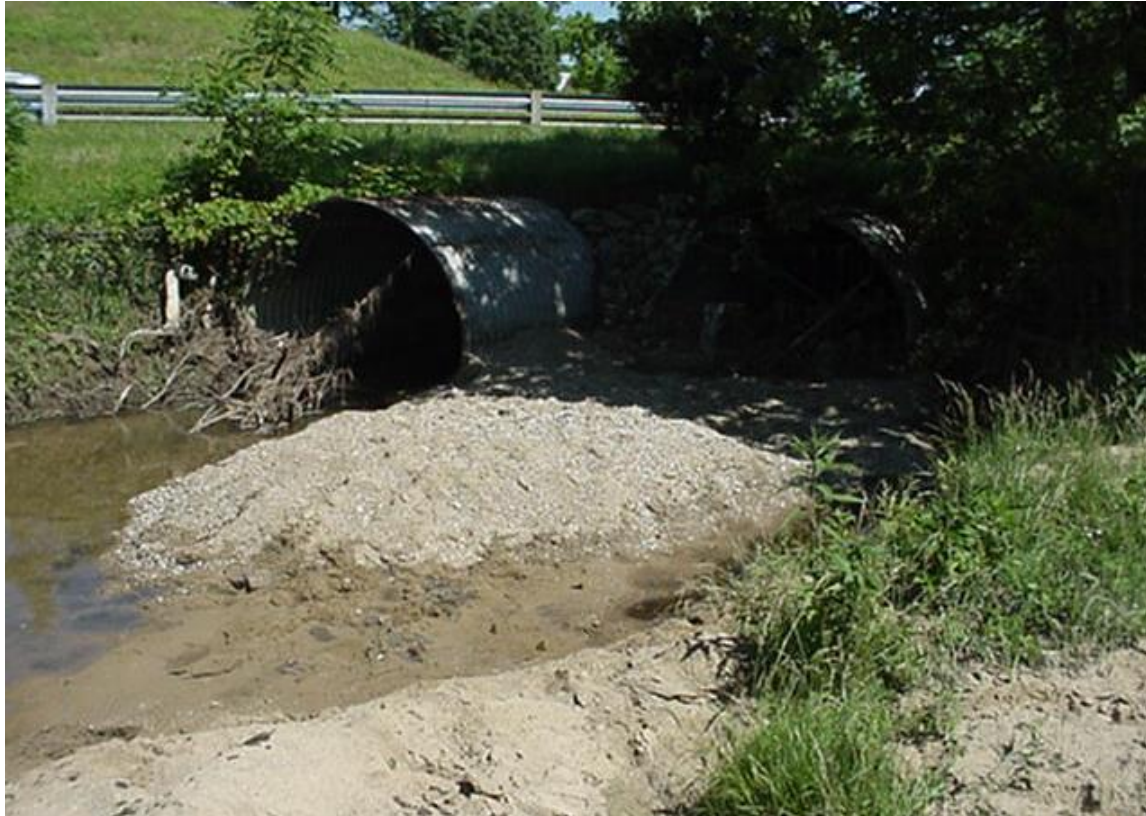
I-70, Putnam Co., June 2008, Twin 9.5 x 6.0 SPPA

Culvert Outlets, east culvert (one that floated) barely visible in the shade. Note the embankment material that was transported through the culvert when it was floated.

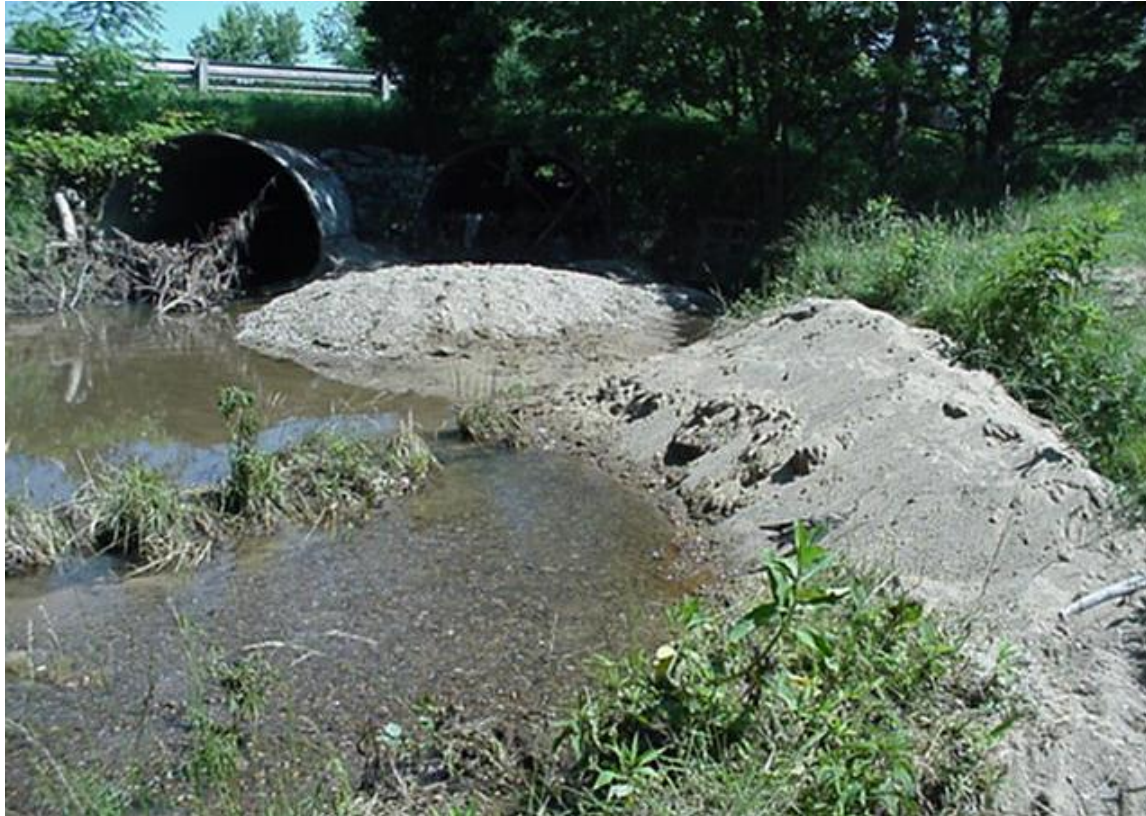
I-70, Putnam Co., June 2008, Twin 9.5 x 6.0 SPPA

Culvert Outlets, east culvert in shade. I-70 embankment material.

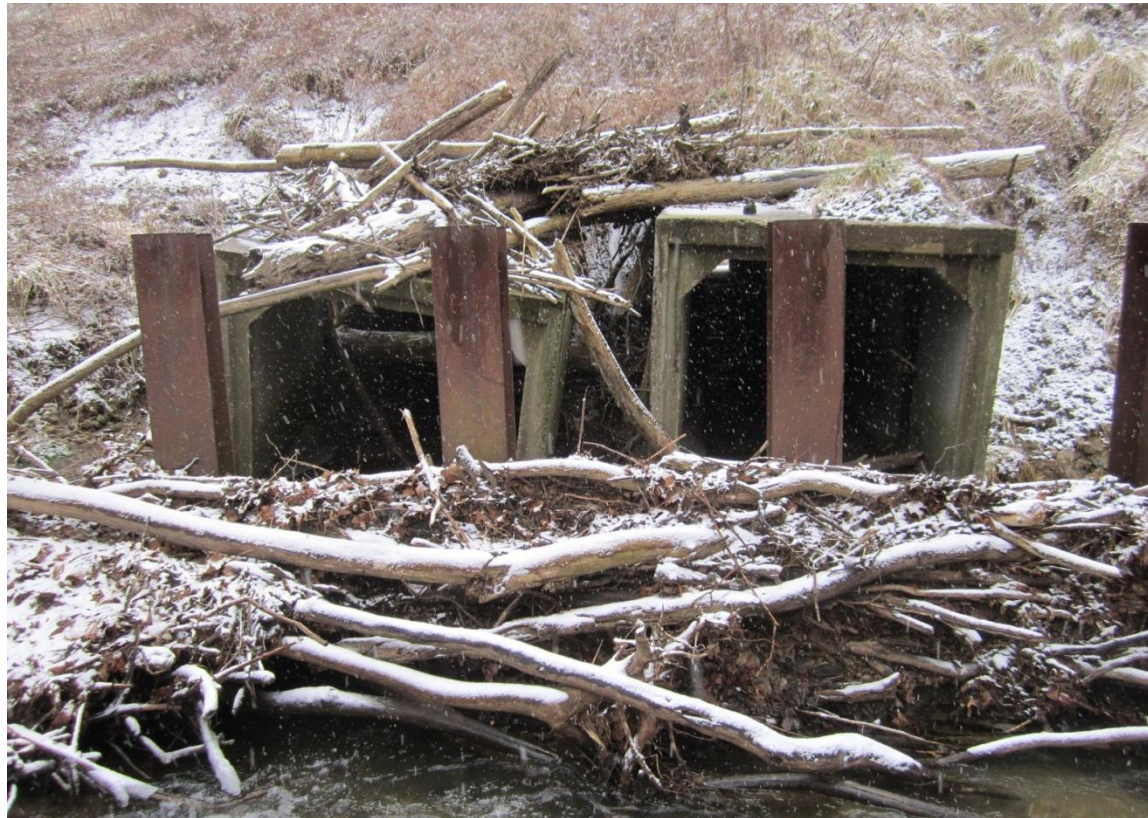
SR-26 RP 28.10 Twin 7 ft x 7 ft Precast RCBs

Culvert inlets with debris collected at deflector and tree lodged between separated sections visible on left. Embankment issues.

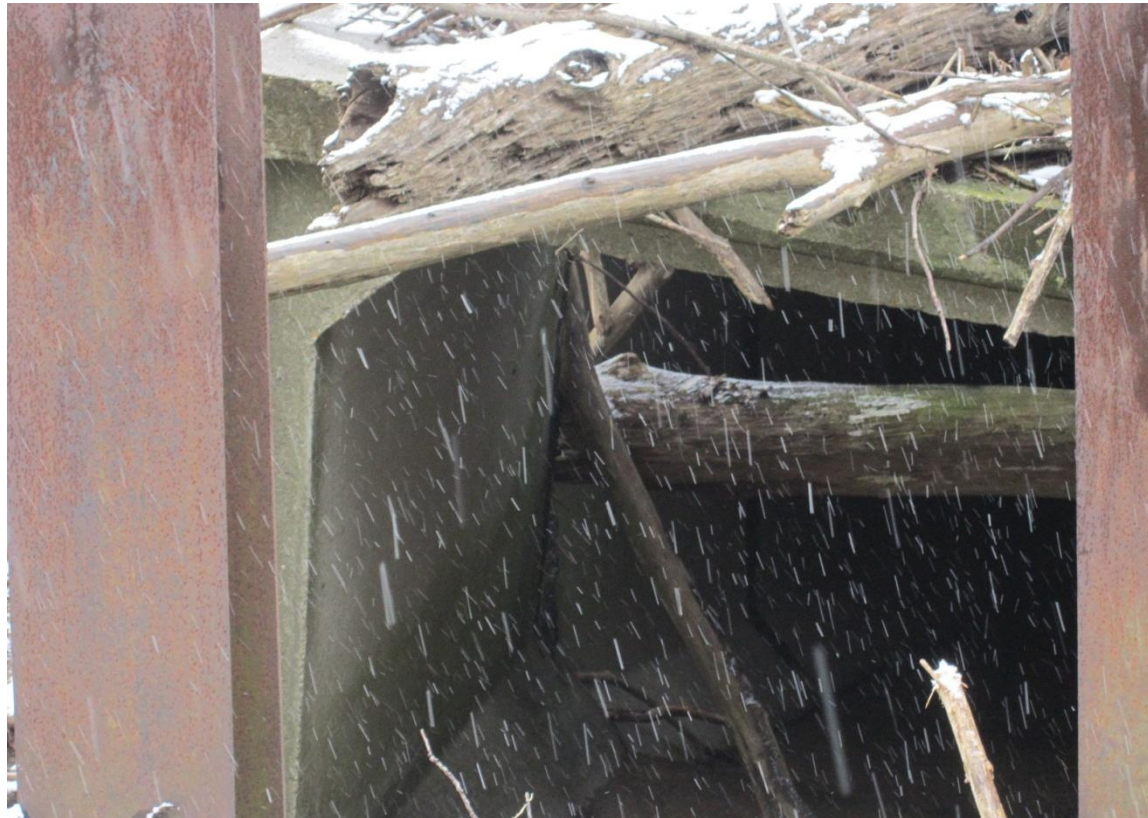
SR-26 RP 28.10 Twin 7 ft x 7 ft Precast RCBs

Culvert inlets with separated section and timber lodged in gap.

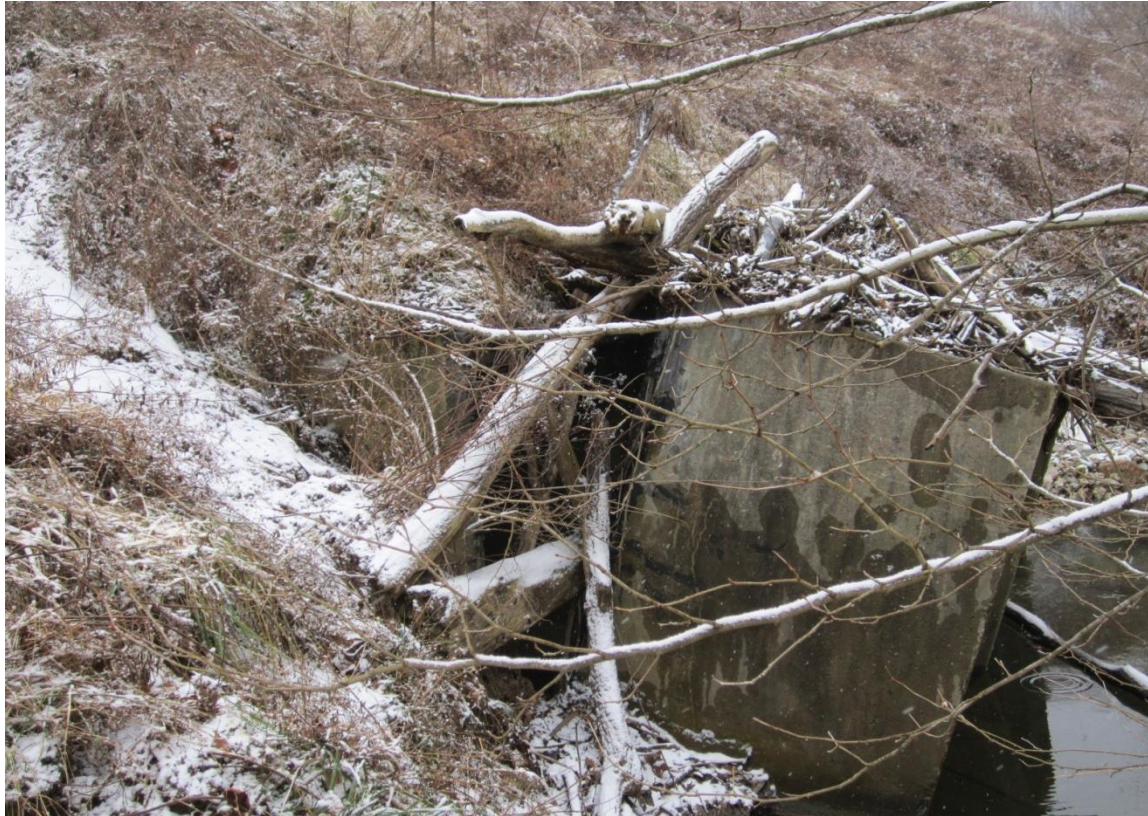
SR-26 RP 28.10 Twin 7 ft x 7 ft Precast RCBs

Culvert inlets with separated section and timber lodged in gap.

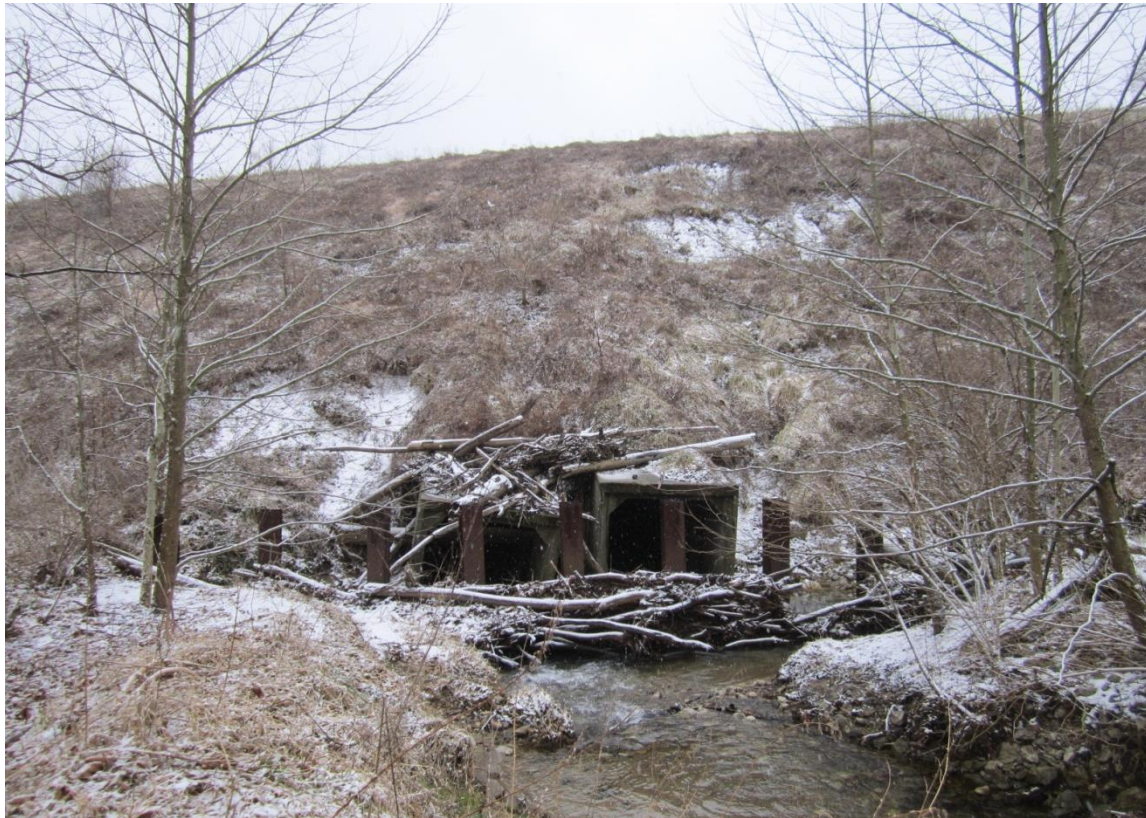
SR-26 RP 28.10 Twin 7 ft x 7 ft Precast RCBs

Slope sloughing on inlet side. Possibly due to embankment disturbance.

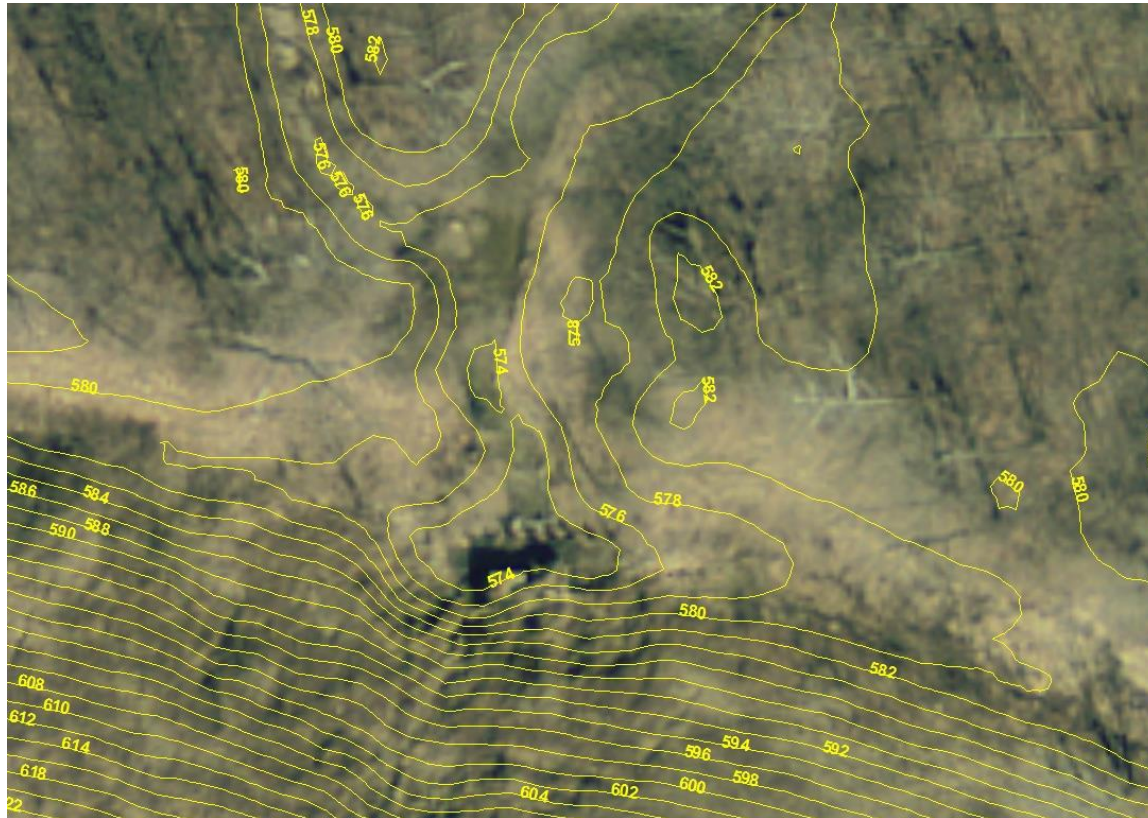
SR-26 RP 28.10 Twin 7 ft x 7 ft Precast RCBs Contours – 2011-13 Indiana Map

Note that the stream is contained and depth at the inlet can easily reach 8 feet.

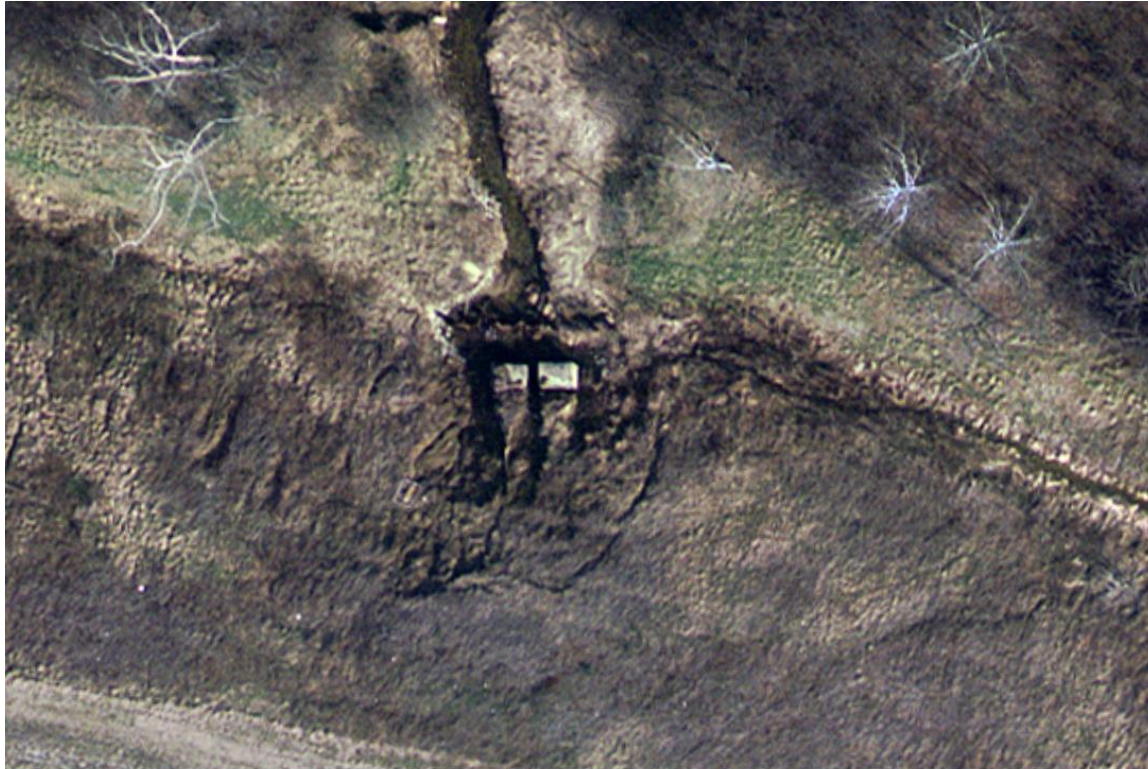
SR-26 RP 28.10 Twin 7 ft x 7 ft Precast RCBs Embankment Damage 2005 Aerial Photo

With ponding at inlet due to blockage, rapid drawdown can result.

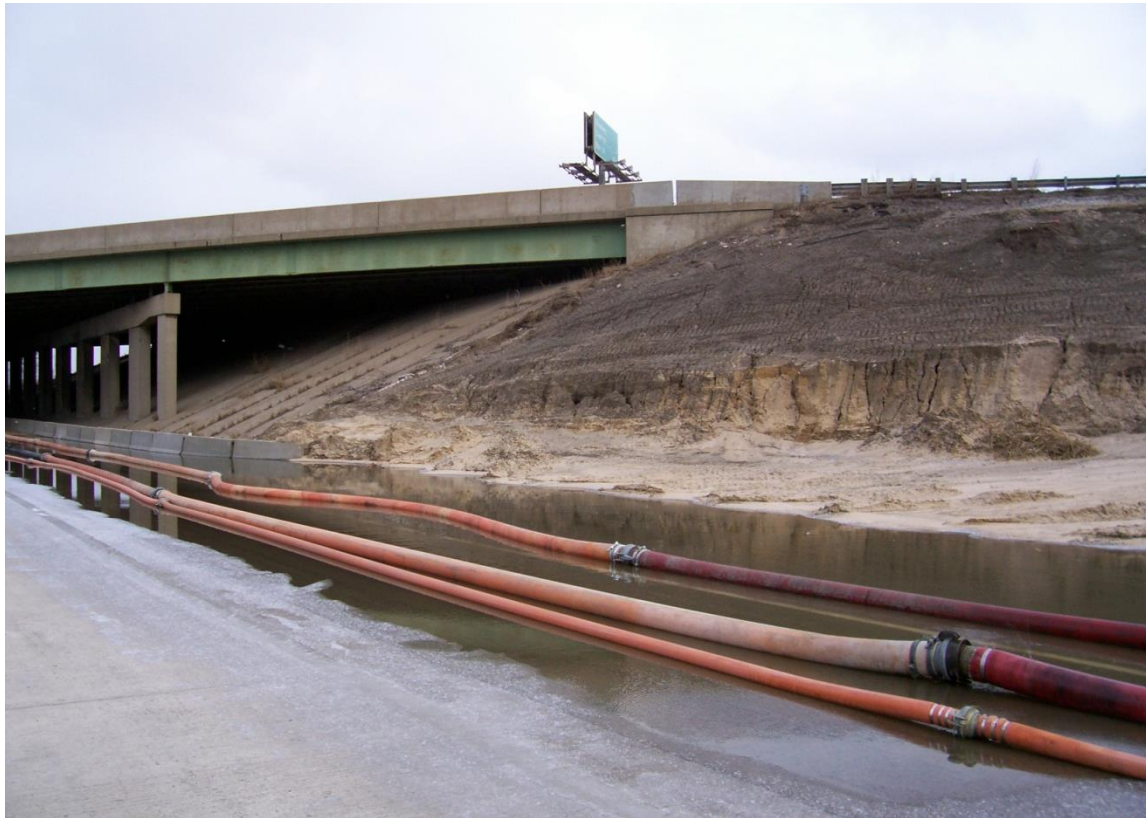
Embankment damage due to rapid drawdown Borman Expressway, 2008

Ponding in interchange due to clogged levee flapgate.

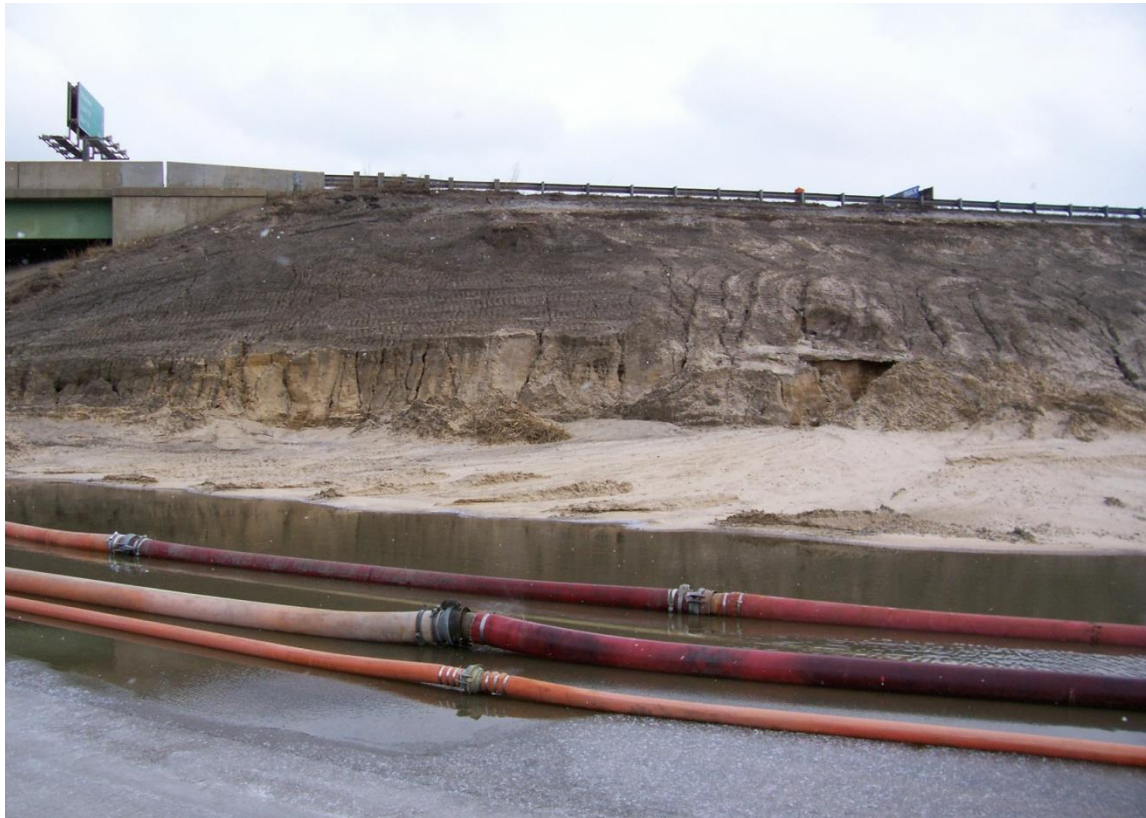
Embankment damage due to rapid drawdown Borman Expressway, 2008

Ponding in interchange due to clogged levee flapgate.

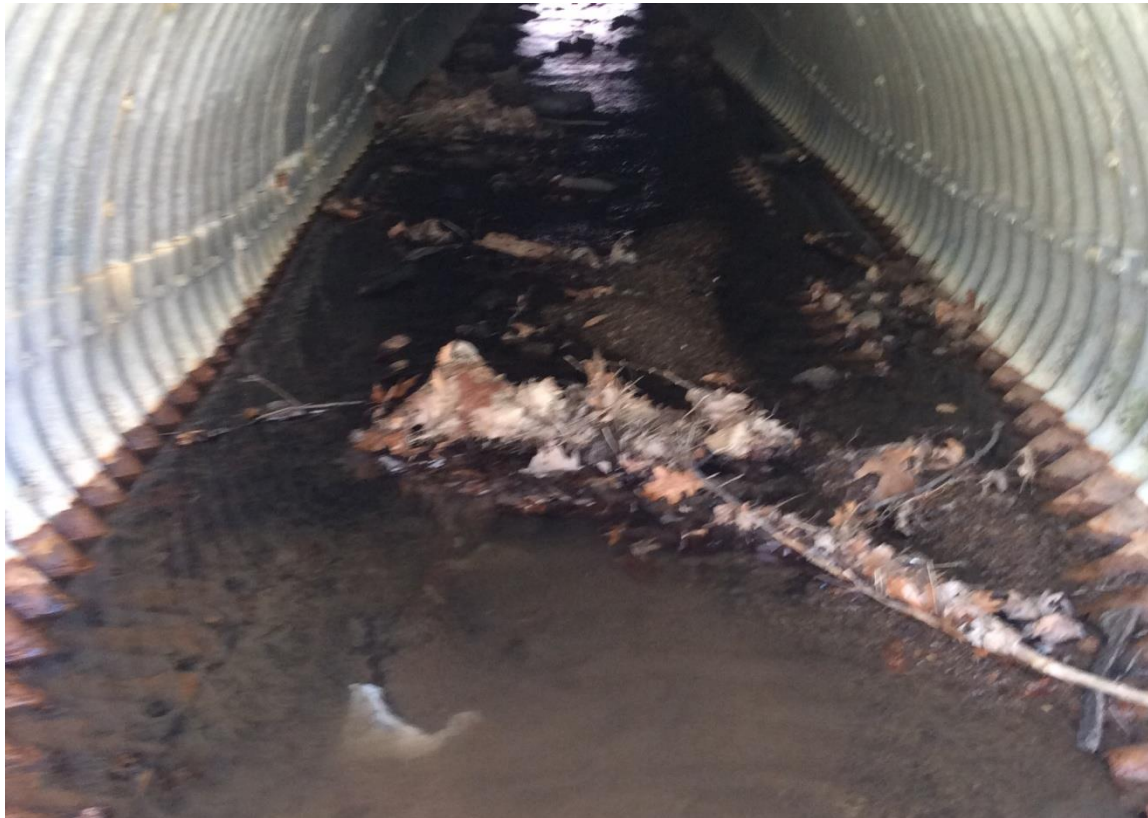
SR-46 RP 80.14 8'-2" x 5'-9"

**Reported to Hydraulics as possibly
in failure mode due to pipe
deformation and bottom of culvert
gone. Anchor was also gone.**

Culvert inlet, invert gone.

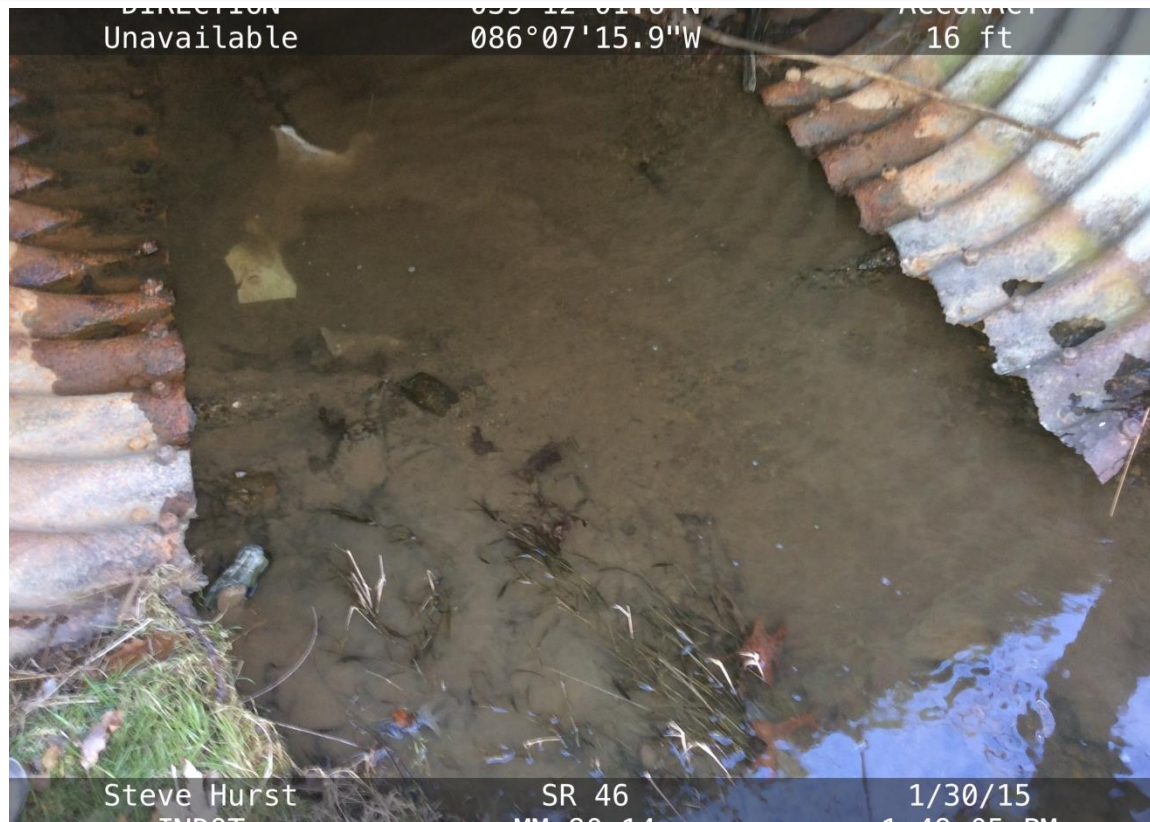
SR-46 RP 80.14 8'-2" x 5'-9"

Culvert inlet, invert gone.

Sharp edge on missing floor of culvert suggests that it was manually removed.

The bottom at the inlet was likely tilted upwards when the culvert was new, the bottom was cut out to allow the creek to flow through.

**Recommendation: pave the invert,
construct a headwall with wingwalls,
and protect the outlet from scour
with riprap.**

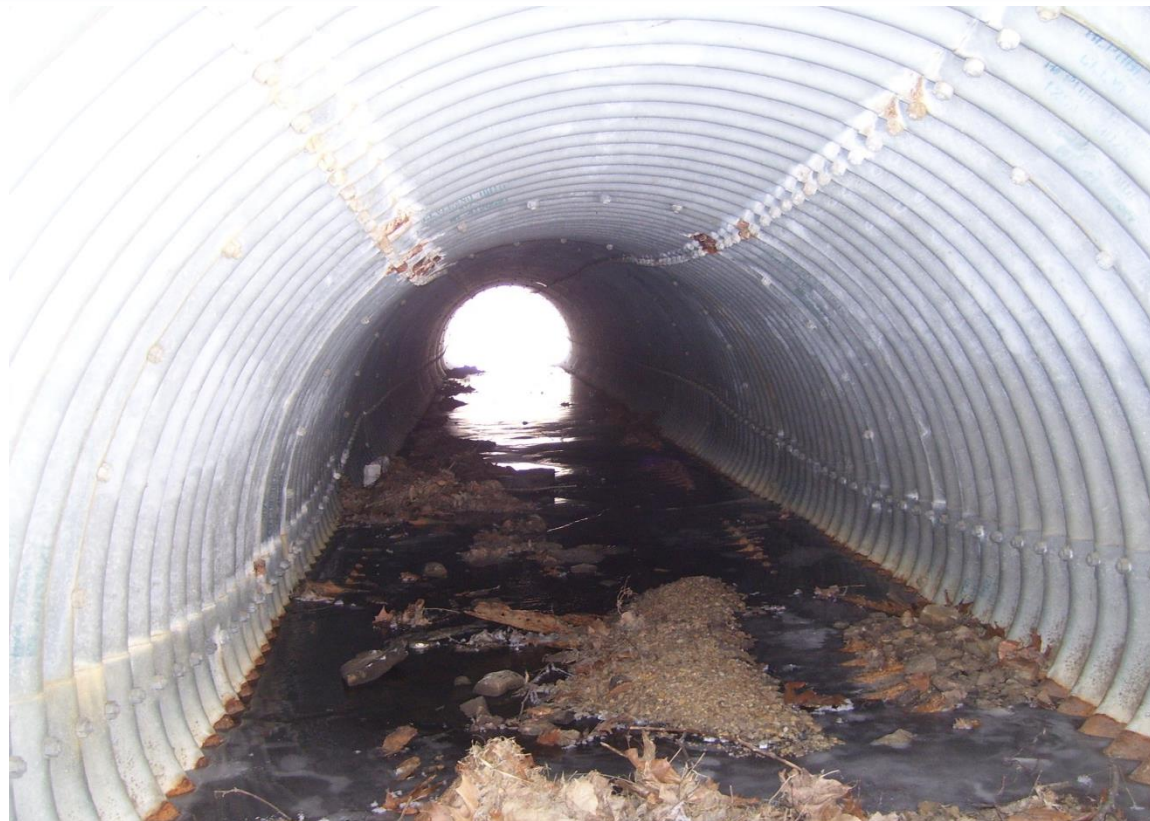
SR-46 RP 80.14 8'-2" x 5'-9"

Culvert inlet.

Note that pipe is in good shape, but is bent upwards at the inlet.

**Upwards bend at culvert inlet
suggests blockage and buoyancy
force occurred in the past.**

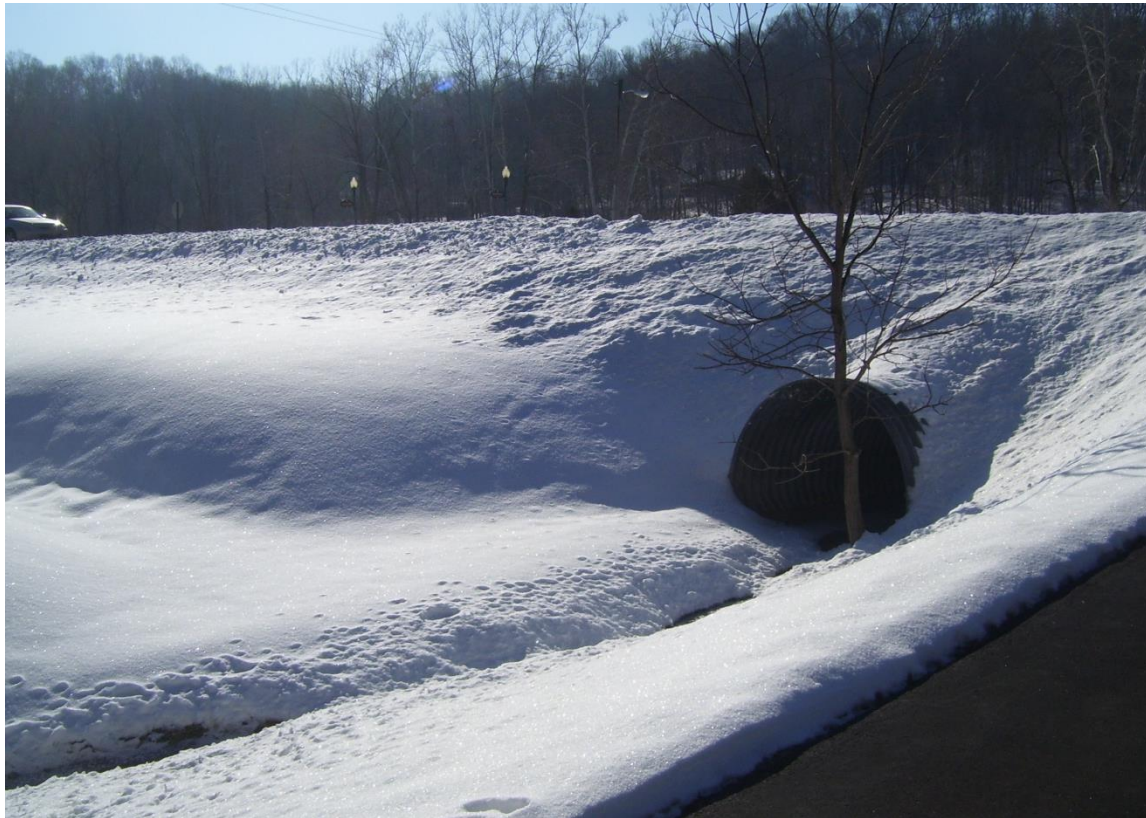
SR-46 RP 80.14 8'-2" x 5'-9"

Culvert inlet. Note driveway adjacent. Resident said it is difficult to mow around the inlet. A headwall with wingwalls will satisfy backwater requirements, plus make it easier to mow the grass.

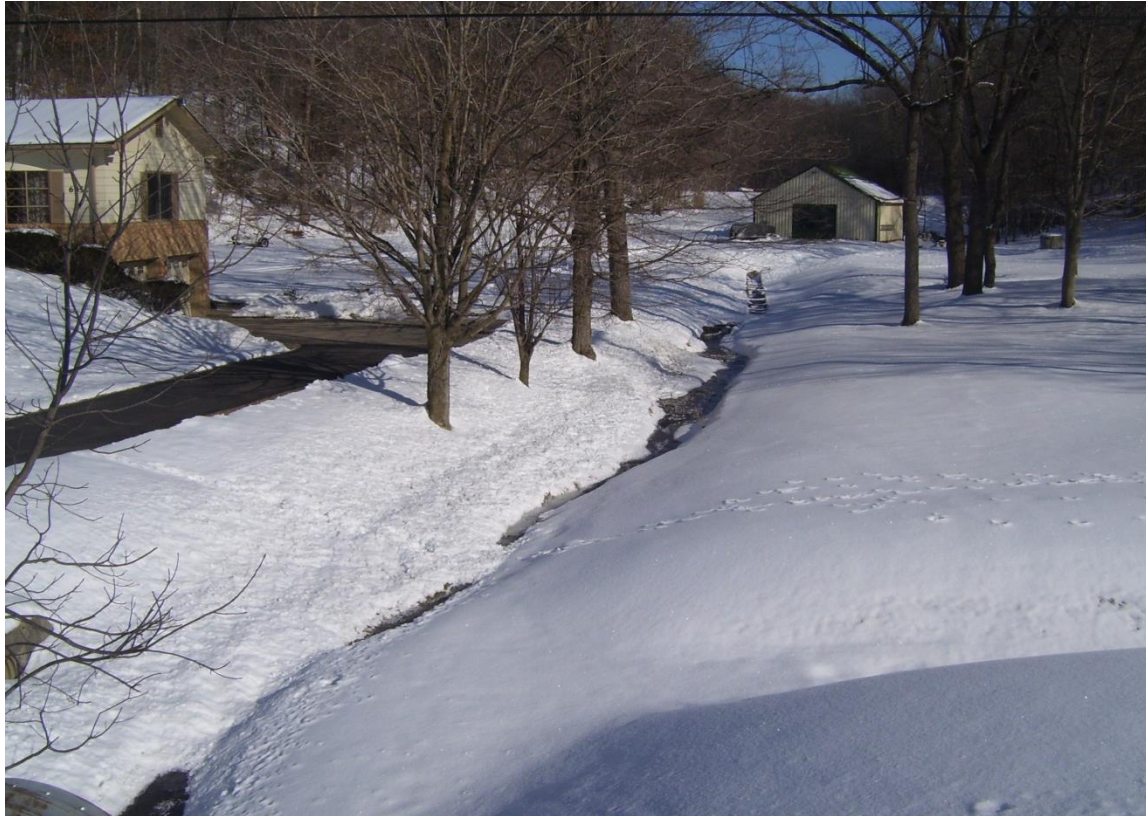
SR-46 RP 80.14 8'-2" x 5'-9"

Upstream. Garage and basement require no increase in backwater necessitating both a paved invert and headwall.

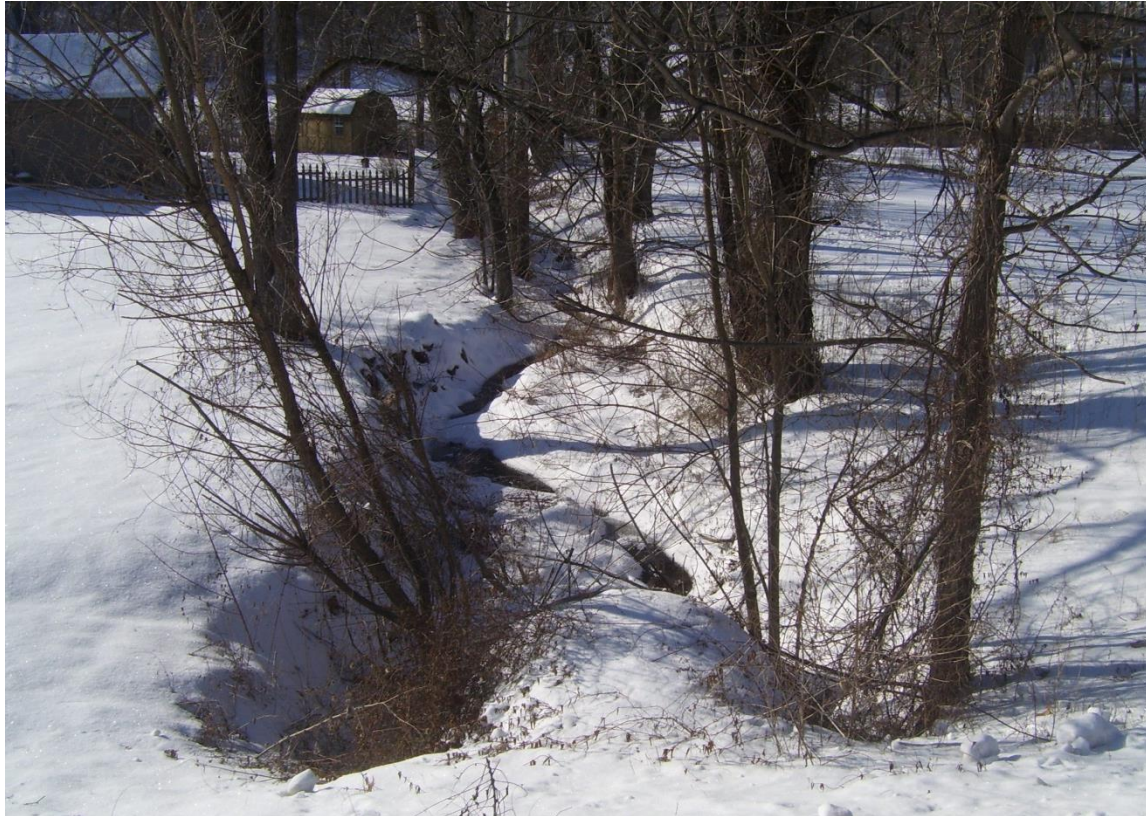
SR-46 RP 80.14 8'-2" x 5'-9"

Downstream. Paved invert will increase outlet velocity requiring riprap to protect channel from scour at the outlet.

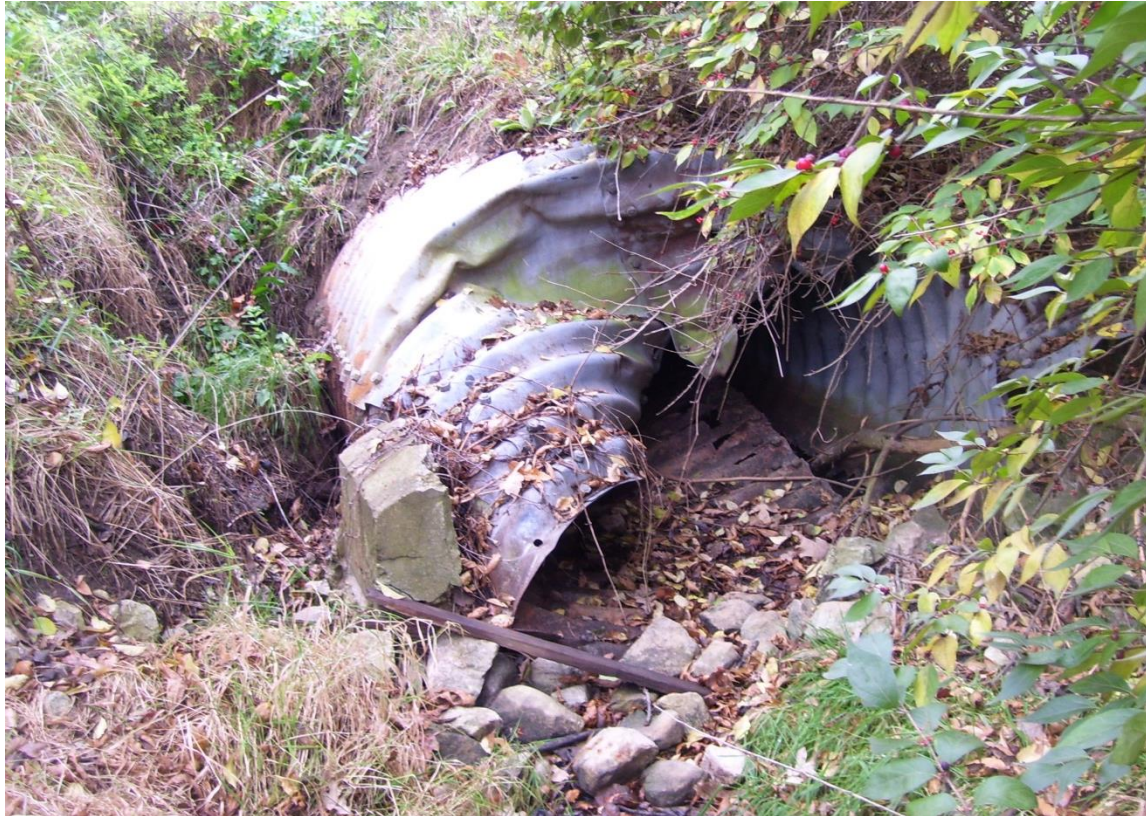
I-70 Morgan Co. RP 55.02 6'-6" x 4'-6" SPPA

Damaged inlet. Bottom distorted. Anchor damaged. Embankment disturbed.

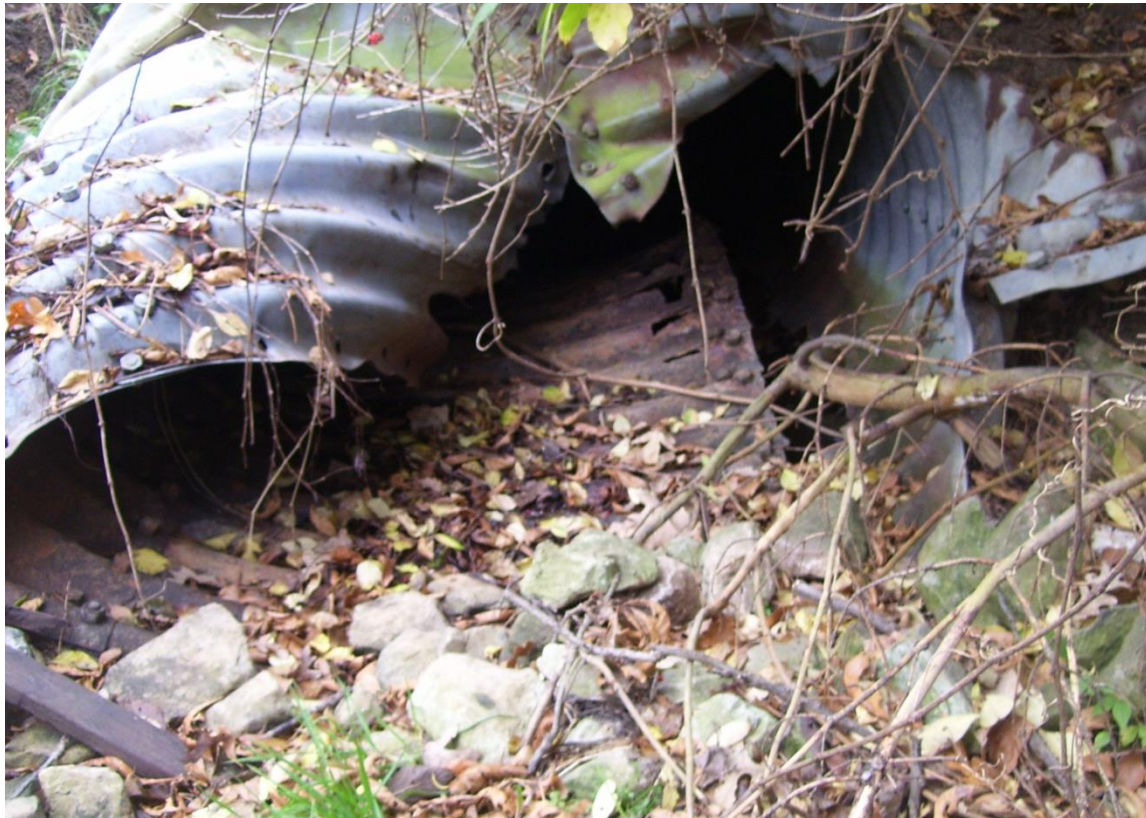
I-70 Morgan Co. RP 55.02 6'-6" x 4'-6" SPPA

Damaged inlet. Bottom distorted. Anchor damaged. Embankment disturbed.

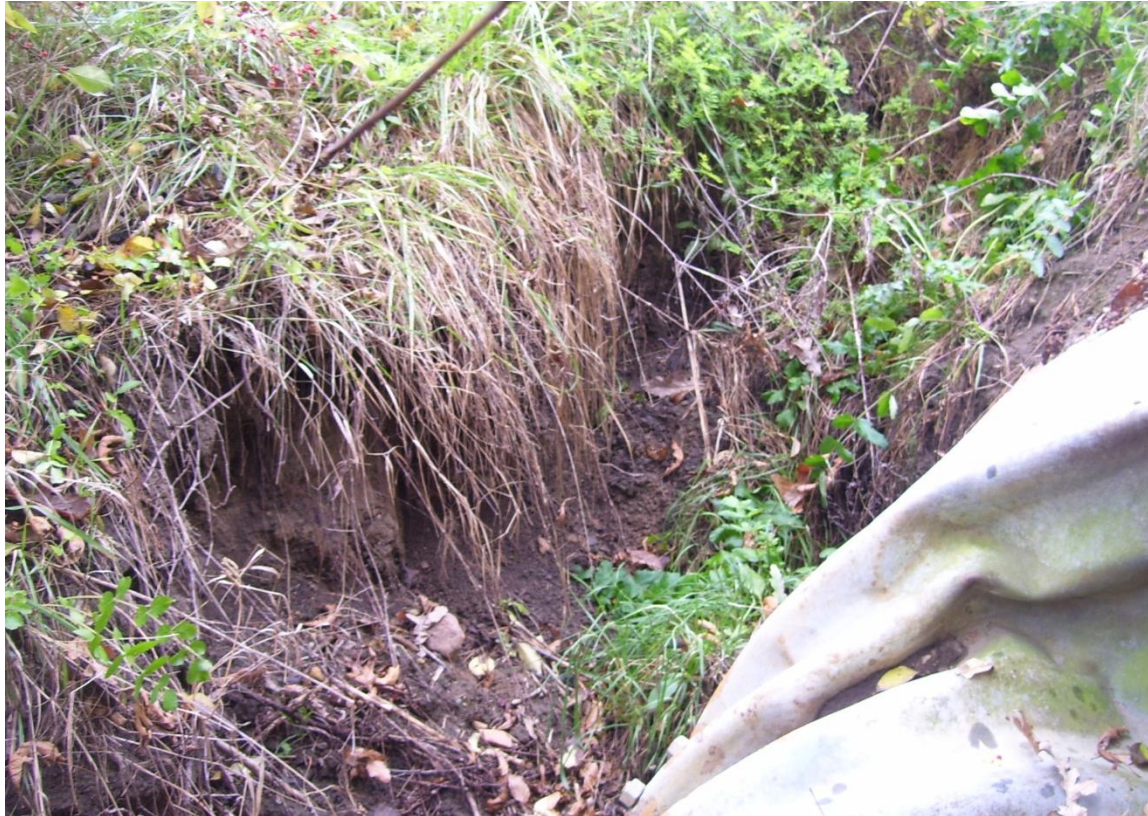
I-70 Morgan Co. RP 55.02 6'-6" x 4'-6" SPPA

Damaged inlet. Bottom distorted. Anchor damaged. Embankment disturbed.

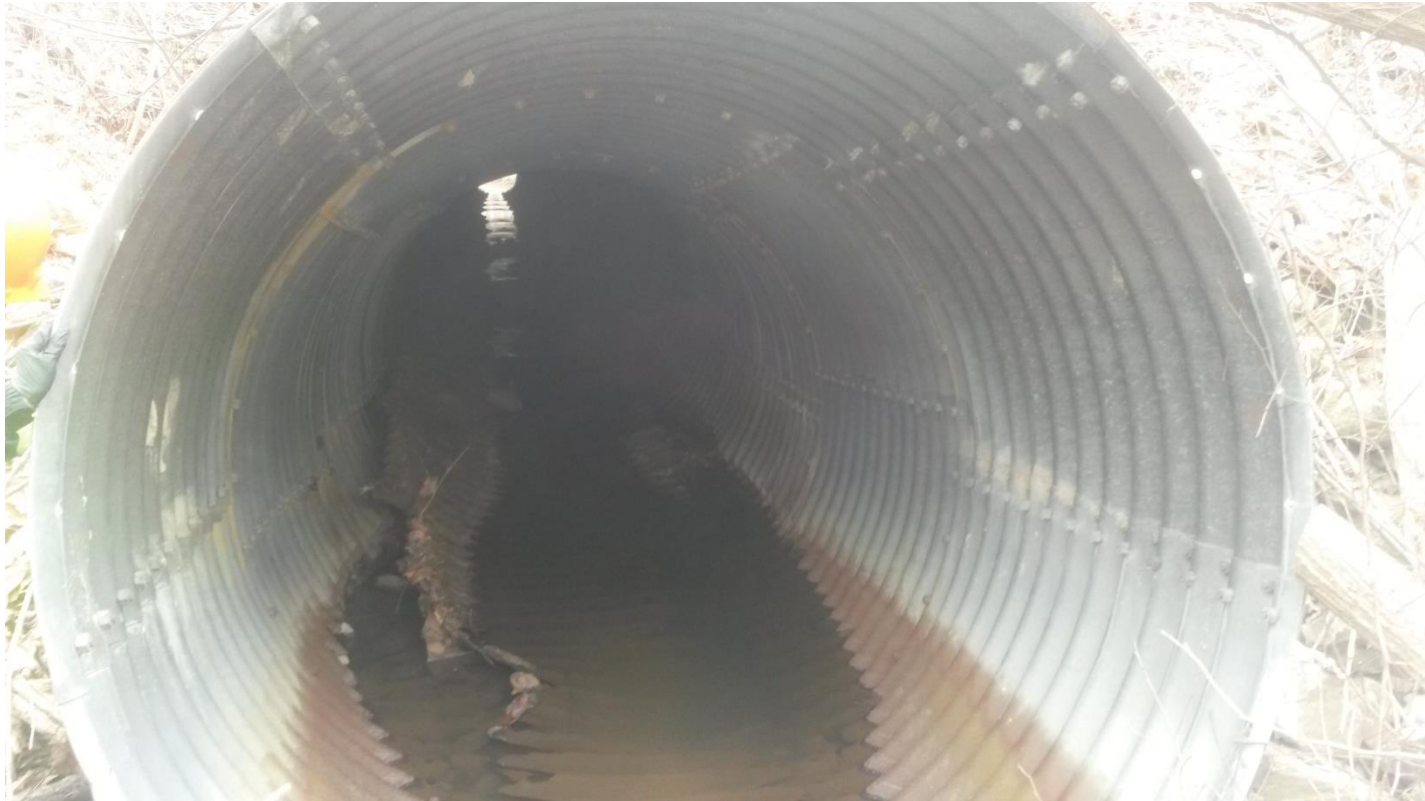
I-65 RP 27+15

Bottom distorted. Pipe has upwards bend.

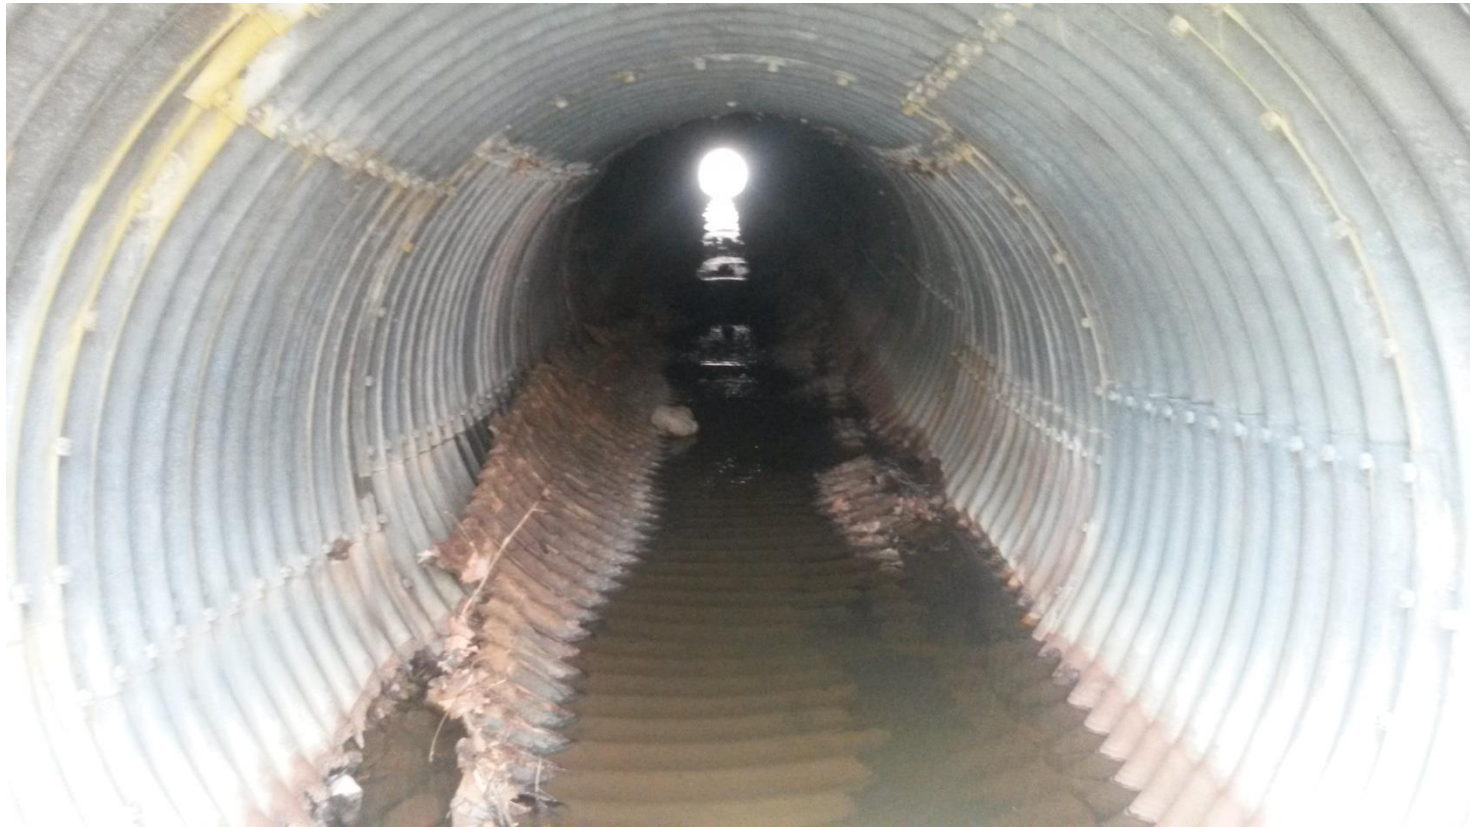
I-65 RP 27+15

Bottom distorted. Pipe has upwards bend.
