Murphy's Law?

A perfect storm of circumstances

Mark Bailey, PE – Hydraulics Manager, INDOT
Dale Sedler, PE – Sr. Hydraulic Engineer, INDOT

Road School 2016

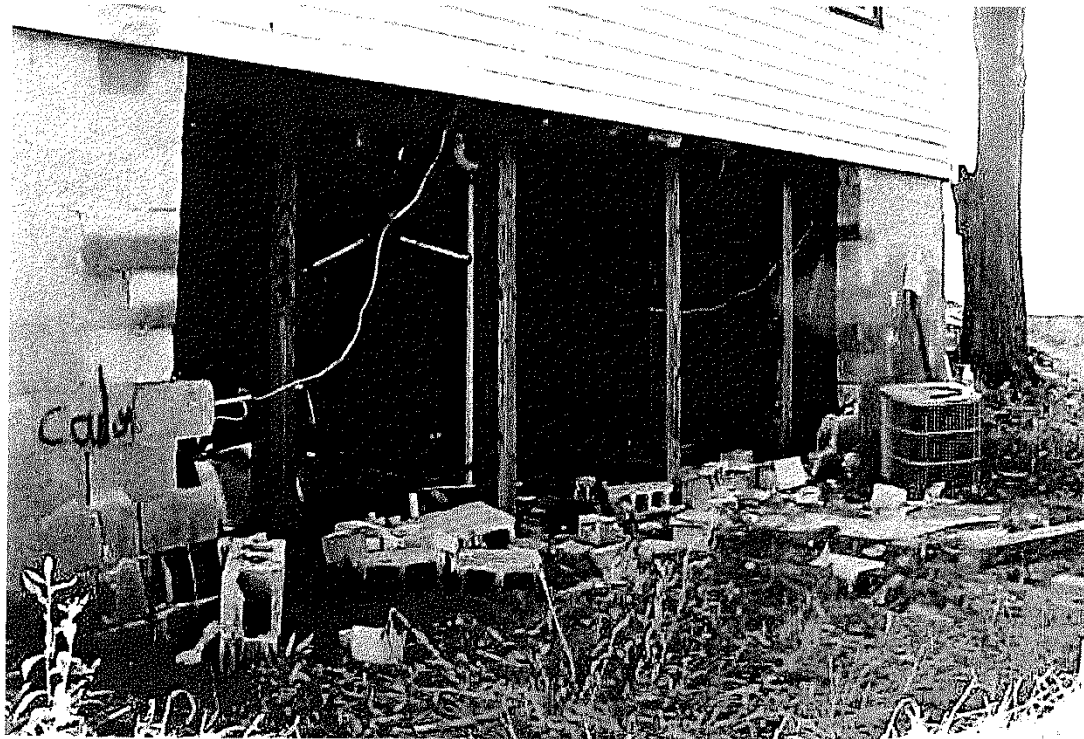
Old US 131@Old SR 62 Foundation Damage

Initial photos – provided by District Maintenance. Note that bricks are scattered outwards from the walk-in crawl space.

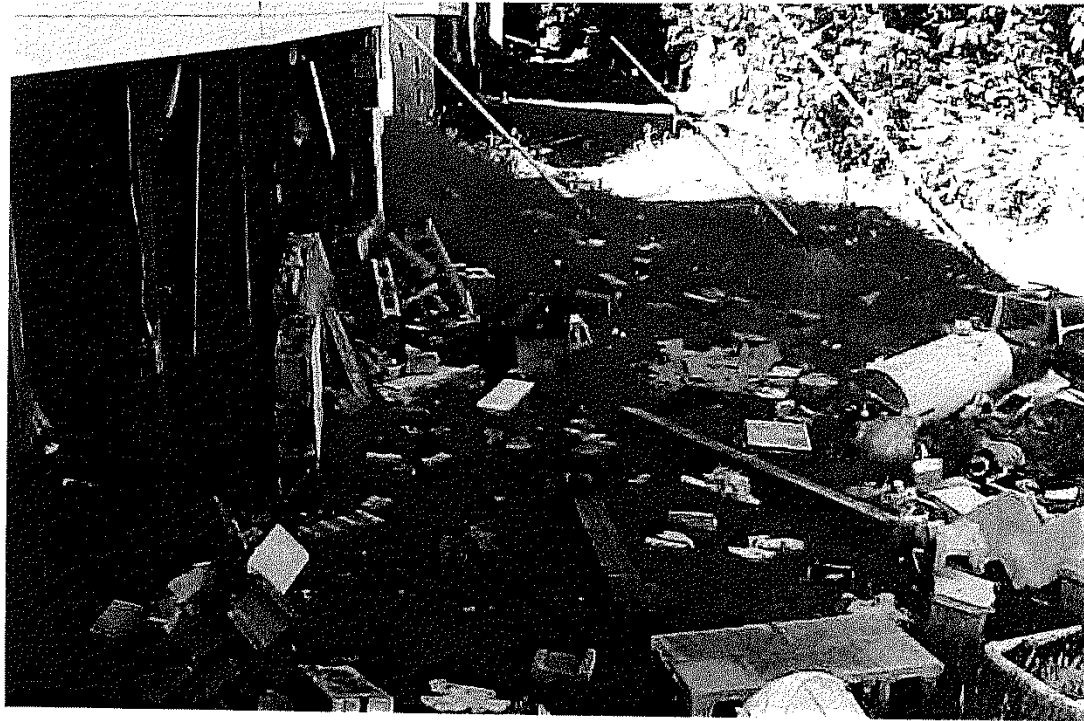
Old US 131@Old SR 62 Foundation Damage

Initial photos – provided by District Maintenance. Note that debris is scattered outwards from the walk-in crawl space. And that crawl space contents is included.

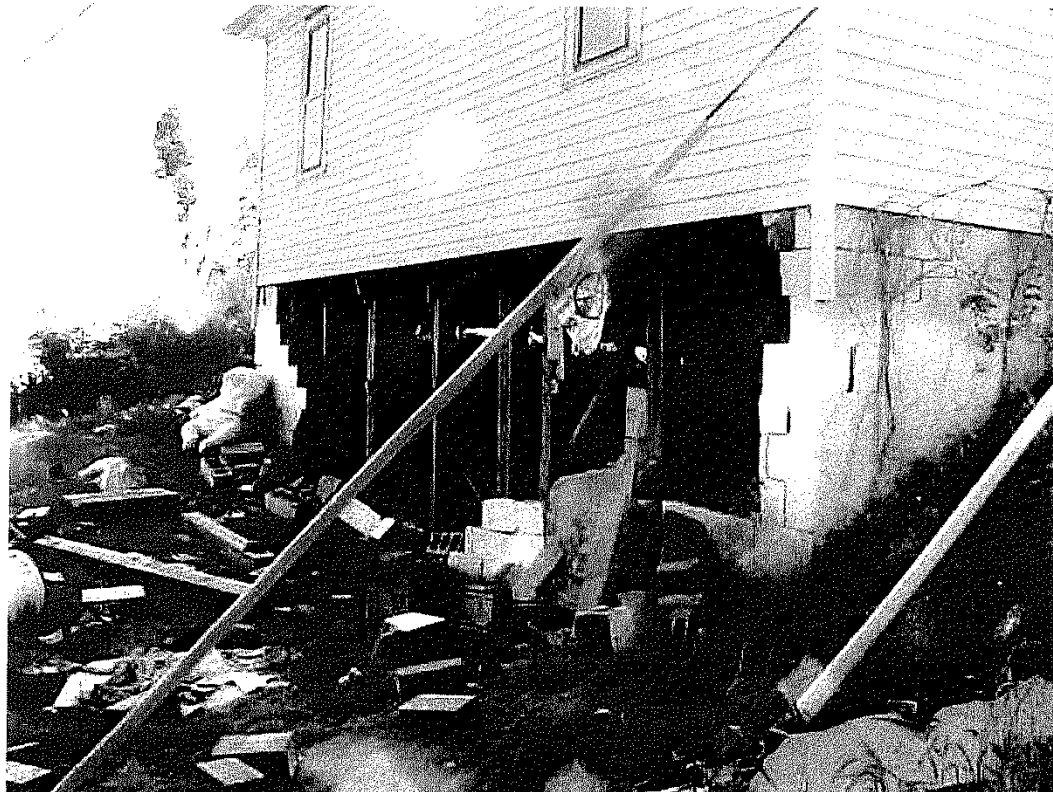
Old US 131@Old SR 62 Foundation Damage

Initial photos – provided by District Maintenance. Note that debris is scattered outwards from the walk-in crawl space. And that crawl space contents is included.

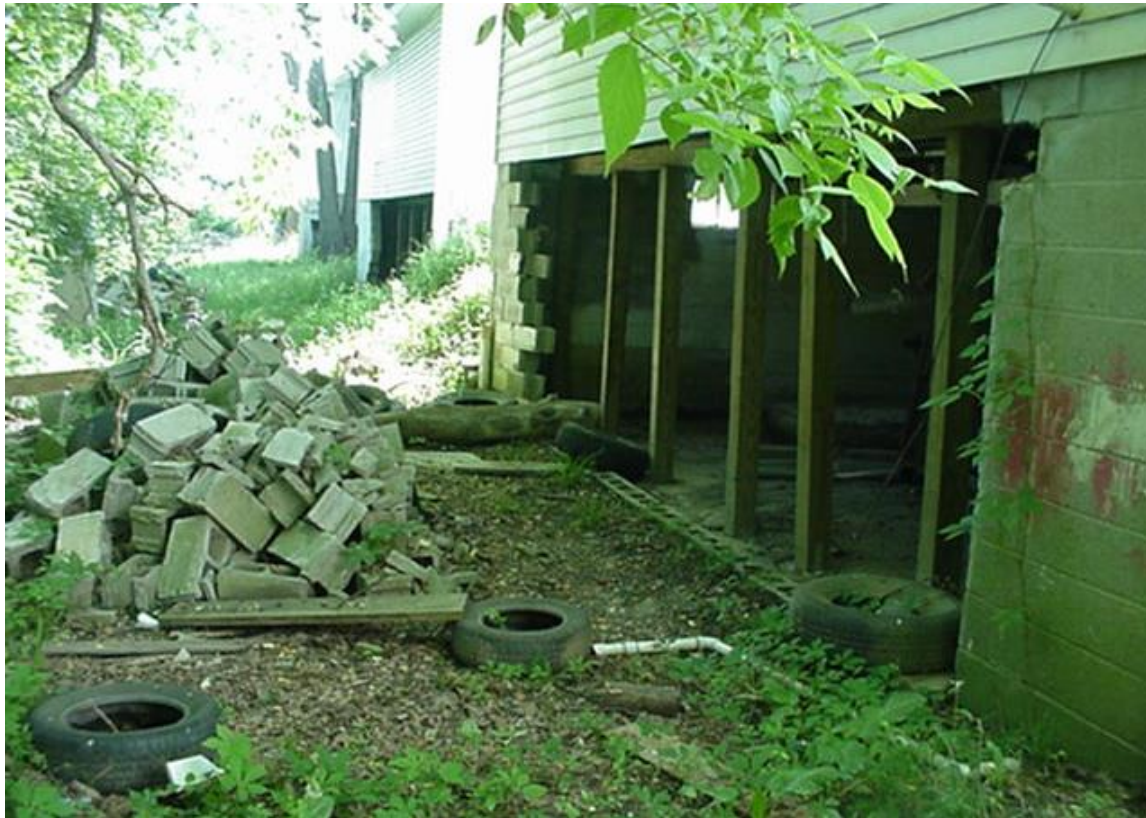
Old US 131@Old SR 62 Foundation Damage

Partial clean-up of debris. Note post and beam temporary support.

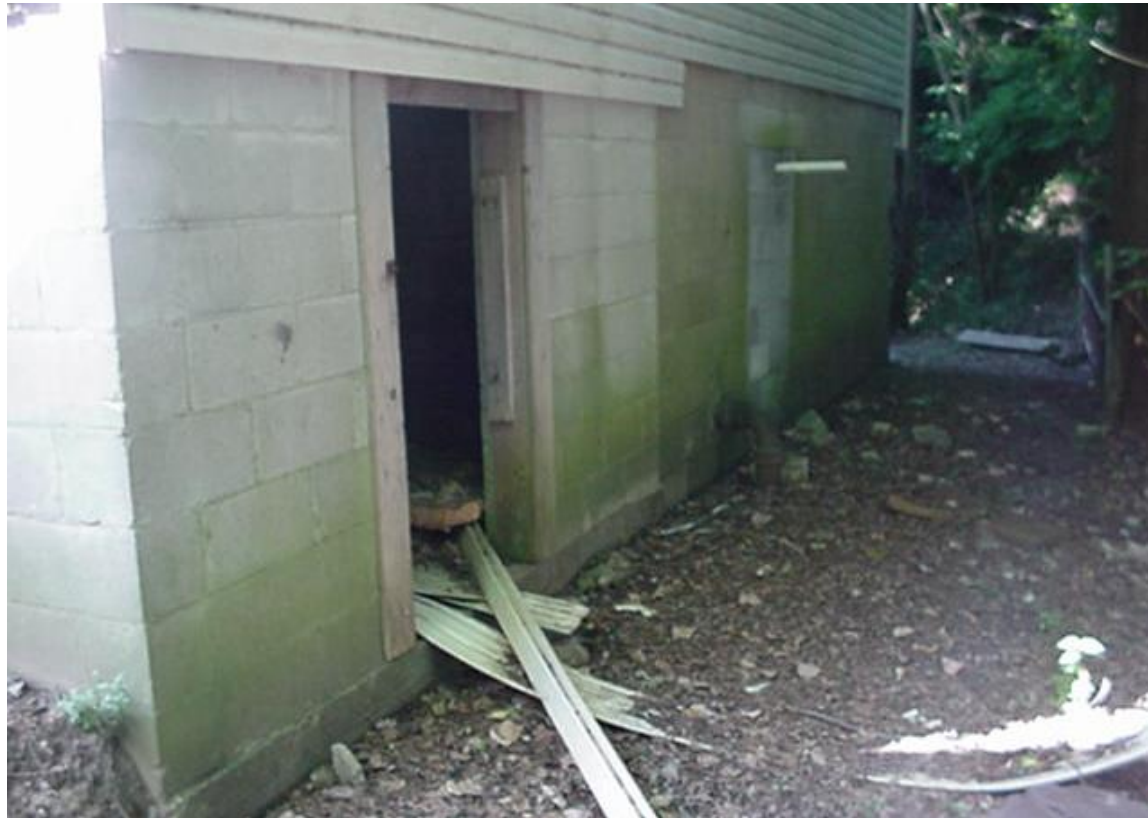
Old US 131@Old SR 62 Foundation Damage

Western most structure.

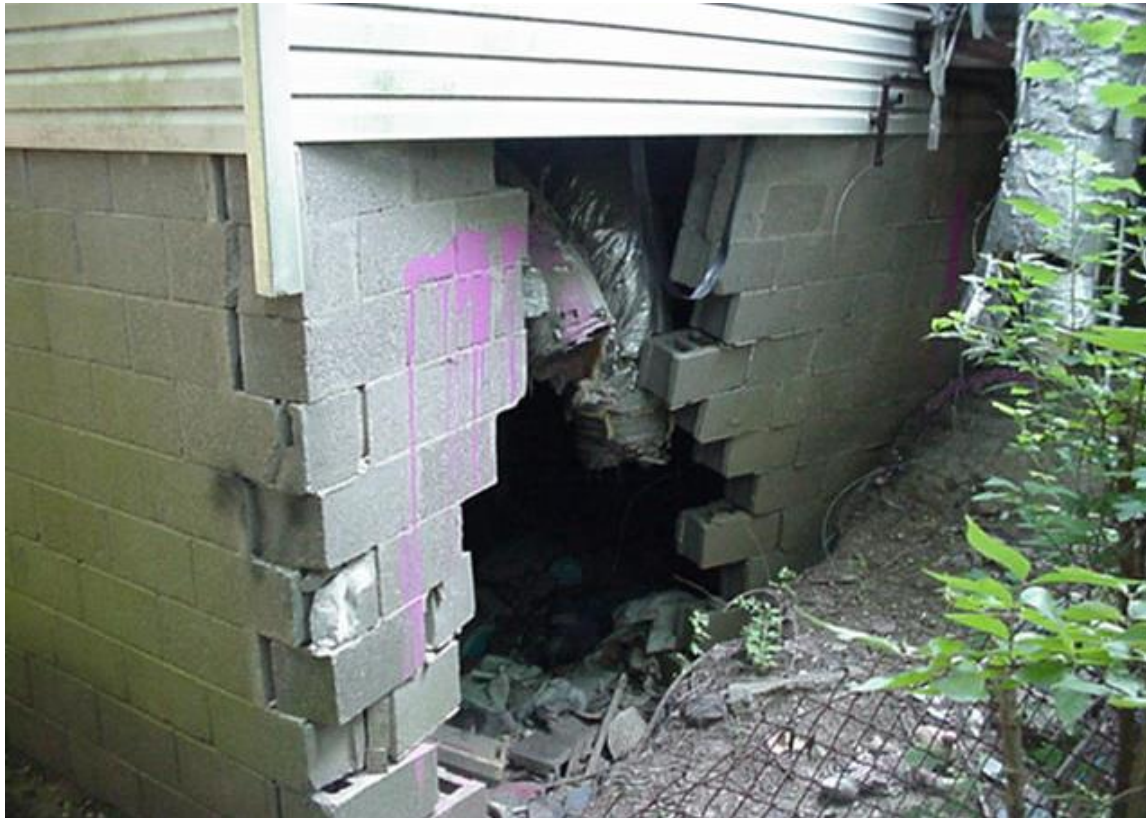
Old US 131@Old SR 62 Foundation Damage

Western most structure crawlspace damage. Foundation was pushed inwards at base.

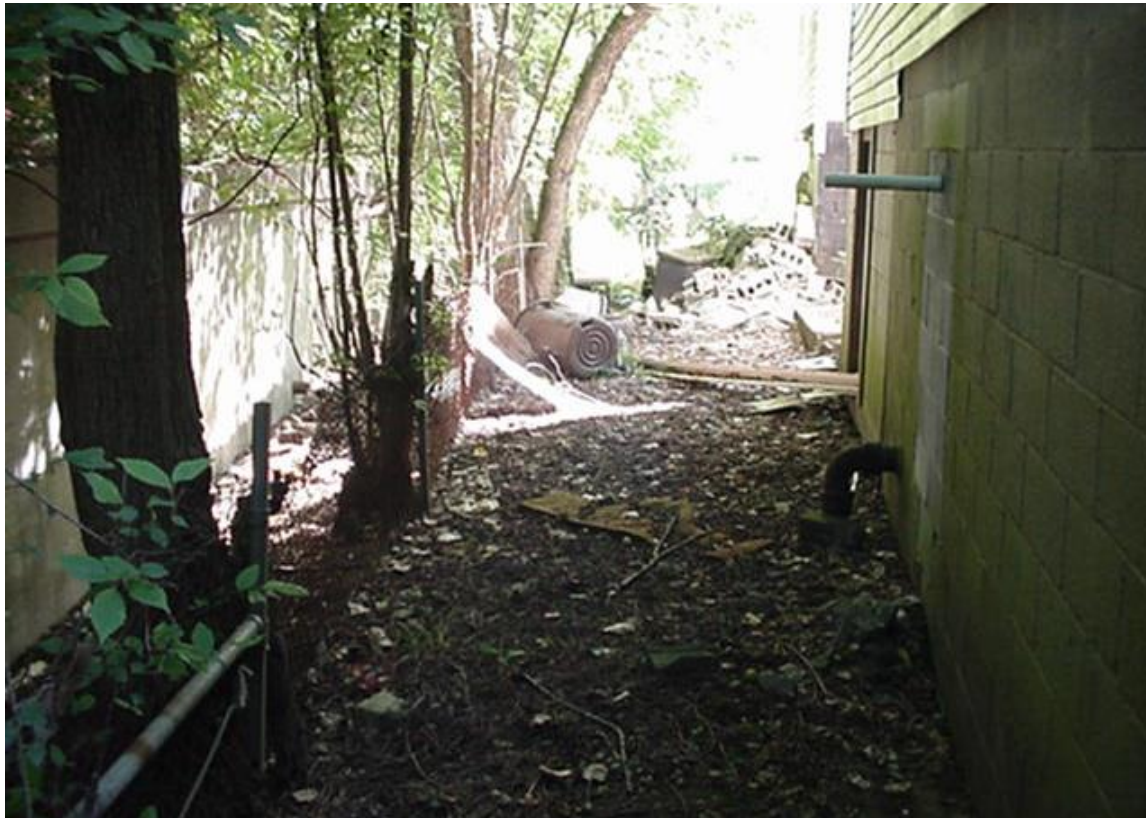
Old US 131@Old SR 62 Foundation Damage

Looking east between foundations and R/W. Note height of R/W fence and retaining wall. Eyewitness report from one of residences affected said water level was above retaining wall.

- 1. Only the Anecdotal storm scenarios began to approach the eye witness report of water above the retaining wall which would have been more than 6 feet of depth.**
- 2. Increased depth in the basin requires significant increase in water volume.**
- 3. To produce the depth reported required more than 100 year storm, culvert blockage and bypass from storm drains.**

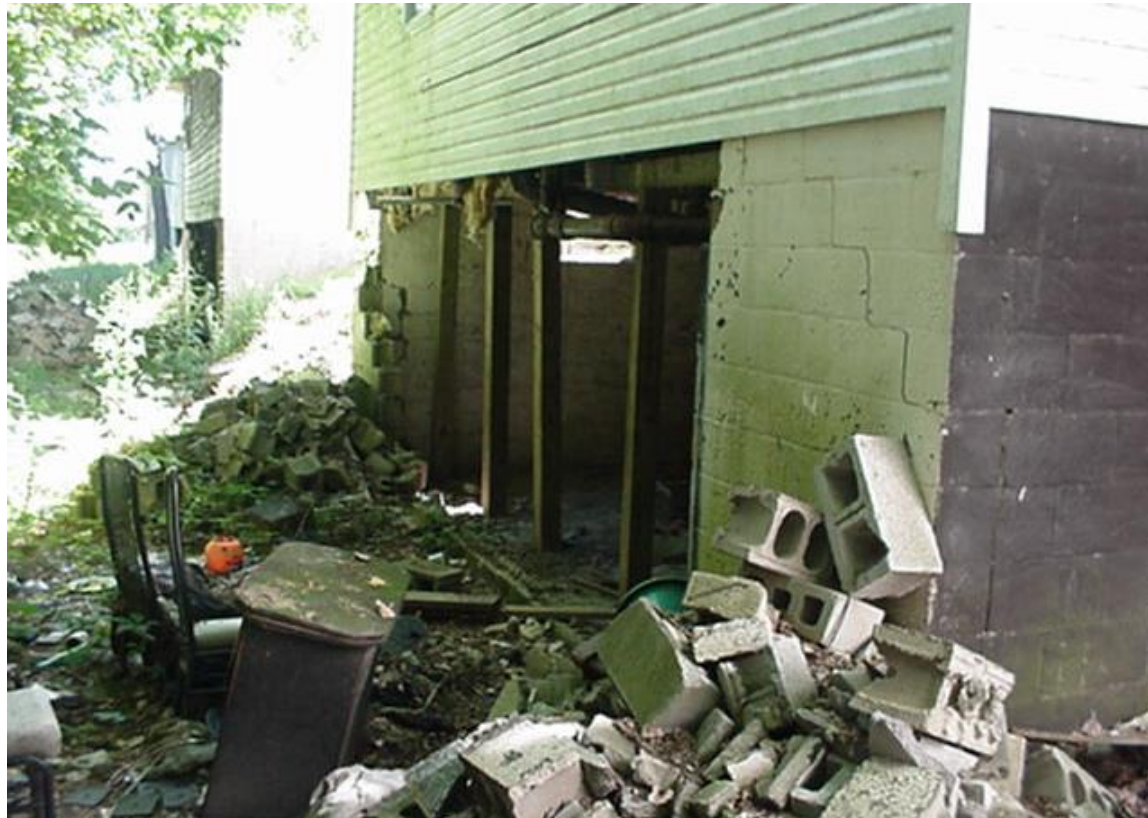
Old US 131@Old SR 62 Foundation Damage

Looking east between foundations and R/W. More damage.

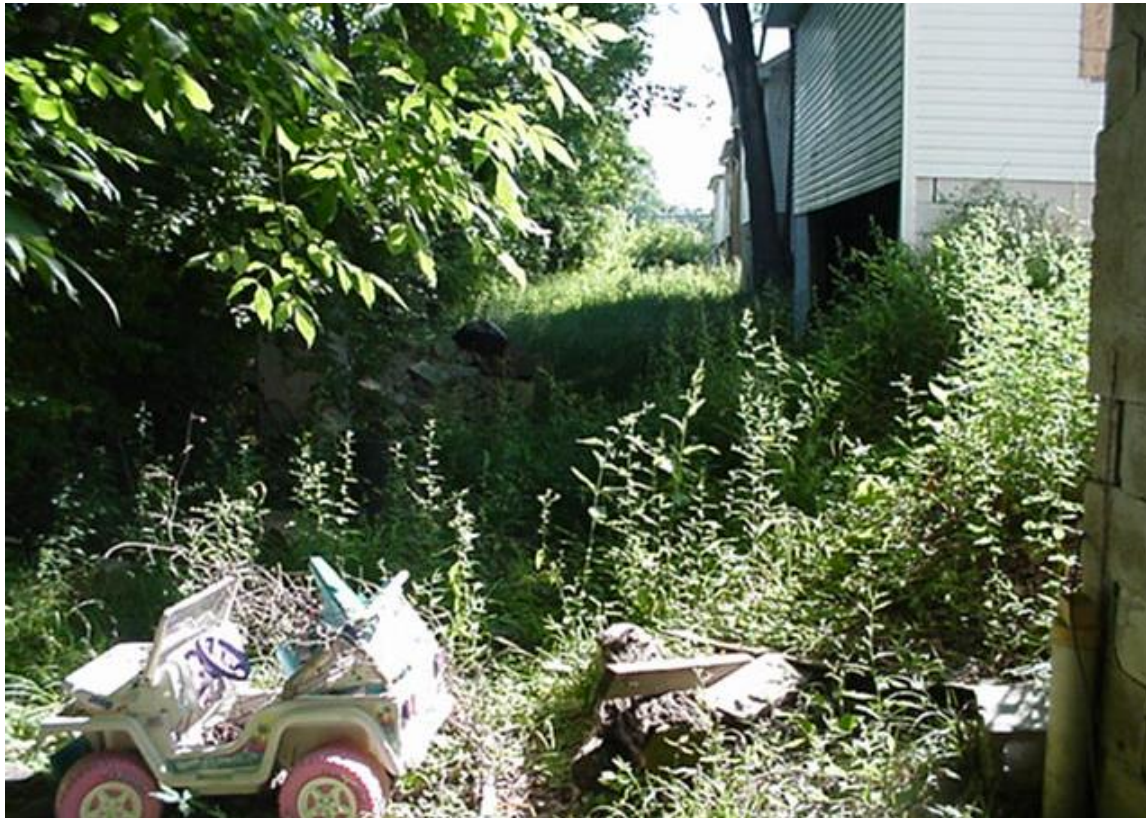
Old US 131@Old SR 62 Foundation Damage

Looking east between foundations and R/W. More damage & crawl space contents.

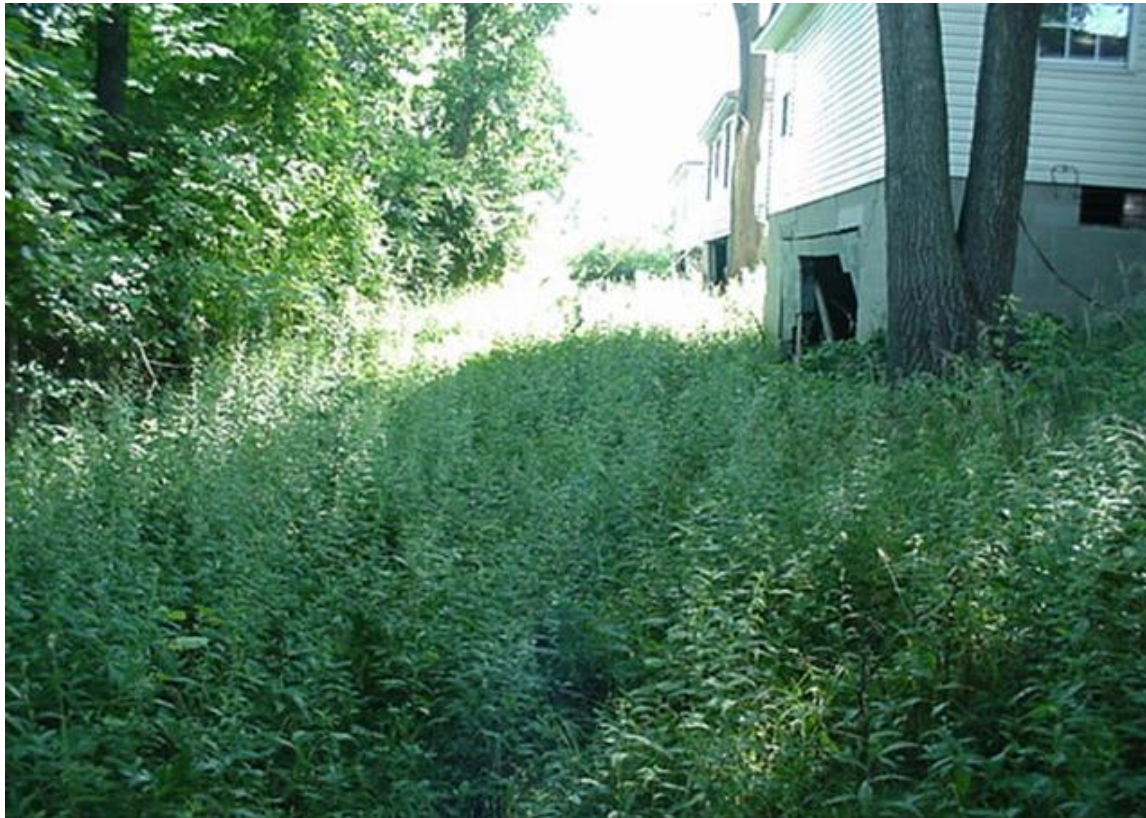
Old US 131@Old SR 62 Foundation Damage

Looking east between foundations and R/W. More damage.

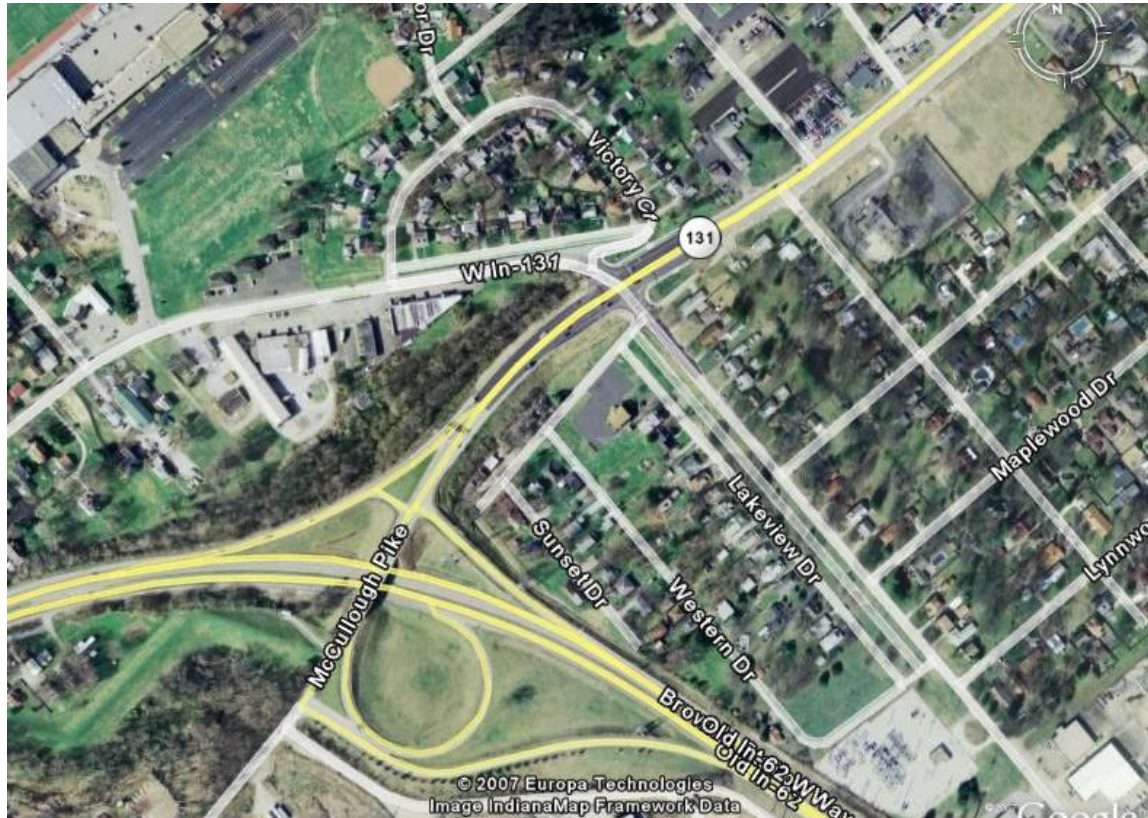
Old US 131 @ Old SR 62 General Area Overview

Old US 131 slope is to SW, area SE of street drains to it, storm drains on NW side of street.

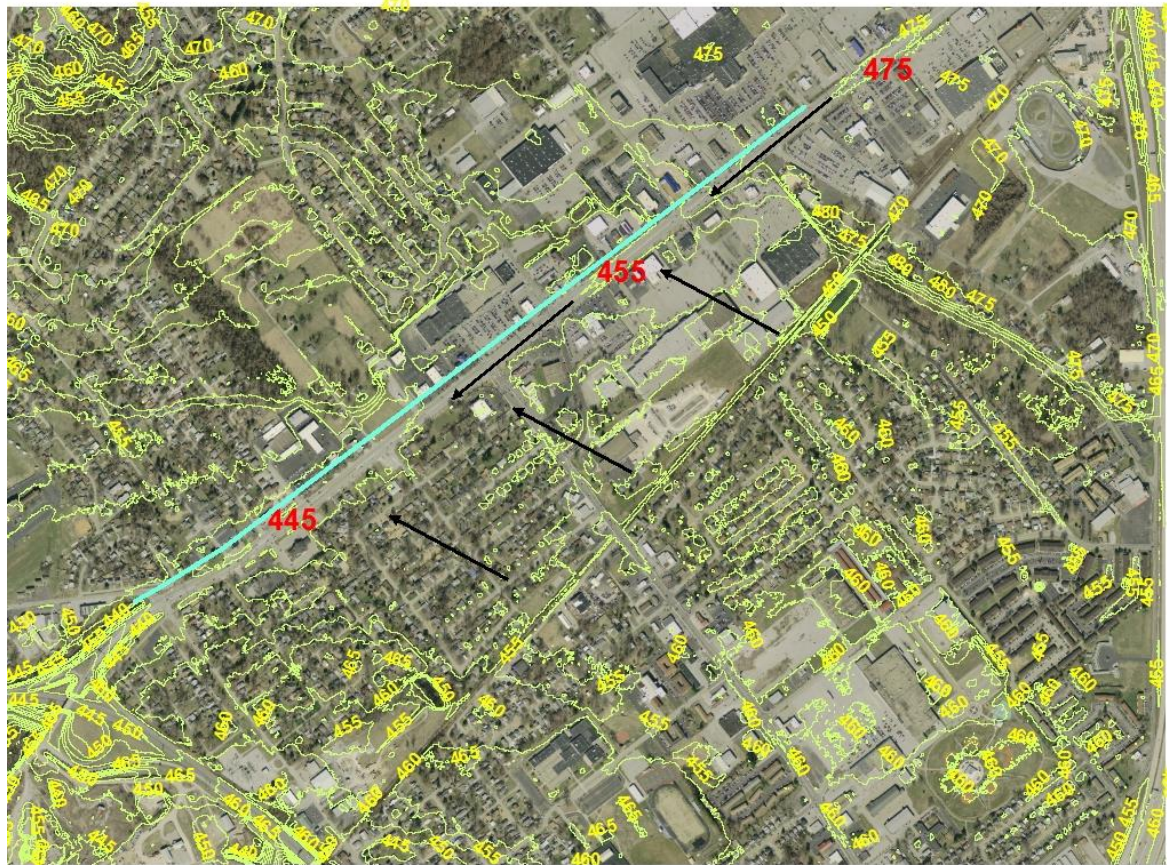
General Area Overview

Old US 131 slope is to SW, area SE of street drains to it, storm drains on NW side of street.

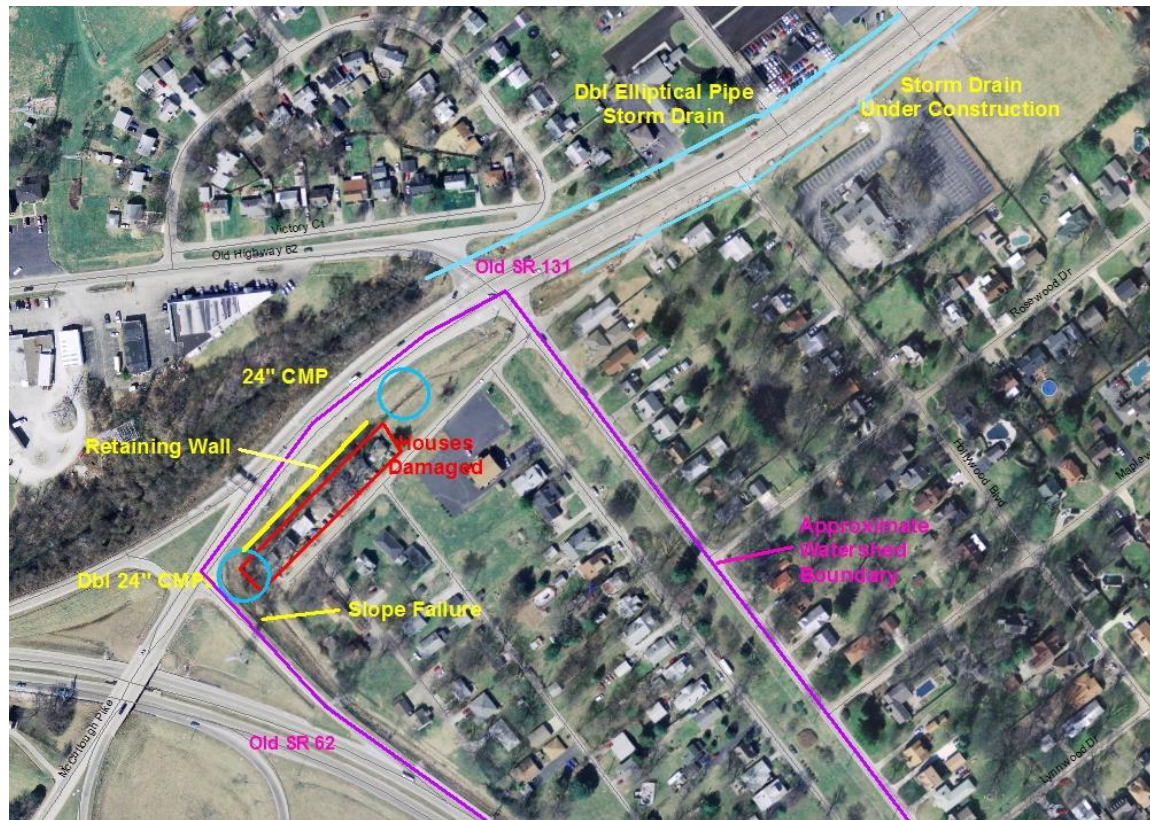
Detailed Site Overview

7 homes affected, storm drain outlets on other side of street, storm drain related construction ongoing.

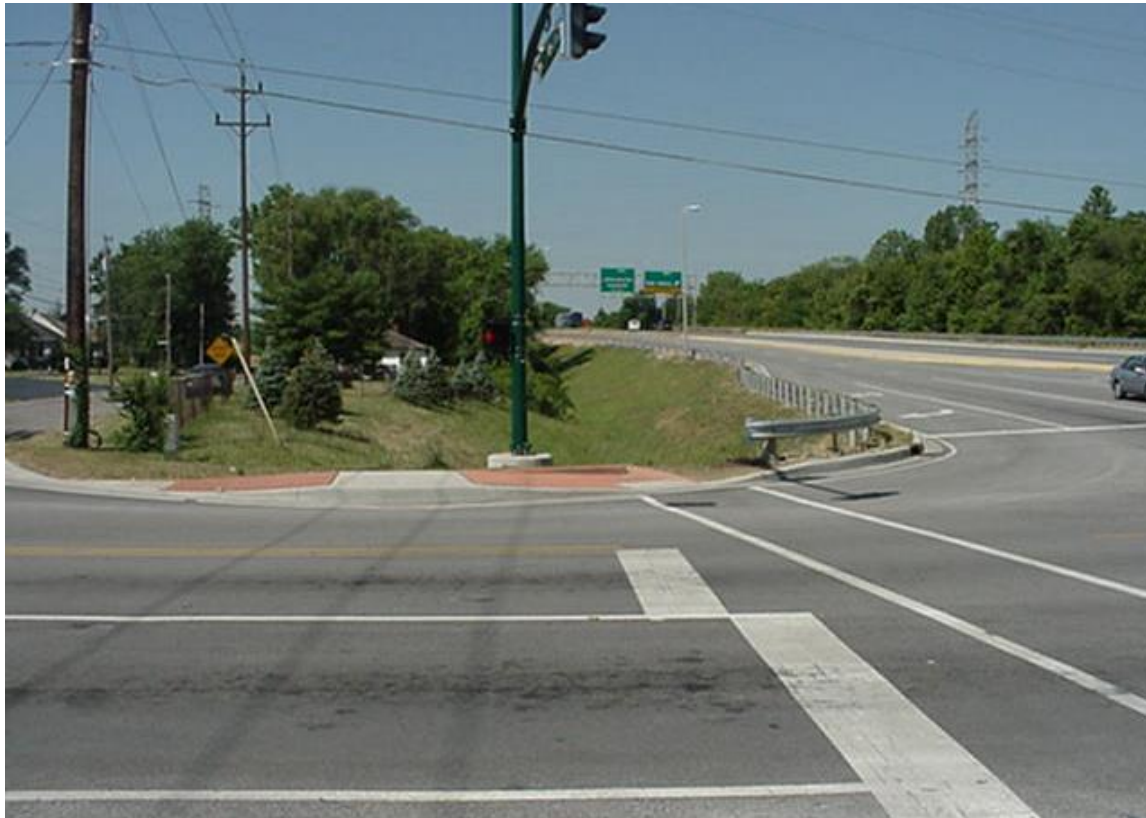
Old SR-131, Sunset Dr/McCulloch Pk extension

Old 131 on the right, Sunset/McCulloch on the left, the damaged houses in between.

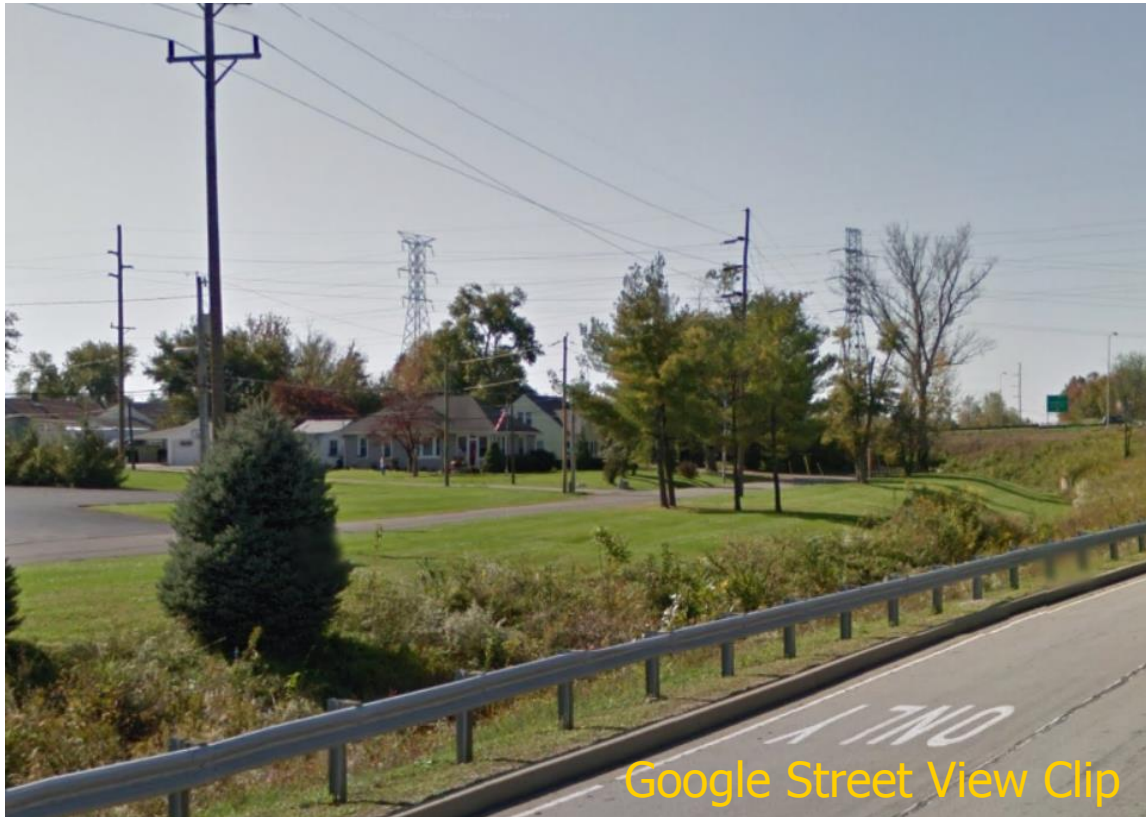
Old SR-131, Sunset Dr/McCulloch Pk extension

Old 131 on the right, Sunset/McCulloch on the left, the damaged houses in between.

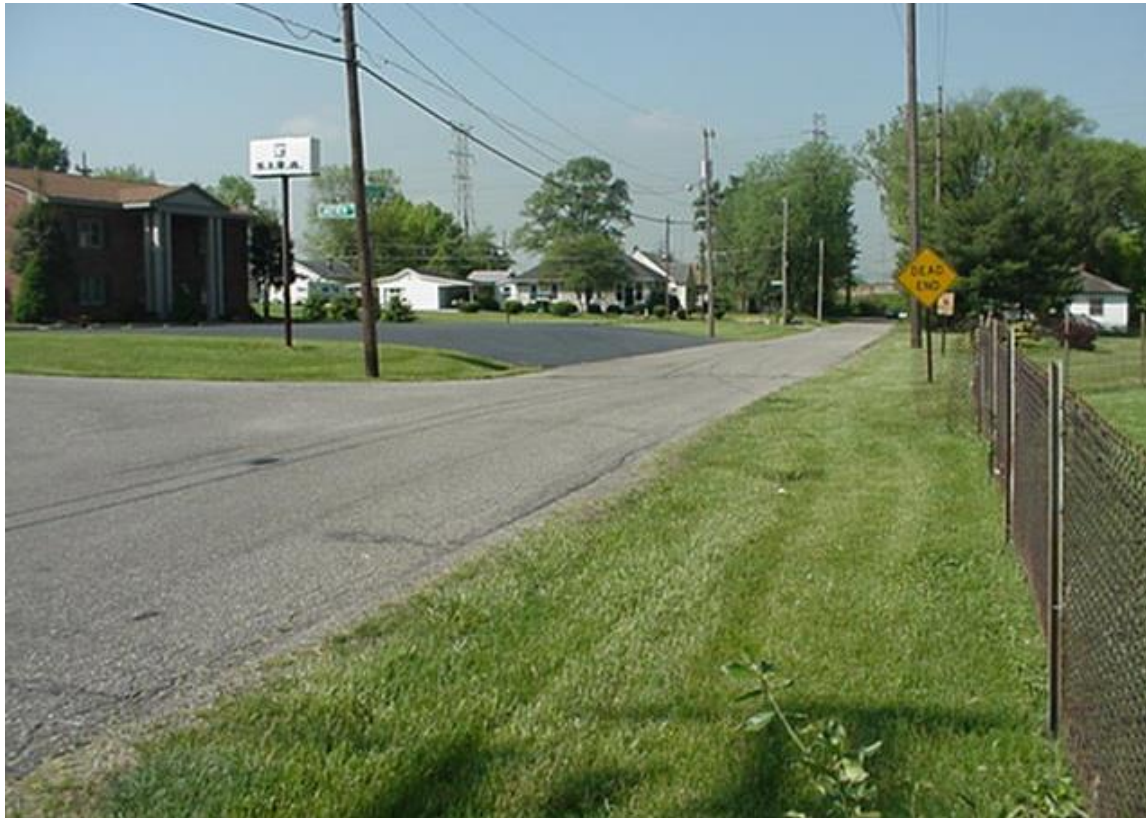
Old SR-62, Sunset Dr/McCulloch Pk extension

Note the damaged houses on the right.

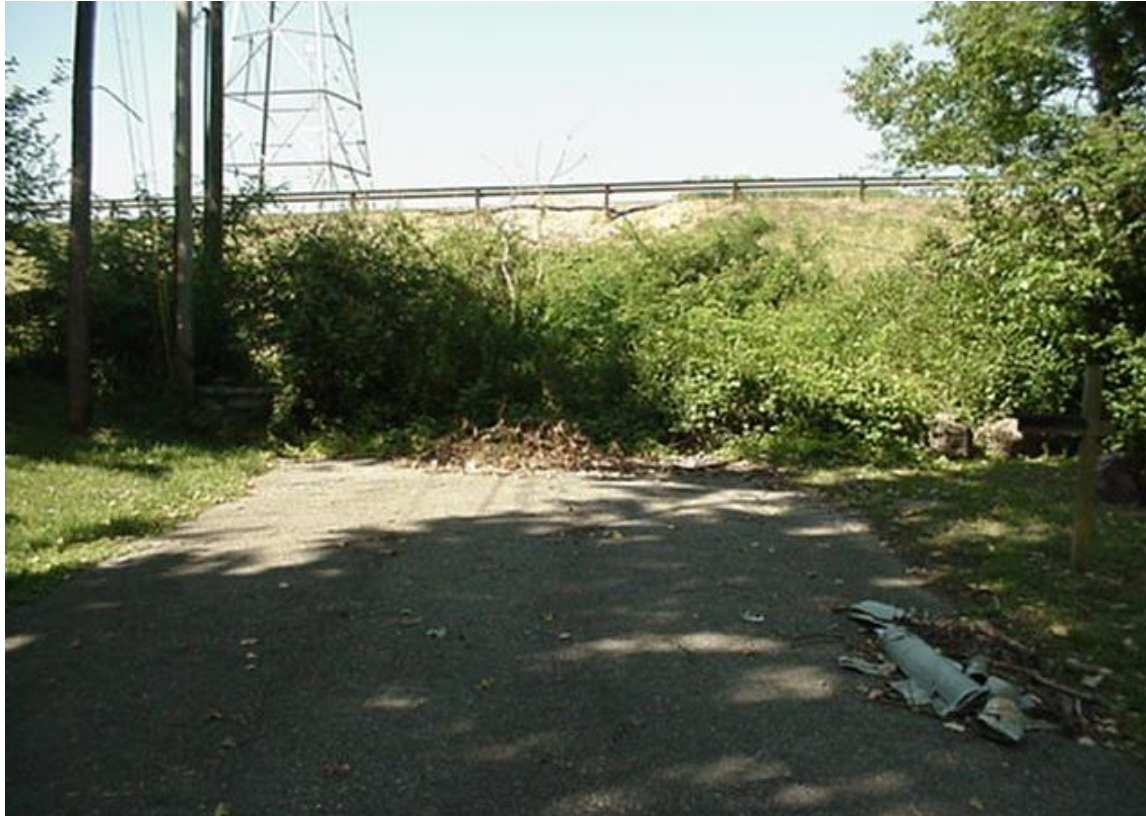
Old SR-62, Sunset Dr/McCulloch Pk extension

Note the bare spot under guard rail

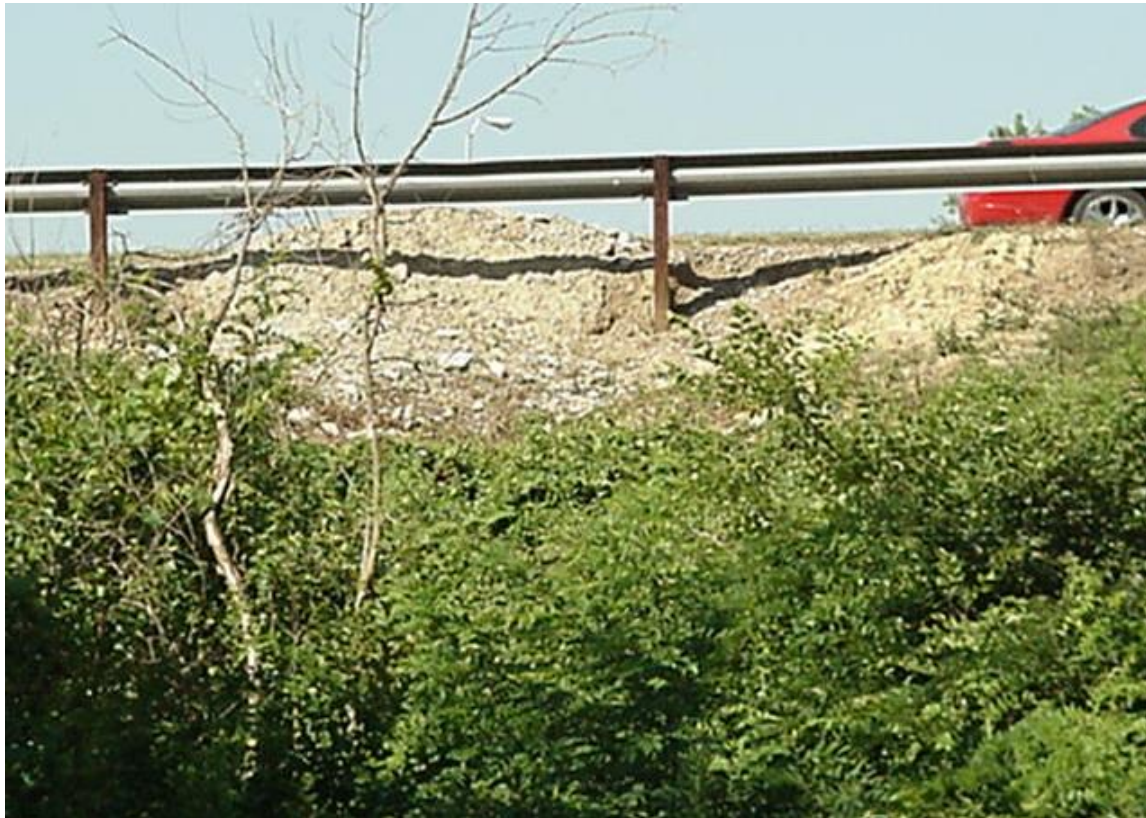
Old SR-62 @ Sunset Dr/McCulloch Pk extension

Evidence of slope failure repair by maintenance forces.

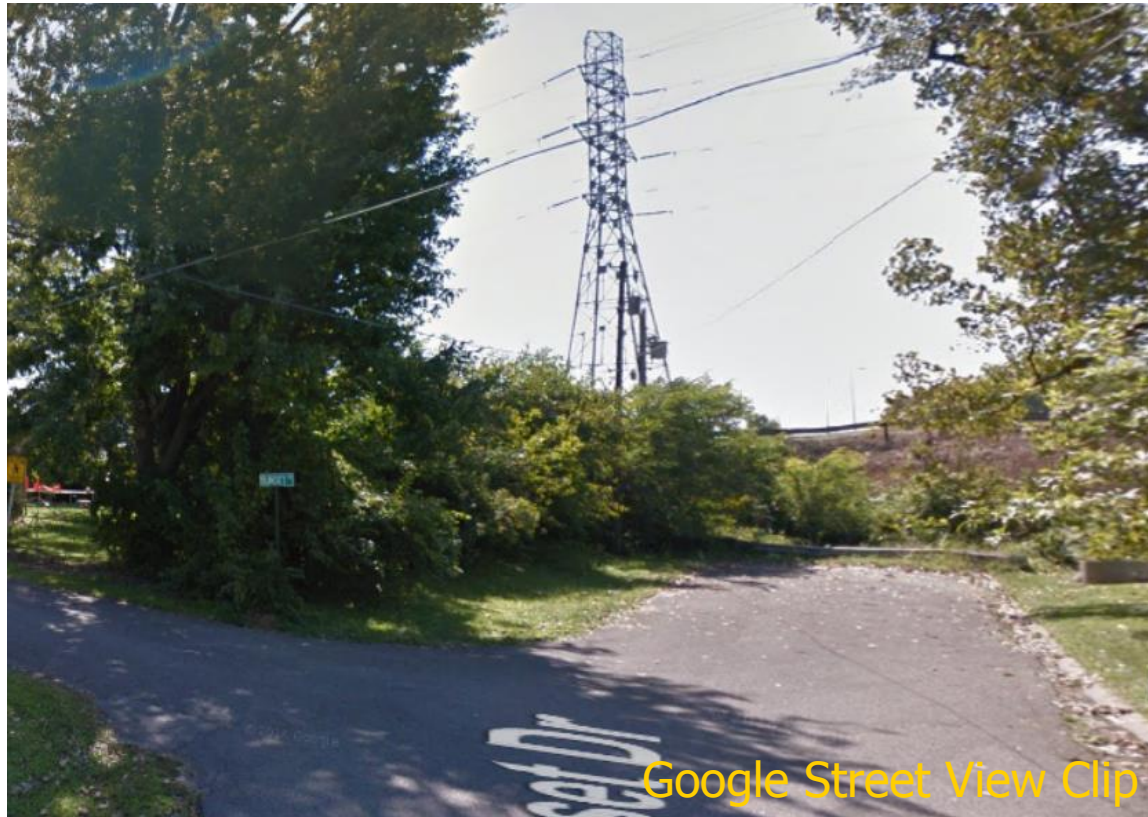
Old SR-62 @ Sunset Dr/McCulloch Pk extension

Time has pretty much eliminated visual aspects of former slide. Side ditch at toe of slope drains to the right where there are double 24 inch corrugated metal pipes (cmps).

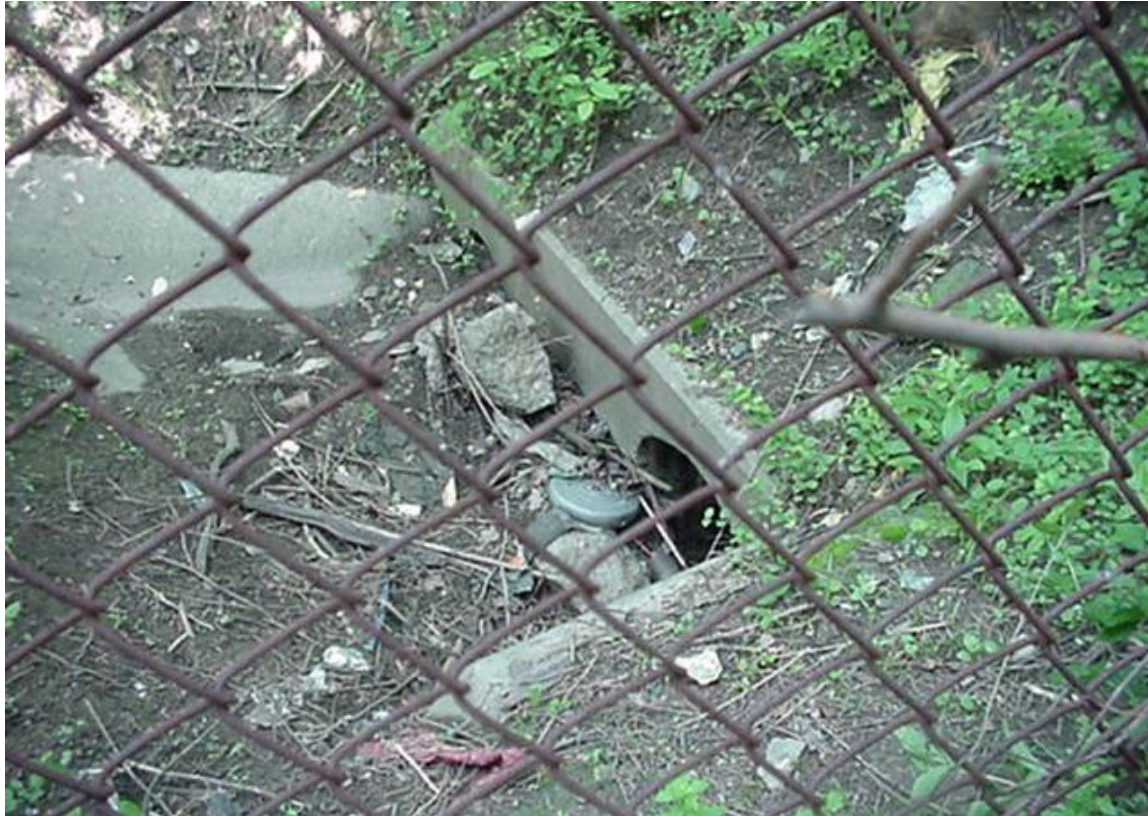
Dbl 24" cmp downstream of slope failure

One culvert appears to be filled w/dirt, other culvert has inlet partially blocked w/various dirt, rock, and other debris.

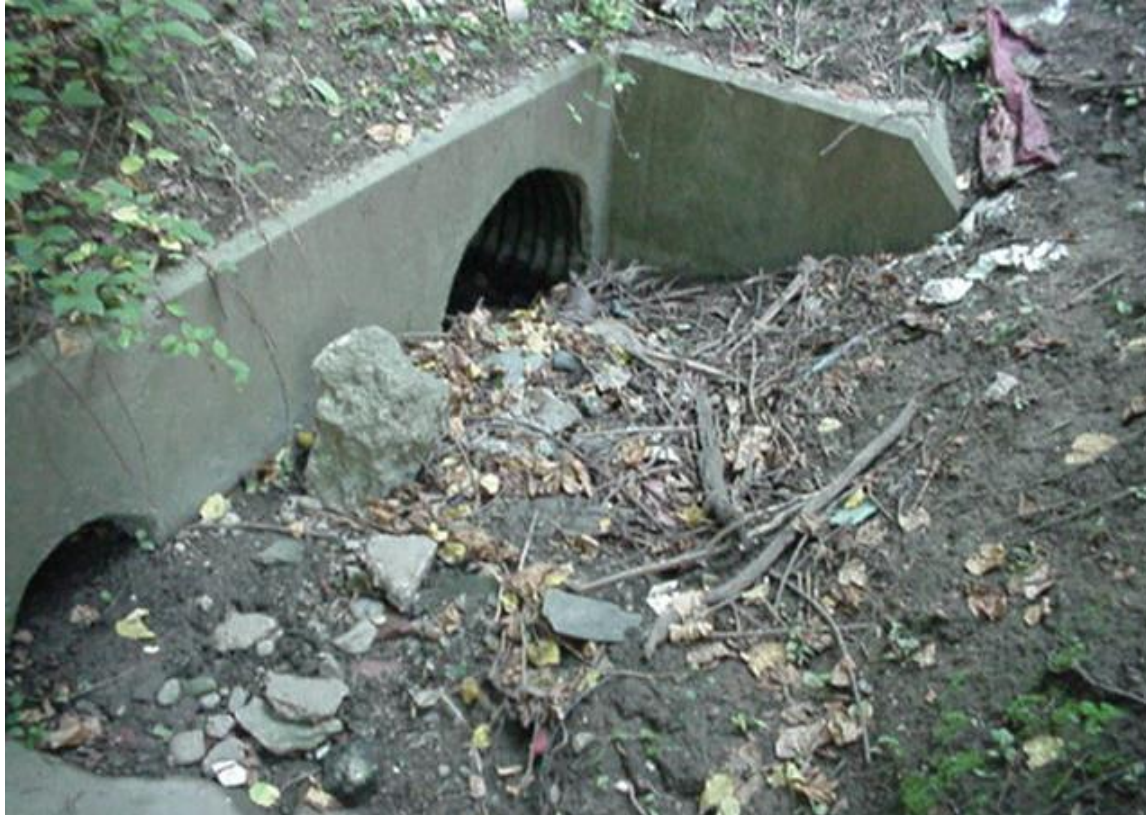
Dbi 24" cnp downstream of slope failure

Note that there is a mixture of soil and rocks of various sizes. Not typical of siltation in culverts over a period of time. It is typical of what is seen in a mudflow.

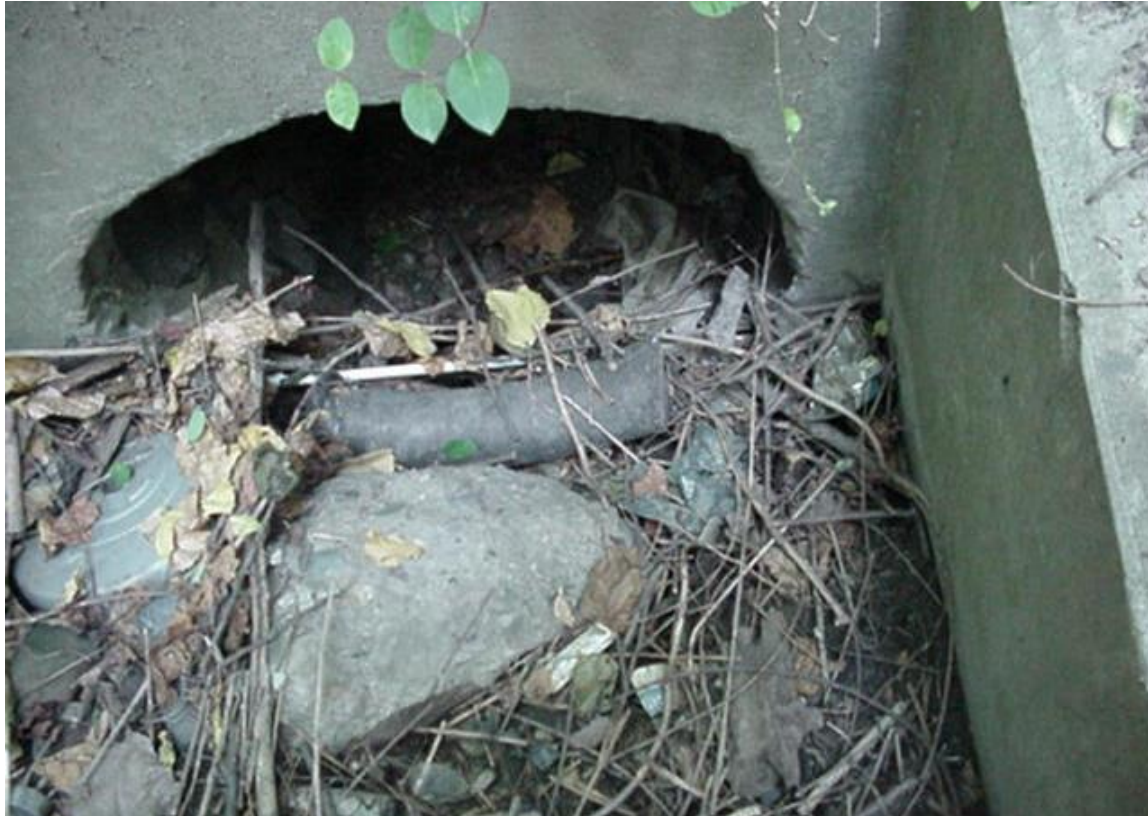
Partially blocked 24" cmp

Dirt, rock, and other debris.

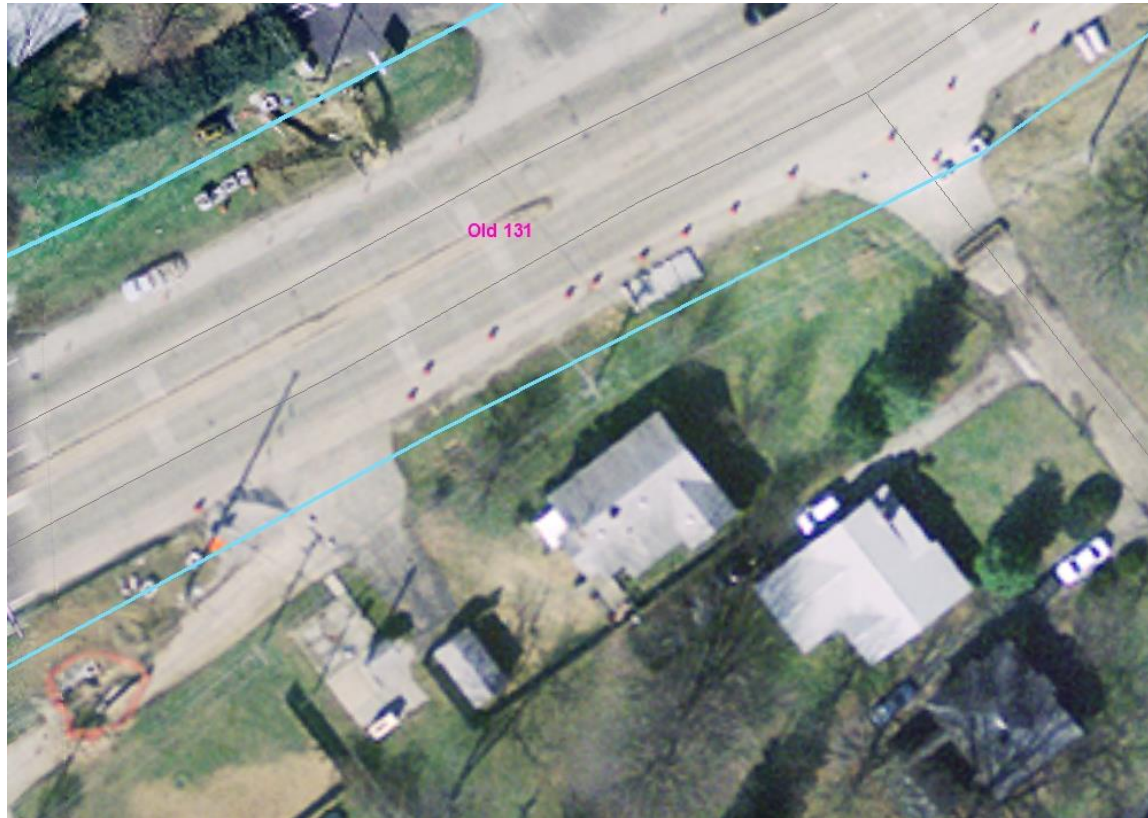
Storm Drain Under Construction – 2005 Aerial Photo

Note cones and fenced area. Typical of storm drain construction and road improvements, paving lifts may be in phases so that water bypasses inlets.

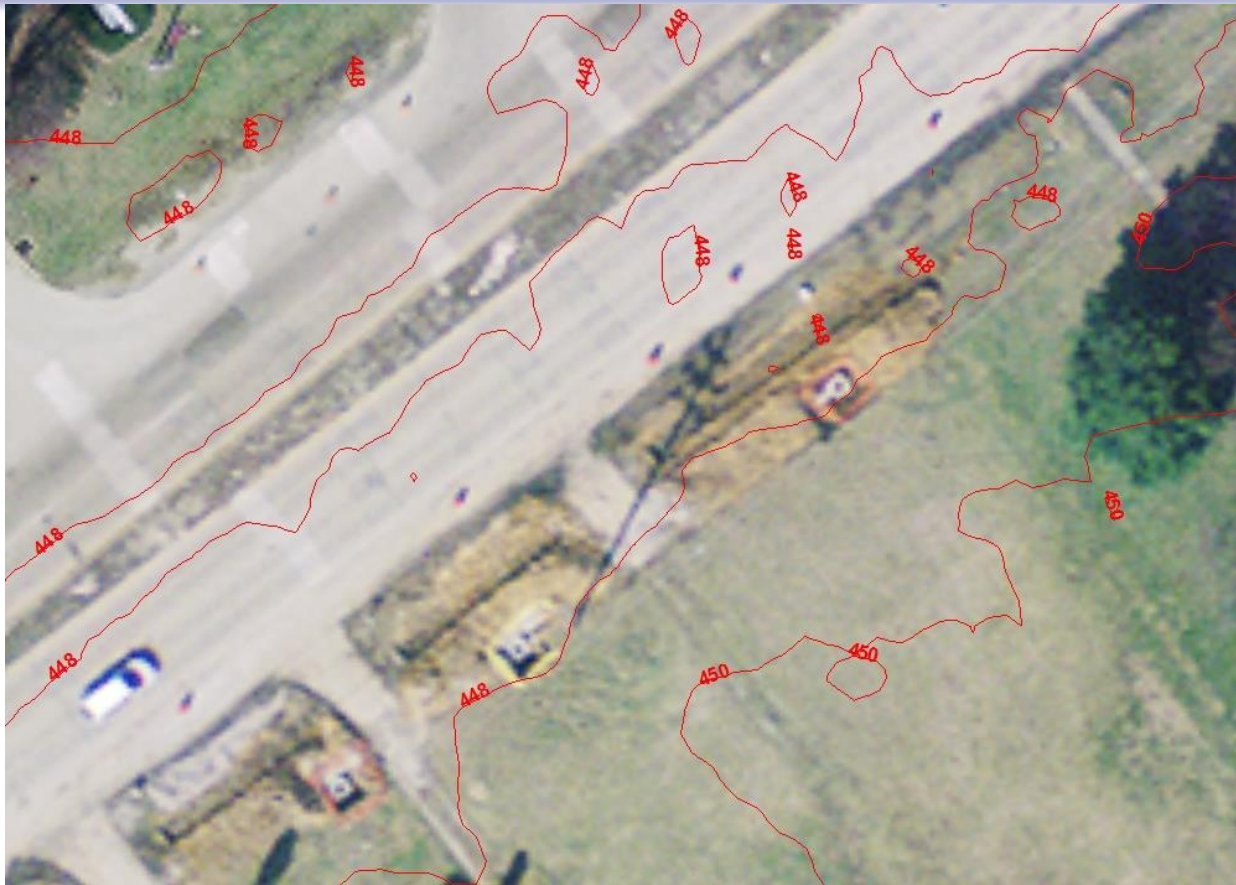
Storm Drain Under Construction – 2005 Aerial Photo

Note cones and fenced area. 2005 aerial photo w/2011-13 Indiana Map elevations.
