Murphy's Law?

A perfect storm of circumstances

Mark Bailey, PE – Hydraulics Manager, INDOT
Dale Sedler, PE – Sr. Hydraulic Engineer, INDOT

Road School 2016

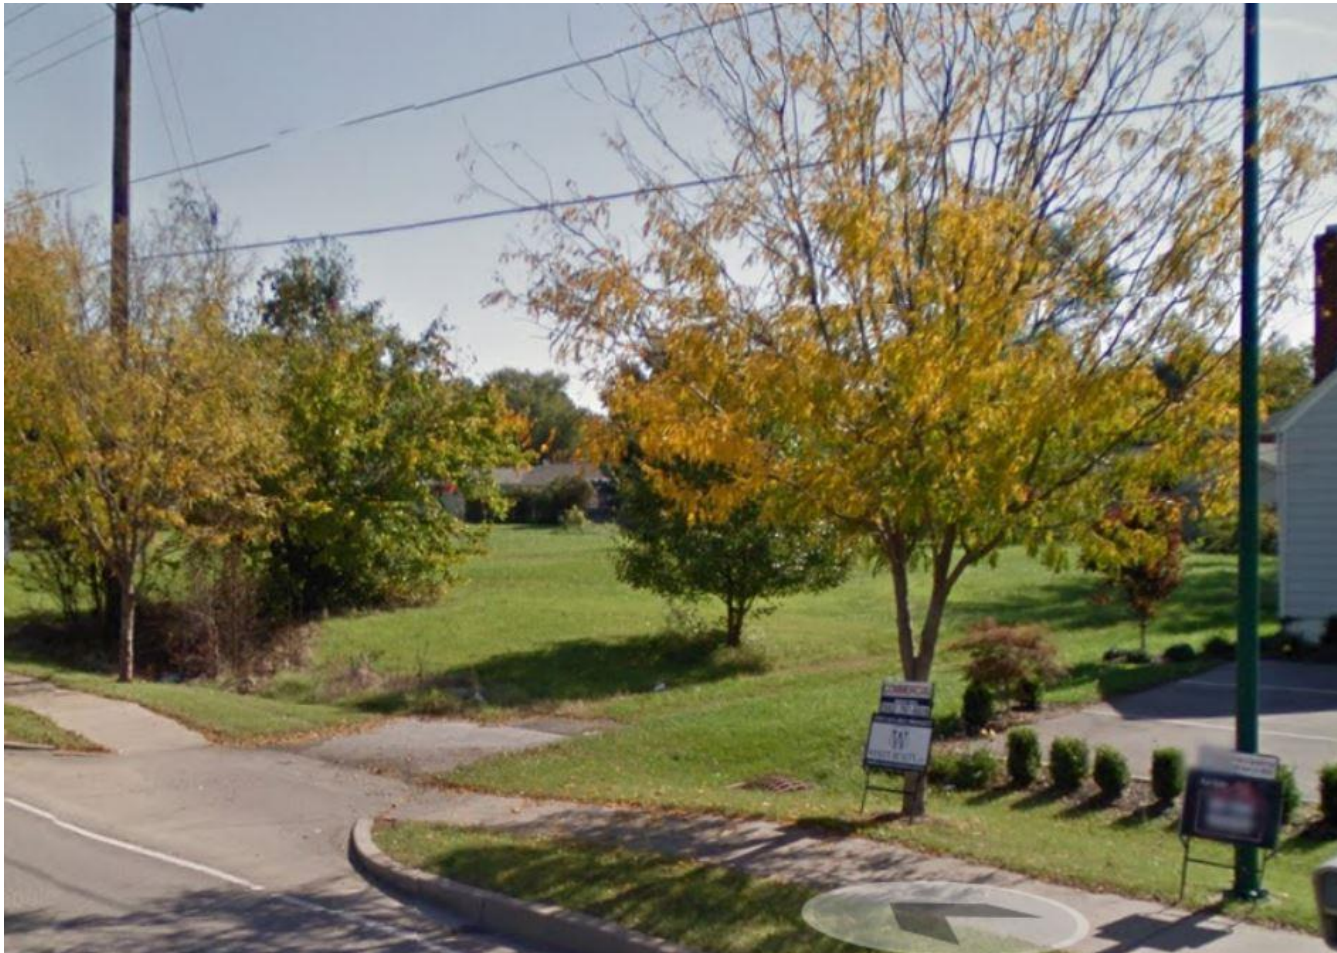
Former ditch location on right - Google Streetview clip

Beehive inlet by bush in front of fence, next to drive.

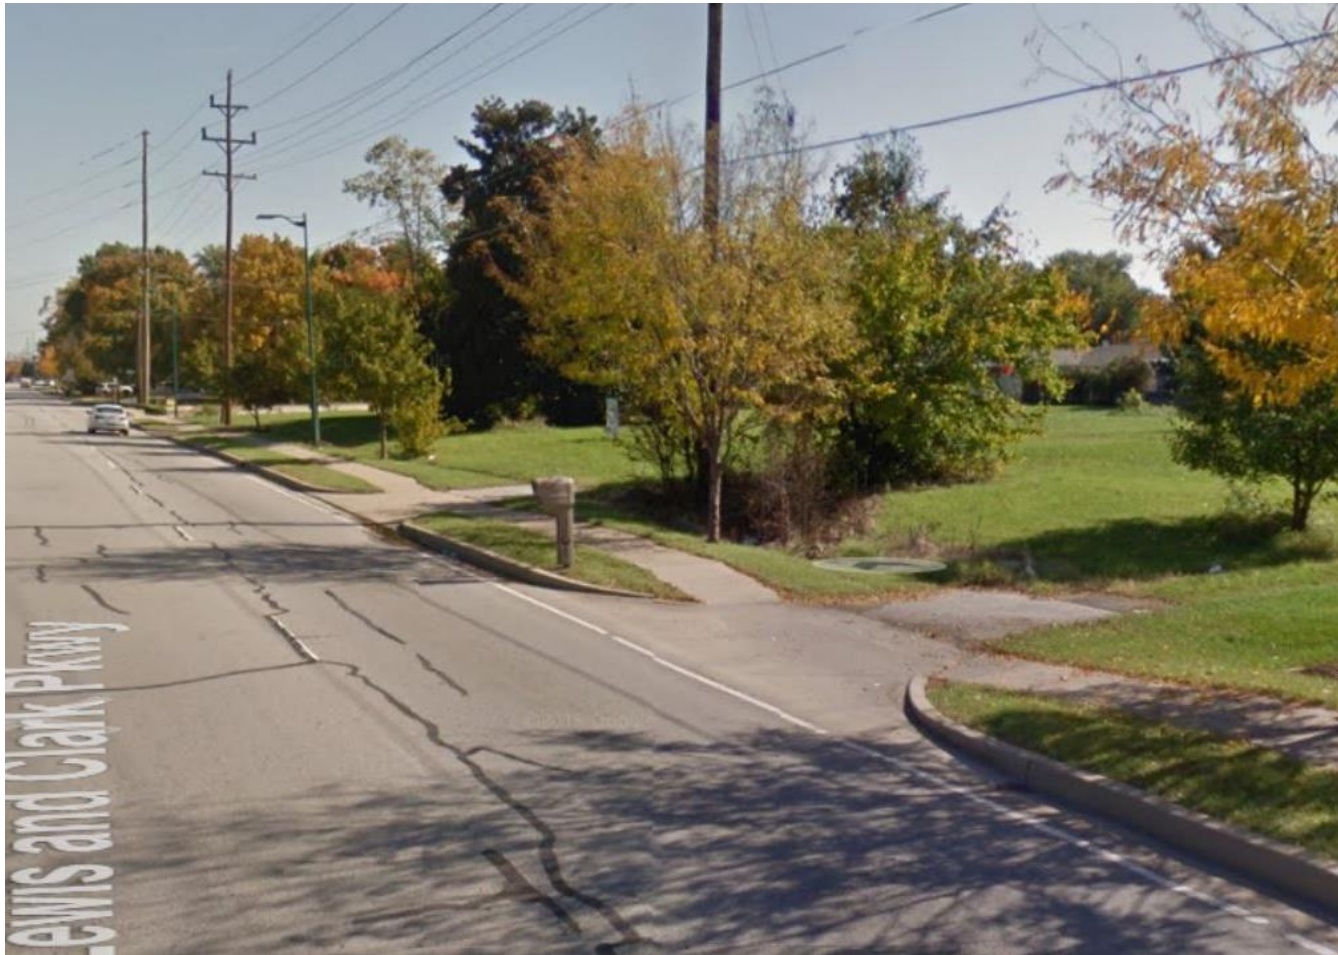
Former ditch location on right - Google Streetview clip

Beehive inlet by bush in front of fence, next to drive.
