Sains Malaysiana 45(7)(2016): 1139–1147

## Occupational Risk Assessment: Review of Wooden Scaffold Board Application in Malaysian Oil and Gas Industry

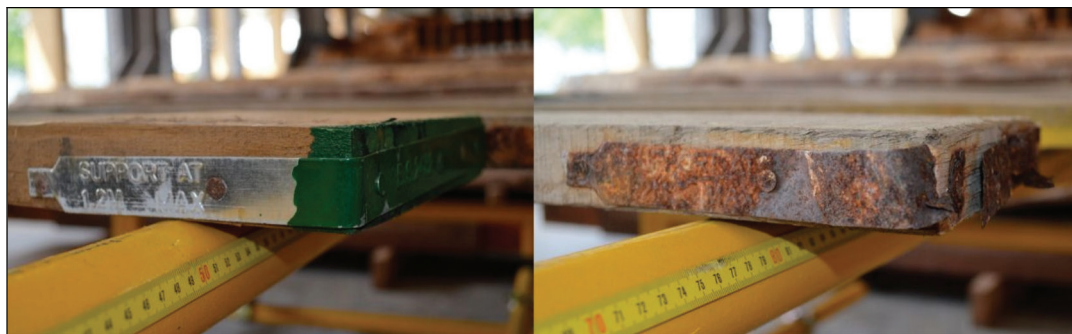
End bands of the scaffold boards were made of metal plates with a nominal dimension of 0.8 mm thick and 20.0 mm in width. These end bands were nailed on the sides and cross sections of the timber boards. Based on AS 1577, fixing of end bands made of metal, plastic or wood is compulsory to restrain end splitting. Figure 2 shows the effect of exposure to oceanic atmosphere on a metal end band. Metallic substances severely deteriorate in corrosive marine environment, particularly when the material was entirely submerged below the sea during high tide. It was observed that both the end bands and the nails were extensively corroded. Many parts of the end bands were destroyed and end bands of some boards were completely loss. The deterioration of the metal plates formed spiky and harmful edges. Act 139 of Malaysian Laws (Anon. 1986)

FIGURE 2. Illustration of an end band before and after exposure to oceanic atmosphere

stated that metal parts in scaffolding application shall be of suitable quality and free from corrosion. Besides, concern about the sharp edges on end bands is stated in BS 2482 as to avoid injury to workers. Thus far, this subject has never been an argument of safety, but it is definitely important for future improvement of timber scaffold board application.

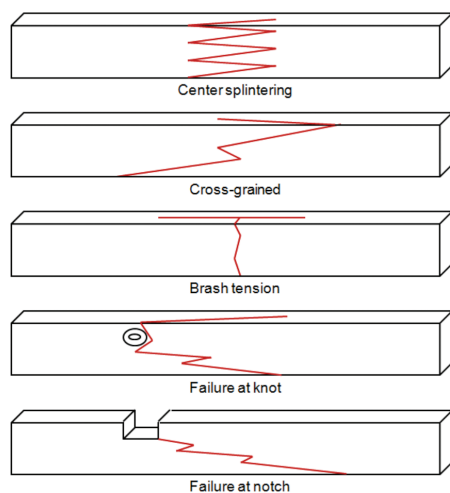
Overall, there were five modes of fracture observed during destructive test namely center splintering, cross-grained, brash tension, failure at knot and failure at notch. The facies of failure is described in Figure 3. Correlation between density, maximum load and failure mode of each board is shown in Figure 4. High density boards demonstrated higher maximum strength. Most boards of higher strength failed by center splintering. Apparently, majority of the lower strength boards failed in brash tension mode.

As fracture always begin at a defect point, timber boards which failed in splintering mode are most likely having straight grain and free of knot. Nevertheless, crossing grain and knots can be distinguished with a proper visual grading procedure. Brash tension failure is normally associated with decay, characterised by abrupt breakage across the grain without splinters (Highley & Scheffer 1989). Thus, species and grades selection plus periodical inspection on the timber boards are vital to prevent decay.

FIGURE 3. Facies of timber scaffold board failure (bottom view)

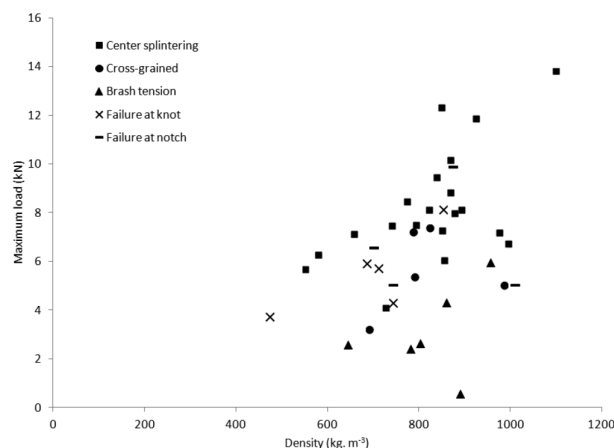
Table 2 shows the bending test results of each board. The average maximum load was 6.64 kN. The lowest and highest maximum loads were 0.57 and 13.82 kN, respectively. The density of the boards ranged between 473 and 1100 kg/m<sup>3</sup>. Moisture contents (MC) were approximately the same, within 13.7 to 17.6%. However, these are not the absolute on site MC, which should be much higher. Thus, it is rational to assume that the maximum load for each board during on site is lower than the obtained value.

FIGURE 4. Maximum load versus density of the scaffold boards

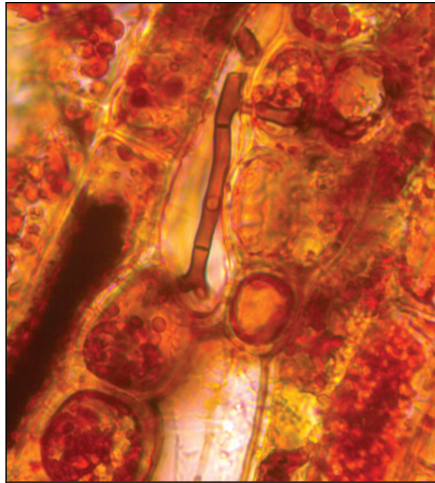
FIGURE 5. Microscopic view of hyphae on a sample slide

presence of hyphae (Figure 5). The growing phase of fungi is characterised by hyphae in the form of microscopic threads that developed from germinating spores. In addition, hyphae indicated the extent of microbiological deterioration of the timber boards.

The rate of wood deterioration by decay fungi depends on the chemical and mechanical properties of timber and the species of the fungus. Thus, the service life of structural timbers highly depends on the selection of species, installation and maintenance procedures that suited to physical and climatic features of the construction site. Treatment of timber using appropriate preservatives increases its service life. Common options for preservatives are; oil-type preservatives such as creosote or petroleum solutions of pentachlorophenol and waterborne preservatives such as copper chrome arsenate and ammoniacal copper arsenate (Highley & Scheffer 1989). However, there is a concern for toxicity when the application of chemically treated timbers is in direct contact with human.
