Retrieval analysis of ceramic-coated metal-on-polyethylene total hip replacements

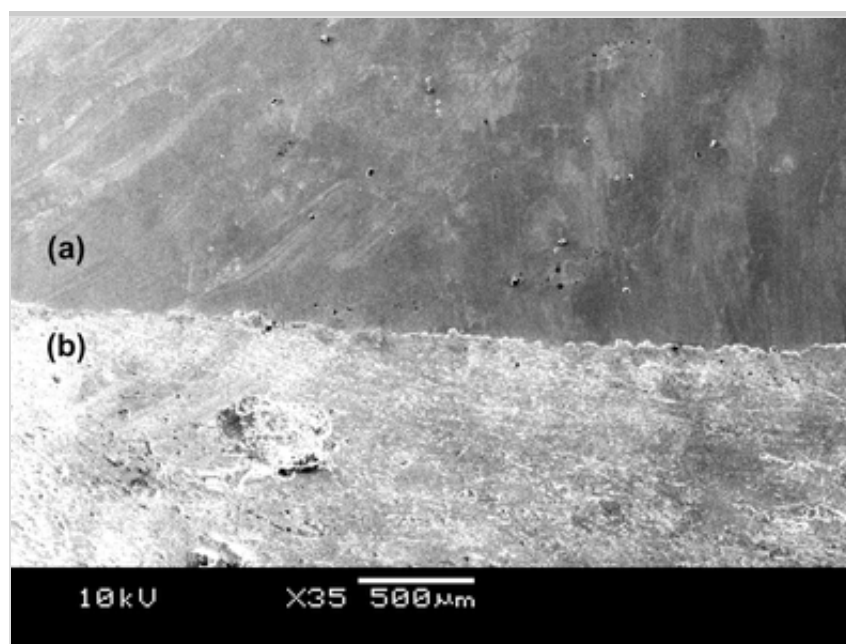
Fig. 2

Examination of the head surfaces under SEM revealed considerable evidence of scratching on the exposed metal surfaces, possibly due to third bodies such as coating fragments (Fig. 2). There were small localised regions of coating loss visible in the coated areas however there was notably less evidence of scratching.

SEM analysis revealed (a) minimal scratching on the coated surface regions and (b) considerable scratching of the exposed surfaces with coating loss

coated region, due to the increased surface roughness of the metal surface in comparison to the ceramic coating [25, 26, 27]. Another possible mechanism for increased polyethylene wear may be detached coating fragments manifesting as third body particles embedded in the articulating space between femoral head component and polyethylene.

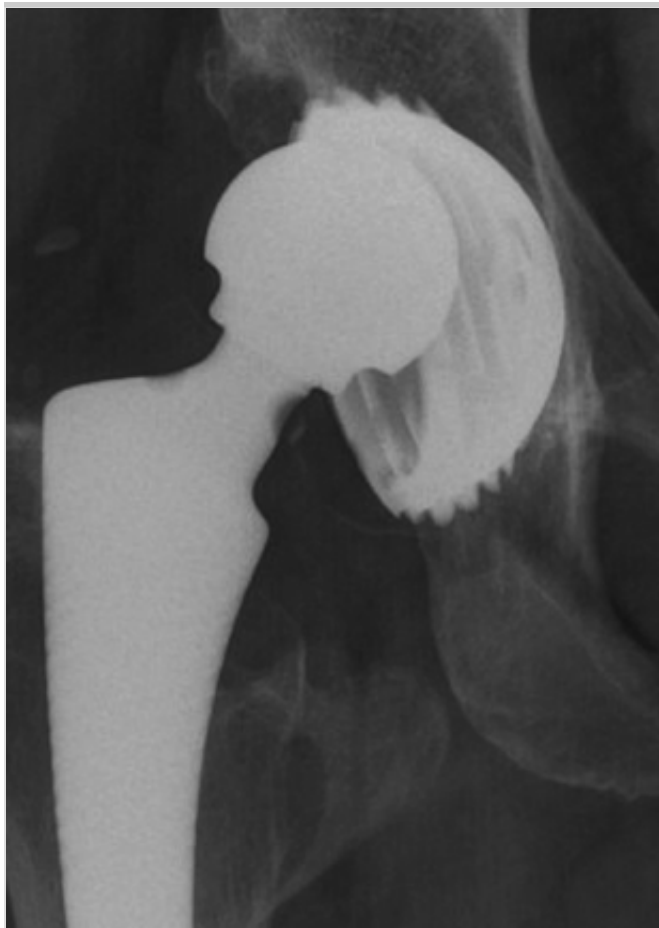
Fig. 3

Of the 35 cases available for radiographic analysis, 37 % (n = 13) revealed evidence of gross polyethylene wear (Fig. 3). All implants that were categorised as demonstrating polyethylene wear upon radiographic analysis

were revised due to a malfunctioning acetabular component, either due to cup loosening or gross cup damage.

Gross polyethylene wear was characterised if the X-ray demonstrated implant head penetration in a supero-lateral direction

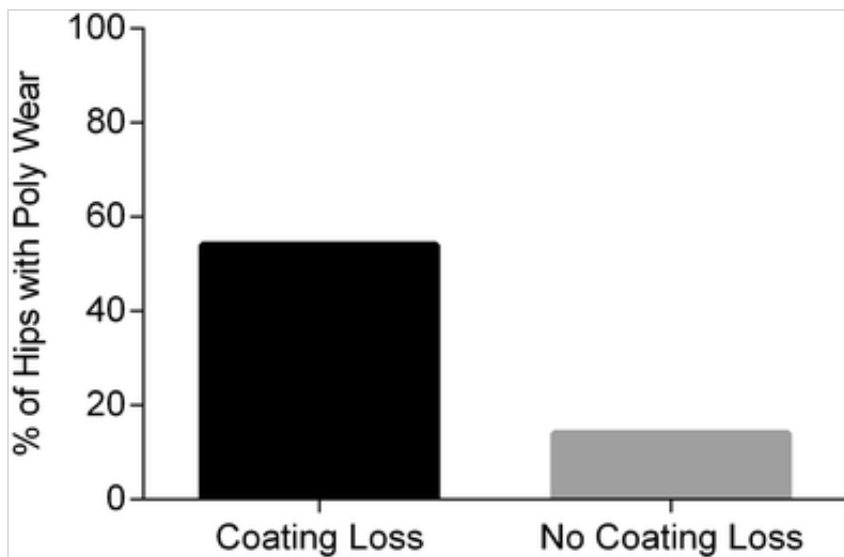
Fig. 5

The incidence of polyethylene wear in samples with coating loss was 54 %, which was significantly ($p = 0.02$) elevated compared to samples with intact coatings (14 %) (Fig. 5).

Plot of the distribution of hips with gross poly wear with femoral heads exhibiting evidence of coating loss or no loss visible
