The April 16 2016 M_w 7.8 Muisne Earthquake in Ecuador – Preliminary Observations from the EEFIT Reconnaissance Mission of May 24 - June 7

G. Franco⁽¹⁾, H. Stone⁽²⁾, B. Ahmed⁽³⁾, S.C. Chian⁽⁴⁾, F. Hughes⁽⁵⁾, N. Jirouskova⁽⁶⁾, S. Kaminski⁽⁷⁾, J. Lopez⁽⁸⁾, N.G. van Drunen⁽⁹⁾, and M. Querembás⁽¹⁰⁾

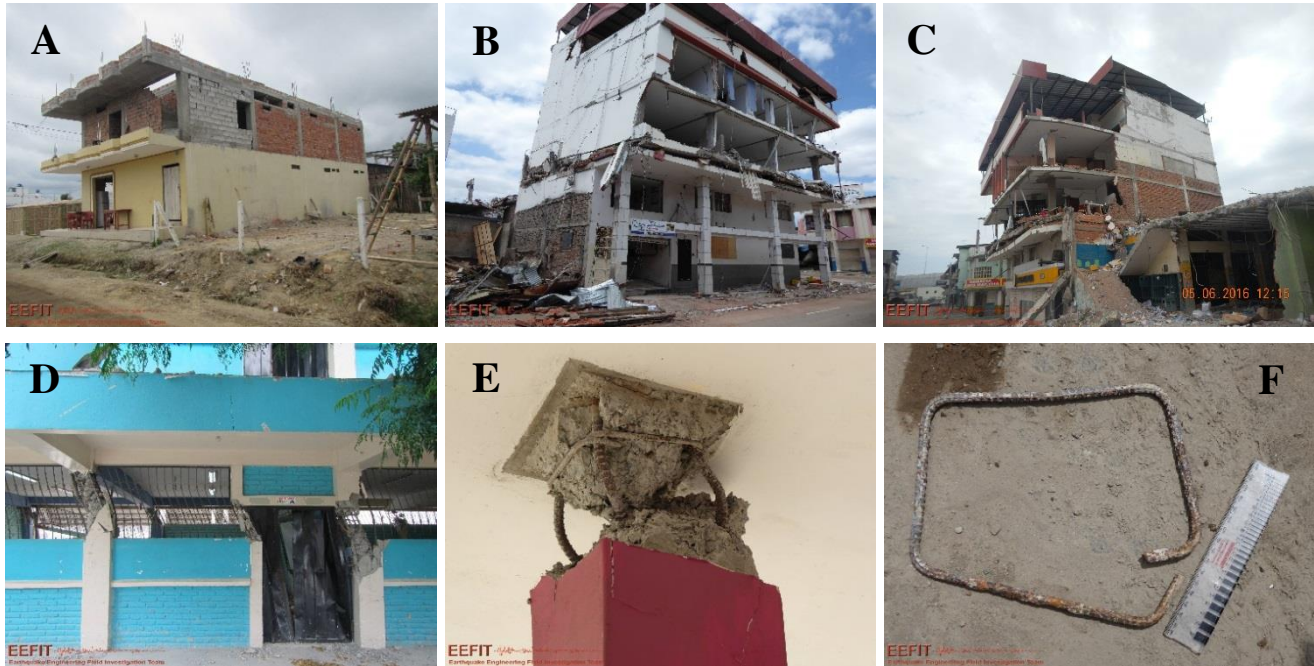
Failure at upper levels: Upper floor soft/weak storey failures were observed in a number of buildings. It is suspected that this could be due to constructing upper floors long after the bottom floors are completed (as extensions of the building when new resources become available or when new needs arise; see Figure 4A). The joints between new and old are typically poorly executed with insufficient lapping of the rebar, resulting in local reduction in capacity promoting failure in these areas (Figure 4B). This localised upper storey damage may also be attributed to all rebar being lapped at one height, resulting from the use of the same length bars in all

columns. Additionally, some upper storey failures could be attributed to changes in plan or elevation at specific levels, resulting in a weak/soft storey.

Inadequate design and detailing of RC moment frames: RC moment frames in seismic areas require several key considerations to ensure they behave safely in an earthquake: 1) Sufficient overall moment and shear capacity, 2) Columns' flexural strength should exceed that of the beams, such that flexural failure occurs first in the beams, 3) Columns and beams should be stronger in shear than in flexure, such that a ductile flexural failure mode occurs before a brittle shear failure mode, and 4) Adequate detailing of the reinforcement in all elements. Damaged RC structures observed generally failed some or all of these requirements (see Figure 4C).

Figure 4 – Two-storey building with columns' rebar left sticking out of roof for future extension (A). Weak/soft storey failure at upper level (B). Inadequate design/detailing of RC frame and infills (C). School building with short column failure (D). Column head failure showing insufficient and poor shear design and detailing (E). Column link with no 135°-bend (F).

Short columns: This failure mode was seen in a number of buildings, with a reoccurring detail of high level windows for the full length of the frame bays (see Figure 4D).

Inadequate design and detailing for shear: In many RC buildings surveyed there was poor detailing of shear reinforcement, with sparsely-spaced links and with poor/no anchorage of these links into the columns (i.e. no 135°-bends in links; see Figures 4E & 4F).

- Improved knowledge and application of basic fundamental structural and seismic design principles
- Better reinforcement detailing, notably detailing of links and rebar overlaps, and increased cover
- Better masonry infill walls and bed joints, better seismic connections to frames, and better materials
- Superior construction quality standards, especially concrete
- Better building maintenance, especially for timber or bamboo structures
