Analysing a mechanism of failure in retrieved magnetically controlled spinal rods

Vasiliki C. Panagiotopoulou^{1,2} · Stewart K. Tucker³ · Robert K. Whittaker¹ · Harry S. Hothi¹ · Johann Henckel^{1,2} · Julian J. H. Leong^{1,2} · Thomas Ember^{3,4} · John A. Skinner^{1,2} · Alister J. Hart^{1,2}

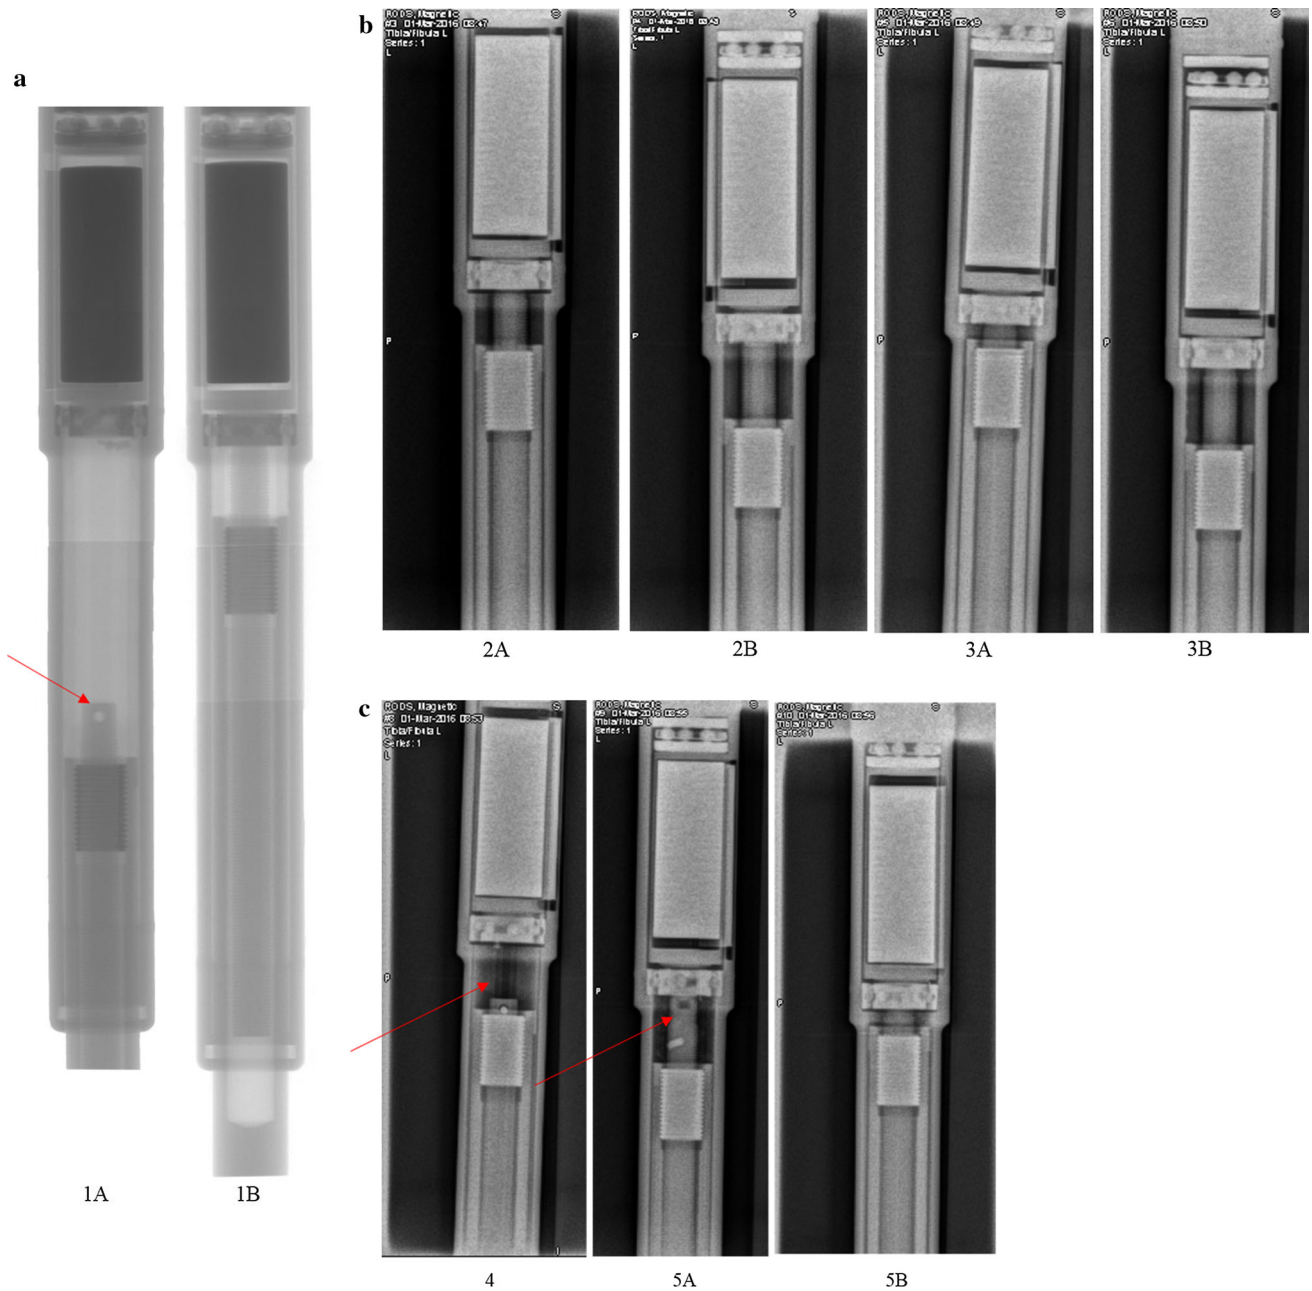
We hypothesized that the failure of the MCGRs was caused by fracture of the pin in the actuator. Our primary outcome measure was evidence of pin fracture on plain radiographs taken of the explanted device [16], Fig. 2b, c.

Fig. 2 a High power radiographs of two retrieved MCGRs. In rod 1A, the internal mechanism is no longer in place (indicated by the *red arrow*), while rod 1B appears intact. **b** Plain radiographs of four

retrieved rods, all of them appear intact. **c** Plain radiographs of three retrieved rods, two of them having a fractured mechanism as indicated by the *red arrows*, while the rest remains intact

Plain radiographs showed evidence of dislocation of the thread mechanism of the telescopic components in three cases.

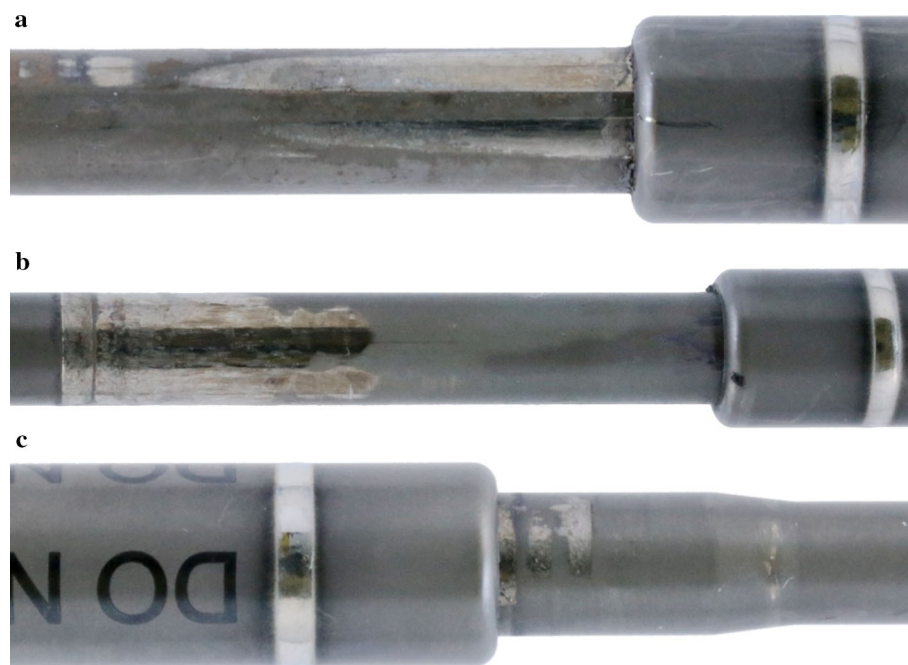
Fig. 4 Images showing the patterns seen of surface wear and removal on the extendable telescopic rod. **a, b** Show the pattern of surface wear on the same rod at different orientation, while **c** shows a different pattern of surface degradation on another rod

All retrieved implants showed signs of surface degradation on the extendable telescopic rod on regions that had been extended during the lengthening procedure and showed surface damage in two predominant patterns (see Fig. 4a–c). All implants showed some evidence of scratches attributed to surgical tools used during implantation and revision surgery. The results of grading the areas of interest in terms of surface damage are shown in Table 3. Table 4 presents the findings from the macroscopic inspection (type of pattern at the junction) with the results from the radiographs (fractured or not mechanism). All rods with fractured pins had the same wear pattern at the junction, removing a larger area of the surface layer than the MCGRs with an intact internal mechanism.

MCGRs with fractured pins. The regularity of the distribution of scratches in MCGRs with intact pins (Fig. 4c) likely reflects the number of distraction therapies. In contrast, the irregular patterns of surface damage (Fig. 4a, b) were only seen in cases with fracture of the pin. The surface damage seems to be linked to the bending moment.

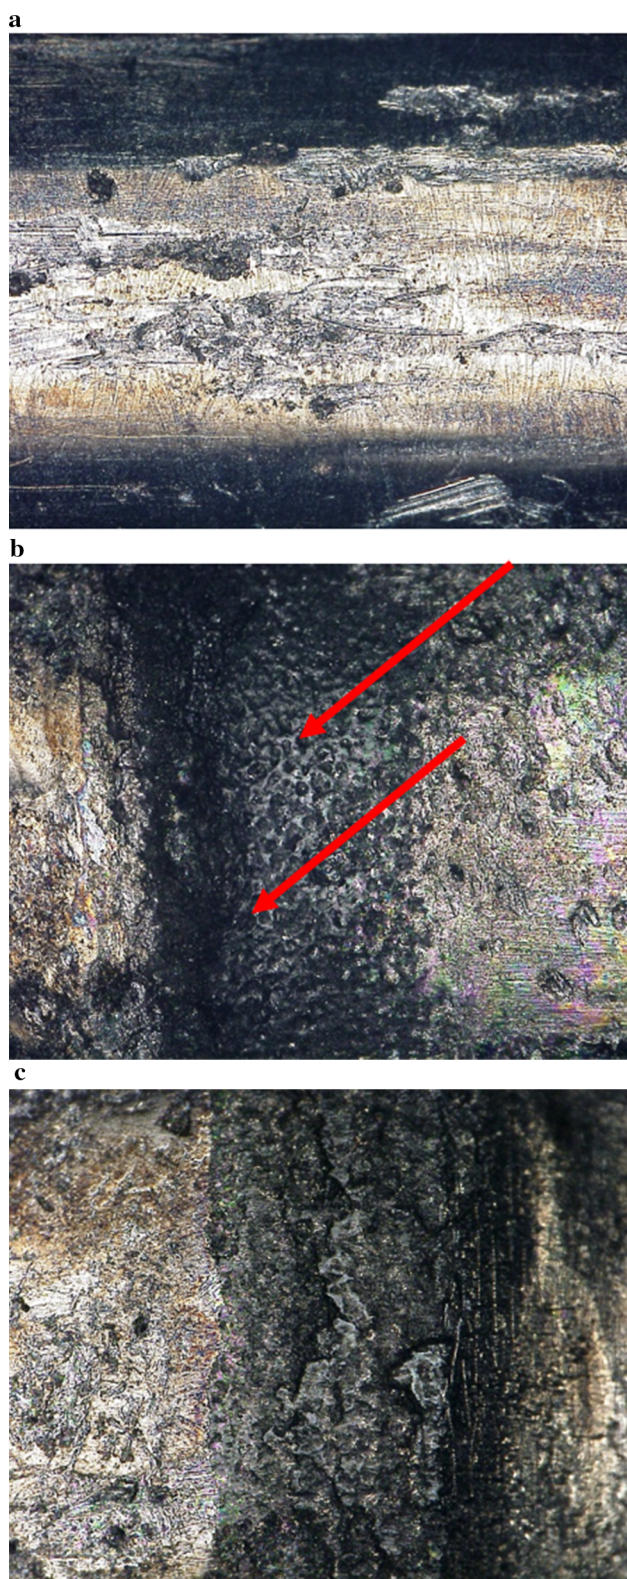
All implants showed signs of pitting and fretting on areas of the rod exposed during distraction, Fig. 5a–c.

Fig. 5 **a** Microscopic picture of the damaged surface near the junction at $\times 200$ magnification. **b** Microscopic picture of the damaged surface near the junction at $\times 200$ magnification, with *red arrows* showing the pitting. **c** Microscopic picture of the damaged surface near the junction at $\times 200$ magnification

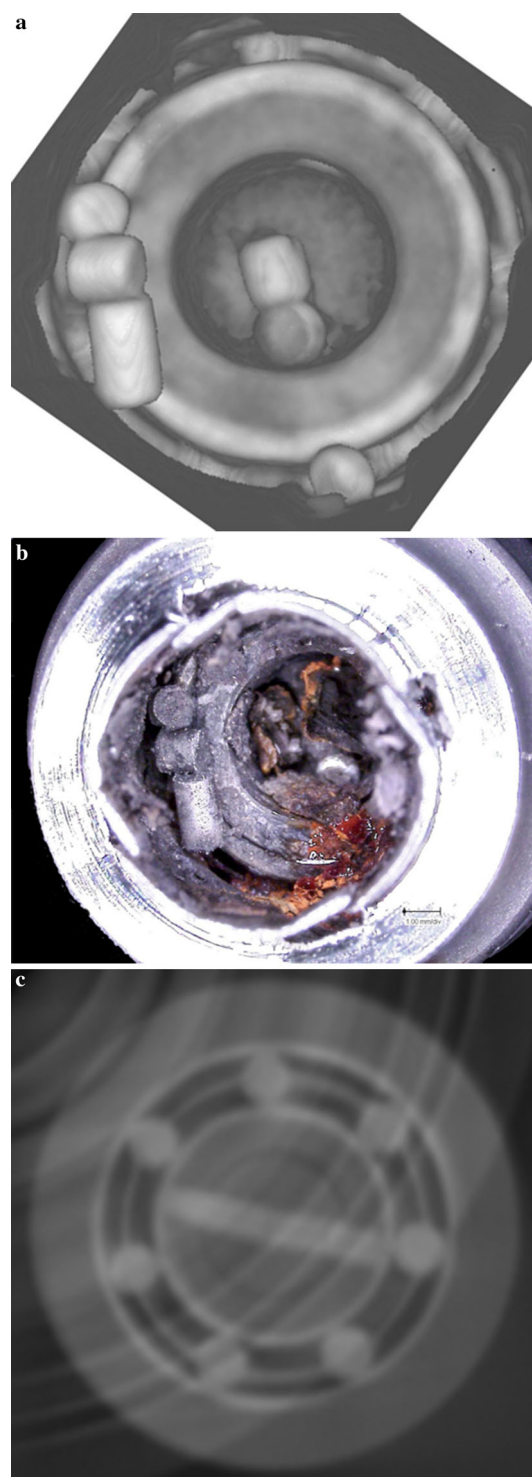
MCGR with fractured pin—mCT of the MCGR showed the drive shaft had become disengaged from the magnet, Fig. 6. Fragments of the pin were located around the ball bearing and had fractured into two pieces. Two of the fragments were located within the plain ball bearing with the remaining four on top, Fig. 6a. **MCGR with intact pin**—mCT confirmed that the magnet and the drive shaft were still engaged, with the pin in place, Fig. 6c.

The MCGR with the fractured pin was sectioned in two areas: (1) one to allow access to the site of the fractured pin and (2) the other to access the thrust ball bearing and magnet within the sleeve, Fig. 7a, b. We found that the pin was fractured into six pieces, and once sectioned, the pieces were located in the same region, Fig. 6a, b.

Fig. 6 **a** Micro-CT image of the fractured pin in and atop of the ball bearing. **b** Image of sectioned rod showing the fractured pin in and atop of the ball bearing **c** Micro-CT image of the intact pin

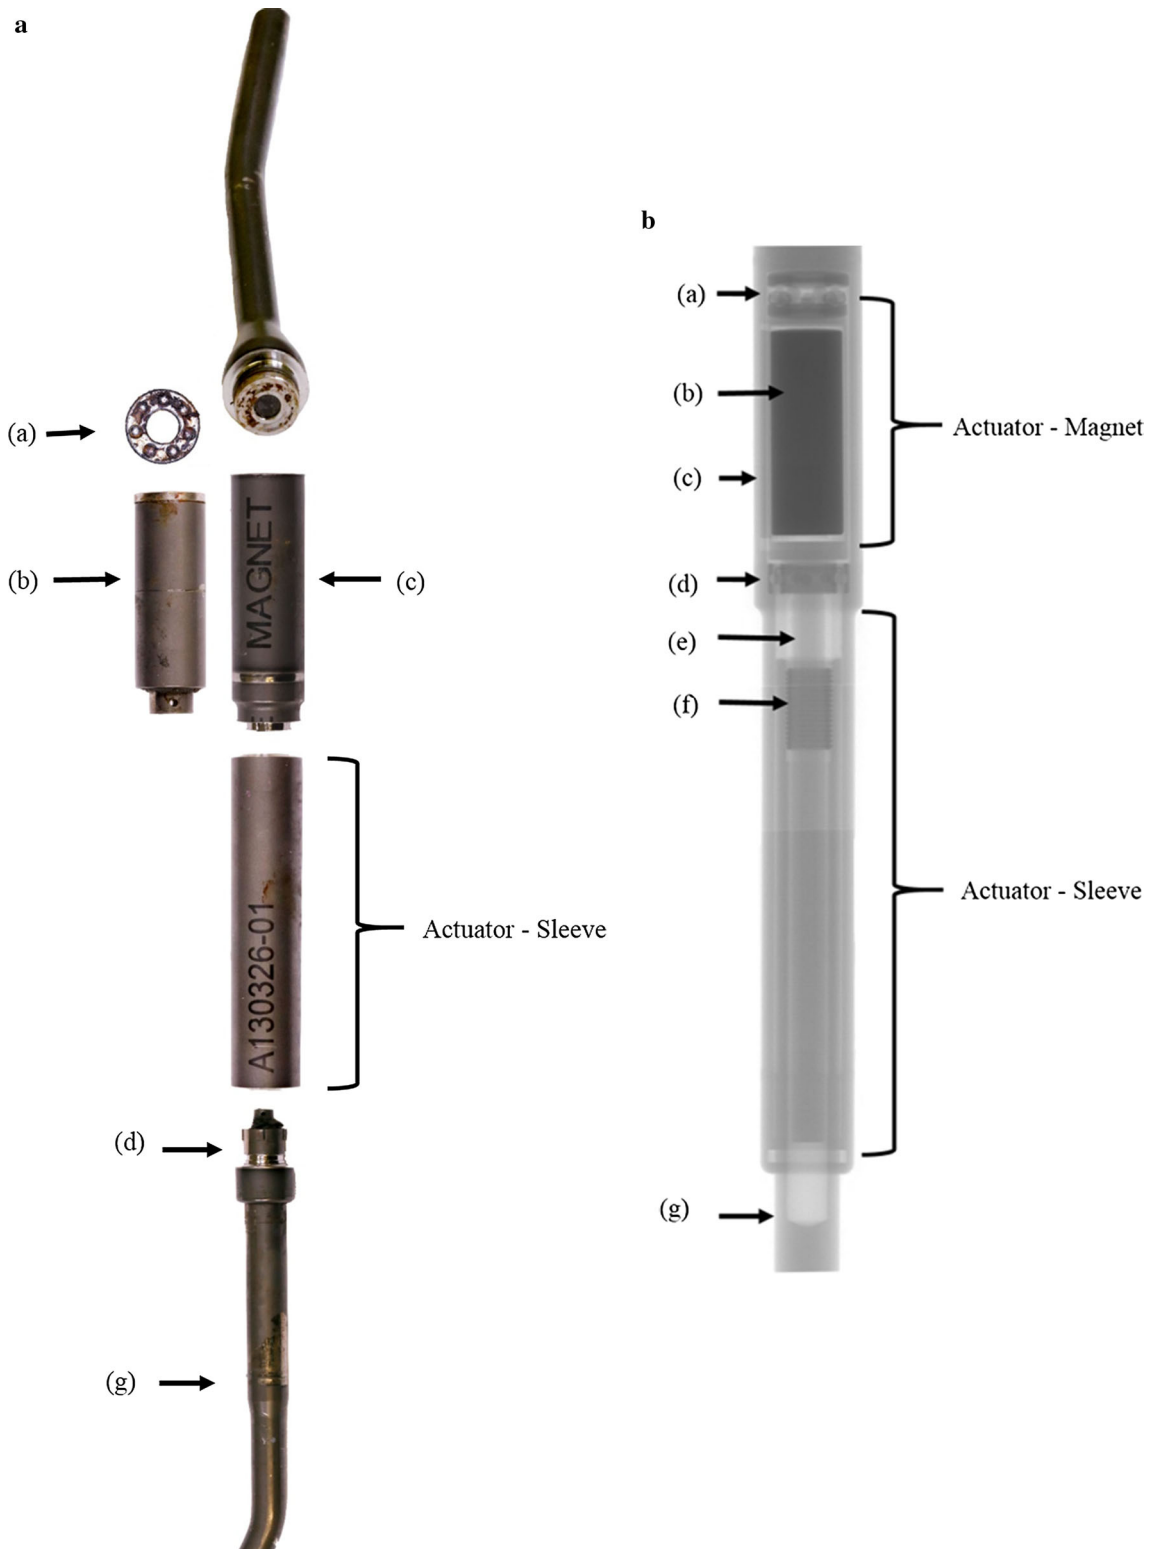
Fig. 7 a Image of all parts of the fractured rod after sectioning. (a) Thrust bearing (b) magnet (c) keeper plate (d) ball bearing (e) drive train screw (f) fixed nut (g) extendable telescopic rod.

b Radiograph showing the construct of an intact spinal rod. (a) Thrust bearing (b) magnet (c) keeper plate (d) ball bearing (e) drive train screw (f) fixed nut (g) extendable telescopic rod

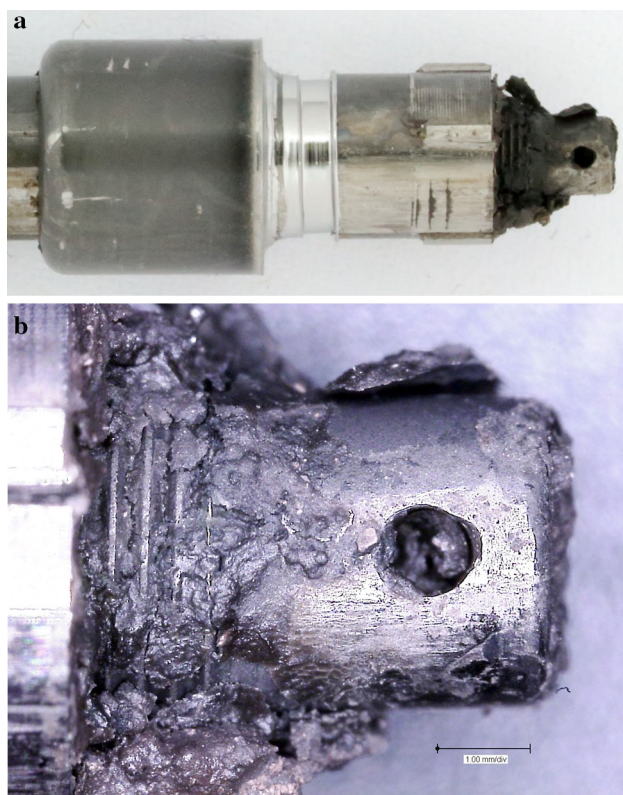
Visual and microscopic inspection showed debris and deposits on the bearings (see Fig. 8a–d). The lengthening component of the rod was inseparable from the caudal part of the implant, unable to move due to large build up of debris, Fig. 9.

Fig. 9 **a** Image showing drive train pin hole and debris. **b** Microscopic image showing drive train pin hole and debris ($\times 30$ magnification)

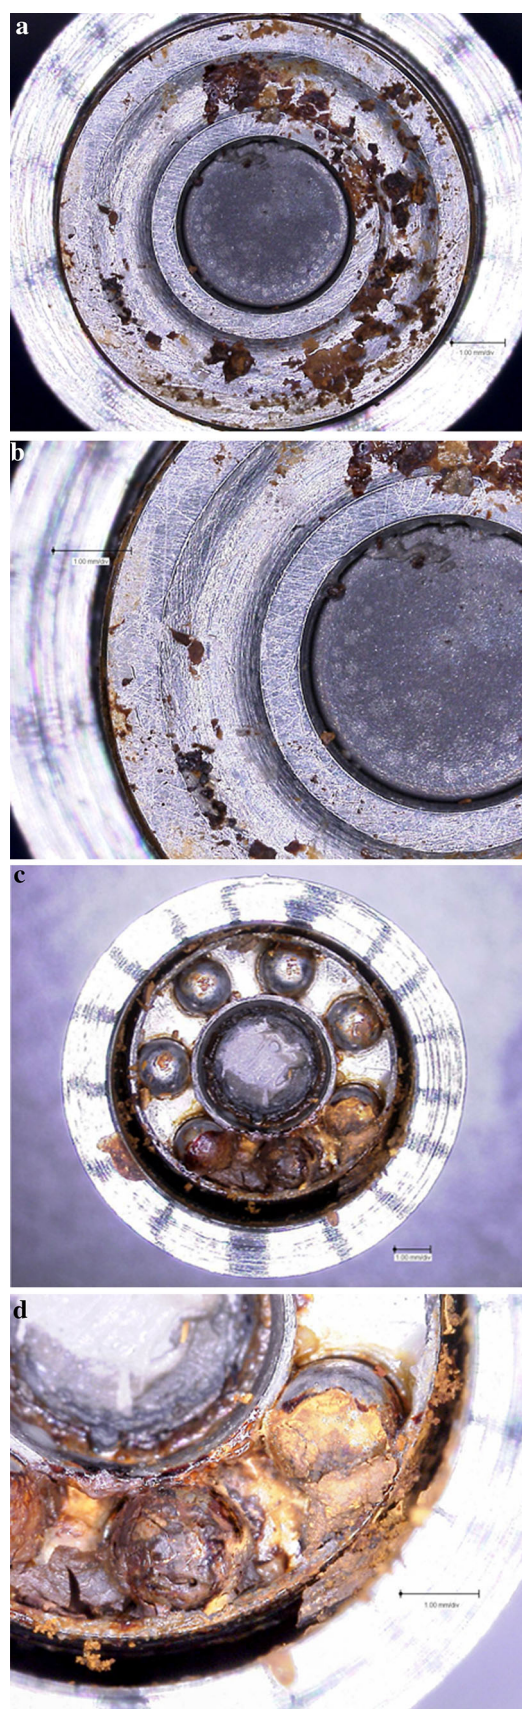
The intact rod was sectioned in two parts, to reveal the train drive mechanism, which is not visible at the failed rod, Fig. 10a. There were also signs of debris at the interior of the intact rod although not in the same quantity as the pin fractured rod, Fig. 10b, c.

Fig. 10 **a** Train mechanism as revealed from sectioning the intact magnetic rod. **b** Train drive mechanism of the intact rod under the microscope ($\times 20$ magnification). **c** Microscopic picture of the junction of the intact rod showing signs of debris ($\times 50$ magnification)

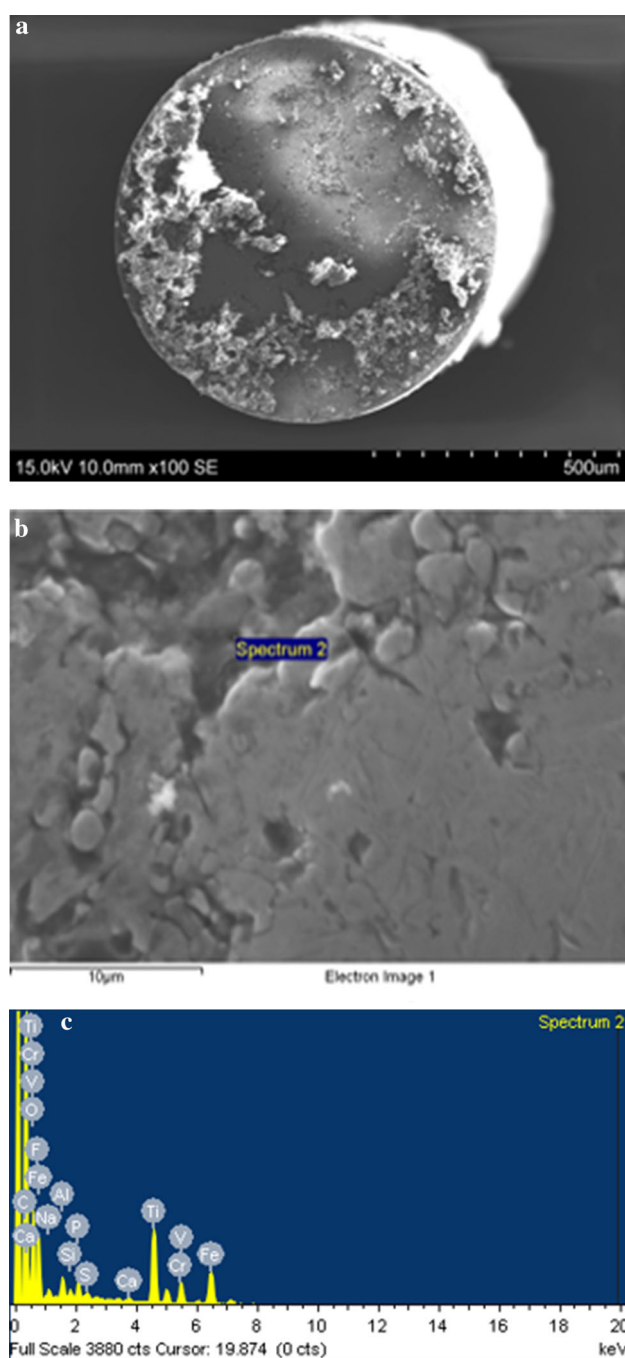
SEM confirmed the presence of debris on the pin, on the train drive mechanism and on the exterior lengthening rod. The fractured surfaces of the actuator pin were rough with

no clear indication of the exact location of fracture initiation. The rough morphology of the fractured areas did not account for any fatigue-related cracking. EDX analysis suggested that the pin was made of ferritic stainless steel, but was highly corroded (Fig. 11–c); we found traces of sulphur (0.2%), calcium (0.12%) and titanium (Fig. 11c). Specifically, oxygen amount was more than double on the corroded regions of the actuator pin compared to the original areas (60 versus 30%). On the corroded region, we noticed a tenfold decrease of the amount of iron and a fivefold reduction of the chromium content compared to non-corroded areas. The presence of titanium (5%), aluminium (0.4%), and vanadium (0.4%) suggested transfer of metal debris from mechanical wear of the rod to the actuator pin. We confirmed that the rod (Fig. 12a, b) and the drive mechanism (Fig. 13a–c) were made of titanium

Fig. 11 **a** SEM image on the internal pin. **b** SEM image on the internal pin. **c** EDX analysis of debris on the internal pin

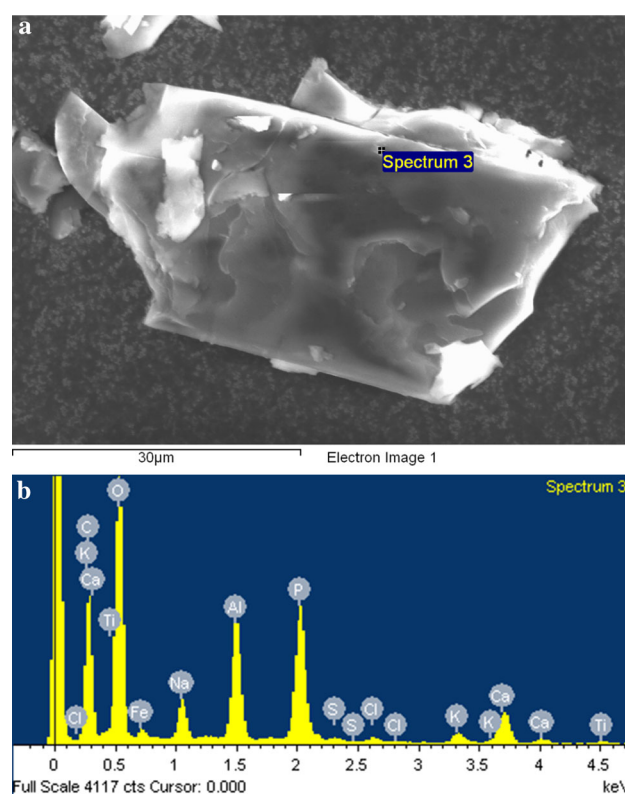
Fig. 12 **a** SEM image of debris on the external damaged surface of the rod on a carbon coated tab. **b** EDX analysis of the debris on the external damaged surface of the rod

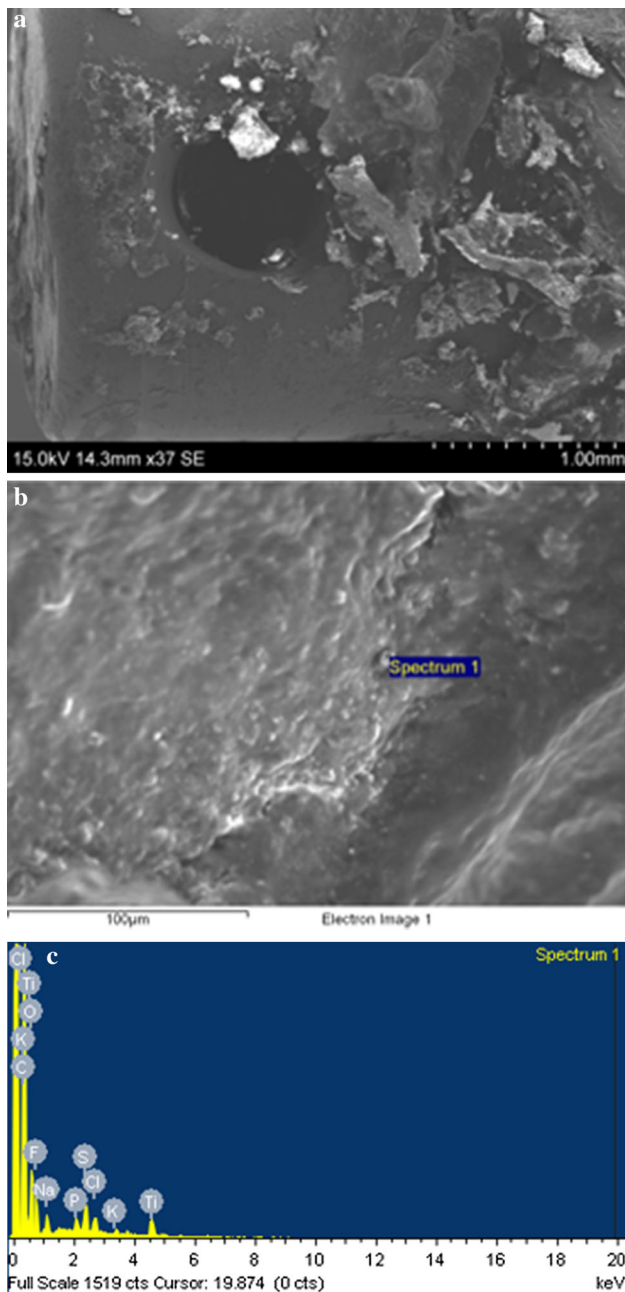
alloys and that both had evidence of corrosive products containing sulphur (0.15 and 0.6%, respectively), iron (1% in the case of the rod), phosphorus (6 and 0.4%, respectively), and calcium (Figs. 12b, 13c). EDX analysis of the debris on the drive mechanism revealed the presence of sodium (0.6%), potassium (0.2%), and chlorine (0.4%), confirming the presence of body fluids inside the magnetic rod.

Fig. 13 **a** SEM picture of debris on the drive mechanisms of the fractured rod. **b** SEM picture of debris on the drive mechanisms of the fractured rod. **c** EDX analysis of debris (*graph on the right*) on the drive mechanism of the fracture rod
