Performance and Impact from Duct Repair and Ventilation Modifications of Two Newly Constructed Manufactured Houses Located in a Hot and Humid Climate

Florida Solar Energy Center
Cocoa, Florida 32922

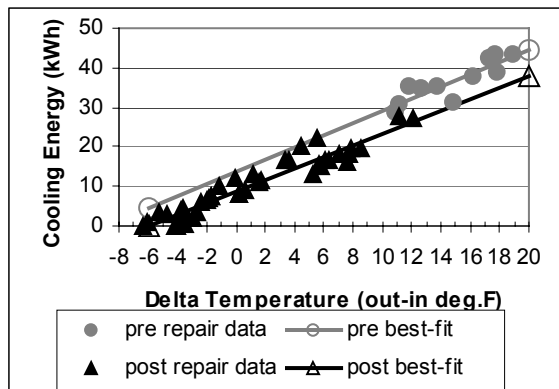
Figure 2 House B Cooling Energy vs. dT.

Following the same calculation procedure as House A with a 12 F dT for House B, results in a pre-repair daily energy use of 32.24 kWh and a post-repair daily energy use of 26.42 kWh. (R^2 before repair was 0.75 and 0.92 after.) Therefore, duct repair with the ventilation system operating results in a daily reduction of 5.82 kWh (18.1% savings).
