School Conditions Will Continue to Earn Failing Grades

ABSTRACT

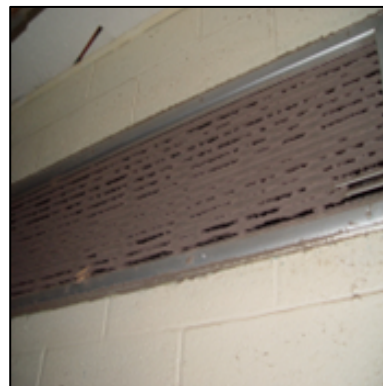
Significant audit observations included low classroom temperatures, high relative humidity levels and operations and maintenance problems (see Figure 6). Room temperatures as low as 64°F were measured during the audit visit, with the average temperature of 13 rooms measured being 68.4°F. Monitored temperature and relative humidity data from 7 classrooms during the week after the audit also showed a number of rooms with low temperatures and high RH levels. Of these, over a two day period with outdoor high temperatures of 86°F and an average dew point temperature of 68°F, temperatures in three classrooms, the cafeteria and library averaged at or below 70°F, and RH levels in one classroom, the cafeteria and library averaged above 65%. Dew point temperatures in Florida are commonly well above 70°F, so maintaining rooms at these low temperatures can create opportunity for condensation in exterior wall cavities, especially if the building operates at negative pressure.

Figure 6.
Main
Return
Grilles
Behind
Stage of

Cafetorium Blocked b/c Maintenance Staff Unaware of Their Locations

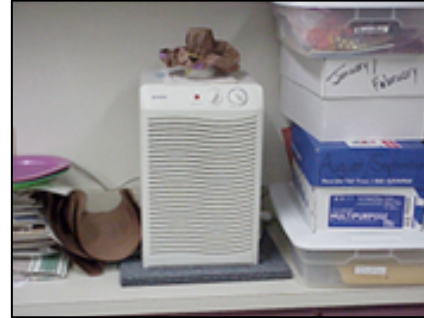
Significant audit observations include high RH levels (60-70%), leaky building envelopes and several instances of low classroom temperatures. At the time of the audit, portable dehumidifier “band aids” were commonly in use in the classrooms to help control RH levels (see Figure 7).

Figure 7. A Portable Dehumidifier Used to Reduce Classroom Humidity Levels

- Tighten the buildings by sealing the eave vents. This will make it easier to get the buildings to operate at positive pressure, reduce the natural infiltration rate, and allow indoor humidity levels to remain below 60% for extended periods (even several days at a time) with the conditioning systems off.

- Reduce the air handler flow rates to improve their dehumidification performance.
- Adjust the outdoor air intakes to 15 cfm per person based on average occupancy. It is expected that once the buildings are tightened, the outdoor ventilation air will be sufficient to produce pressures in excess of a +2 pascal target.

- Operate the air conditioners in the fan “auto” mode during hot and humid cooling periods. The “auto” fan setting will optimize latent removal (dehumidification) performance.

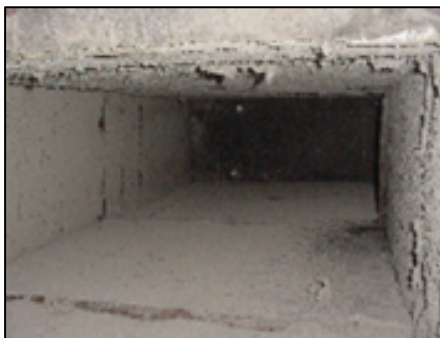
Significant audit observations include dust accumulation, negative pressure in part of the building, low ventilation rates and musty odors (see Figure 8). A visual inspection showed dust accumulation throughout the building, especially in the ceiling space, likely due to inadequate filtration of outdoor air or outdoor air bypassing the filters. Blower door tests showed that both main buildings are very airtight (south wing ACH50 = 1.0 and north wing ACH50 = 1.5). Pressure mapping found that with all operational HVAC equipment running, the main area of the south building was operating under significant negative pressure (-8 Pa) and the north building was operating under somewhat positive pressure (+2.3 Pa).

Figure 8. Dust in Return Duct after Outside Air Intake

Tracer gas decay testing was also performed and indicated a ventilation rate of 0.47 ach or approximately 8.5 cfm per student in the south building, and an extremely low 0.10 ach or approximately 1.1 cfm per student in the north building. It was also noted that two of the nine exhaust fans on the south wing were not working, and none of the exhaust fans on the north wing were working.

- Get exhaust systems operating per original design parameters.
- Install exhaust air on the janitor's closet.
- Repair bathroom fans and make sure bathrooms operate at negative pressure with respect to all adjacent spaces including the bathroom ceiling spaces. Also eliminate cases where the bathrooms are being depressurized by the adjacent mechanical rooms (which are acting as return plenums).

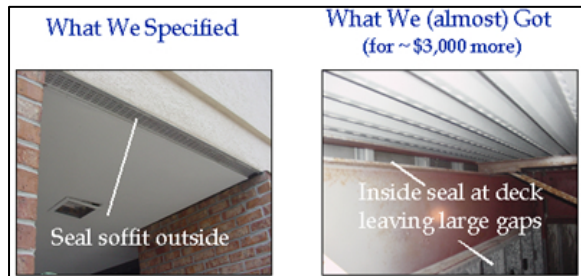
Although outside soffit sealing was specified, the contractor was planning on attempting to seal off an opening inside the space above the eave. This plan still would have left significant areas unsealed at a cost of approximately \$3,000 more than what was

specified finally budgeted. Figure 12 below shows the differences in the specified and planned sealing solutions.

Figure 12. Specified vs. Contractor-planned Soffit Sealing Solutions

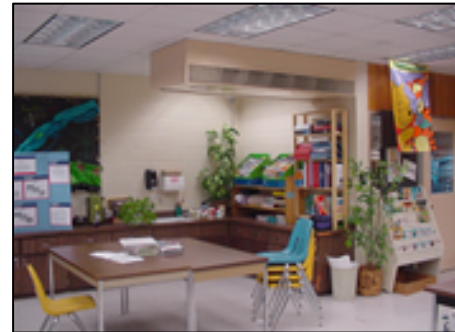
At the second Florida elementary school, issues identified from the conditions audit included low classroom temperatures, high relative humidity levels and operations and maintenance problems. Room temperatures as low as 64°F were measured during the audit visit, with the average temperature of 13 rooms measured being 68.4°F. Monitored temperature and relative humidity data from 7 classrooms during the week after the audit also showed a number of rooms with low temperatures and high RH levels. Dew point temperatures in Florida are commonly well above 70°F, so maintaining rooms at these low temperatures can provide surfaces on which water can condense. Recommended retrofits included:

Figure 13. Air Handler in One of the Florida Elementary School #2 Classrooms

- A dedicated outdoor air ventilation system
- Tightening building envelope / evaluate fan coil

leak openings.
