Estimation the performance of solar fiber optic lighting system after repairing the glass Fiber Cables in a South Korean Residential Building

Kwang-Seok Cha
Renewable Team Leader
Hyundai Engineering and
Construction, Ltd.
Seoul, South Korea

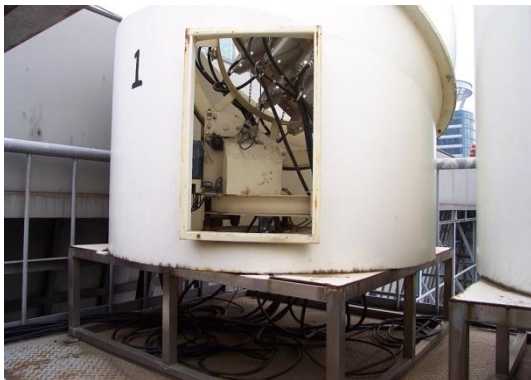
Fig. 3 Corrosion of the body

and the dirt covering it. Fig. 3 shows the body's corrosion due to its being constructed from steel. Fig. 4 shows the sensor installation for the sun tracking.

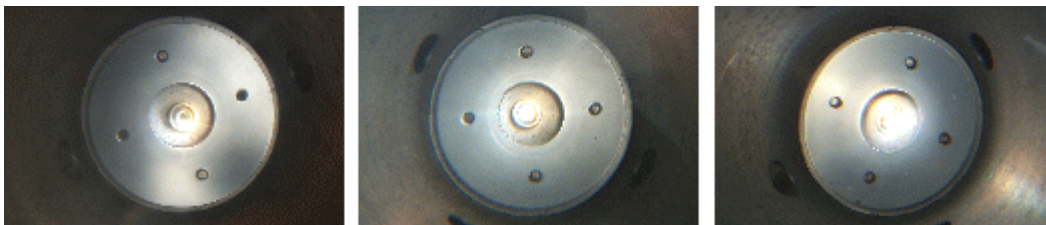
Fig. 6 Sample of focusing shape at the terminal of cables in concentration part

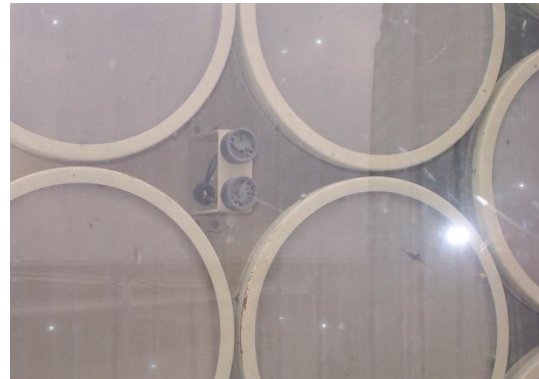
Fig. 4 Exchange of sensors

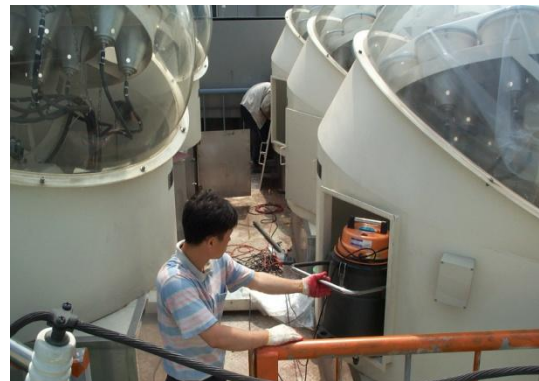
Fig. 5 Cleaning inside

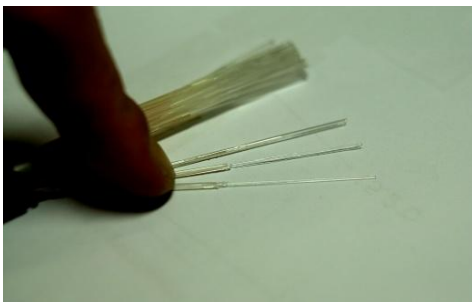
Fig. 10 Fiber Optic Cable has double covers
