45<sup>TH</sup> **TURBOMACHINERY** & 32<sup>ND</sup> **PUMP SYMPOSIA**  
HOUSTON, TEXAS | SEPTEMBER 12 – 15, 2016  
GEORGE R. BROWN CONVENTION CENTER

# Analysis and on-stream countermeasures of sub-synchronous vibration of a centrifugal compressor

SANGJOO LEE

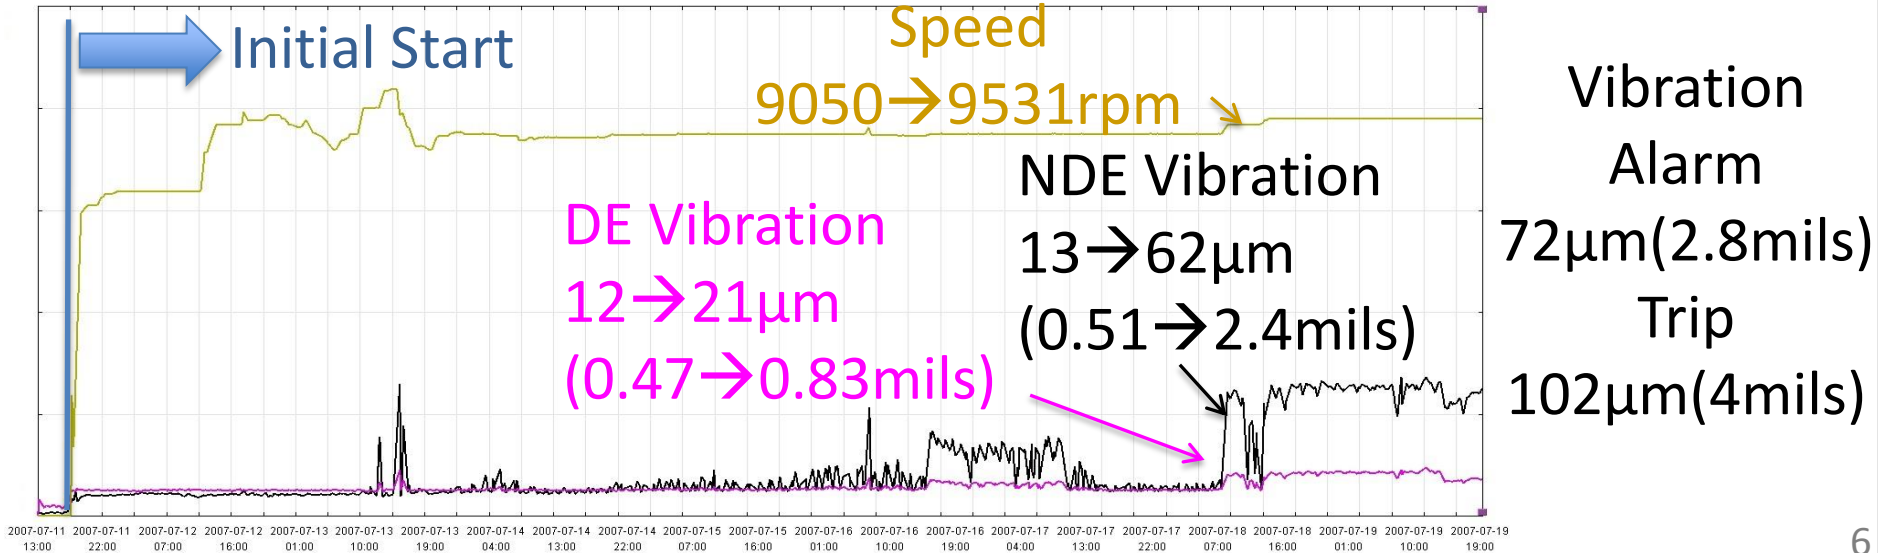
[ Speed & Radial Vibration. Trend ]

The Recycle compressor started initially in 2007. After initial start-up, radial vibration of compressor was relatively stable. But the radial vibration of compressor increased during increasing compressor speed to supply more H<sub>2</sub> to reactor. (Higher H<sub>2</sub>/feed ratio is better for catalyst lifespan)

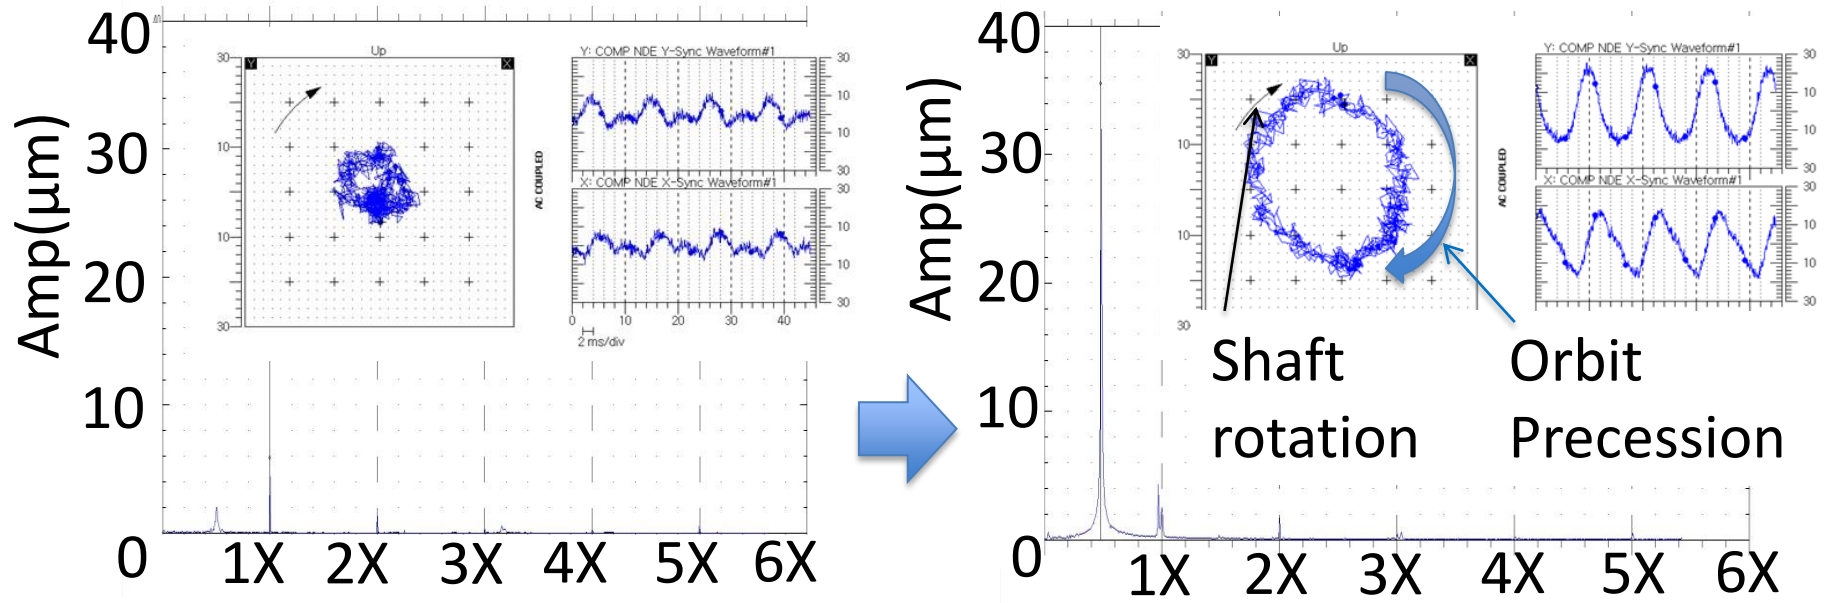
Before high vibration occurred, dominant frequency was 1X with small sub-synchronous. When high vibration occurred, dominant frequency of high vibration was sub-synchronous which is 0.48X.

[ Stable vibration – 5.79@1x Order] [ High vibration – 35.5@0.48x Order]

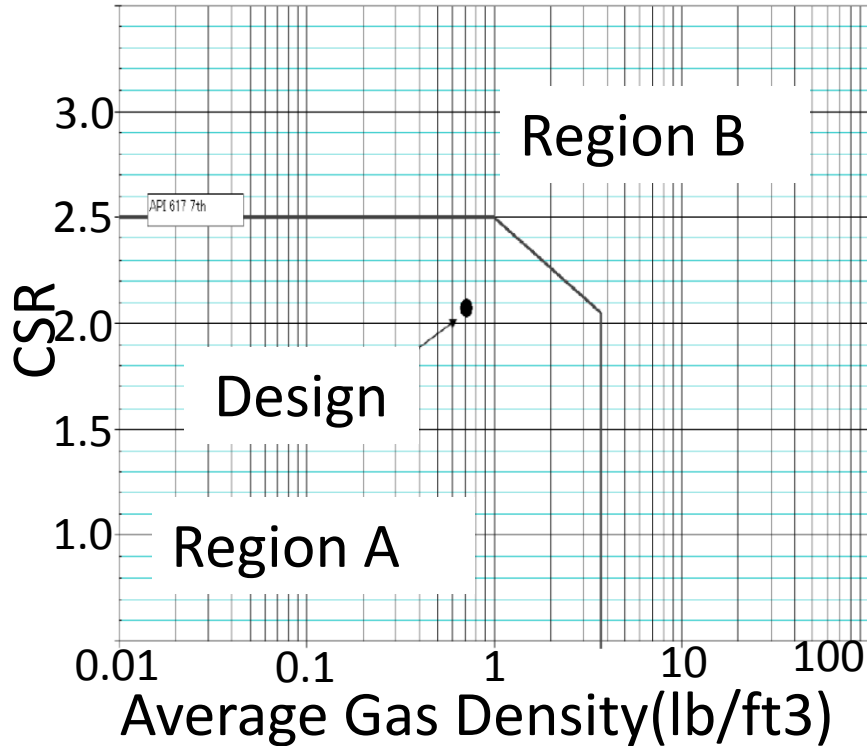
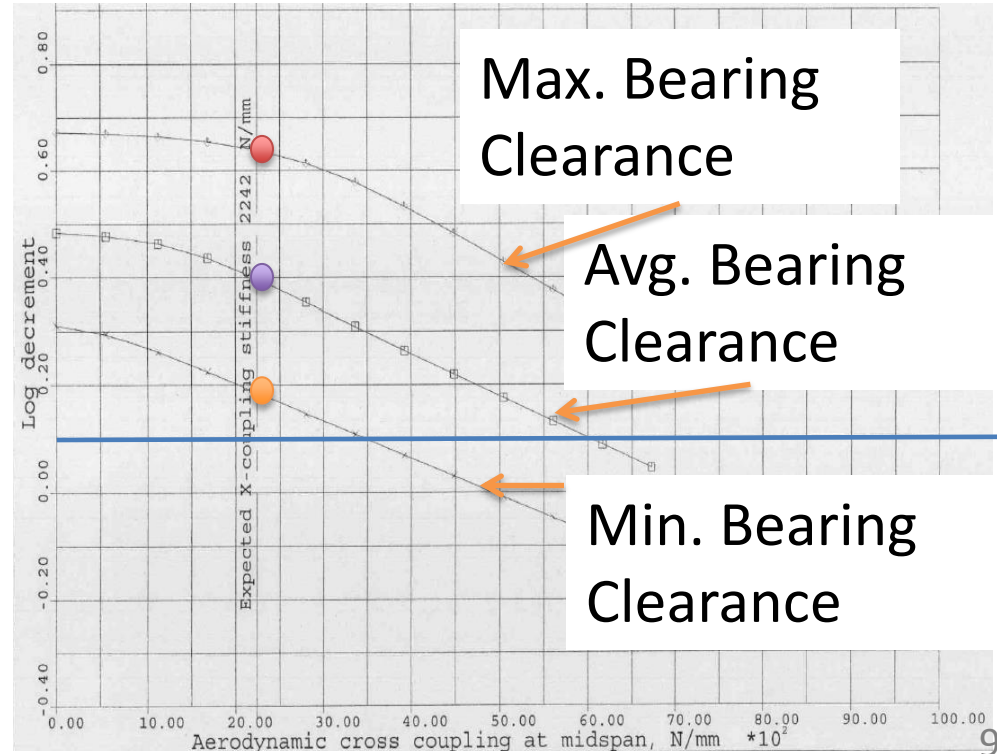
### 3. Troubleshooting - ① Insufficient Stability Design

Base on the stability analysis result, the API Level I criteria was satisfied. (i.  $Q_0/Q_A=2.16 > 2.0$ , ii.  $\delta A=0.194 > 0.1$ , iii CSR Region A)

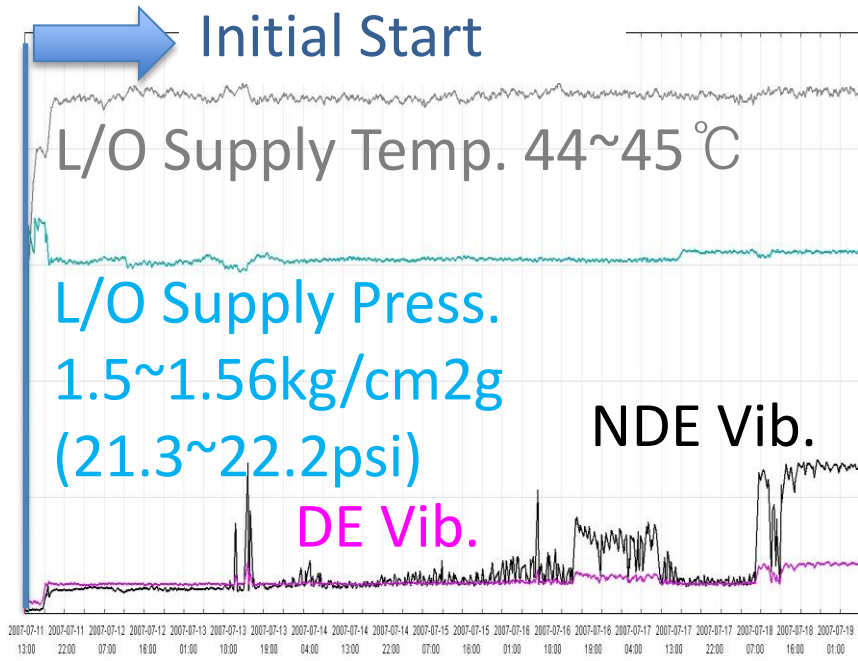
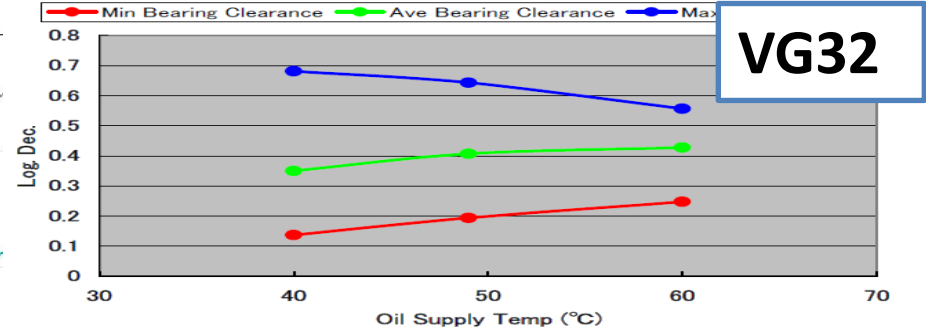
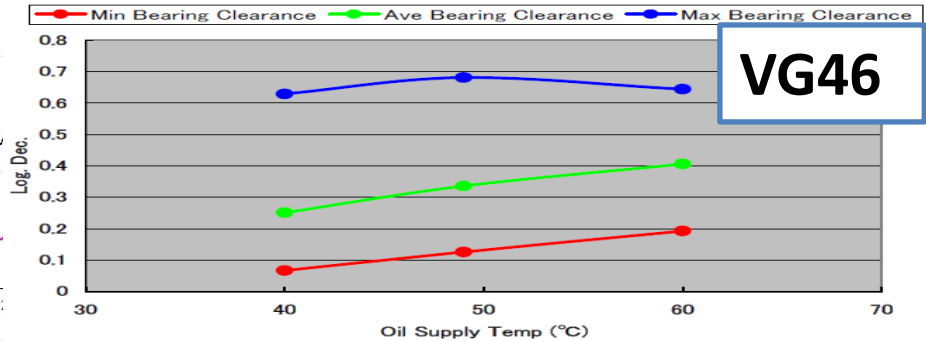
### 3. Troubleshooting - ② Improper Operating Condition

Base on the stability analysis, the Log Dec. was predicted to decrease with decreasing supply temperature and higher viscosity oil. Actual operation maintained design temperature (44 °C) and manufacturer viscosity recommendation (VG32)

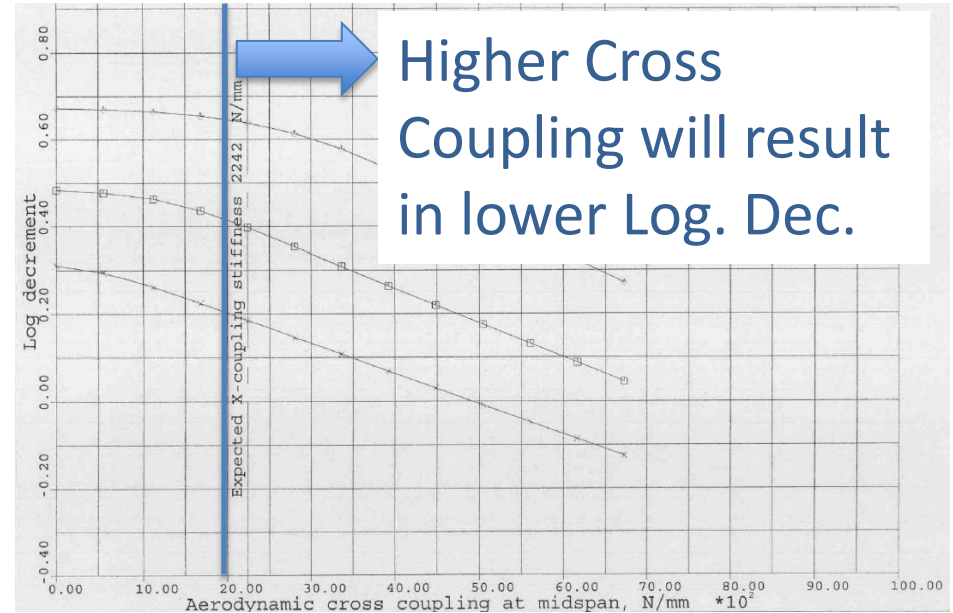
### 3. Troubleshooting - ③ Unexpected High Destabilizing Force High

Unexpected high mole weight (low hydrogen purity) which is almost twice higher than design occurred during initial start-up. The higher mole weight can lead higher destabilizing force than design expected. (higher cross coupling)

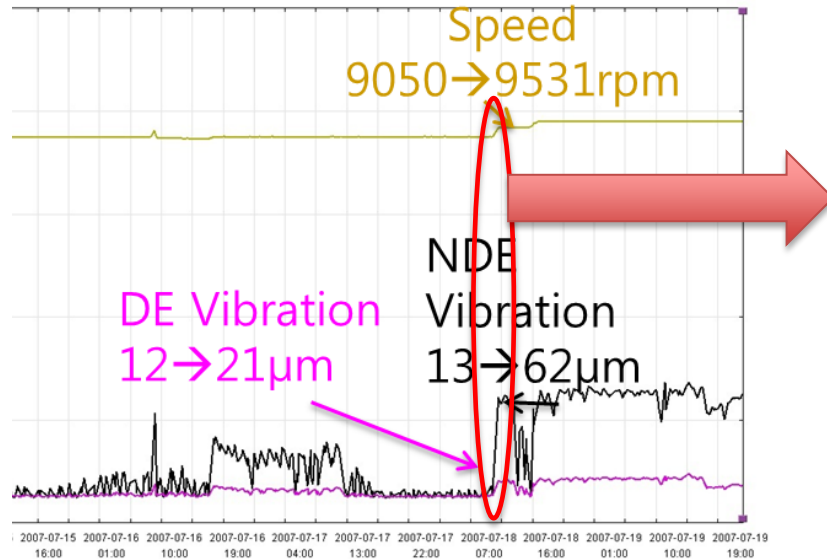
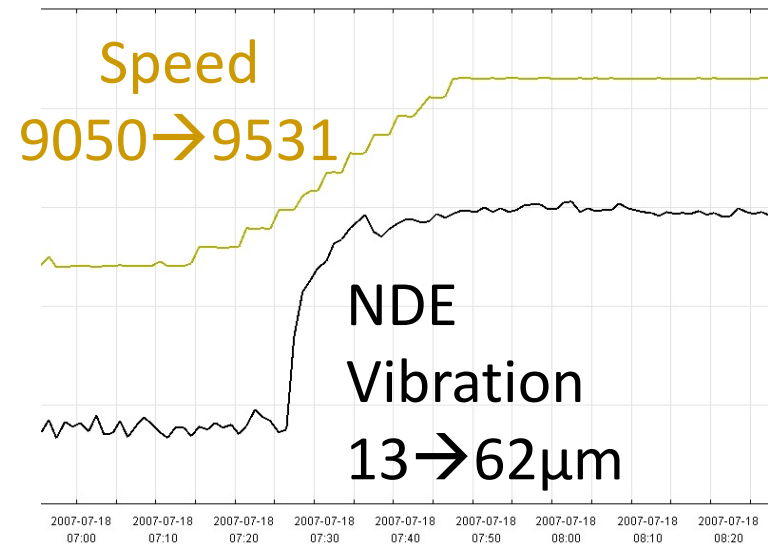
### 3. Troubleshooting - ③ Unexpected High Destabilizing Force

Addition to higher mole weight, vibration amplitude increased as speed increased.

→ Log Dec decreases as speed increases

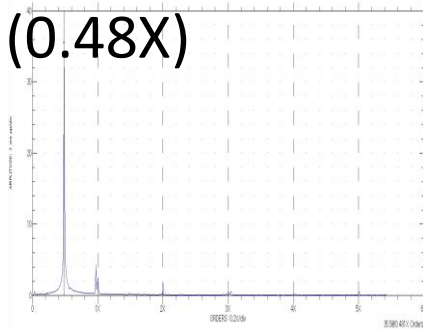
- Sub-synchronous (0.48X)

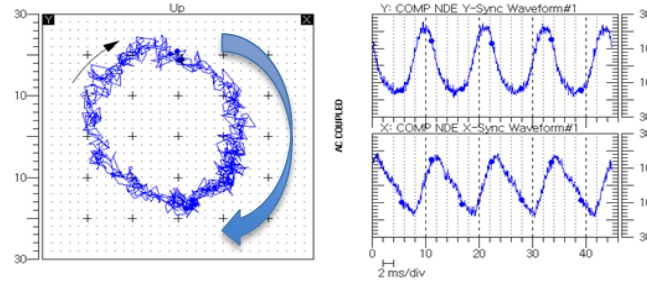
- Orbit form(circular) and Precession(forward)

**Fluid Induced Instability**

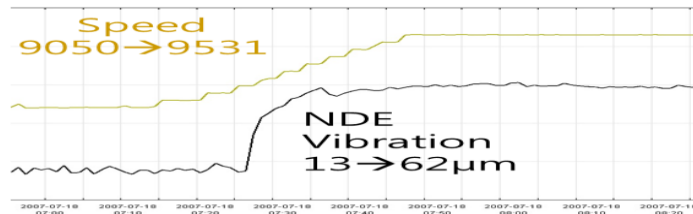
- Higher MW
- Higher speed → higher gas momentum → high vibration

Design : 4.34

Actual : 8.09

**Gas Whirl**

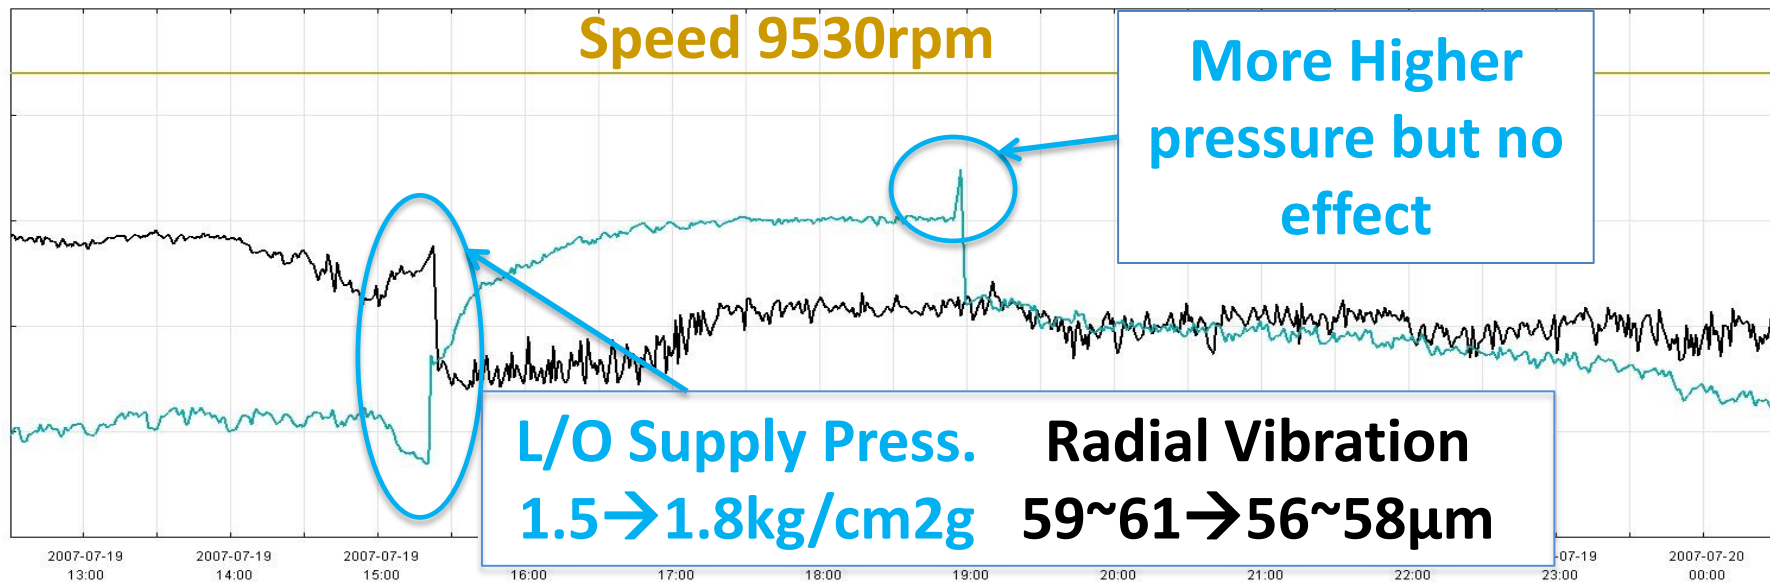
### (1) Increase lube oil supply pressure

Higher oil pressure increase radial stiffness[1]. When oil pressure increased  $1.5 \rightarrow 1.8 \text{ kg/cm}^2$  ( $21.3 \rightarrow 25.6 \text{ psi}$ ), vibration decreased but effect of decreased amplitude is little.

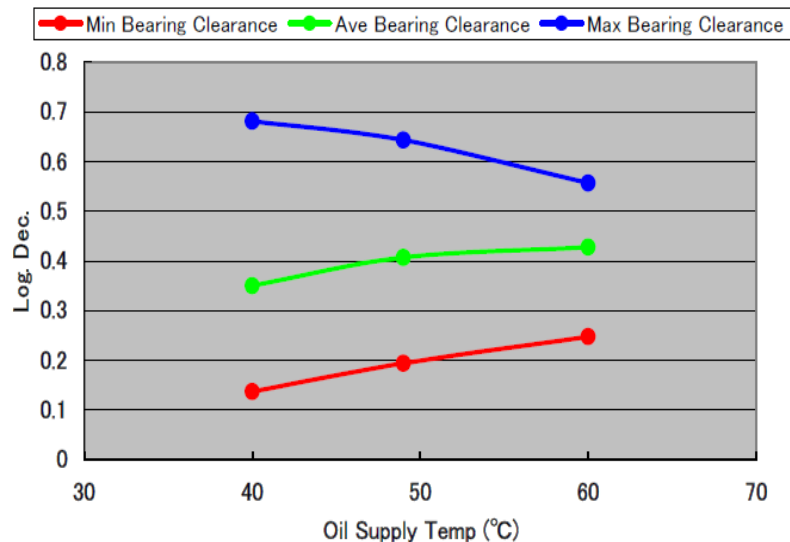
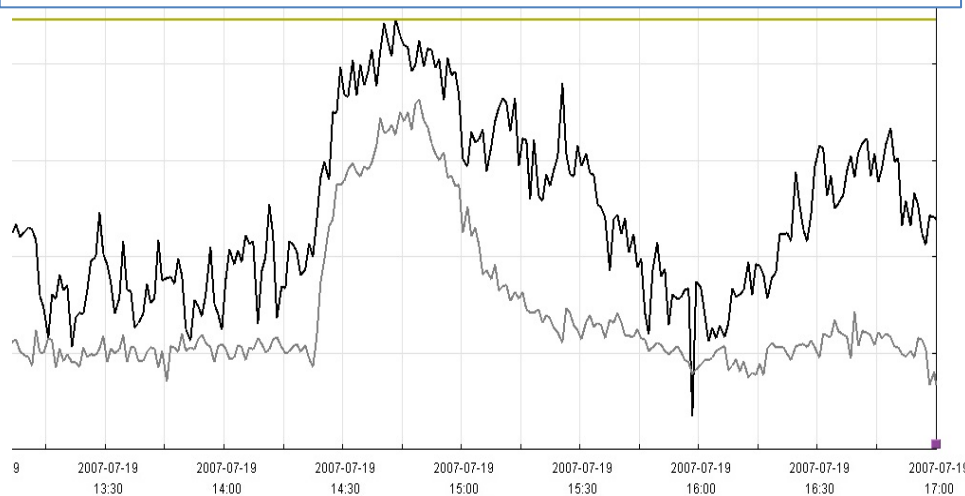
## (2) Increase lube oil temperature

Base on stability analysis, increasing oil temperature should increase log dec. (Bearing clearance was average clearance based on shop assembly result) But increasing lube oil temperature made worse vibration.

L/O Supply Temp. 44→49°C  
Radial Vibration 62→69μm(2.4→2.7mils)

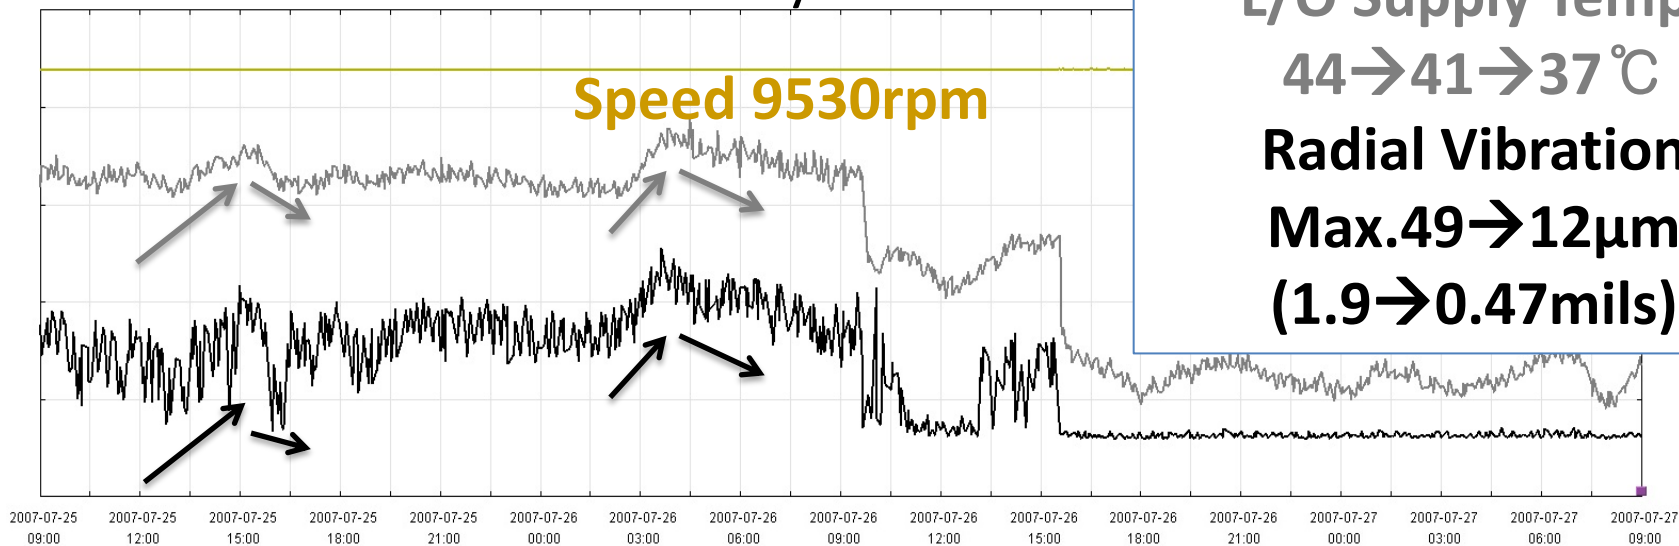
### (3) Decrease lube oil temperature

Base on stability analysis, increasing oil temperature should increase log dec. but increasing oil temperature didn't work. The lube oil temperature was decreased to increase oil damping. (Oil temperature and vibration showed directly related trend also) Then vibration was successfully decreased

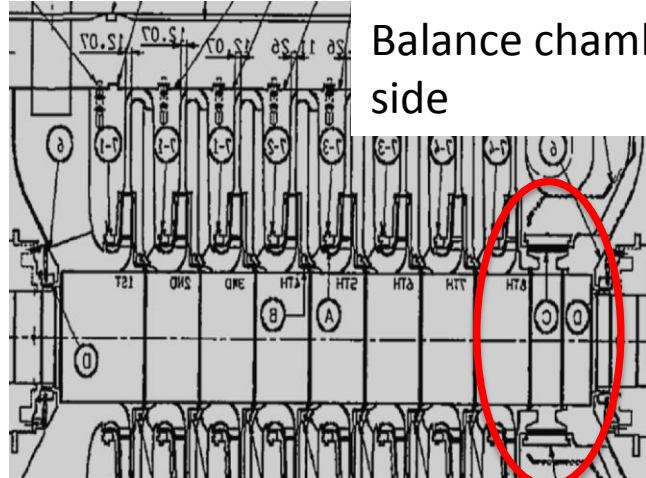
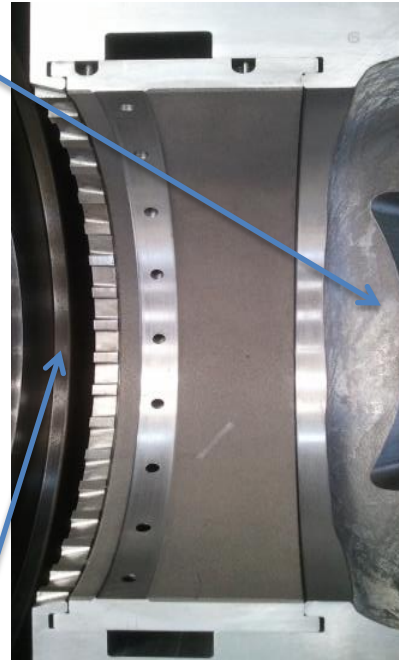
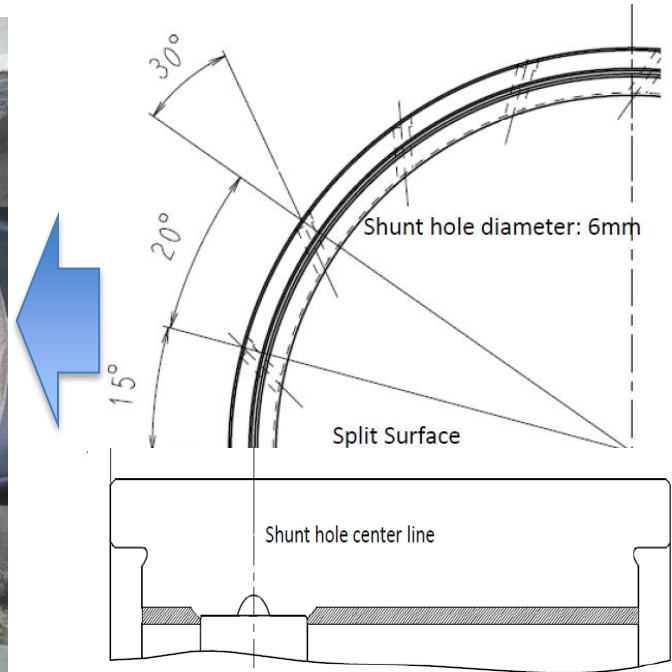
### (4) Apply anti-swirl hole and swirl breaker

Discharge Side (upstream of balance piston)

To solve gas whirl, anti-swirl hole were swirl breaker applied during next T/A(2008). And bearing clearance was increased (0.17~18→0.19mm) to increase log dec.

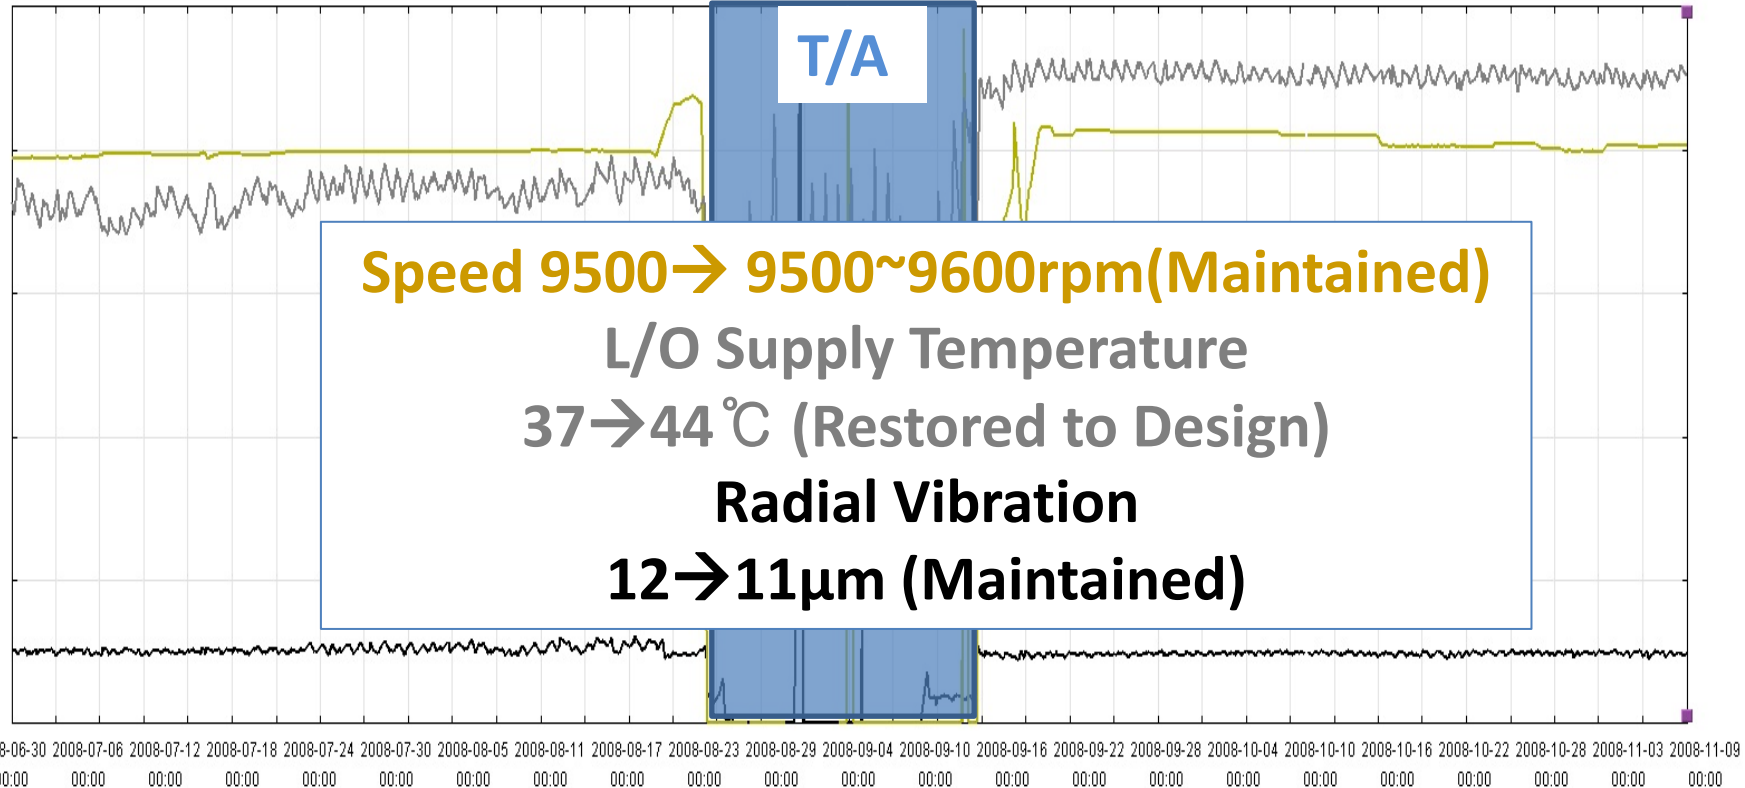
After apply above countermeasure, compressor has been operated stably with oil temperature back to design
