45TH **TURBOMACHINERY** & 32ND **PUMP SYMPOSIA**
HOUSTON, TEXAS | SEPTEMBER 12 – 15, 2016
GEORGE R. BROWN CONVENTION CENTER

A High Bearing Temperature Troubleshooting of Centrifugal Heat-Pump Compressor

Woonsil Lee, and Chi Hyuk Kim
Hyundai Oilbank co. Ltd,
Daesan, South Korea

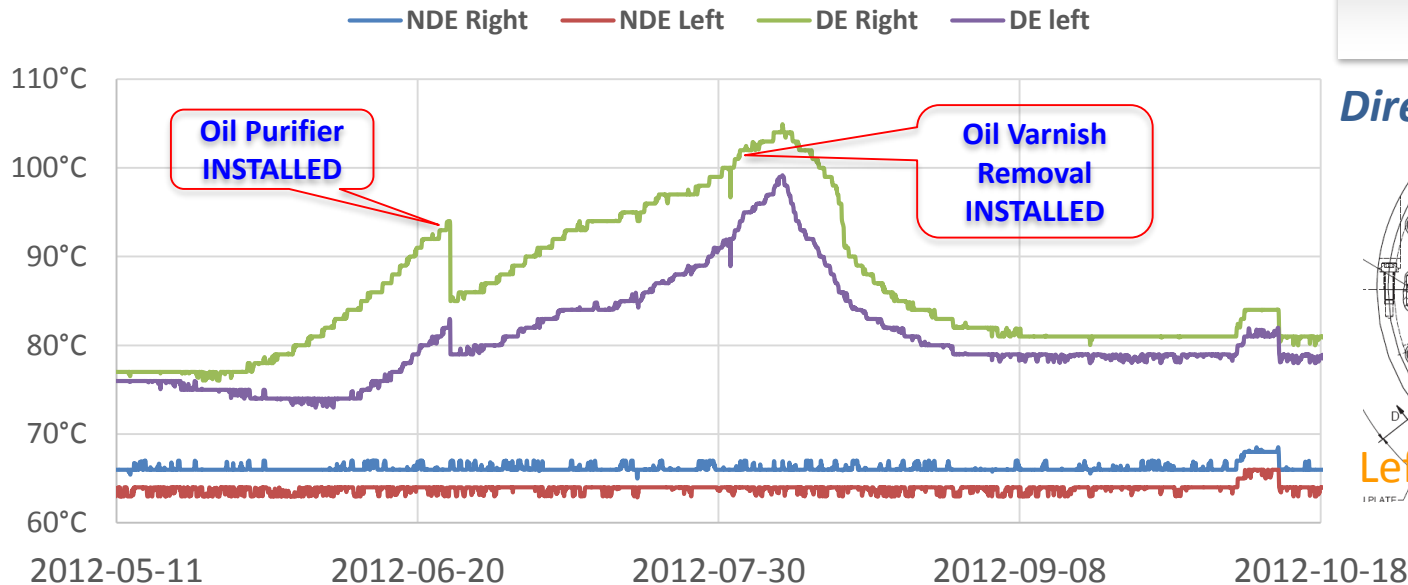
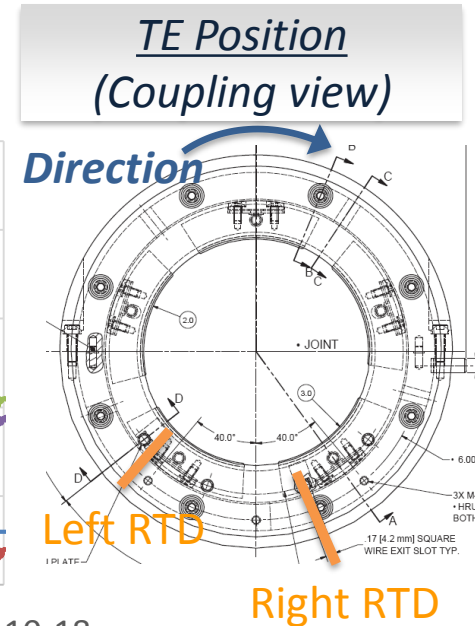
- ✓ In fact, a similar rapid temperature rise had occurred in the same bearing in May 2012.
- ✓ Then the cause of the problem was judged to be **Oil Varnish**; hence, an **Oil Purifier and Varnish Removal Equipment** were installed in the Oil Delivery System. After this action, the DE-BRG temperature decreased and stabilized at around 80°C.
- ✓ **But a similar problem occurred one year later!**

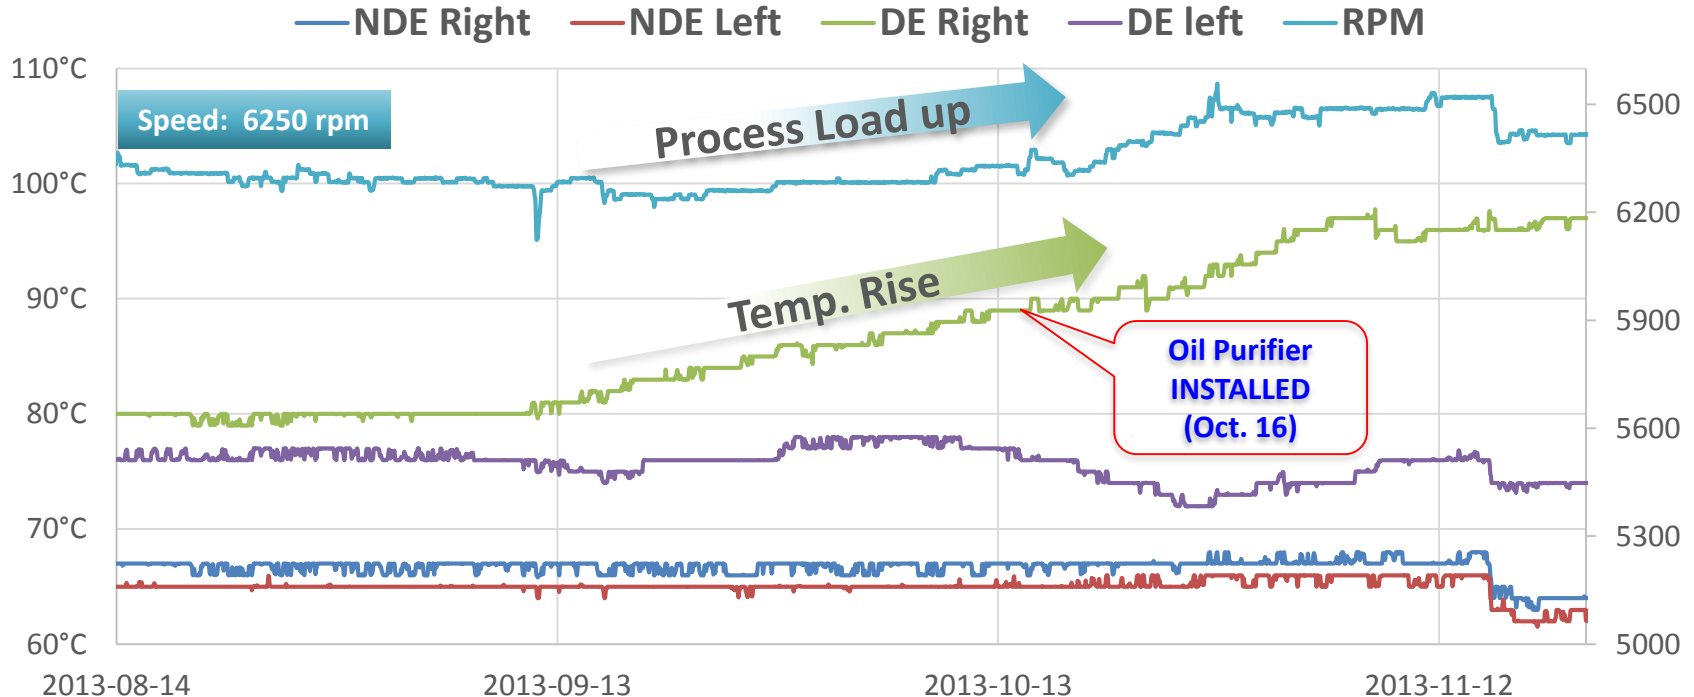
In Sept. 2013, the phenomenon appeared again when increasing the rotor speed following a process of load-up. After installing the **Oil Purifier** and **Varnish Removal Equipment**, the DE-BRG temperature was stabilized at around 100°C.

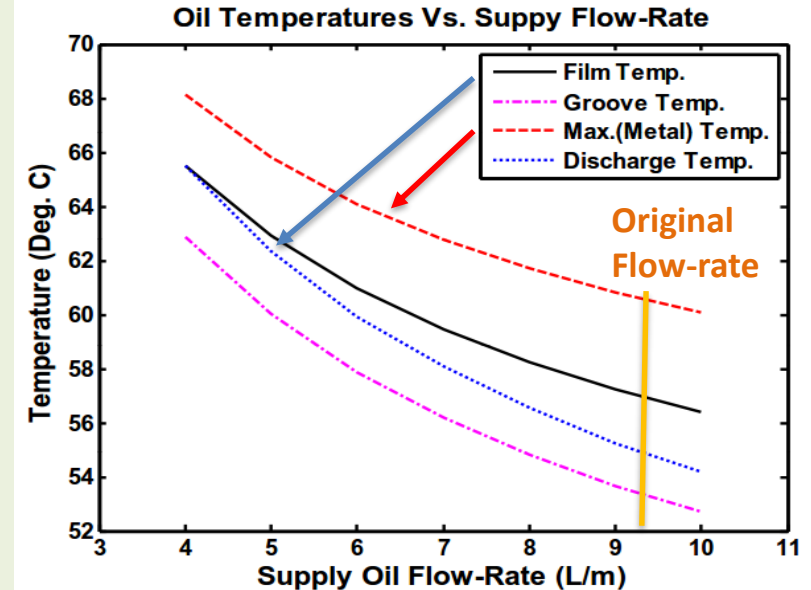
Solution (1) Effect of Supply Oil flow rate checked. Significant improvement (reduced T) when increasing flowrate to the bearings.

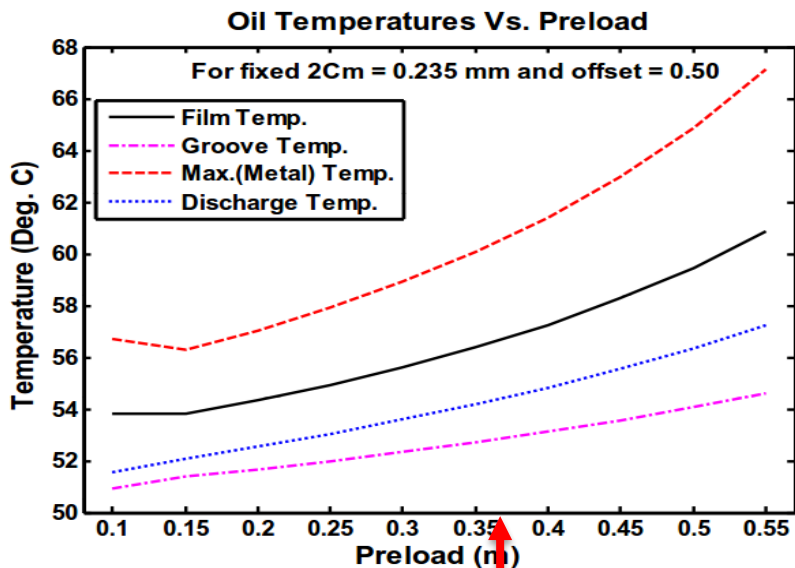
Original Preload(0.351)

Solution (2) Effect of pad preload with fixed machined clearance checked.

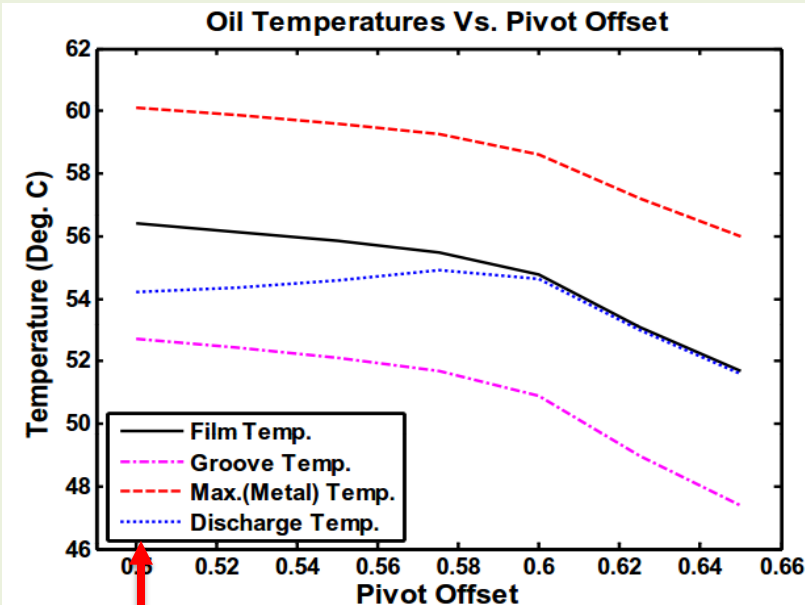
Original Offset(0.5)

Solution (3) Effect of Pivot Offset checked.

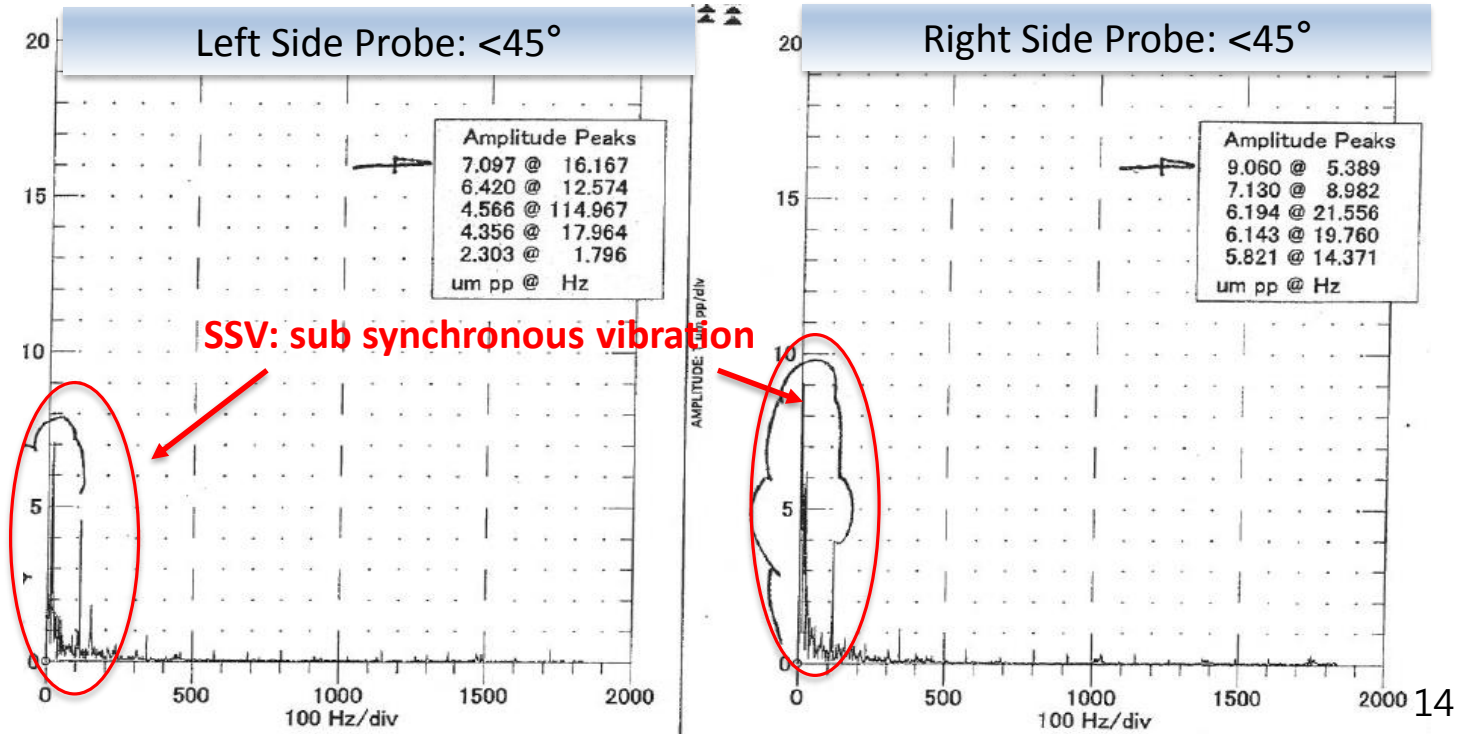
➤ In addition, since SSV Harshness was observed during a Mechanical Running Test of unit, the designed **Pad Preload of the bearing was changed from 0.351 to 0.574** (with Pad Shim) to eliminate the low frequency vibration.

- AT DE side Journal Bearing
- Rpm:6898 (MCS)
- Temp: 38.9°C
- Pressure : 117kpa(16.9psi)
- Flowrate: 5 l/m
- Preload: 0.351

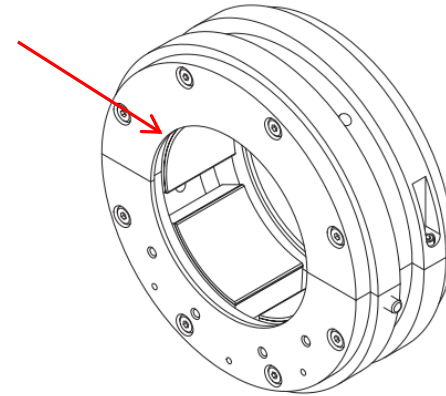
➤ In addition, since the **End Seals' Clearance** on the bearing = 1.52 mm >> than Normal Clearance (0.4 ~ 0.66 mm), the bearing would have actually operated under a **“much more starved flow condition.”**

Bearing Maker	End seals Clearance(mm, Dia.)	Remark
A	1.52	Existing Bearing
B	0.4~0.65	
C	0.64	
D	0.66

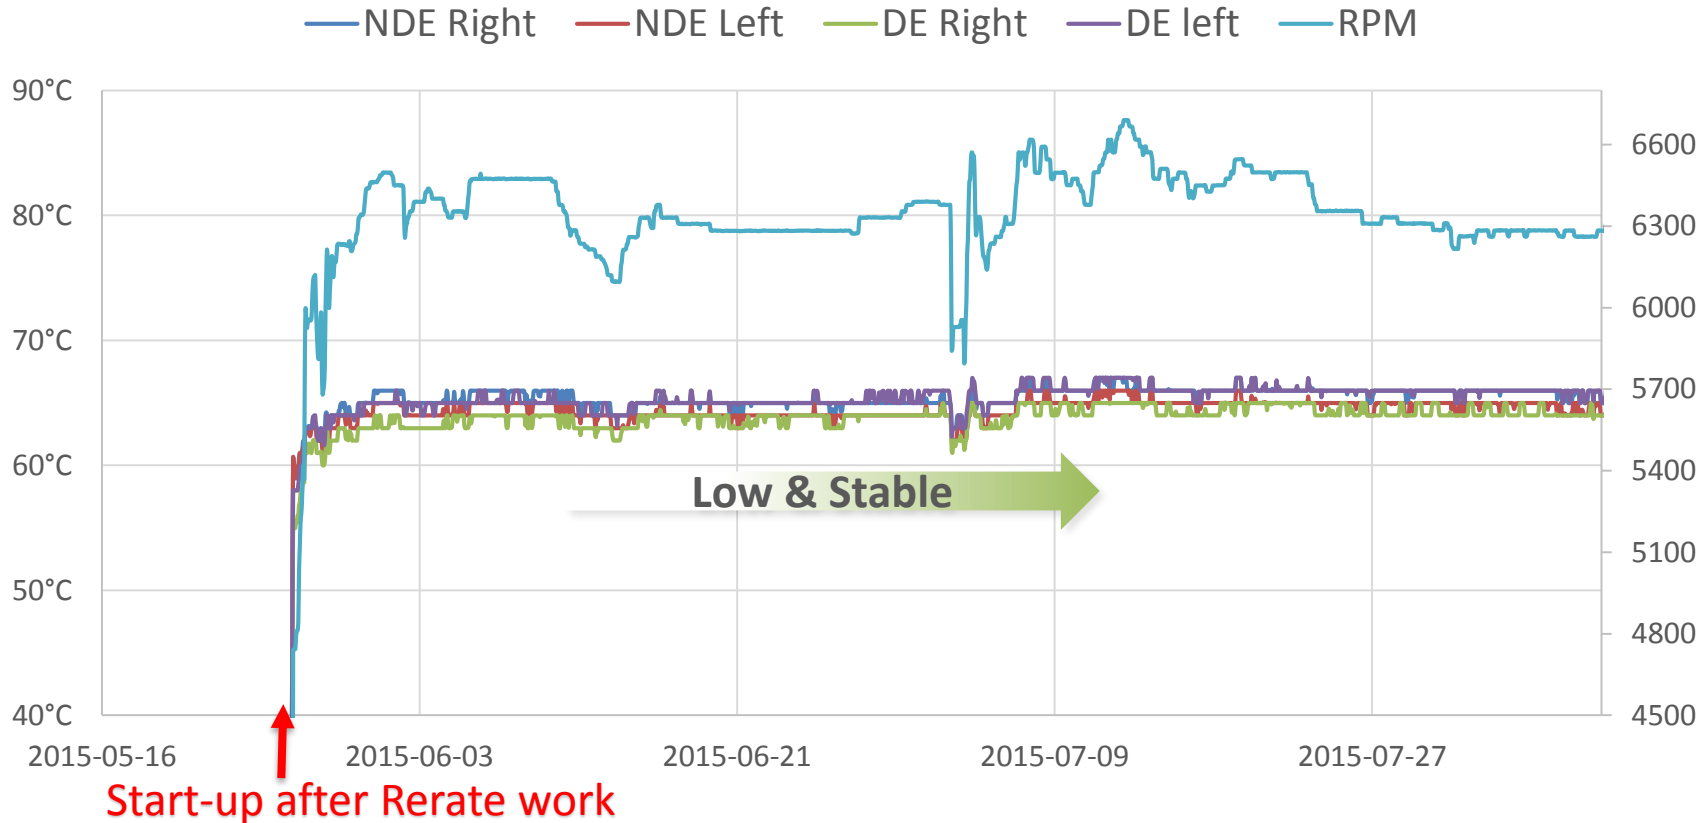
- DE bearing Temperature Vs PRM trend is also steady, in spite of speed variation.
