Mechanical Properties of the Assembly Welded Joint of the Oil Transportation Tank After a Long-Term Service

A L Pimnev¹, M Yu Zemenkova², Yu D Zemenkov³, D P Iljyashchenko⁴

Abstract. The paper provides results of studying a change in mechanical properties of the design elements metal and assembly welded joints of a vertical steel tank after a long-term service in oil transport facilities.

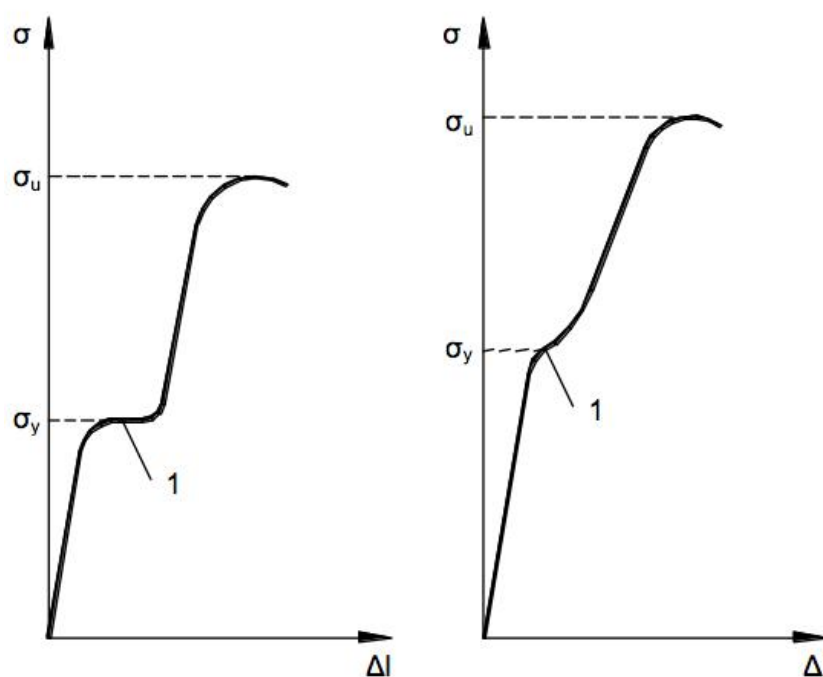
Figure 2 provides stress-strain diagrams of cross-section specimens cut out from the first and second tank rings: the former has a clearly pronounced yield plateau, the latter has almost none. The results of processing the machine stress-strain diagrams are given in table 2.

Figure 2. Stress-strain diagrams of specimens from the first and second tank rings (1 – yield plateau)
