Post-Earthquake Reconnaissance of Unreinforced and Retrofitted Masonry Parapets

Marta Giarretton,^{a)} M.EERI, Dmytro Dizhur,^{b)} M.EERI, Francesca da Porto,^{a)} and Jason M. Ingham,^{b)} M.EERI

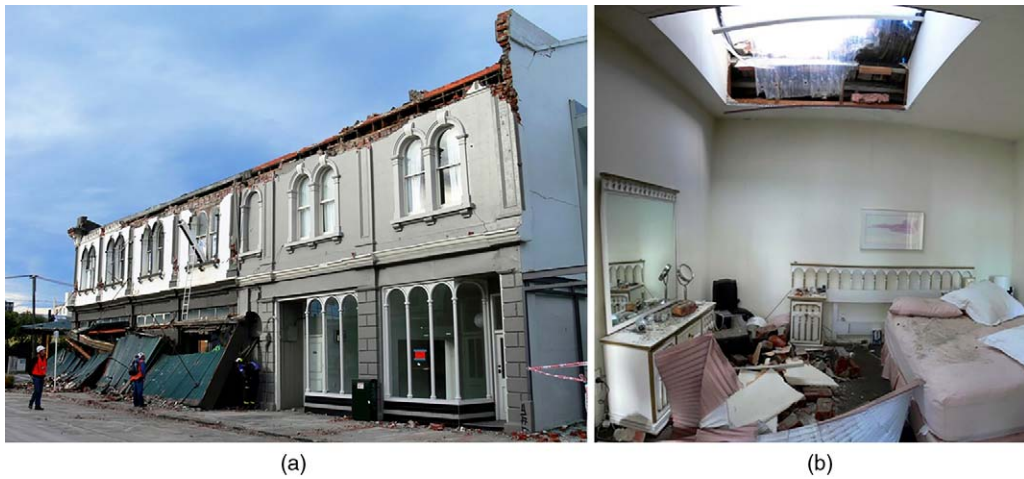
Figure 1. Examples of parapet failures during the 2010/2011 Canterbury earthquakes: (a) URM parapet that has collapsed onto the street frontage; (b) URM parapet that has collapsed into the building interior.

resulting in extensive out-of-plane failure during moderate-to-high intensities of earthquake shaking (Figure 1). Due to the elevated location and the extent of the parapets above the main street frontage and main building entrances, unrestrained parapets of URM buildings represent a major risk to nearby pedestrians and building occupants. Following the 2010/2011 Canterbury (New Zealand) earthquakes, it was reported that 70% (35 people) of the deaths caused by the collapse of URM facades or wall portions occurred outside the buildings, involving pedestrians, persons in vehicles, and people who ran out of a URM building to escape (Canterbury Earthquakes Royal Commission 2012, Johnston et al. 2014).

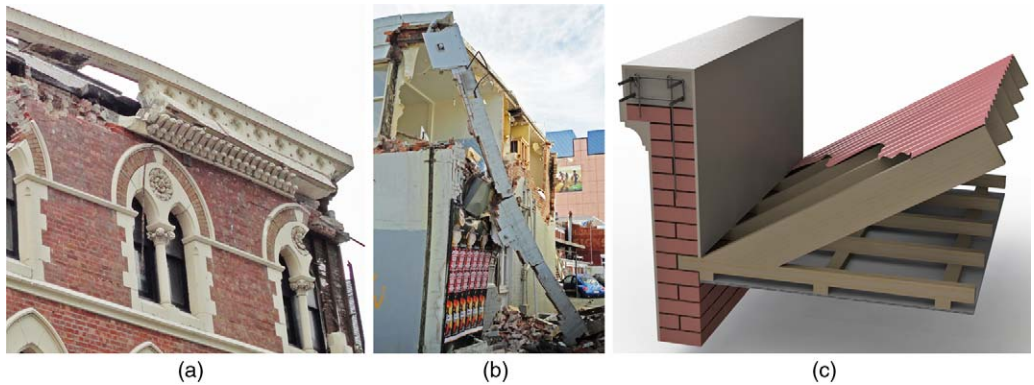
Figure 10. Examples of retrofit with the addition of a concrete bond beam at the top of the parapet: (a) typical concrete bond beam; (b) common failure; (c) design scheme.

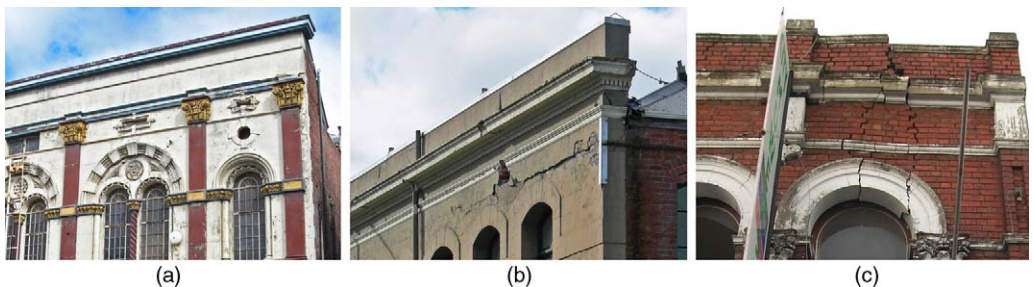
- Standing parapets, Figure 14, includes: (a) no visible damage, (b) visible horizontal cracking highlighting the initiation of rocking behavior of the parapet, and (c) other

Figure 14. Examples of failure categories considered in standing parapets: (a) no damage; (b) horizontal cracking; (c) other types of cracking.

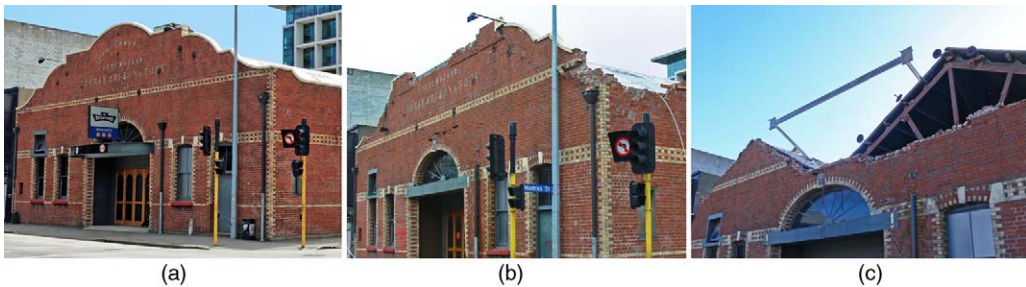
Figure 16 presents an example of progressive parapet damage after different earthquakes.

Figure 16. Examples of progressive damage to retrofitted parapet: (a) former Canterbury Horse Bazaar, prior to earthquakes; (b) partial collapse after 22 February 2011 earthquake; (c) parapet and wall collapse after 13 June 2011 earthquake.

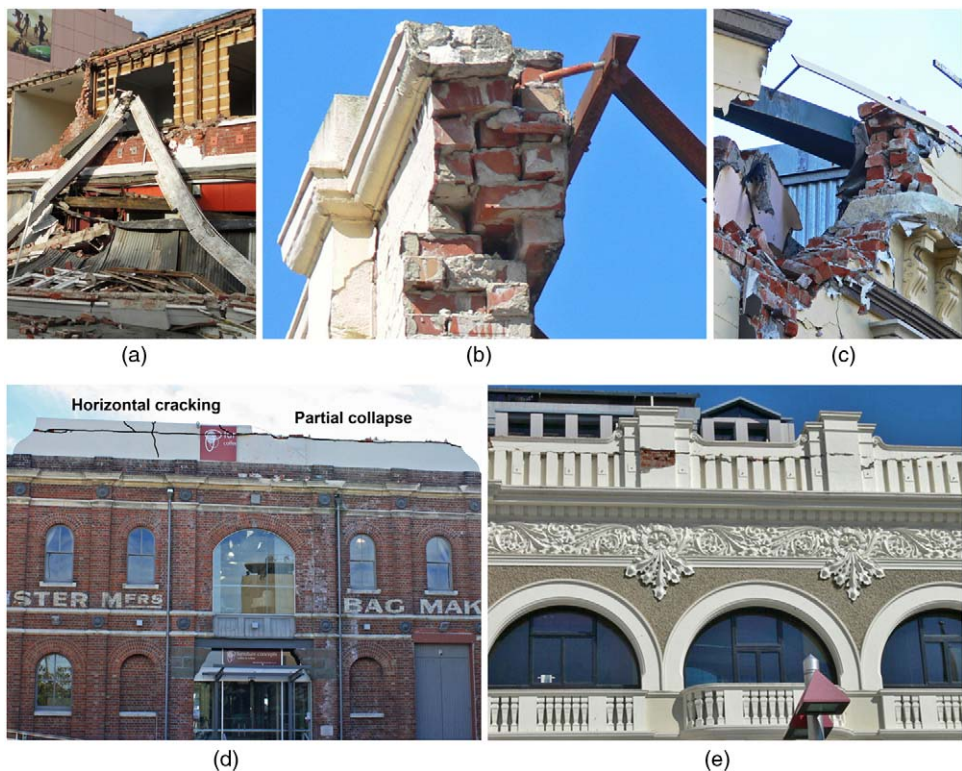
Due to the increased mass the addition of a concrete beam at the top of the parapet was often the cause of collapse of the masonry parapet under the beam or the collapse of both the parapet and the concrete beam (Figure 21a). The typical failure modes of steel braces mounted behind the parapet were: (1) failure due to short embedment of the ties adopted to fix the beam to the parapet (Figure 21b); (2) horizontal cracking corresponding to the location of the horizontal steel beam, followed by collapse of the remaining un-retrofitted part above (Figure 21d); and (3) horizontal cracking at the base of the parapet. Collapse was typically observed when the parapet was retrofitted using only steel braces locally fixed with

Figure 21. Typical examples of observed failure mode for adopted retrofit interventions: (a) collapsed concrete beam; (b) bracing back to structural element – short embedment of the adhesive anchors; (c) steel strip; (d) bracing back to structural element – cracking above the horizontal steel strip (highlighted in black); (e) steel strip – cracking above the horizontal steel strip.

location of the steel strip was observed when the steel strip was applied to all the perimeter parapets as a ring beam (Figure 21e). In some cases, it was recognized that the horizontal steel strip had occasional vertical steel struts connected to the roof structure, typically having insufficient capacity to support the parapet when subjected to earthquake loads.
