PALAZZO LA SAPIENZA IN PISA: STRUCTURAL ASSESSMENT AND RETROFIT OF AN HISTORICAL MASONRY BUILDING IN ITALY

S. Caprili¹, F. Mangini¹, N. Mussini¹ and W. Salvatore²

¹Department of Civil and Industrial Engineering, University of Pisa Largo L. Lazzarino 1, 56122 Pisa silvia.caprili@ing.unipi.it, f.mangini@ing.unipi.it, nicola.mussini@ing.unipi.it, walter@ing.unipi.it

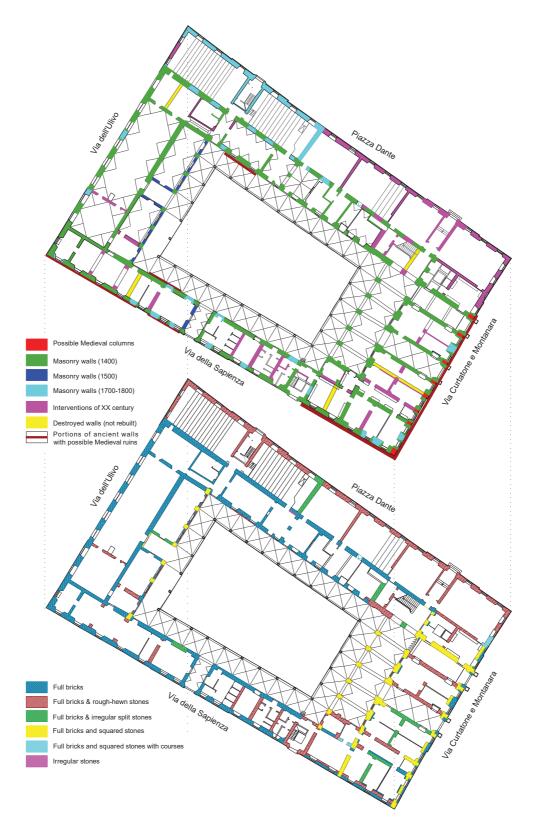
Figure 2: Hypothesis of the evolutive development of the building and plan of ground floor with indications of the various types of masonry.

1. Corner between Via Curtatone e Montanara and Via della Sapienza. As visible from Figure 2, pillars characterized by the presence of full bricks and squared stones demonstrate the pre-existence of ancient tower houses incorporated and connected to adjacent masonry structures during the centuries. The discontinuity and heterogeneity of masonry belonging to different constructive typologies, realized in different periods and not connected to one another yielded, during the years, to the development and to the progressive spreading of a diffused cracking scenario visible both in vertical elements and in horizontal structures, allowing the clear identification of this structural unit.

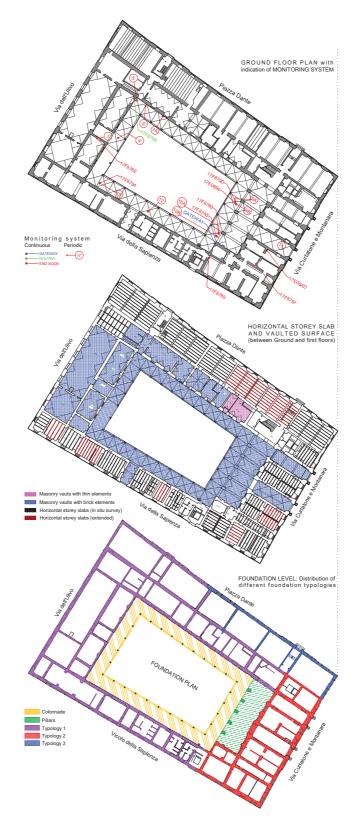
Different types of horizontal structures are present in the building: the ground floor (Figure 3) shows cross or cloister vaults with solid-brick masonry, mainly located in correspondence of the ancient and not modified areas of the Palace – such as in the rooms around the internal courtyard parallel to Piazza Dante and Via dell'Ulivo. The double-height Aula Magna is topped by a masonry/r.c. vault. Floor slabs made of steel and brick blocks in single or double bonds - mainly located in correspondence of Piazza Dante at the ground floor and, in general, at 1st and 2nd floor, portions of the building that suffered for progressive modifications, enlargements and transformation due to use requirements – were also deeply surveyed to obtain information regarding structural profiles and weight of the upper filling layers.

The inhomogeneous and inadequacy of the foundation structure to sustain the increasing loads due to the enlargements of the building in relation to the hosted activities was evident by the early 1900s. A deep in situ investigation of foundations was executed through microcore samplings at different angles in the proximity of the masonry walls, at locations planned according to the evolutionary reconstruction of the building: different types of foundations (for both size and depth) were determined (Figure 3). The investigations performed in correspondence to the interior colonnade revealed the absence of connections between single columns, with an isolated square footing placed at -1.90 m from ground level, below the foundation of the portico pillars, laid at -1.75 m.

Figure 3: Distribution of the floor slabs and types on the building's ground floor, Foundation plan, different typologies evidenced and ground floor plan with indication of monitoring points.

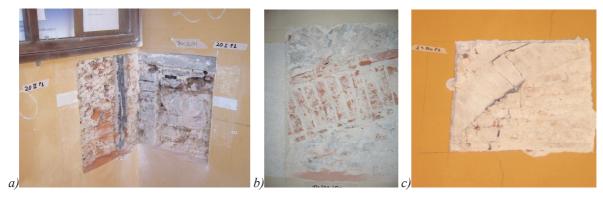
A diffused lack of connection between masonry walls was evidenced (Figure 4a) and different masonry typologies were revealed even in the same element: Figure 4b and Figure 4c, for example, show the presence of masonry arches of ancient openings nowadays closed due to the modified functional needs. The heterogeneity of masonry walls is higher at the ground and first floors (i.e. corner Via Curtatone e Montanara / Via della Sapienza, Figure 2) respect to the second level, realized at the beginning of the 19th century.

Figure 4: Discontinuities of vertical masonry walls: a) absence of connection between perpendicular walls, b-c) arches identified in correspondence of the first floor level, probably old windows currently closed.

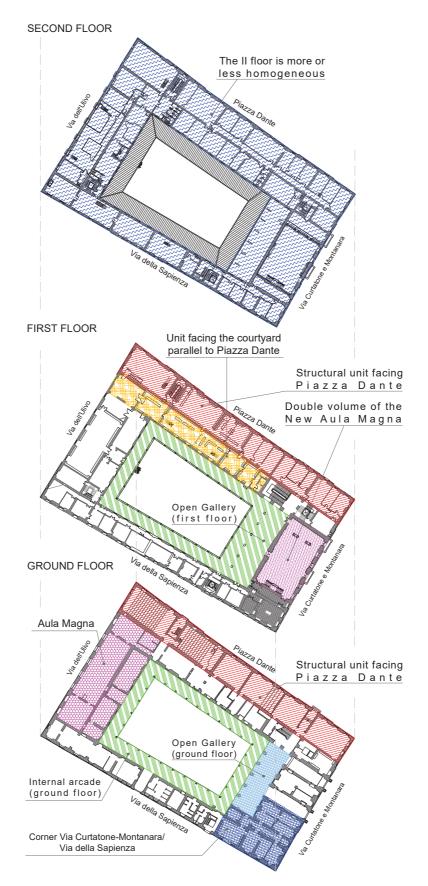
Such more or less rigid systems connect several different structural units resulting from modifications executed during the centuries; according to the results of structural/architectural/geotechnical surveys, the following systems can be identified as "independent structural units inside the aggregate", as simply summarized in Figure 5:

Figure 5: Structural units that can be determined as independent parts of the aggregate.

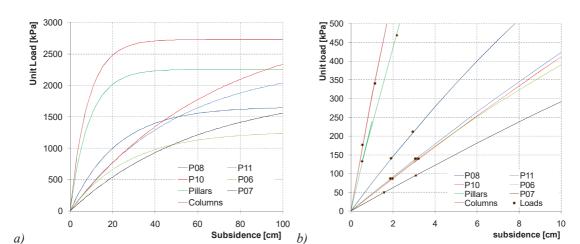
The relative displacements evidenced in correspondence of the wooden elements of the colonnade at the 1st floor and the masonry walls, as well as the diffused cracking scenario revealed in the crossed vaulted surfaces of the ground floor are the direct consequence of the differential subsidence due to the different typologies of foundations (Figure 3). The foundations of columns of the internal arcade are not connected to one another and lay at different levels respect to the masonry walls facing the courtyard: these differences result in relative subsidence evidencing the non uniformity of the overall mechanical response of the foundation system, the variability of soil stiffness and of ultimate loads. The structural analysis of foundations considering actual loads (permanent, live and seismic action) allowed the determination of the unit load-subsidence diagrams of the foundation-ground assemblage of the various analyzed sections (Figure 6a): the difference between the building's perimeter and its interior (i.e. colonnade and pillars of the interior courtyard) can expose the whole structure to considerable damages in those areas where significant differences in stiffness and loads were measured (Figure 6b).

Figure 6: a) Unit load-subsidence curves for the different sections investigated, b) estimates of the subsidence of different building zones as a function of the applied loads.

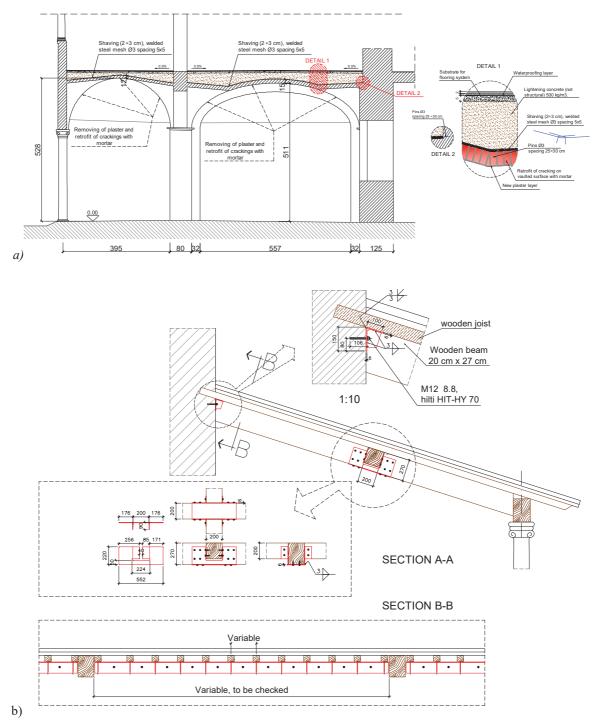
Figure 7: a) Example of the intervention foreseen for the retrofit of the vaulted surfaces of the ground floor arcade; b) retrofit intervention foreseen to provide adequate support to the wooden elements of the first floor colonnade.

The retrofit of the vaulted surfaces consisted in the removal of the filling material on the extrados of the vaulted surfaces – with the following decrease of the dead load – and in the restoration of cracks using specific materials for historical masonry buildings (Figure 7a); a similar retrofit procedure was also adopted for cracks present at the intrados of the vaults. A thin shaving layer of 2-3 cm of thickness with welded steel mesh (ϕ 3 mm and spacing 50x50 mm) was also foreseen provide a global behaviour without altering the structural feature of the aggregate. Some problems were revealed also in correspondence of the 1st floor colonnade, with relative displacement between the wooden secondary elements of the roof and the masonry wall, with support length equal, in some cases, only to few centimeters; in order to prevent the pull out of such elements, an additional steel profile was positioned in correspondence of the whole perimeter of the colonnade (Figure 7b), providing a final support length of about 10 cm. Several additional retrofit interventions were designed for damaged elements of the roofing system.

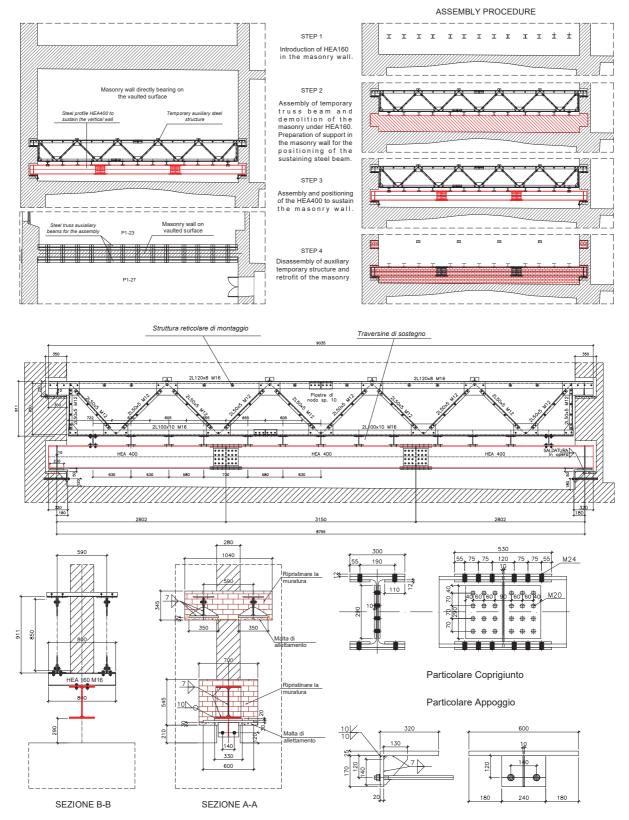
Figure 8: Introduction of stele profile and assembly procedure to avoid the load directly upon the vaulted surface near the Aula Magna.

To solve the problem of the masonry infill wall directly bearing on the vaulted surface close to the Aula Magna at the ground floor, the introduction of a steel HEA profile able to directly sustain the masonry wall and the rest of the superstructure - including the vault at 1^{st} floor and the corresponding masonry wall at the 2^{nd} floor - was accurately designed. The design of the bearing profile took into account both strength and stiffness aspects – this last to avoid the vertical deflection of the masonry wall – and, moreover, the analysis of the assembly procedure (Figure 8). A temporary bearing structure made up of two twin truss beams with transversal support steel beams with spacing equal to 50-70 cm was adopted, allowing safety conditions during the phases of cutting of the masonry wall and introduction of the HEA bearing beam.
