A multidisciplinary approach to assess the health state of heritage structures: the case study of the Church of Monastery of Jerónimos in

Lisbon

Maria-Giovanna Masciotta^{a,1}, João C. A. Roque^{b,2}, Luís F. Ramos^{a,3}, Paulo B. Lourenço^{a,4}

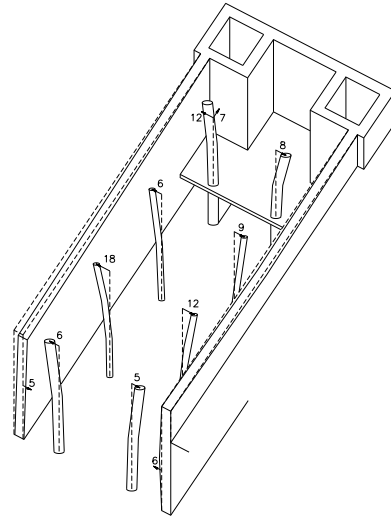
nave that feature larger slenderness. The inspections were executed at about 7 m height from the floor level (one third of the columns' development) and revealed the homogeneity of the material as well as the absence of significant anomalies and cramp irons between stone blocks. A few shallow cracks (or stone detachments) were found in the columns, likely imputable to high stress levels or material defects.

Figure 3 – In situ testing [15]: (a) topographic and photogrammetric survey of nave vault; and (b) out of plumbness of columns and sidewalls.

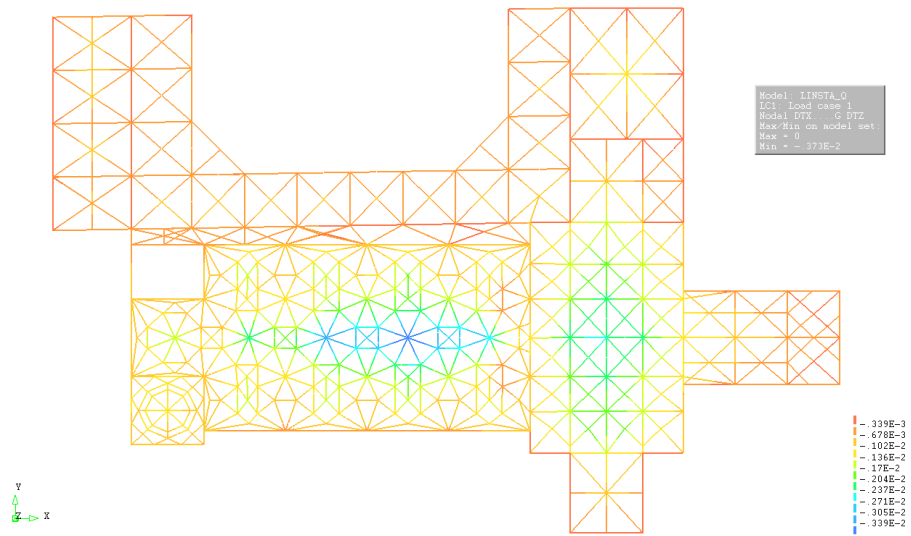
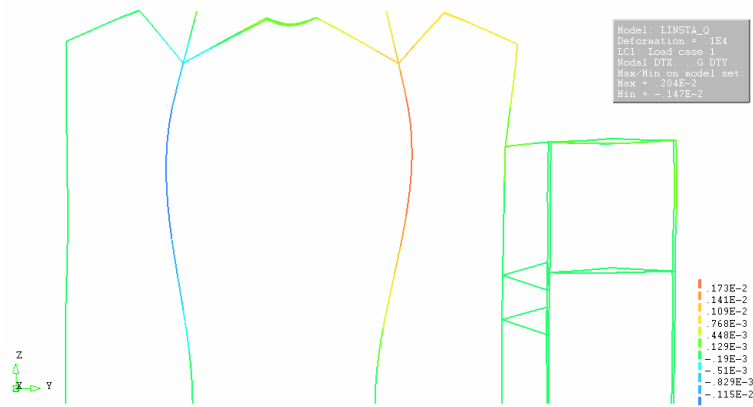
In order to proceed with the evaluation of the safety level of the church, a first analysis was carried out under vertical loading assuming linear elastic behaviour of the material. The results indicated that the maximum deformations occur in the main nave of the church and are rather small. Figure 9 shows the typical arch shape deformation of the transversal section of the nave (central arcade), where maximum displacements of 3.7 mm and 21 mm are found for the vault key in vertical direction and for the upper part of the columns in horizontal direction, respectively. Unlike the north wall, the south wall does not show any outward displacement, sign of its minor sensitivity to the thrust action generated by the vault above. The stresses present in the structure are within the linear range of the material, e.g. the maximum compressive stresses in the columns are lower than 3.30 MPa. Tensile stresses up to 0.6 MPa are found in the nave vault, but they are very localized and the compressive stresses do not exceed 4.0 MPa in the critical areas where the ribs spring. Altogether, the average tensile stresses present in the structure are below the tensile strength of masonry.

Figure 9 – Linear static analysis for vertical loads. Deformed mesh of the church: (a) plan and (b) central arcade of the nave.

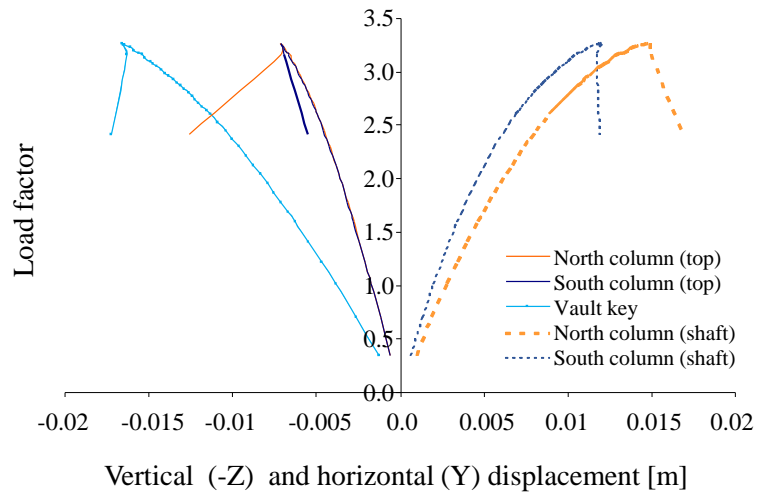
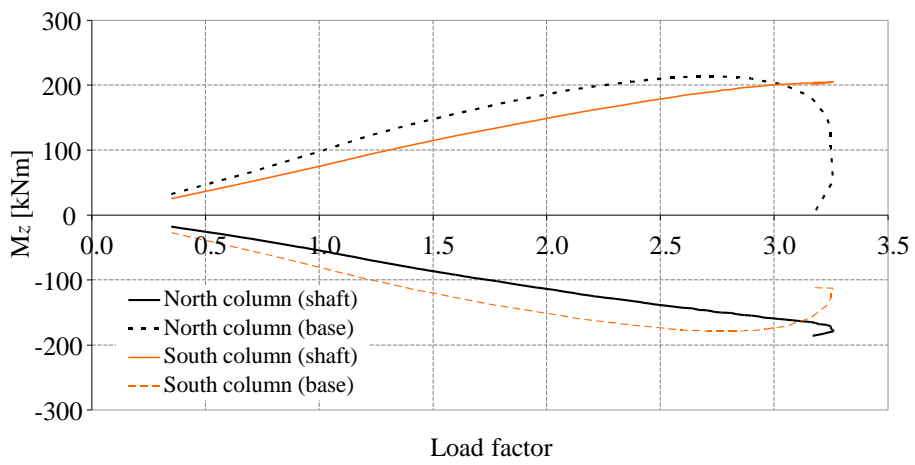
As columns and vault resulted to be the most critical sub-structures of the system, a second nonlinear static analysis under vertical loading was carried out in order to catch the possible occurrence of non-linear phenomena in these elements and to assess the global structural capacity of the church for gravity loading. A uniform distribution proportional to the mass is adopted for the loads (uniform pushover). The results of the nonlinear analysis are shown in Figure 10a and Figure 11 in terms of post-peak deformed shape and load-displacement diagram for both vault key and columns of the central arcade. Here, the load factor represents the ratio between the self-weight of the structure and the applied load. It is highlighted that the response of the church is severely affected by the structural behaviour of the supports, especially in

Figure 10 – Nonlinear static analysis for vertical loads: (a) capacity curve; (b) moment-load factor diagram for the central arcade of the nave.

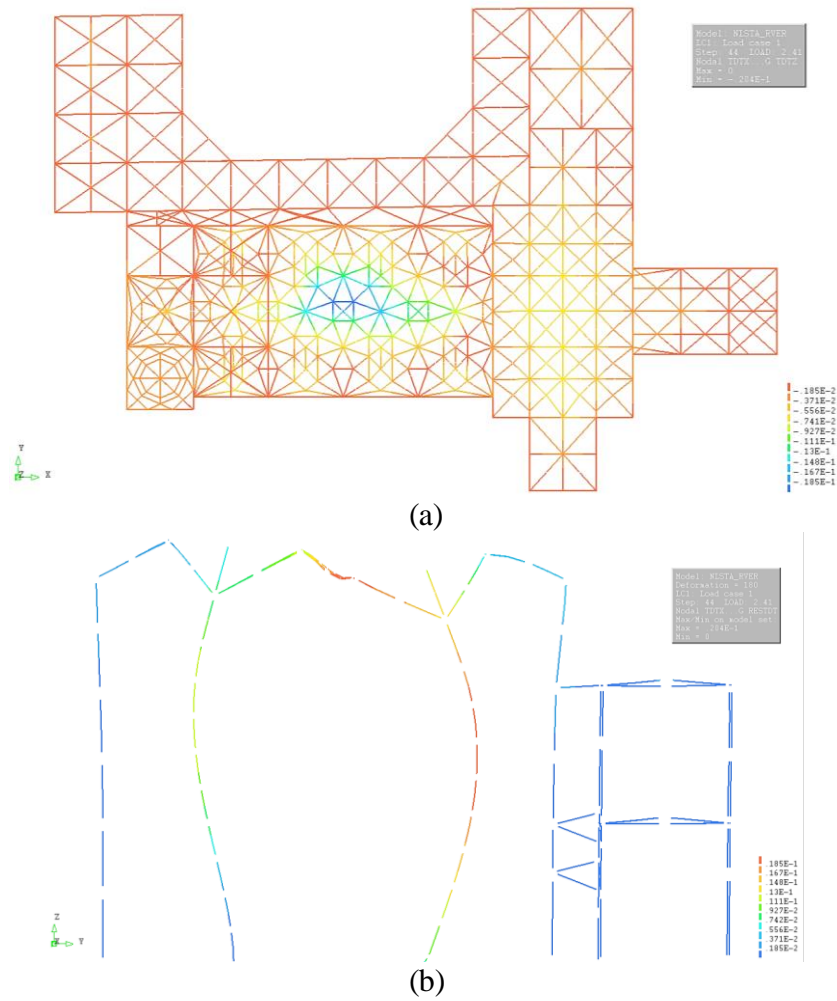
regard to the north column which shows a sudden loss of bearing capacity associated with increasing horizontal and vertical displacements (up to 13 mm) which affect in turn the vault key. The ultimate load factor is 3.25 and corresponds to the collapse of the north column due to combined normal and flexural actions. For the same peak value the nave vault exhibits a nonlinear behaviour with diffuse cracking. Note that the maximum ‘flexural moment’ at the base of the columns is attained for a load factor of 2.7 (Figure 10b), but the stress redistribution associated with the nonlinear behaviour of the supports delays the failure. Therefore, the crushing of the north column occurs for increasing compressive stresses of decreasing eccentricity.

Figure 11 – Nonlinear static analysis for vertical loads. Post-pic deformation of the church (LF = 2.41): (a) plan and (b) central arcade of the nave.

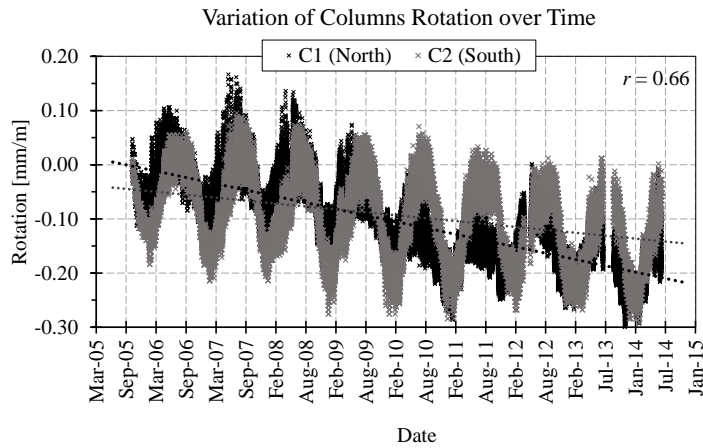
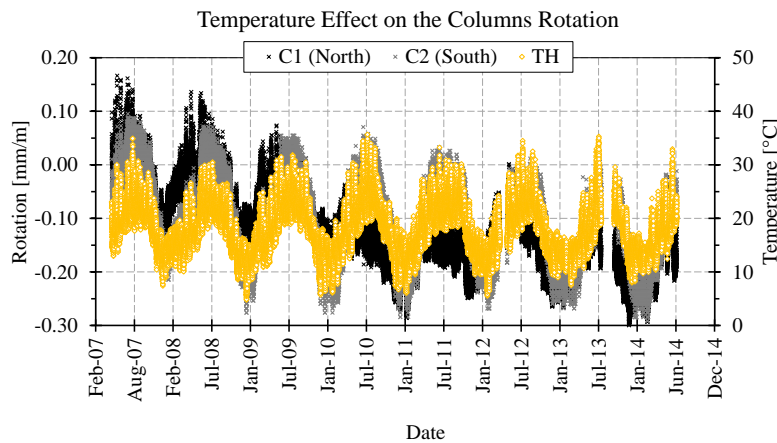
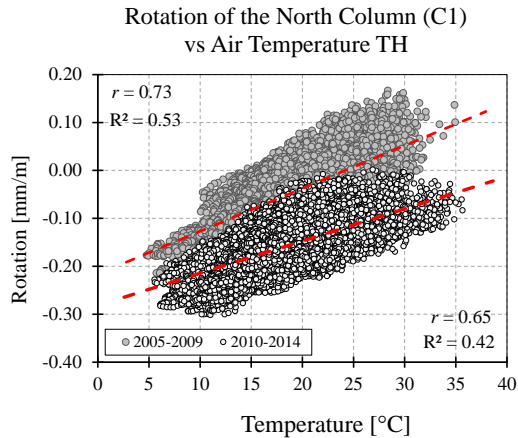
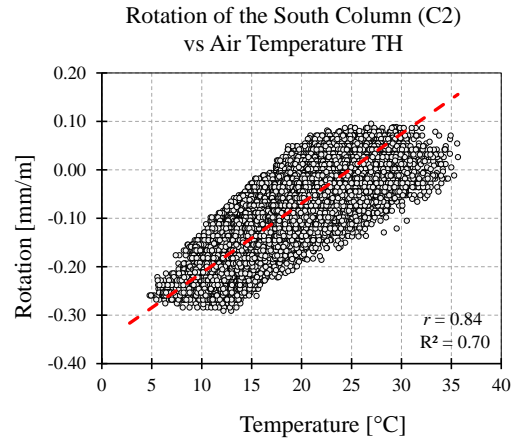
Analysing the tilt data, it is found that the two columns of the central arcade are moving in north-south direction with in-phase cyclic oscillations of different amplitudes (Figure 15a) which follow a linear decreasing trend. Column C2 is leaning towards south (negative direction) with an average tilting rate of 1.3×10^{-2} mm/m per year and oscillations ranging between 0.10 mm/m and -0.29 mm/m. Column C1 is also leaning towards south, but with a wider oscillation range varying from 0.17 mm/m to -0.30 mm/m and a tilting rate of 2.0×10^{-2} mm/m per year, 35% faster than column C2. Assuming the centre of rotation at the bottom of each column and rigid body movements, the horizontal displacements at the top of the columns range between 0.21 mm and 0.32 mm. The inspection of Figure 15b reveals that the cyclic oscillations of the columns considerably suffer from the seasonal fluctuations of the temperature: when the temperature goes up, the columns do rotate towards north, whereas when the temperature goes down, the columns do lean towards south. However, after each cycle, the columns never recover their original position, but show an increasing residual tilt towards south which indicates that the out-of-plumbness of both supports is permanent and keeps on raising over time, especially in regard to column C1. This behaviour is further confirmed by the analysis of the rotation-temperature relationships which show a remarkable change of the slope of the regression line for the north column C1 (Figure 15c), although the range of temperature

Figure 15 – Columns rotation: (a) variation over nine-year span (trend lines are added as visual aid); (b) temporal variation with respect to air temperature; (c) rotation-temperature correlation for column C1; and (d) rotation-temperature correlation for column C2.
