Durability of Ring-Road II asphalt pavement

Phase I report on forensic analysis of Ring-Road II pavement distresses

Aalto University publication series
SCIENCE + TECHNOLOGY 18/2013

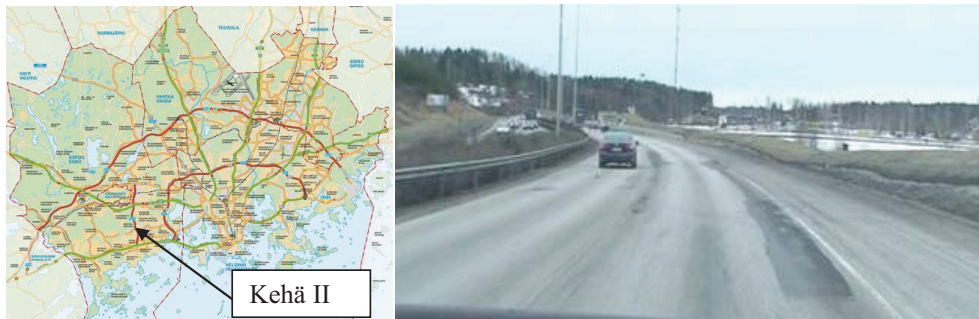
Figure 1. Ring-road Kehä II location and pavement condition before overlay in 2011.

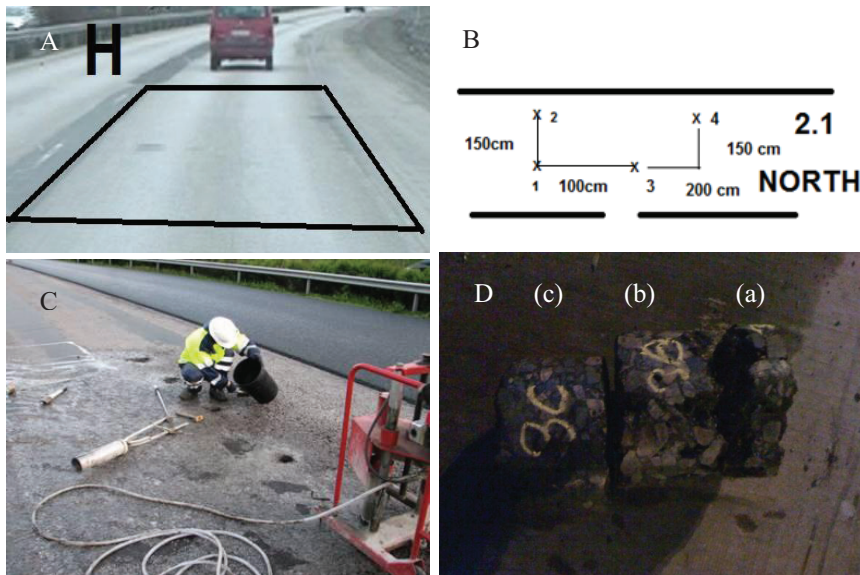
Figure 5. A) Core location H, B) coring plan, C) obtaining samples by coring, D) pavement layers separated during coring, layer (a) is wearing course, (b) is binder course SMA 20 and layer (c) is asphalt base course (ABK) .

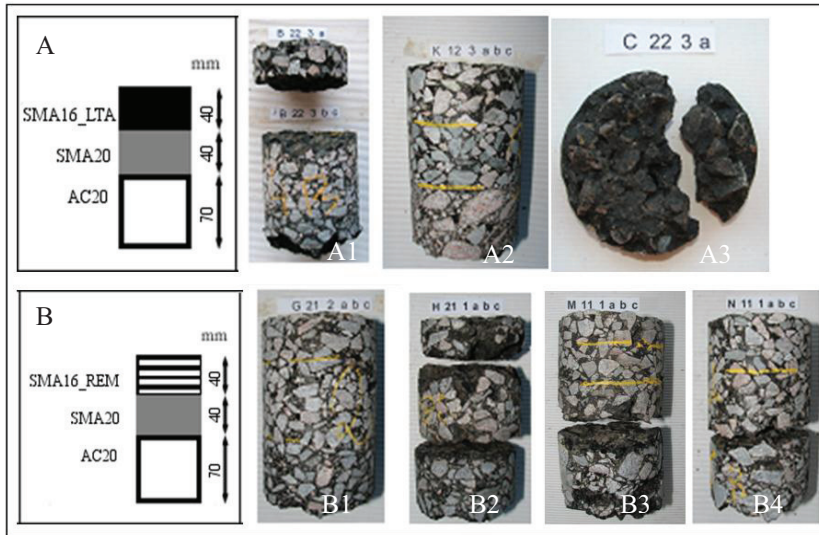
Initial findings during sampling suggested very weak pavement structure as cores broke during coring, see Figure 6. In location O, there was some finer levelling course mixture placed between the ABK and SMA 16 binder course layers, as shown in Figure 7a. Visual inspection of pavement slabs confirmed that the original SMA 16 2002 layer was brittle and colour of asphalt was brown while the newly laid SMA layer was black and shiny as expected (Figure 7b). Also, there was thin layer of ice underneath the SMA 16 LTA 2002 layer indicating that moisture was able to infiltrate to the pavement structure due to lack of bonding between layers.

Figure 6. (A) Sketch of original road structure asphalt layers – 2002, (A1) surface layer was not bonded; (A2) monolithic pavement structure in good condition; (A3) weak mixture and binder washed away; (B) sketch of road structure after rehabilitation in 2007-09, (B1) structure in good condition; (B2) all layers were separated; (B3&B4) ABK layer is separated.

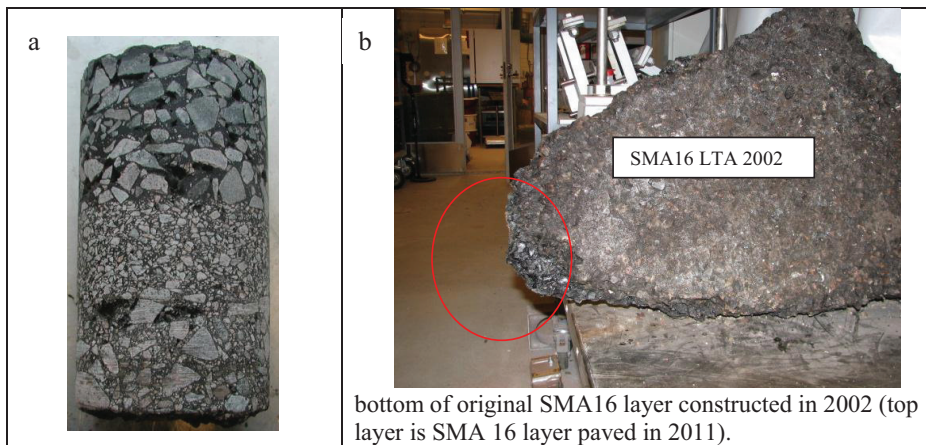
Figure 7. a) Core drilled from location O, b) slab from location E, brown color of SMA 16 LTA 2002 is clearly visible.

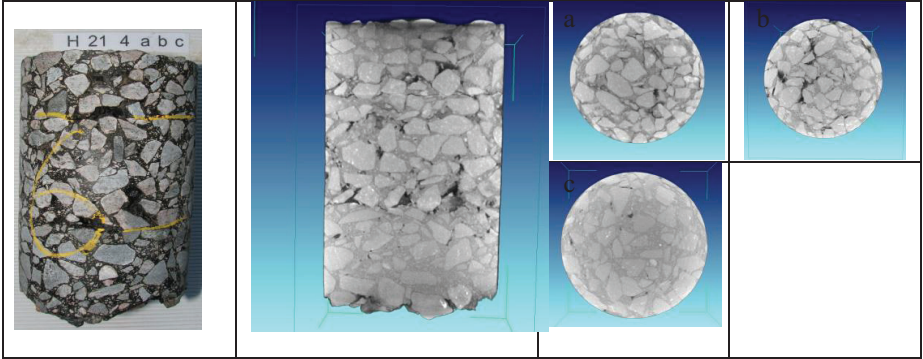
Figures 9 to 12 show the test specimen photographs and tomography pictures for the whole core and three slices from top, middle and bottom of core. It can be seen from the figures that there were large air void pockets in the specimens. Photos from samples H, I and N show black continuous lines between layers indicating that layers are not well bonded and there is a small gap between them. In sample M, joints are not visible but the whole sample has large air void pockets. These photos suggest that the treated or remixed layer depth was less than 40 mm for all other samples expect for perhaps sample M.

Figure 9. X-Ray scan of core H 21 4abc, on right: top (a), middle (b) and bottom (c) slice of the core.

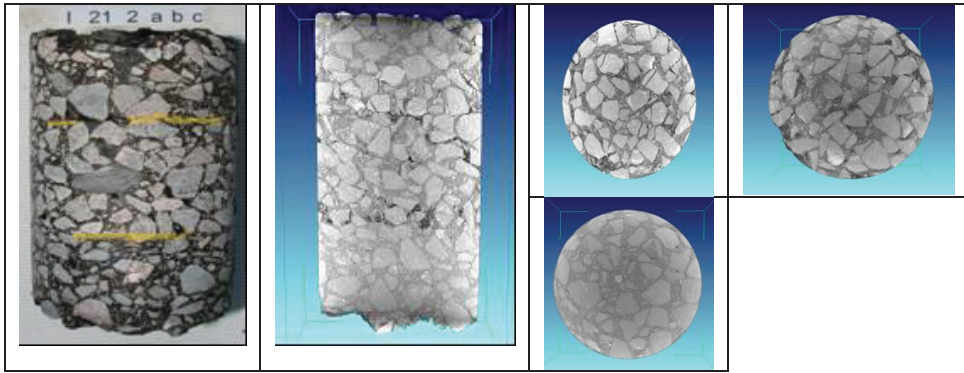
Figure 10. X-Ray scan of core I 21 2abc, on right: top, middle and bottom slice of the core.

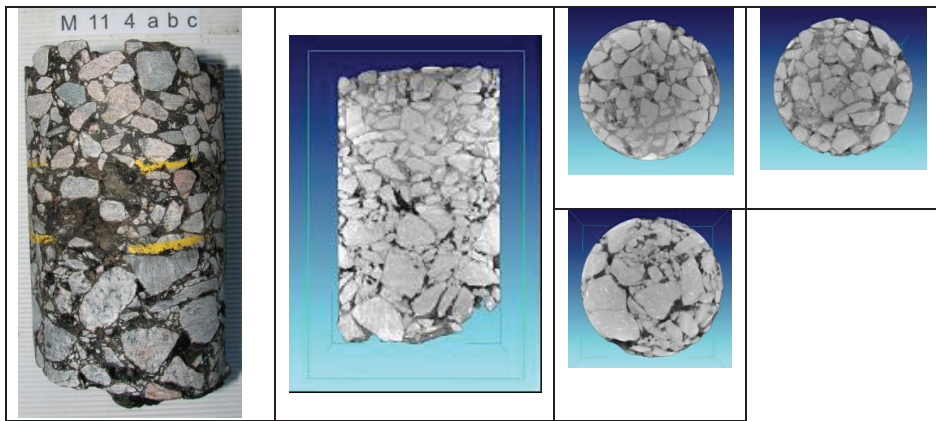
Figure 11. X-Ray scan of core M 11 4abc, on right: top, middle and bottom slice of the core.

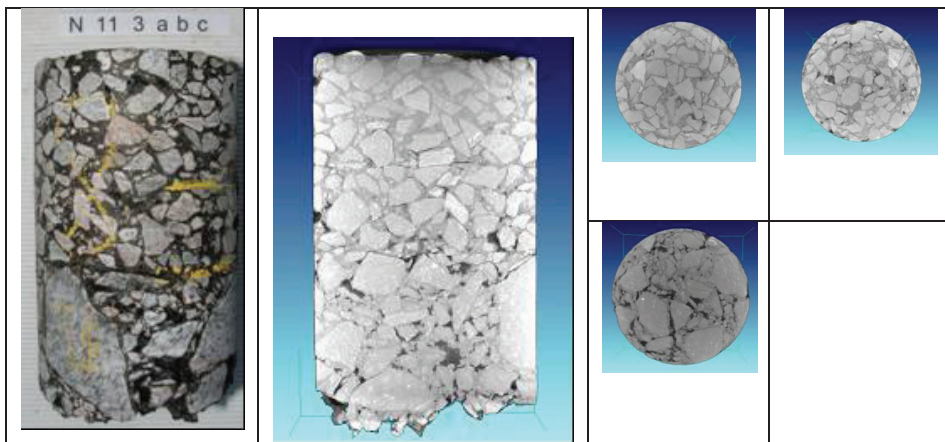
Figure 12. X-Ray scan of core N 11 3abc, on right: top, middle and bottom slice of the core.

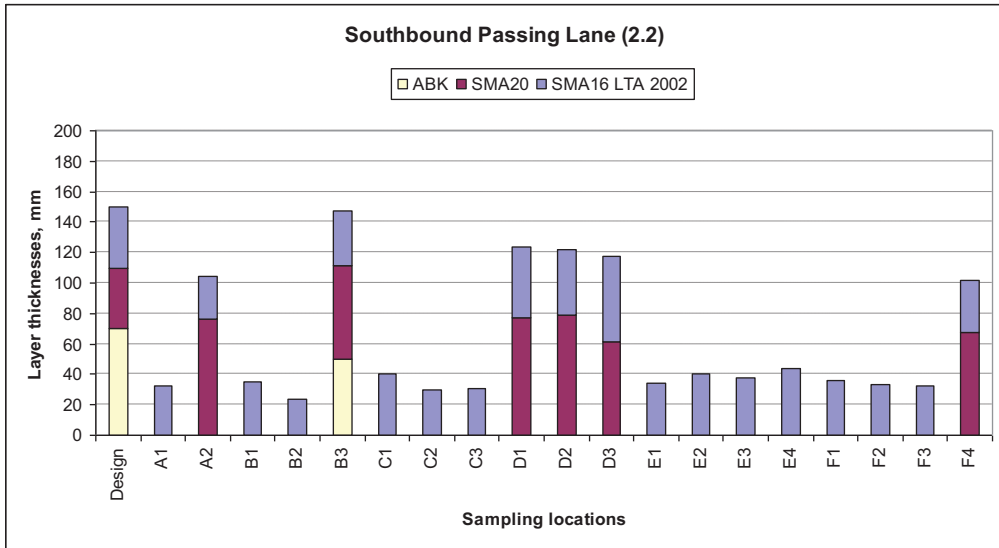
Southbound passing lane was badly deteriorated as cores broke, and therefore full depth cores were not obtained from most of these locations (Figure 16). Northbound lanes were in better condition and total pavement thickness generally met or exceeded the total design thickness of 150 mm (70+40+40 mm). This agrees with construction records, as the amount of laid mixture was reported to be 99,06 - 99,93 kg/m², i.e., layer thickness being 40 mm. However, construction records did not indicate how much tack coat (glue) in liters was used during construction. The observed bond failure between layers was caused either by lack of applying tack coat during construction, or by the fact that it was washed away by excessive water infiltration to the pavement, or by the combination of these both.

Figure 16. Core thicknesses of southbound passing lane samples.

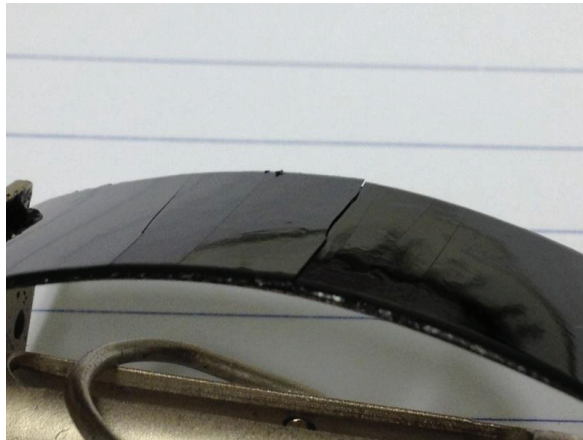
Figure 21. Binder film cracking on Fraass breaking point measurement test: example of large crack easy to see and smaller cracks more difficult to detect by naked eye during testing.

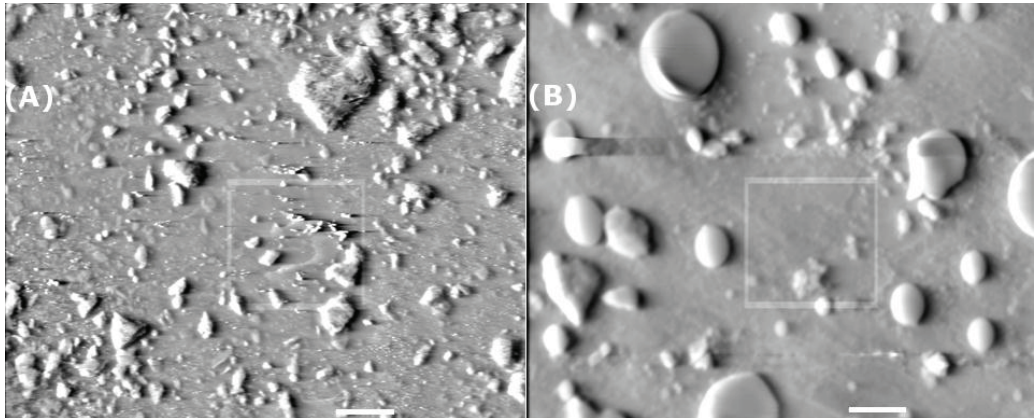
Dominating shape within particle size of 100 μm was assigned to the coarse aggregate (Figure 25(A)). As magnification increased (Figure 25(B)), the dominant particle size became spherical, ovoid, amorphous or fractured spherical, which was assigned to the particles originating from fly ash.

Figure 25. Images of *Kehä II* fines, area E after extraction, fraction $<0,063$ mm. Legend bar indicates distance of (A) 100 μm and (B) 10 μm .

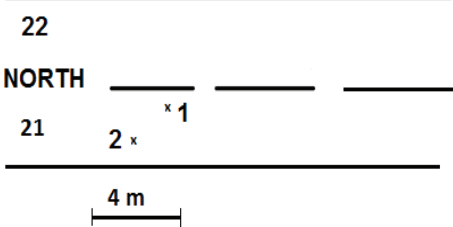
<p>Distance between 1&2 2,25 m</p>			
Comments: This was visibly a good area. All the three layers of both samples were bonded together.					
SAMPLES	I 21 1 a b c		I 21 2 a b c (NS&T)		
Thickness (mm)	a=46,02 b=60,9 c=56,3		a=50,1 b=61,39 c= 52,3		
Air voids content %	a=3,1 (2,430) b= 4,9 (2,443) c= 0,0 (2,490)		abc=3,3 (2,459)		
Bulk density ρ_b (Mg/m ³)	a=2,354 b=2,324 c=2,489		abc=2,378		
IT Strength (MPa)	a=2,56				
IT Stiffness (MPa)	a=8708 b=10596				
Max. density ρ_m (Mg/m ³)	a=2,430 c=2,470 (too low compared to ρ_m)				
Binder content (%)	a=5,9 c=4,8				
Penetration, Soft. Point (°C), Fraass (°C)	Pen 17,7 SP 65 °C				
X-Ray Scanning	NO		YES		
Size (mm)	%-passing I1c

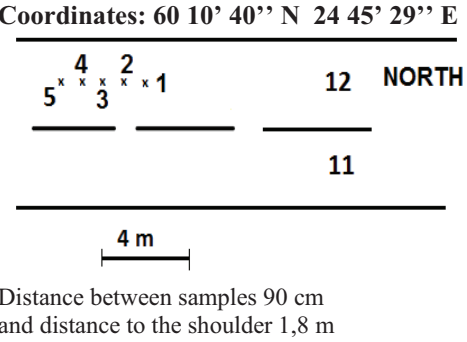
Comments: This was a good area. All the three layers were bonded together.
