MADAGASCAR POST-DISASTER DAMAGE ASSESSMENT:

Feasibility Study For a Training Program  
In Housing Repair

June 1, 1984

INTERTECT  
P.O. Box 10502  
Dallas, Texas 75207

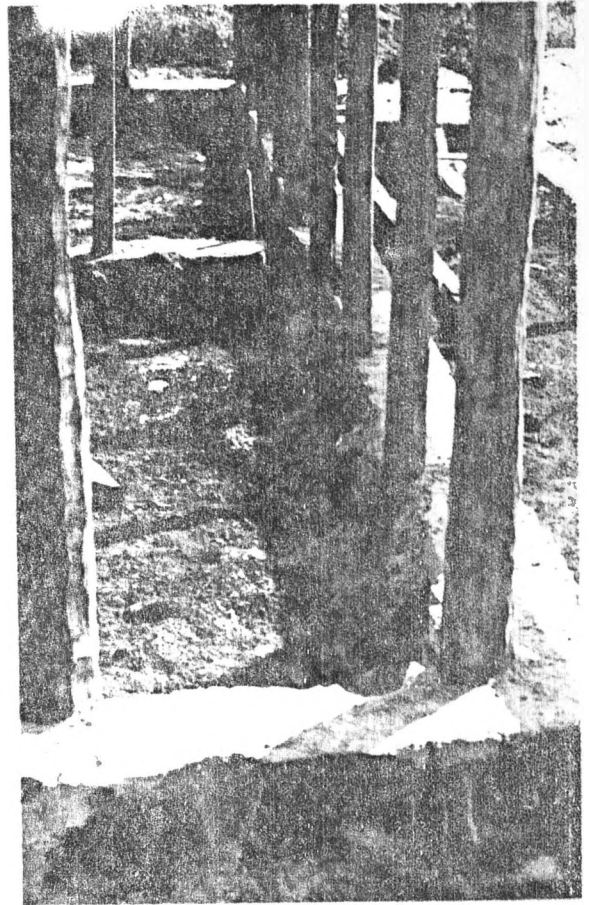
Figure 6 - Posts Cemented to Foundation

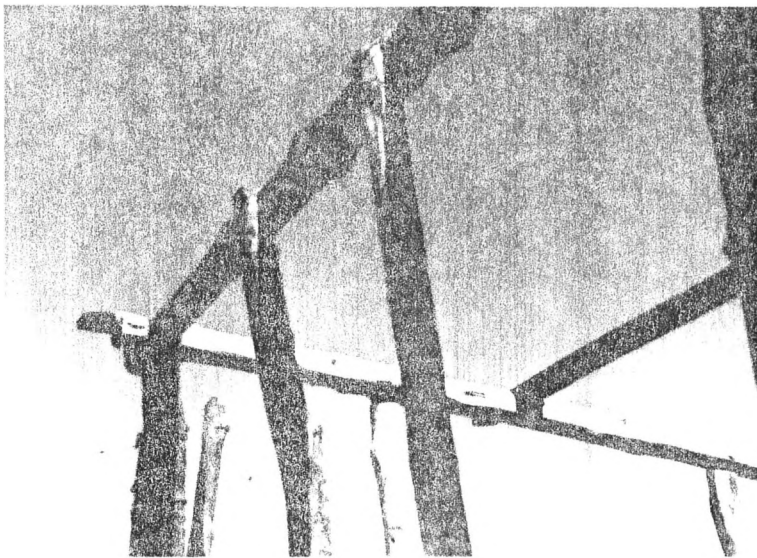
Figure 7 - Posts and Beam Showing Weak Connections

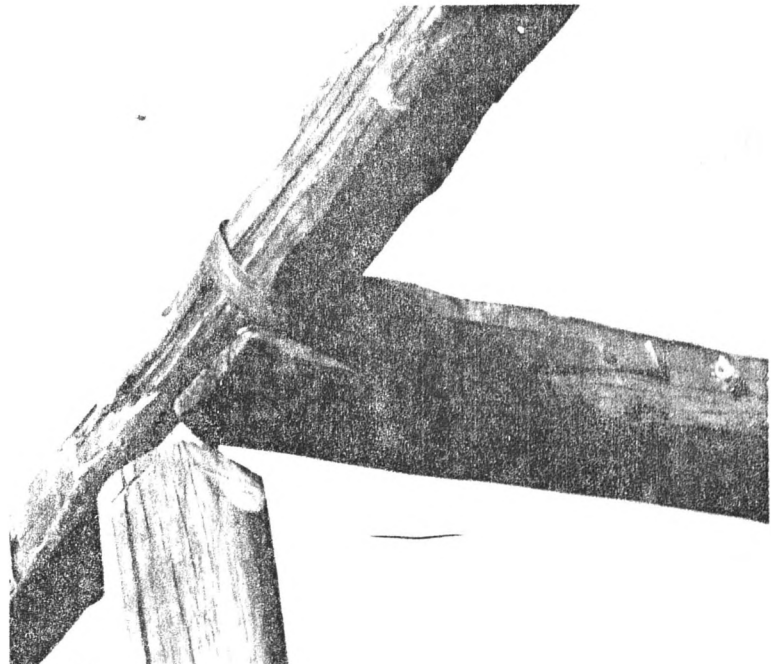
Since the cyclone, many families are using bindings such as wire or metal straps to help strengthen the joints. Unfortunately, many of these are not done correctly (see Figure 8).

Figure 8 - Improper Use of Strap

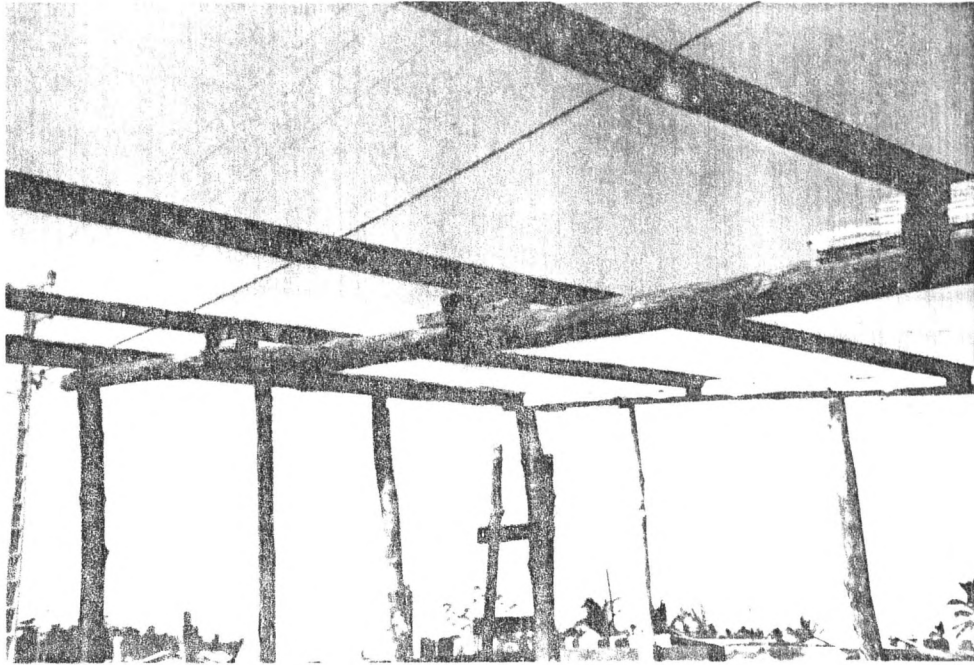
Typical weak points of metal houses are the connections between the roof sheets and the roof frame (due to both a lack of nails and excessive spans and/or the lack of sufficient use of purlins to provide additional connections); weak connections between the roof trusses and the walls; lack of rigidity in the building frame, especially the failure to use sufficient wood in the frame to permit adequate fastening; and the use of small-head nails rather than nails and washers to improve the connection between the CI sheets and the frame.

Figure 9 - Detail of Weak Roof to Wall Connections

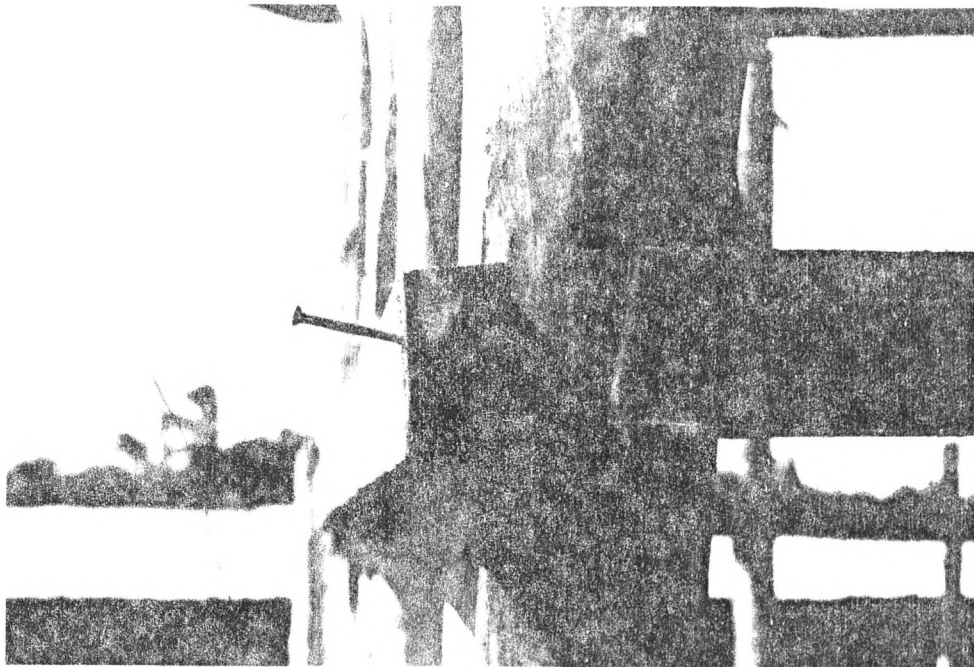
Crude wood joints are used throughout the frame. Wood pegs or nails are used to fasten the frame together. Where small-diameter poles are used, the nails split the wood, thereby offering little resistance to extraction in high winds. When larger posts are used, the number of nails is insufficient (see Figure 10).

Figure 10 - Poor Use of Nails

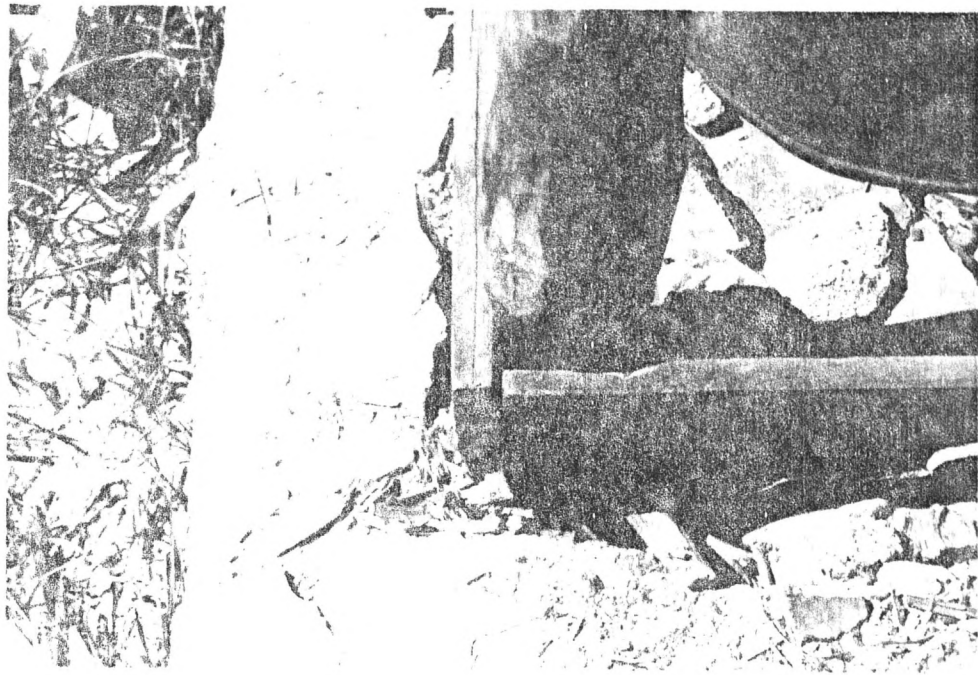
Figure 11 - Boards Used for Attaching CI Sheets at Bottom of Wall  
(Note Small Size of Board and Only One Nail)

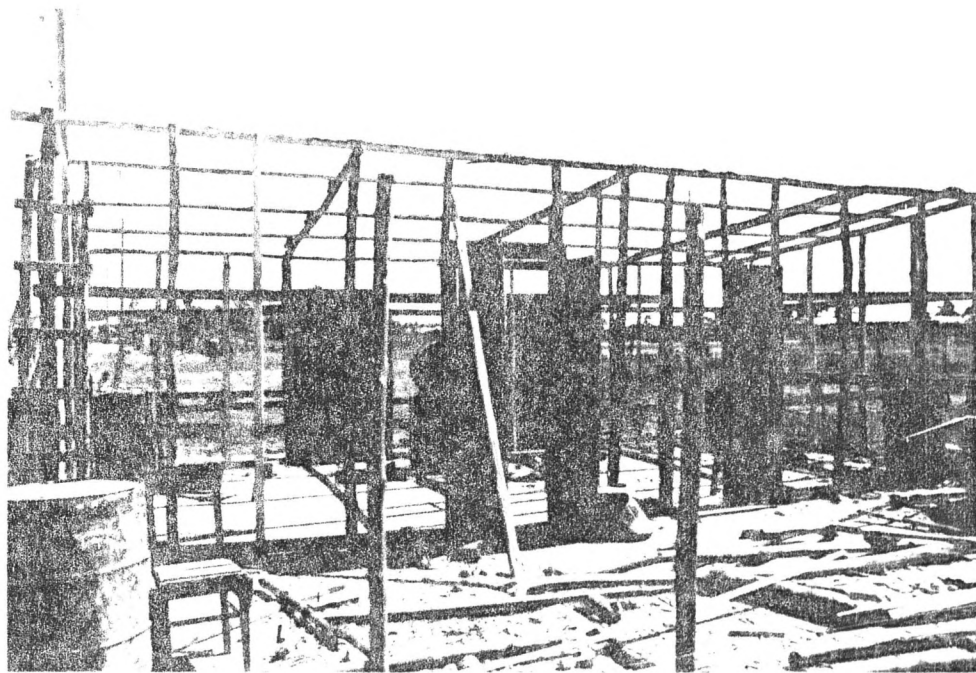
Figure 12 - Building Frame Near Completion (Note Small Size  
of All Members)

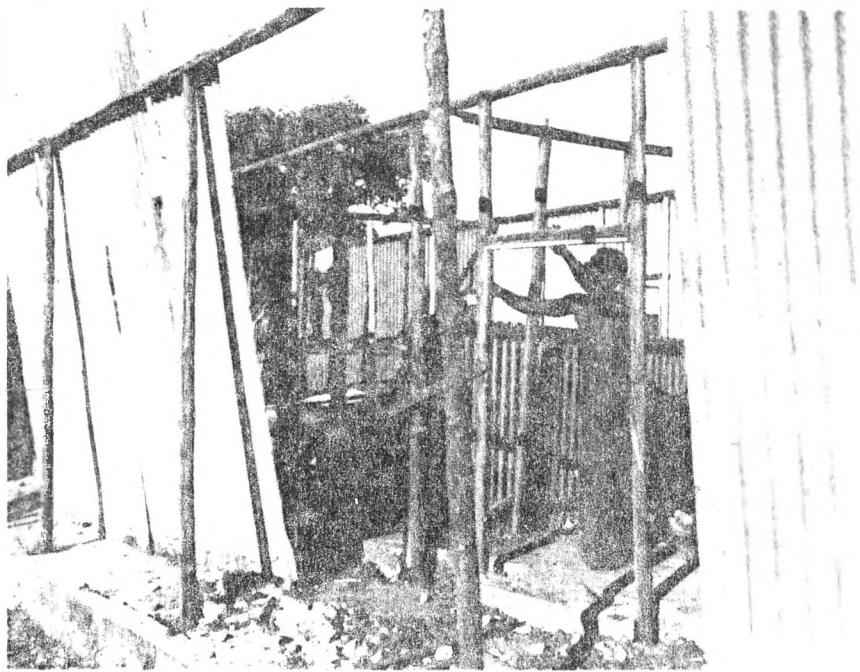
Figure 14

A third problem is that many individuals have initiated the repair of their houses without adequate technical assistance and are rebuilding in an extremely poor fashion (see Figures 14-16). Rather than decreasing vulnerability to future disasters through safe repair, vulnerability is probably increasing.
