Cyclic shear tests on RC precast beam-to-column connections retrofitted with a 1

2 three-hinged steel device

3 Gennaro Magliulo Maddalena Cimmino Marianna Ercolino Gaetano Manfredi

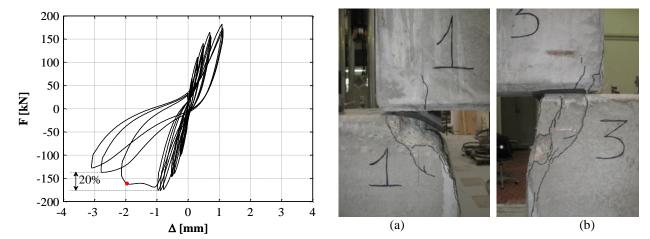
- 7 pulling loads after the attainment of the peak shear strength (176.57kN). This peak value
- 8 corresponds to the occurrence of the first crack in the column concrete cover (red marker in Fig. 3).

- 9 The connection failure occurs for very low beam-to-column relative displacements (2mm), due to 10 the high initial stiffness of the connection system

Fig. 3 Force-displacement curve for the dowel connection up to the 20% of the shear strength degradation

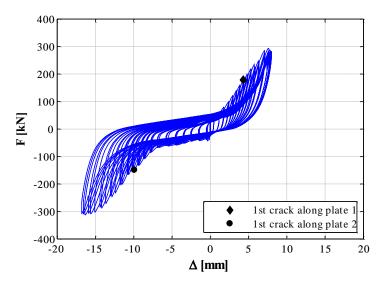
The diamond and circle markers in Fig. 9 correspond to the formation of the first crack in the node 2 on the beam concrete surface, along the steel plate 1 and 2, respectively. The cracks occurrence is

36 first crack along the plate 1 appeared during the first cycle of the 8th step, for a positive shear load

forces for plate 2. Instead, the first crack along the plate 2 appeared during the first cycle of the 11th step, for a negative shear load equal to 149.42kN, which corresponds to tensile axial forces for plate

Fig. 9 Force-displacement curve for the cyclic shear test 1 on the retrofitted specimen

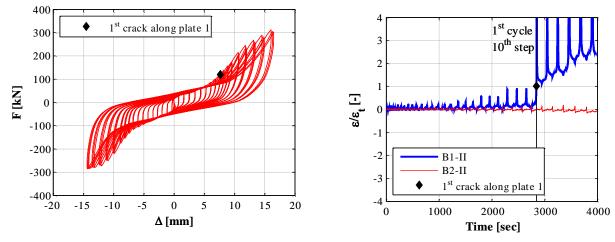
Fig. 15 Force-displacement curve of the cyclic shear test on the retrofitted connection (test 2)

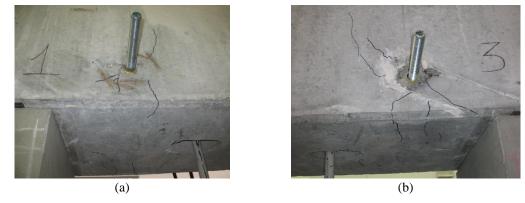
3 deformations due to the large compressive loads (Fig. 18). Several inclined cracks appeared in the 4 concrete around the node 2 at both the sides of the specimen (Fig. 19). However, in this test the

5 width and the length of the crack were smaller than in the test 1 because of the positive effect of the

Fig. 19 Cracks pattern at the node 2 at the end of the test 2: (a) West and (b) East view

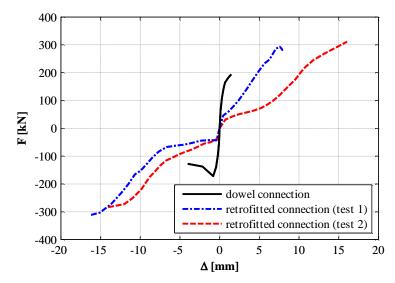
25 In terms of maximum recorded shear forces, the dowel connection performed the lowest shear strength in both the considered load directions. Moreover, the cyclic behavior of the dowel 26 27 connection is strongly not symmetric in the two loading directions; a sudden strength and stiffness 28 deterioration was recorded for pulling loads after the concrete cover failure. The first tested 29 retrofitted connection (test 1, blue dash-dot curve in Fig. 20) shows a larger shear strength with 30 respect to the dowel connection in both the directions. Moreover, the similar performance in terms 31 of maximum shear strength, for both the loading directions, demonstrates the efficiency of the 32 retrofitting system. However, it is worth to underline that this connection shows larger relative 33 displacements for pulling loads (force negative values) with respect to pushing loads, due to a 34 significant damage around the horizontal steel dowels for this load direction.

The retrofitted connection of test 2 (red dashed curve in Fig. 20) shows a good cyclic performance, with both large shear strength values and a quite symmetric response. The rubber hose around the horizontal dowel in the beam led to a lower initial stiffness (about 60%) in test 2 than in test 1 for pushing loads (force positive values) because of its flexibility; on the contrary, for pulling loads the

Fig. 20 Force-displacement envelopes of the tests on the dowel beam-to column connection (black solid curve) and on
 the two retrofitted connections, i.e. without (blue dash-dot curve) and with (red dashed curve) the rubber hose around
 the horizontal dowel
