Surface and subsurface changes as a result of tribocorrosion at the stem-neck interface of bi-modular prosthesis

M.G. Bryant, D. Buente, A. Oladokun, M. Ward, G. Huber, M. Morlock, A. Neville

This study presents a detailed multi-scale analysis of the degradation processes occurring on both the CoCrMo and TiZr alloy surfaces at different regions across the taper interface. Co-ordinate measurement machine, scanning electron microscopy, transmission electron microscopy and X-ray Diffraction methods have been utilised to identify the roles of degradation from the mm to nm scale. Dependent on the region of interest, varying topographies and subsurface morphologies were observed across both surfaces. In regions where high pressures are expected, retention of the surface topography was seen on the CoCrMo trunnion. This was complimented by gross shear and plastic deformation of the subsurface material. In regions where maximum penetration was seen, evidence of fretting-corrosion was seen and a loss of the nano-crystalline layer. For the TiZr surface, refinement of the alloy was seen in the top 5  $\mu\text{m}$ , with fatigue cracks within the bulk present. Precipitation and formation of

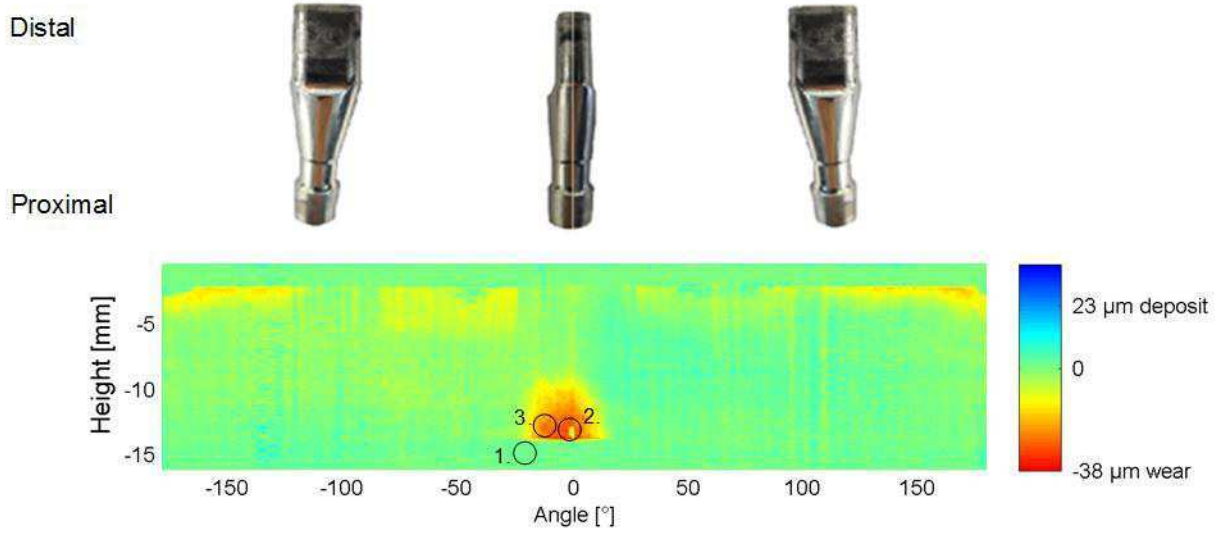
CMM contour plots are shown in Figure 2 for the CoCrMo trunnion component. Material loss varied as a function of the interface height and angle. High amounts of material loss was observed at the proximal-medial edges of the CoCrMo trunnion. A preserved patch of material was observed, surrounded by regions of high wear. Three areas of interest were highlighted by the CMM analysis and subject to further examination. These are indicated on Figure 2 and described as: 1 – Reference (i.e. unworn material outside the region of contact), 2 – Retained patch (i.e. localised region within the highly worn area where original topography was retained) and 3 – Highly worn (i.e. regions of highest material loss). The taper component was also analysed in the same regions. Details of this particular patient can be found in [16] (Patient 4).

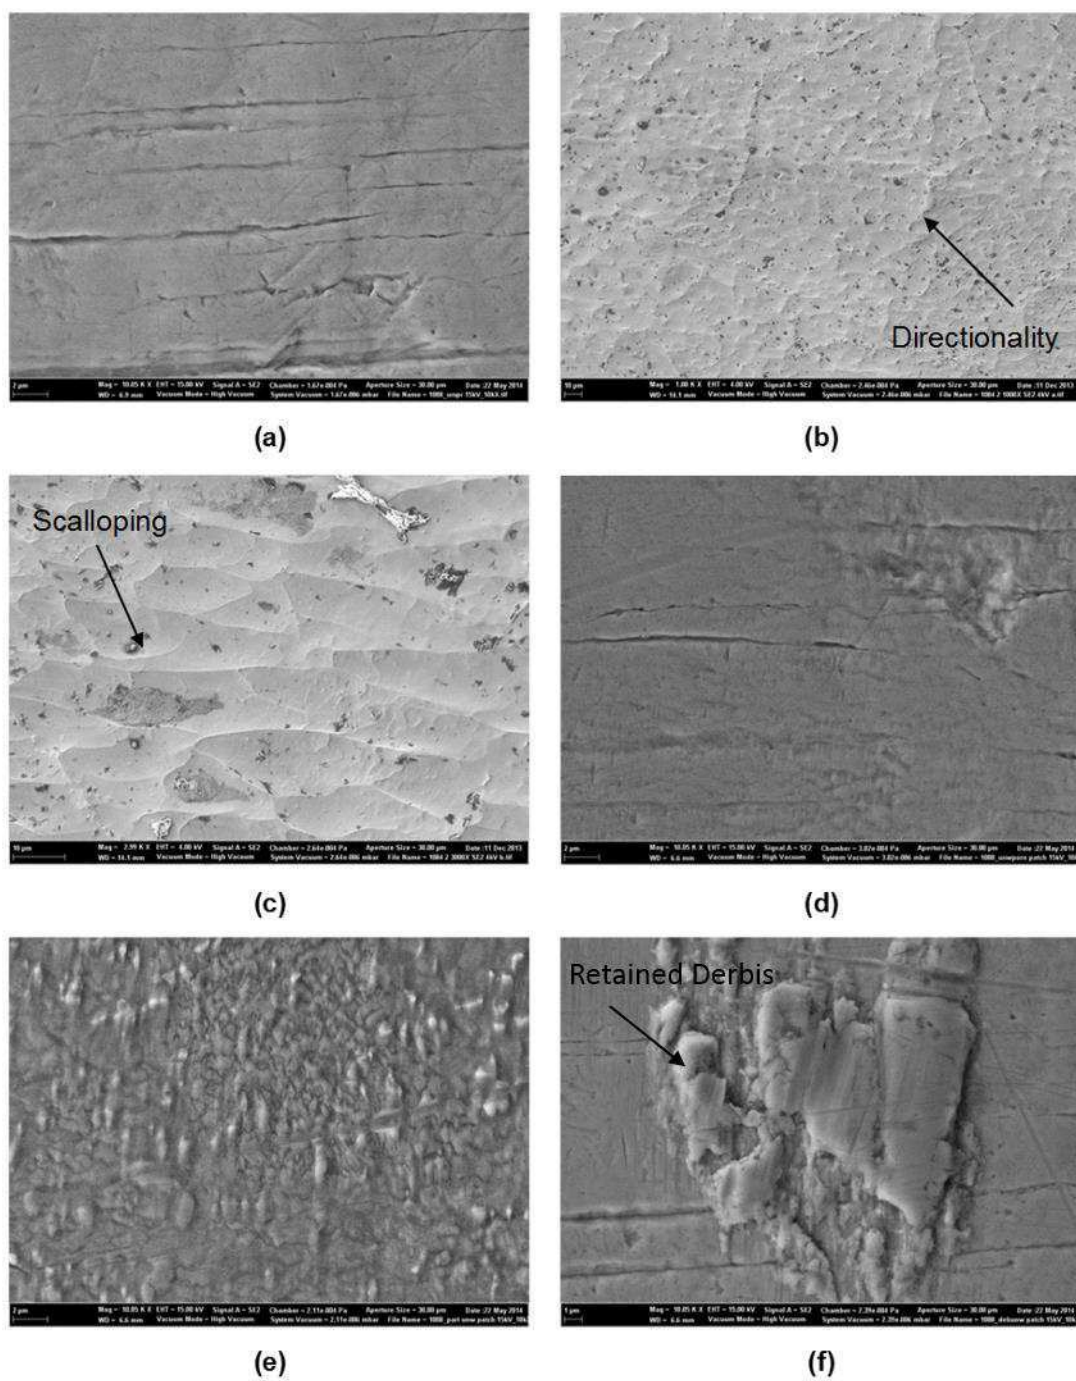
Figure 3 demonstrates the surface topographies observed on the CoCrMo trunnion component at revision. A number of different topographies existed due to the different contact conditions established at the interface; a result of the local variations in device geometry, surgical placement and loads established during daily activities. These range from the original machined topography (Figure 3a, Figure 2 region 1), regions that depicted evidence of fretting-corrosion (Figure 3b and c, Figure 2 region 3) and areas that seemingly retained the original machined surfaces whilst surrounded by regions of high wear (Figure 3 d-f, Figure 2, region 2). In regions where surface topography was seemingly retained (Figure 2, region 2), a 'wrinkled' type surface morphology was observed. Localised areas of debris emanating from the TMZF taper component was observed on the patch area (Figure 3e-f, Figure 2 region 2). This was confirmed using EDS analysis as presented in section 3.1.5. In regions in which fretting corrosion was observed, scalloping and directionality of the surface was observed.

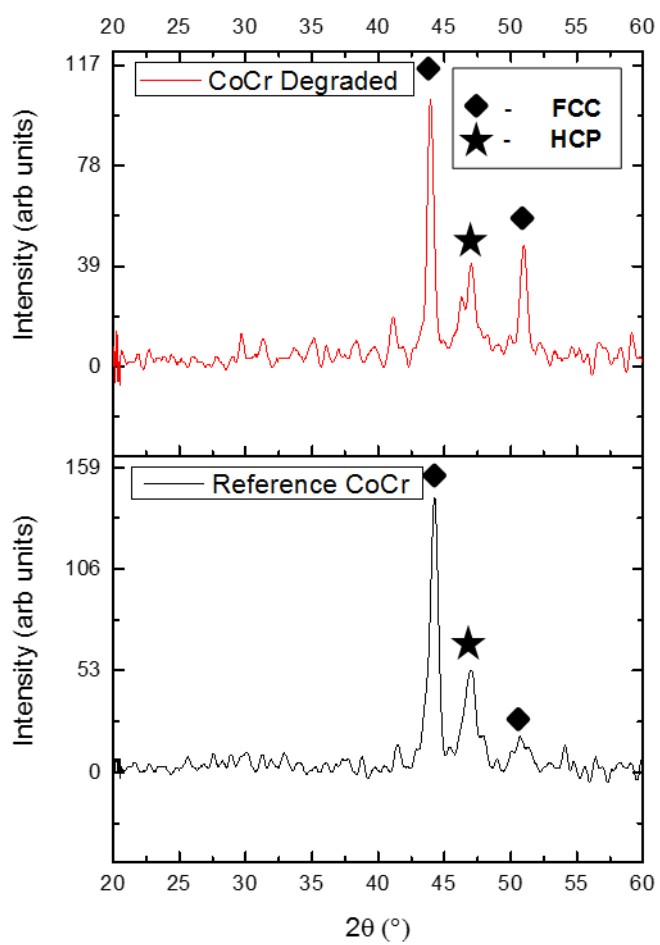
Figure 4 presents the XRD diffractograms of the CoCrMo trunnion in areas of no measurable wear and those that demonstrated high wear (Figure 2). Due to the geometry and localisation of the medial patch observed in this type of prosthesis XRD plots could not be obtained in these areas. It could be seen that both FCC and HCP phases existed within the alloy: an observation reported extensively within the literature. From the XRD spectra, no significant differences in subsurface crystallinity or excessive amounts of strain within the lattice were observed by shifts in peak position (strain effect) or broadening (changes in crystallite size). This is likely due to the sampled area size, the inability to locally probe regions of high degradation and the possibility of preferred texture/orientation of the crystalline structure.

**Figure 4** – XRD diffractograms obtained for the trunnion CoCrMo component in unworn and worn area.

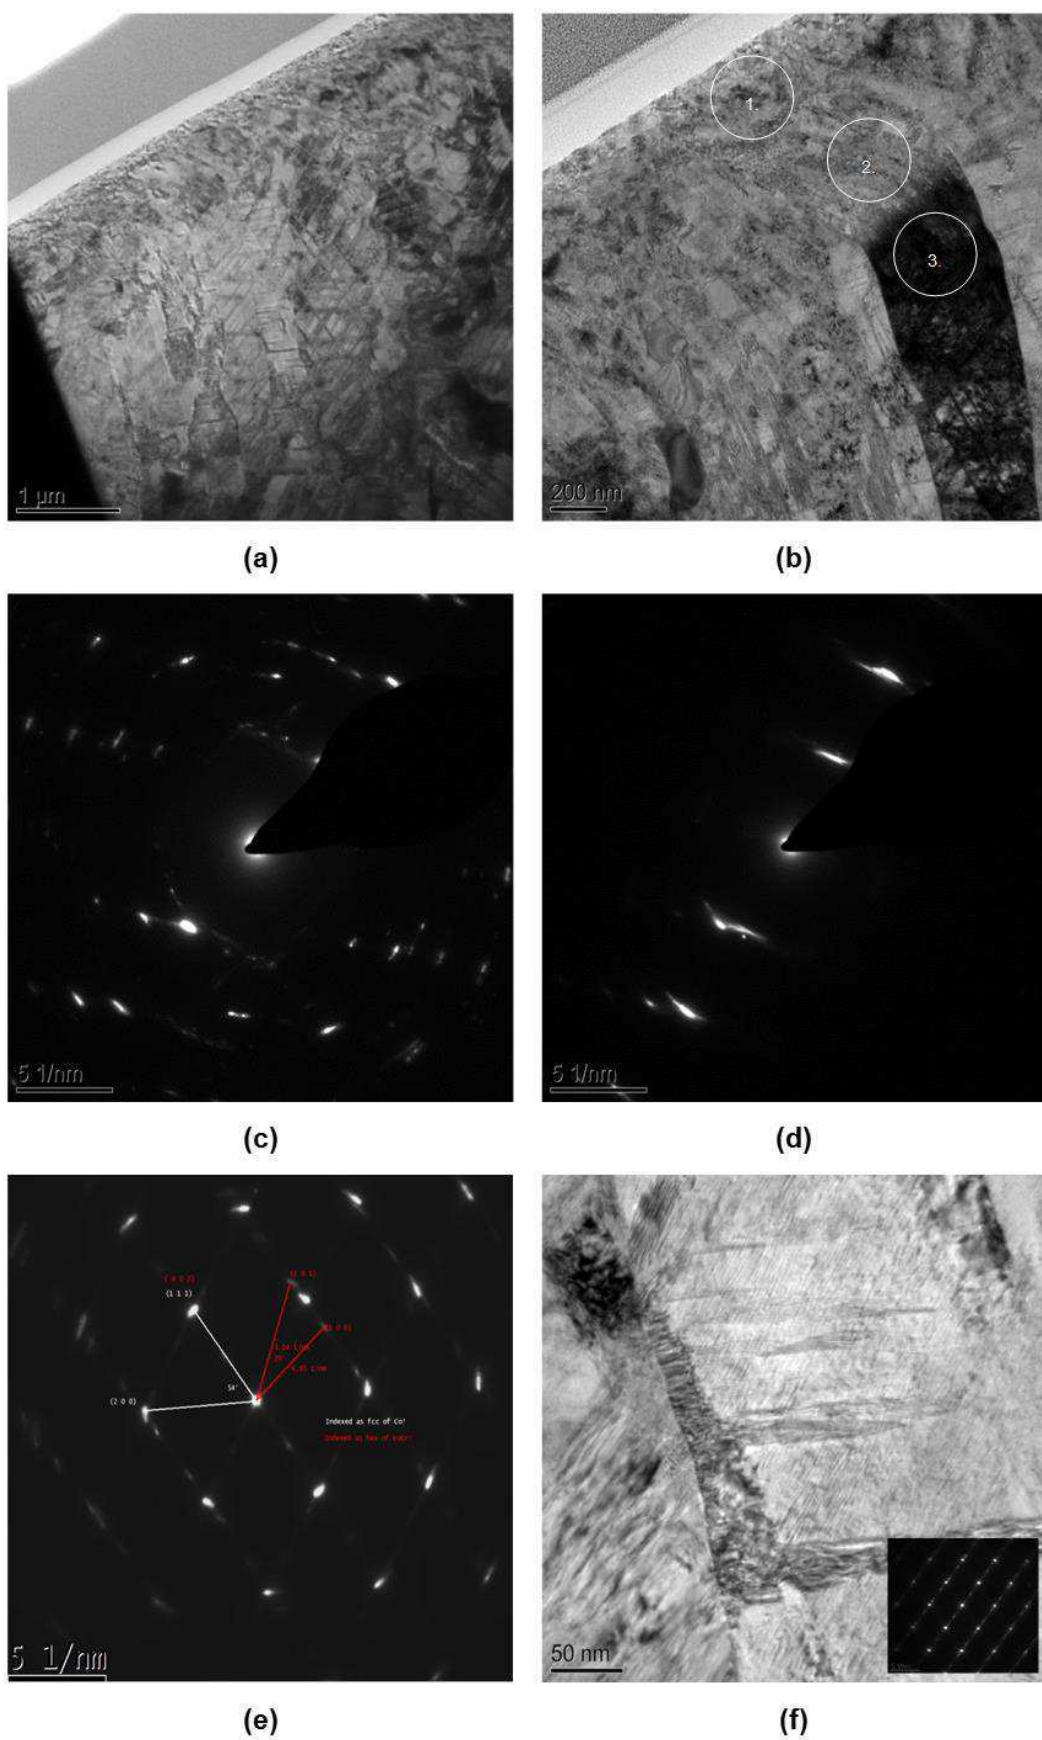
Figure 6 shows bright-field TEM and electron diffraction analysis of subsections prepared from the patch area of the CoCrMo trunnion component (ie Region 2, Figure 2). It must be noted that this is the area in which surface topography was seemingly retained whilst surrounded by regions of high material loss. Within this region it is hypothesized that a tribological regime with sufficiently high contact pressure and low displacement is established so a stick or partial slip fretting regime exists resulting in a retention of an unworn area and worn gradient across the surface similar to that described by [21]. Figure 6a shows refinement of the microstructure within the top 300 nm, formation of  $\epsilon$ -martensite, stacking faults and the presence of twinning when compared to the reference subsection (Figure 5a). Deformation of grains and evidence of directionality was observed within the top micron of the surface (Figure 6b). Bulk single crystals being sheared to form a nano-crystalline layer was observed in the absence of any visible  $\epsilon$ -martensite. This correlated with the direction of joint loading.

Electron diffraction analysis was taken in three areas of interest (Figure 6b). It can be seen in region 1 (Figure 6c), a nano-crystalline structure with no preferred orientation was observed with crystals in the region of 50 nm. This again was indexed at a HCP structure. In region 2 (Figure 6d), a nano-crystalline structure was also observed. This again was indexed to a HCP structure. However preferred orientation was observed. Towards the bulk of the alloy (region 3, Figure 6e) a composite electron diffraction pattern was obtained, this was could be indexed as both FCC and HCP atomic

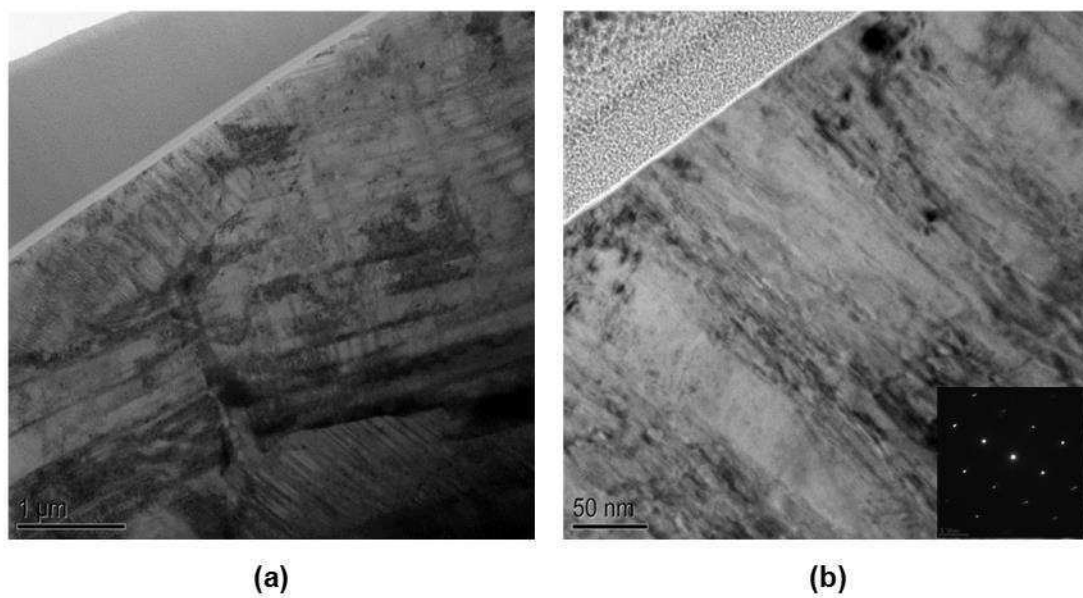
Figure 9

Typical subsurface microstructures observed in the sample taken from the highly worn regions on the CoCrMo trunnion (Figure 2, region 3) can be seen in Figure 9. A loss of the nano-crystalline layer was observed with no evidence of reformation. A bulk single crystal structure remained at the interface. Less residual strain was seen within the crystals, indicated by sharp, streak-free electron diffraction pattern. This was indexed as a typical FCC orientation found for bulk CoCrMo alloys. An interfacial layer, presumed to be  $\text{Cr}_2\text{O}_3$ , was observed and confirmed by EDX at the CoCrMo-Pt interface in the region of  $3\text{-}5\text{nm}$ .

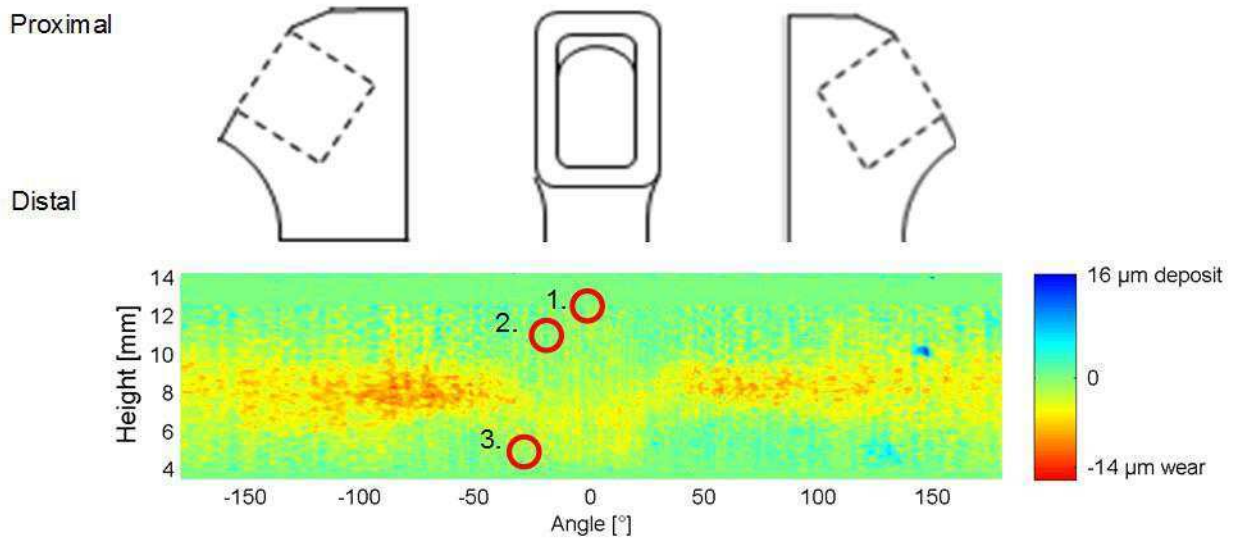
Figure 10 shows the tactile CMM contour plots obtained from the TMZF taper components. Measureable material loss had occurred within the resolution of the CMM. However the depth of material loss was less compared to the CoCrMo trunnion (Figure 2). Evidence of material loss could be observed in the transverse section of the TMZF component with a maximum penetration of  $14 \mu\text{m}$  being observed at  $\pm 35\text{-}120^\circ$  (Compared to  $38 \mu\text{m}$  around  $\pm 25^\circ$  for the CoCrMo trunnion component). The TMZF taper presented a different wear pattern with no localisation of degradation been observed when compared to the CoCrMo trunnion (Figure 2). SEM, FIB-TEM analysis was

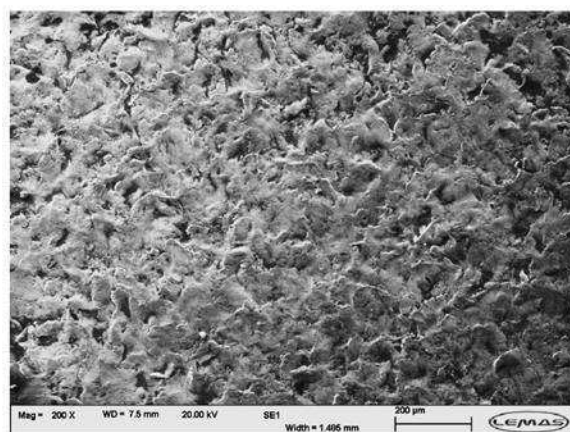
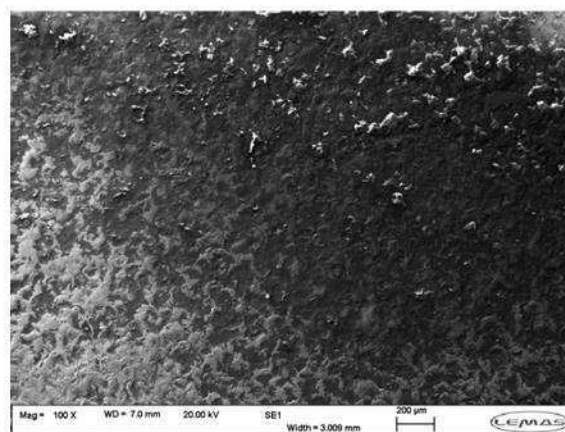
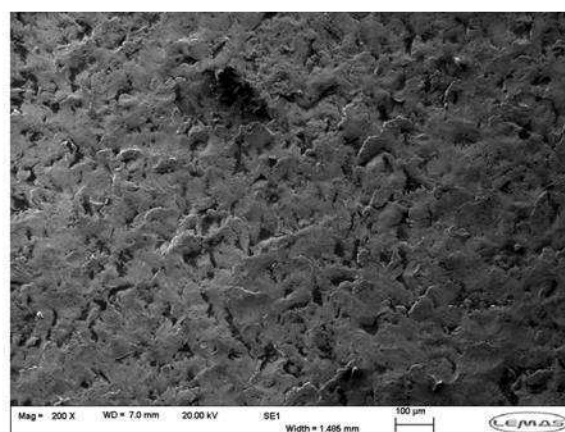
Figure 11 shows the surface topographies observed on the TMZF taper component. Again, a range of topographies could be observed as a function of location. In regions where little to no degradation was observed (Figure 10, region 1 and Figure 11a) topographies were homogenous in texture and similar to those obtained through a blasting process was observed. Towards the mid portions of the interface a loss of surface topography and the presence of a surface deposit was seen (Figure 11b). Back scattered detection imaging indicated areas of deposit consisted of a lower atomic mass (ie C, Ca, P, O). Towards the distal portion of the interface, Figure 11c, a similar topography was observed to Figure 11a. A textured surface similar to that of a blasted surface was again observed. Figure 12 shows semi-quantitative SEM EDX mapping at 20 kV for the image presented in Figure 11b. Areas where a surface deposit was observed were rich in Cr, C and O. A depletion of Ti was observed in this area. No Co was observed at 20 kV. At higher magnifications, deposits were seen to be localised between the asperities of the rough surface.

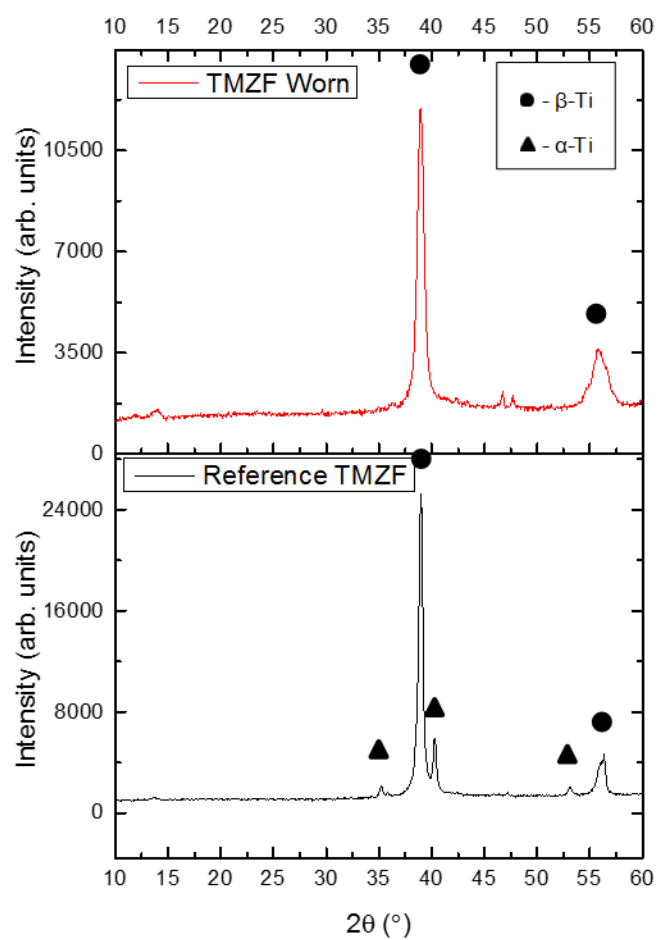
Figure 14 presents the XRD plots obtained for the reference TMZF alloy and areas that had incurred highest incidences of degradation (Figure 10). For the reference TMZF surface a predominantly  $\beta$ -phase alloy was observed with evidence of  $\alpha$ -phases at lower intensities. This is as expected according to literature regarding the metallurgy of the alloy [22]. Distinct difference

between the reference and degraded surface were observed. A loss of the  $\alpha$ -Ti peaks was observed in the highly degraded regions. Significant broadening of the  $\beta$ -phase peaks was also observed, characteristic of an increased strain within the crystal lattice and reduction of crystal size. A gain of peaks at  $2\theta \approx 46$  and  $47^\circ$  was observed. These were unidentifiable from XRD data libraries due to the lack of higher angle peaks however maybe related to the formation of Fe compounds as demonstrated later through TEM analysis. It is evident from XRD data that phase transformation and a high degree of strain is introduced into the TMZF alloy due to the degradation and plastic deformation processes occurring at the stem-neck interface.

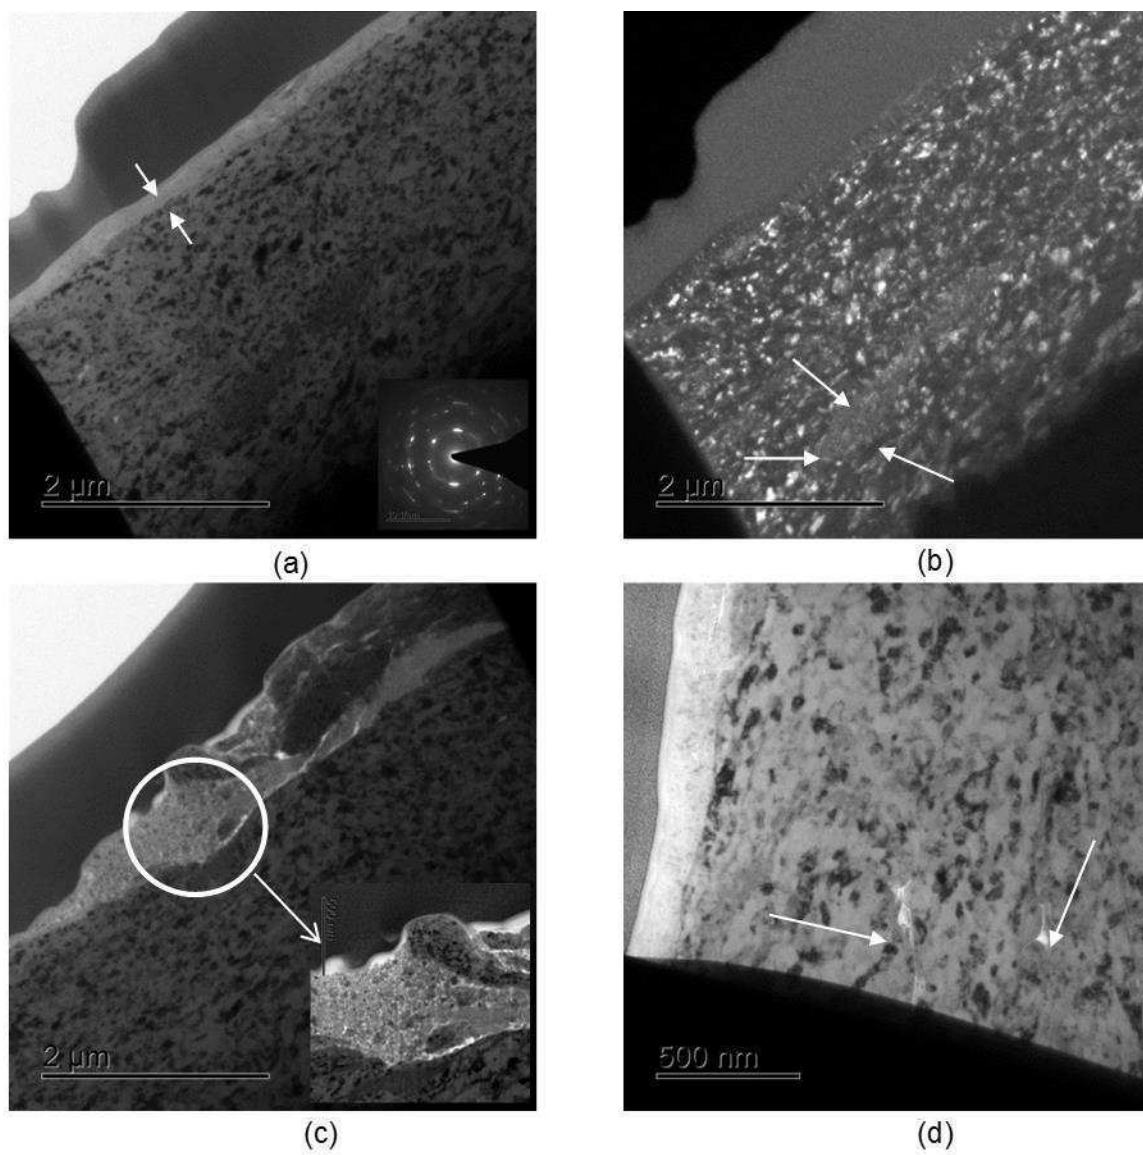
Figure 16

In the regions in which surface topography was retained on the CoCrMo trunnion component, refinement of microstructure in the bulk alloy and the formation of a metallic oxide layer could be observed on the counterpart TMZF surface (Figure 16). A nano-crystalline microstructure with preferred orientation of the crystals was observed (Figure 16a). It can be seen in Figure 16b that areas with different microstructure exist within the polycrystalline structure as highlighted by the white arrows. Precipitation and oxidation of elemental species from and within the subsurface of the TMZF alloy was confirmed with combined STEM-EDS analysis (Figure 17). In comparison with the

Films consisting of metallic oxides were seen to range between 100-500 nm in thickness (Figure 16c) depending upon location. The thickest films were seen in areas around 0 degrees according to CMM contour plots (Figure 2 and 9). These were compact, crystalline and granular in nature. Films were seen to penetrate into the bulk alloy. STEM-EDX analysis (Figure 17) showed films to be Cr and O rich. Cracking of the interfacial surface and ingress of the Cr and O rich debris into the subsurface could be seen. Segregation of Fe at and below the interface was seen. The formation and propagation of subsurface cracks was also witnessed in this area (Figure 16d).

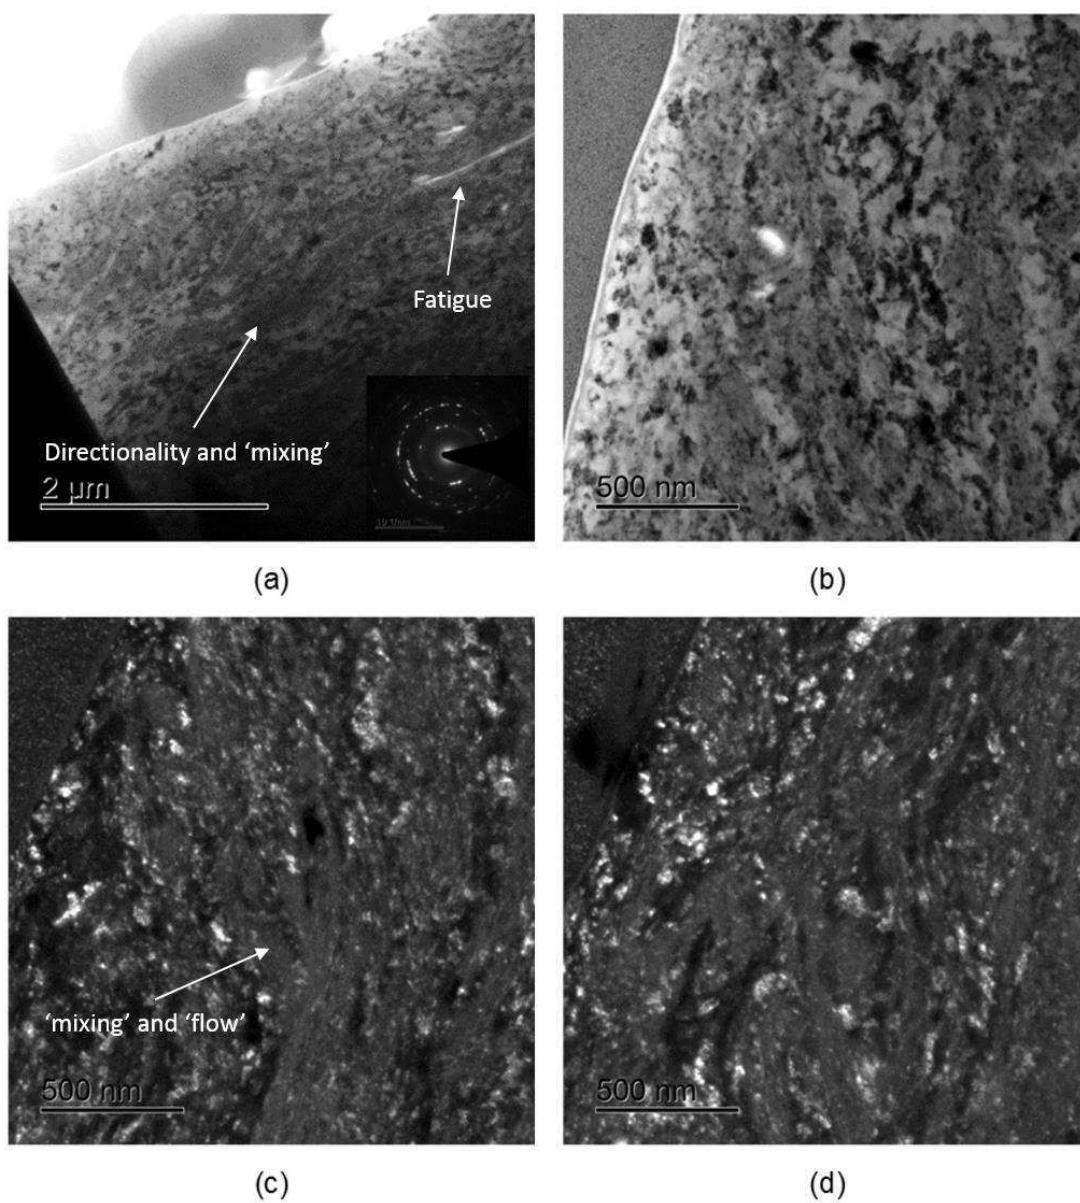
Figure 18

In areas where high amounts of degradation could be observed on the CoCrMo trunnion component (Figure 2, region 3), changes in the subsurface microstructure were also observed for the counterpart TMZF surfaces. The formation of a nano-crystalline microstructure was again seen (Figure 18a and b) along with evidence of subsurface cracking and propagation.

The oxidation and segregation of species within the subsurface region of the alloy was evident. This was consistently seen up to depths of  $\approx 5-10 \mu\text{m}$ . Dark-field TEM micrographs (Figure 18c and d) present evidence of nano-crystalline material, directionality and 'flow' or mechanical mixing of the TMZF alloy. STEM-EDX (Figure 19) analysis further identified the formation of oxides within the subsurface of the alloy at depths of at least 2 - 5  $\mu\text{m}$ . These were Fe and O rich with depletion of Ti in the areas where iron oxides had formed. C was also found to be present and at localised regions within the subsurface of the TMZF alloy.
