Effect analysis of an arc-strike-induced defect on the failure of a post-tensioned threadbar

A temporary threadbar used for precast segmental construction broke during the post-tensioning stage before reaching the service load. Failure analysis showed that the premature failure of the bar was due to the presence of an arc strike. The arc strike effects on the material and threadbar integrity are considered.

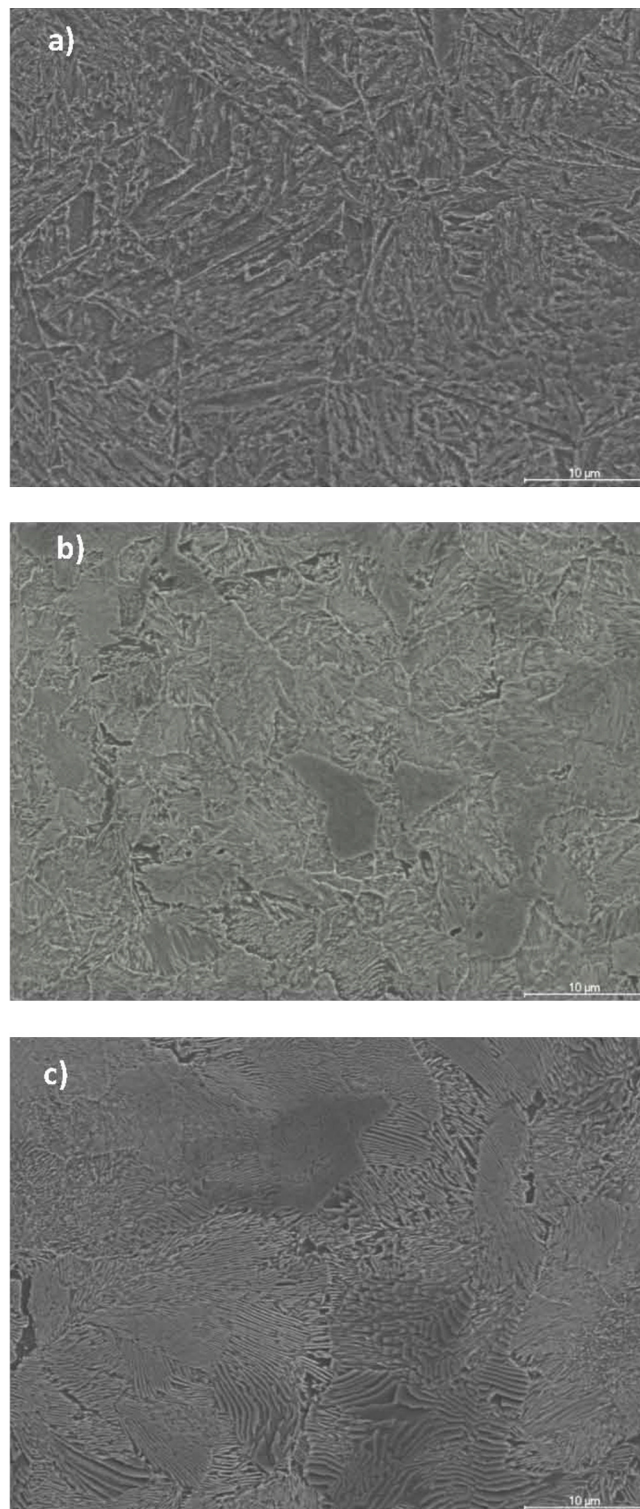
Microstructural analysis was performed on a cross section far from the fracture, which was etched with 2% Nital. The microstructure was a fine perlite in the bar center and a tempered martensite on the surface ring that was approximately 1.4 mm deep, Fig. 1. These microstructure differences are caused by cooling rate differences from the rolling temperature to room temperature during bar processing.

Fig. 1. SEM micrographs showing the threadbar microstructure far from the fracture. (a) Near the surface, the microstructure consists of tempered martensite. (b) At one-quarter of the diameter, the microstructure consists of bainite and fine perlite. (c) Near the bar center, the microstructure consists of perlite.

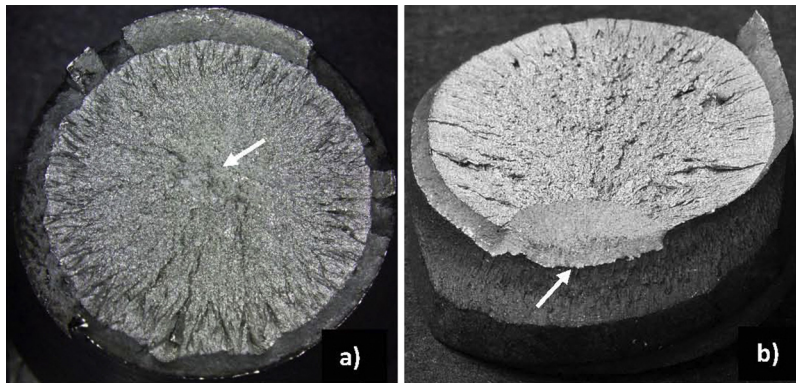
Fig. 2. Appearance of fractures in the tensile specimens: (a) Machined tensile specimen. (b) Threaded bar sample. The white arrows indicate the initiation point of the fracture.

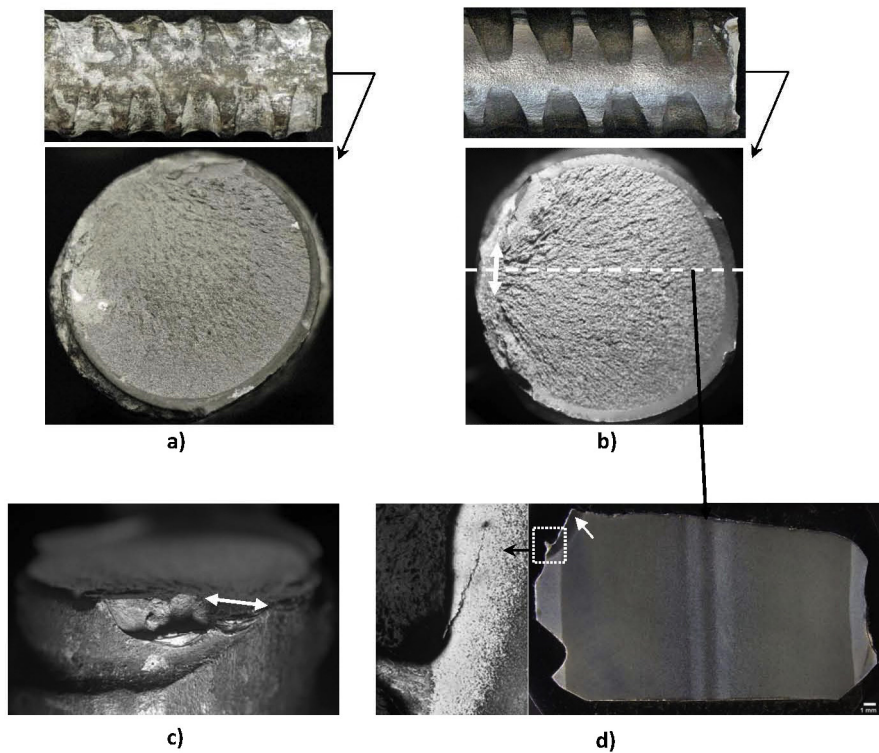
The threadbar failure occurred without plastic deformation. When the fracture surface was observed with a naked eye, some directional tear ridges were observed (Fig. 4(a) and (b)). By tracing back the directional features it was possible to identify the fracture initiation zone. The fracture started from a linear segment with an approximate 9 mm length located

2.5 mm from the bar surface. By analyzing the bar surface in the immediate vicinity of the fracture initiation zone, a material alteration, presumably caused by an arc strike (AS), was observed (Fig. 4(c) and (d)).

To demonstrate how the AS modified the threadbar material, a longitudinal cross section containing the fracture profile through the initiation zone was metallographically prepared, as shown in Fig. 4(b) and (d). The following was observed: a remnant of molten metal with a microstructure consisting of proeutectoid ferrite and ferrite side plates in prior austenitic grain boundaries and intracolumnar very fine perlite (Fig. 5(a)); a cracked white layer of approximately 1 mm thickness of unmelted material transformed by the heat to martensite with a profusion of defects in the grain boundaries (Fig. 5(b)). The fracture initiation took place at the interface between the molten metal, which was presumably lost during fracturing, and the martensite layer, as shown in Fig. 5(b) (left). Furthermore, the Vickers hardness (9.8 N) variation with distance from the surface at the AS vicinity was investigated. Fig. 6 reveals that the hardness increases from 350 HV1 in the unaffected material to 800 HV1 in the martensite layer. The hardness of the molten metal remnant was 388 ± 60 HV0.3 ($n = 5$).

Fig. 4. Macroscopic aspects of the threadbar broken during service: (a) as received state. (b) After the cleaning process. The double white arrow indicates the linear segment from which the fractures initiated. (c) View of the surface affected by the AS. (d) The longitudinal cross section showing the AS-induced material alteration; the white arrow indicates the fracture initiation point.

Fig. 4(a) (bottom) shows the macroscopic view of the fracture in service. The fracture surface immersion in a 6 N hydrochloric acid solution containing 2 g/L of hexamethylenetetramine inhibitor for 1 min was sufficient to gently remove the traces of rust from the fracture surface.

In terms of the equivalent carbon, the steel used for the manufacture of prestressed threadbars is not weldable. Therefore, it should be neither welded nor locally heated to high temperatures.

Contact with molten slag and unintentional arcing should be anticipated.

The work system should include protection and inspection of the bars until the completion of any welding work.

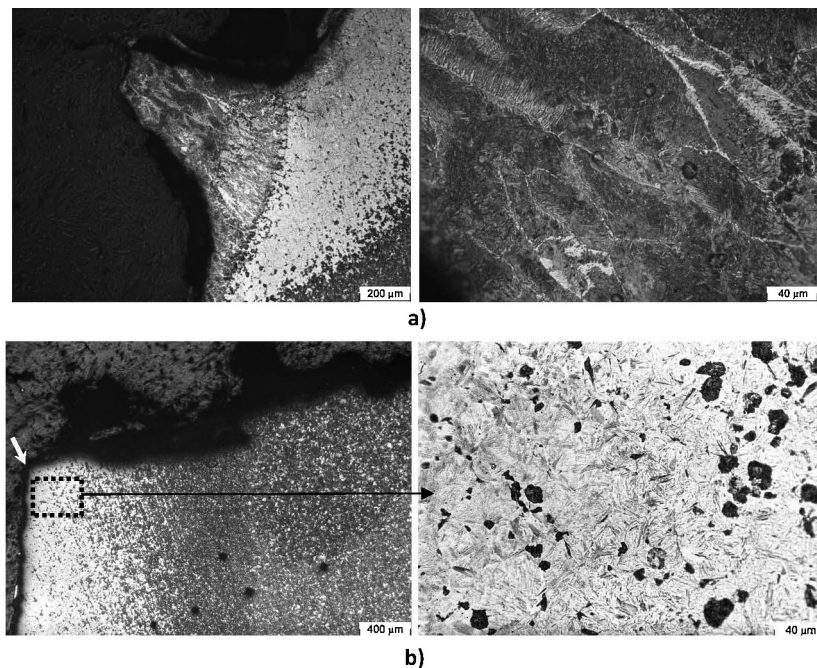
Fig. 5. AS-induced microstructure: (a) microstructure of the molten metal showing a columnar grain structure with proeutectoid ferrite and ferrite side plates at the prior austenitic grain boundaries and intracolumnar very fine perlite. (b) Under the molten metal: martensite with a significant profusion of defects in the prior austenitic grain boundaries; the white arrow indicates the fracture initiation point.

The hydrogen in molten metal results from the arc-induced dissociation of organic molecules on the bar surface or environmental moisture. Because the molten metal was not environmentally protected during the AS process, it is probable that hydrogen was present in the molten metal and martensitic layer. Furthermore, as shown in Fig. 5(a) (right), in the molten metal, the spherical cavities around the inclusions are presumably a consequence of the recombination of atomic hydrogen to form molecular hydrogen or even methane bubbles from the reaction of carbon with hydrogen. Because of the low martensite toughness, the hydrogen bubbles at the martensitic layer grow and merge to form extensive intergranular discontinuities, as shown in Fig. 5(b) (right).

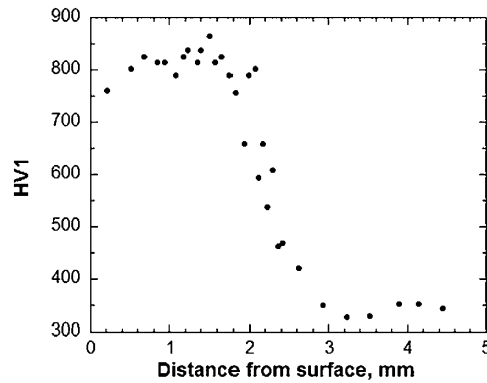
Fig. 6. Variation of the Vickers hardness (9.8 N) with distance from the bar surface in the AS affected zone.

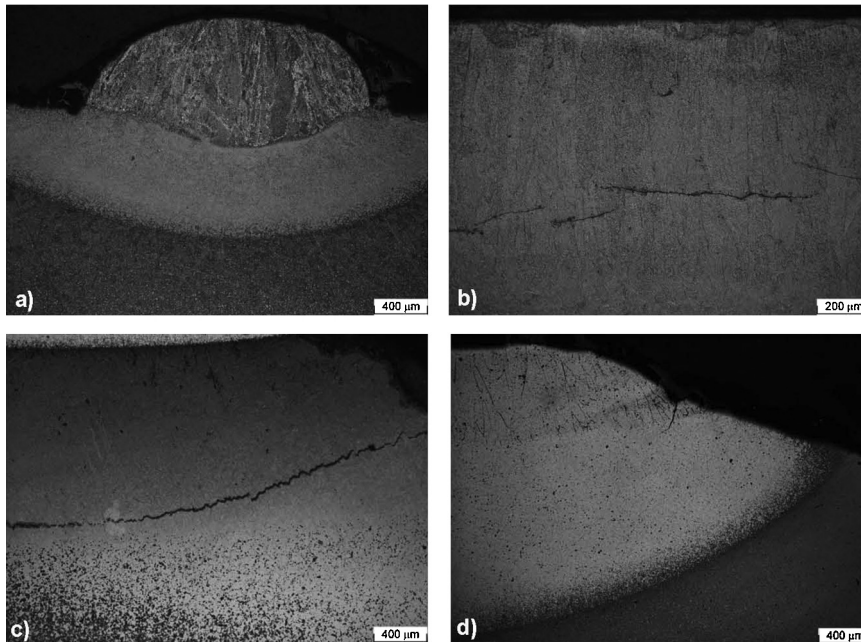
The AS longitudinal and transverse cross sections were prepared metallographically to evaluate the AS-induced damage. Fig. 7 shows representative AS-induced defects found in the bars. Only in one AS were no defects observed (Fig. 7(a)). In other cases, cracks at the molten metal parallel to the bar axis (Fig. 7(b)), at the heat-affected zone bordering the molten metal (Fig. 7(c)) or a small surface crack emerging at the toe of the molten metal and contouring it (Fig. 7(d)) were found. Because of

the cracking runs parallel to the contour of the solidified molten metal (Fig. 7), the possible damage to the threadbar is limited to the AS-affected material spalling. These defects are similar to those referred to in welding as “cold cracking” [10].

Fig. 7. Optical micrographs showing the representative details found in the bars of the AS-induced damage. (a) No macroscopic AS-induced damage. (b) Crack at the molten metal parallel to the bar axis. (c) Crack at the heat affected zone bordering the molten metal. (d) Surface crack at the toe of the molten metal.

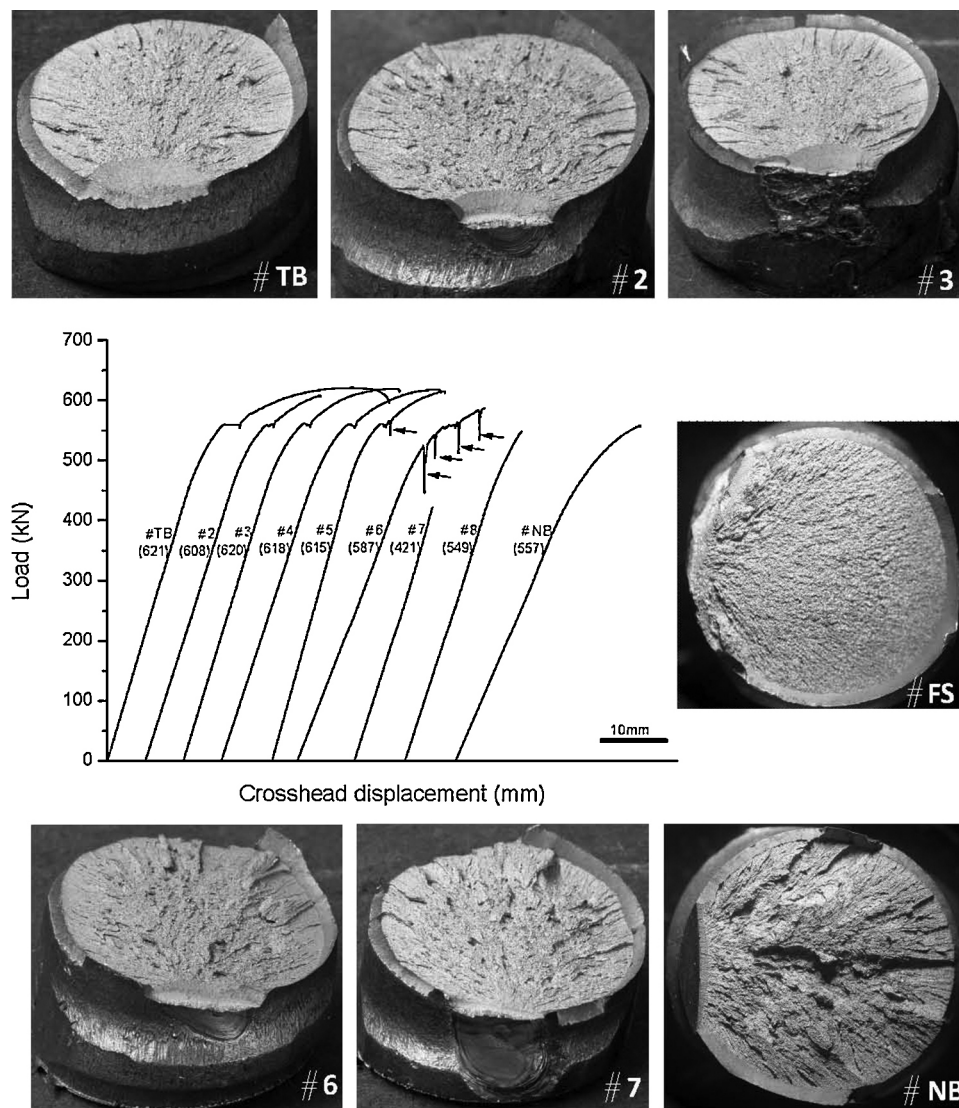
Fig. 8. Load-displacement curves for the undamaged (test #TB), AS-affected (tests #2 to #8), and notched (test #NB) bars, and macrofractographs showing the appearance of the fracture surface of the samples. Additionally, for comparative purposes, the fracture appearance of the broken during service threadbar is shown. The black arrows indicate a pop in. The numbers in brackets are the rupture load values.

Tensile samples of the AS-affected threadbar were tested at the same conditions as the abovementioned undamaged sample. Fig. 8 shows the AS effect on the tensile behavior and the corresponding fracture appearance. For comparative purposes, the following information was included in the figure: the test curve of an undamaged threadbar (TB), the test curve of a threadbar with a transverse arc-shaped notch with a 100 mm curvature radius, 0.25 mm thickness and 1.95 mm depth (NB); and the fracture appearance of the bar that was broken during service (FS). The first conclusion one draws from this figure is the wide tensile behavior variation of the AS-affected threadbar. It is remarkable that for some samples (#2, #3, #4, and #5) the AS did not affect the yield load. Whereas for others (#3 and #4), the AS did not affect the yield load or the ultimate load. However, the location of the rupture is AS-determined. In test #5, a local brittle fracture (pop-in) was noted during tensile testing, but the material fracture toughness was sufficient to stop the crack and allow further plastic deformation to reach the final brittle fracture condition. In test #6, four pop-ins took place prior to reaching the final brittle fracture condition. Test #7 was the only test in which the sample broke in the elastic region of the load-elongation curve prior to reaching the service load of 0.7 times the ultimate load. Moreover, the fractographic features of the fracture surface of the sample are very similar to that of the fractured bar in service. It is worth mentioning that except for test #7, in the remaining tests, some ductile crack extension prior to the final brittle fracture was produced. In tests #8 and #NB, the final brittle fracture took place at approximately the yield load. It is clear that the AS-induced defect severity can be higher than in the notched sample.

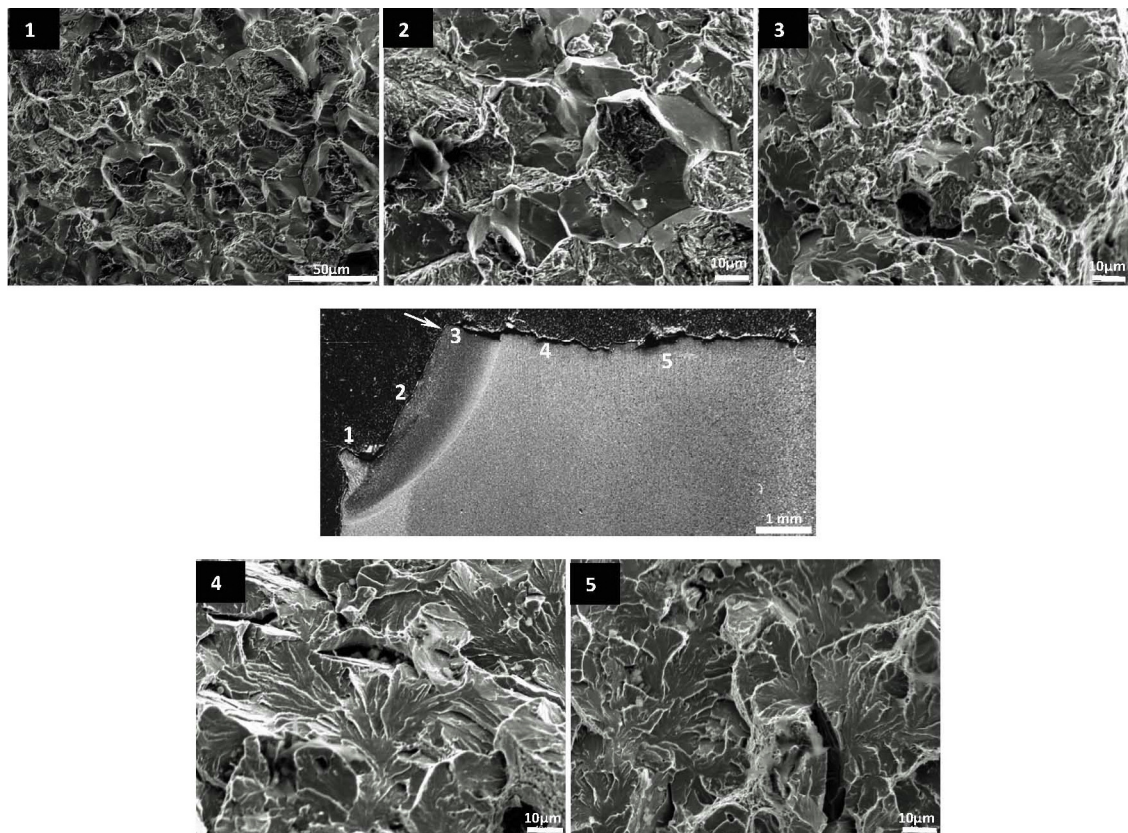
Fig. 9 shows a series of SEM micrographs taken at different positions along the fracture surface near the fracture initiation point. SEM micrographs #1 and #2 show the fractographic features of the spalled zone. SEM micrograph #1 of the molten metal fracture surface shows a mixture with a similar ratio of microvoid coalescence and intergranular brittle fracture. SEM micrograph #2 shows the fracture surface morphological features of the unmelted heat affected zone that consists of the intergranular brittle fracture and, to a lesser extent, microvoid coalescence. The fractographic features near the fracture initiation point (SEM micrograph #3) consisted of the cleaved facets with some microvoid coalescence zones. When the region near the initiation site was studied at successively higher magnifications, it was not possible to identify the microstructural feature that triggered fracture initiation from the converging segment of distinct fan-like radiating fracture patterns. The fractographic features in SEM micrographs #4 and #5, which correspond to the crack propagation stage, primarily consist of the cleavage facets with isolated patches of microvoid coalescence.

Although the failure mechanism of the threadbar it is still not fully clear, the above findings seem to indicate that a microcrack initiates at the martensitic layer and propagates unsteadily toward the bar surface across the molten metal to form a semielliptical surface crack. If crack extends throughout the remainder bar cross section depend on the size of that surface crack. If the crack size is smaller than a critical value a pop in will take place, as occurred in the tests #5 and #6 (Fig. 8). Otherwise, the dynamically growing crack will extend across the remainder cross section.

Fig. 9. SEM fractographs of the bar broken during service. The #1 and #2 SEM fractographs show the intergranular brittle fracture with microvoid coalescence at the spalled zone. The #3 SEM fractographs show the cleavage fracture with isolated areas of microvoid coalescence near the initiation point. The #4 and #5 SEM fractographs show the essentially brittle fracture with extensive cleavage facets at the unsteady propagation zone. The white arrow indicates the fracture initiation point.
