## INSPECTING PV-PLANTS USING AERIAL, DRONE-MOUNTED INFRARED THERMOGRAPHY SYSTEM

Buerhop-Lutz Cl.\* and Scheuerpflug H.  
\*Author for correspondence  
Bavarian Center for Applied Energy Research,  
ZAE Bayern,  
91058 Erlangen,  
Germany,  
E-mail: claudia.buerhop-lutz@zae-bayern.de

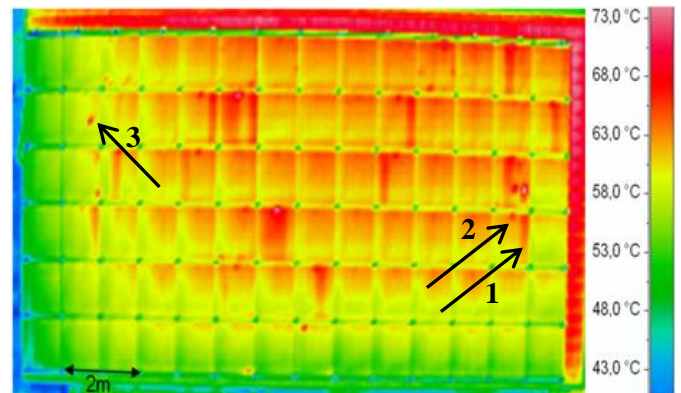
**Figure 8** IR-images of a roof-mounted PV-plant 13,5 kW<sub>p</sub> showing more PV-modules with outstanding locally risen temperature than unsuspecting ones,  $T_{\text{amb}} = 36^{\circ}\text{C}$ ,  $E = 900 \text{ W/m}^2$

Bypassed module substrings are visible when module failures with a strong impact on the output power are present in PV-modules. In the PV-plant from Figure 8 several modules with bypassed substrings are visible, one example is marked with an arrow and number 1. Typical is that the cells of such a substring have a homogeneous, elevated temperature of about 4

to 6 K above the neighbouring cells and additionally that the corresponding bypass diode is operating and has a higher temperature (approx. 6 K) (marked with 2).

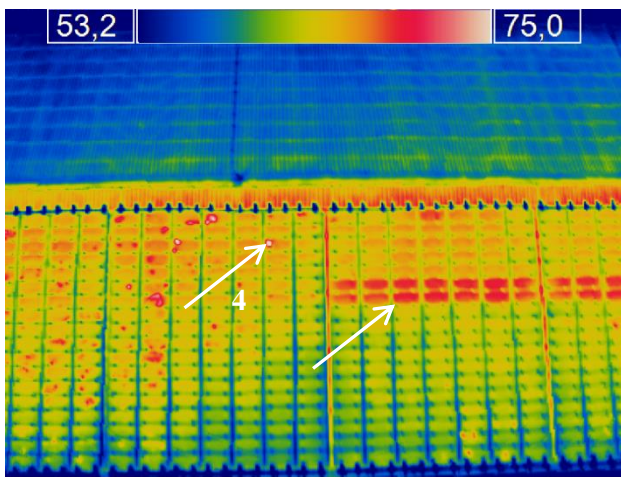
There are entire module strings that have significantly increased temperatures compared to their neighbouring modules, compare Figure 9 (marked with an arrow). Typical temperature differences are 4 to 6 K. The homogeneous temperature distribution is a typical pattern for modules operating in open circuit. Solar radiation is absorbed and all the energy is converted to heat since no electric energy is generated. The most reasonable explanation is that this module string is not connected to the converter or the electric connection is lost. The electric power output is zero. The consequence is a significant power loss for such plant.

**Figure 9** IR-image of a PV-plant section on an industrial roof 67 kW<sub>p</sub> showing two entire module strings with elevated temperature in the right half, a large number of modules in the left half are suspicious, too, T<sub>amb</sub> = 35°C, E = 1000 W/m<sup>2</sup>

Another frequent failure is the presence of faulty solderings. Typically, the temperature locally rises at the sites of open or bad solder joints, see Figure 9 (marked with 4). The area is much smaller than the area of a cell and will therefore is called hot spot. The IR-close-up in Figure 12 illustrates this exemplarily. Figure 12b shows the corresponding EL-image of the same module. At the outstanding sites of the IR-image a bright spot is stated in the EL-image presumably due to increased current density. The other features visible have no influence on the IR-image and apparently no impact on the module performance under operating conditions.

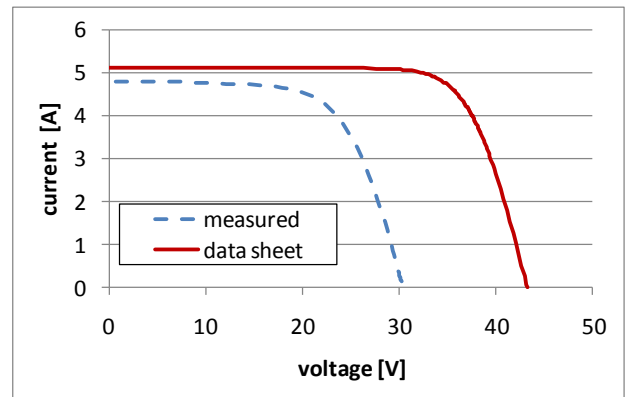
**Figure 10** IV-curves of a PV-module with one bypassed substring, IV-curves: P (data sheet) = 165 W, P (bad module measured) = 95 W [15]

In case of one out of four substrings is bypassed by its bypass diode, the open circuit voltage is reduced by a quarter, compare Figure 10. The output power measured yields 95 W. More than a quarter of power is missing, which might be due to other defects in the un-bypassed substrings.

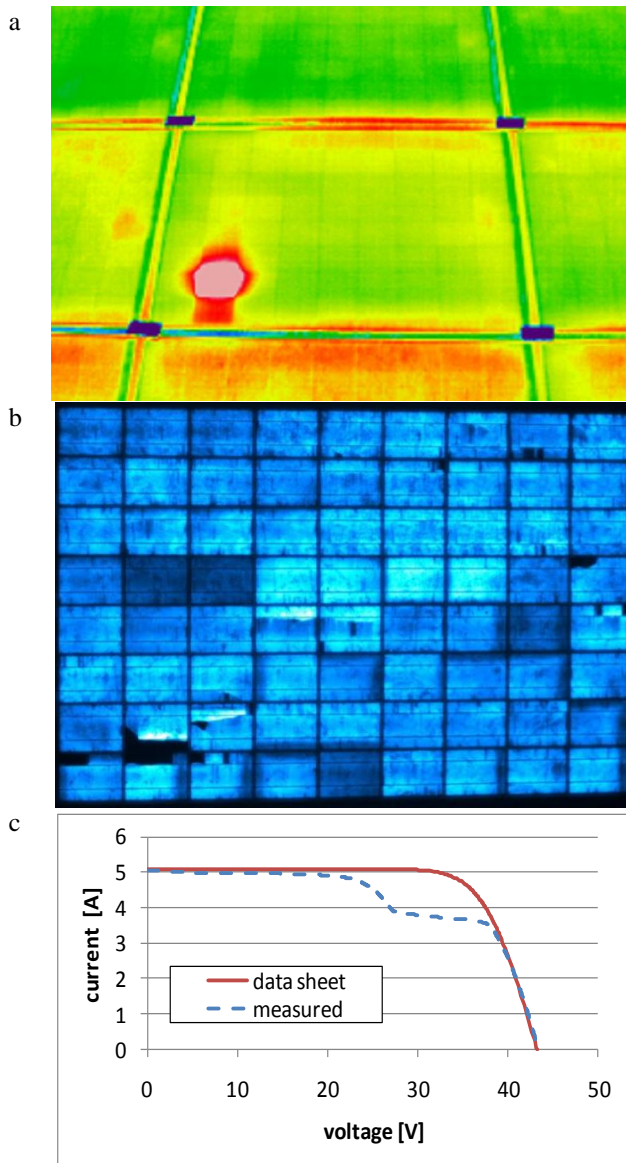
**Figure 11** Detailed analysis of a module with cell fracture, a) IR-image at  $T_{amb} = 17^{\circ}\text{C}$ ,  $E = 650 \text{ W/m}^2$  and temperature difference at fractured solar cell  $\Delta T = 40,6 \text{ K}$ , b) EL-image and c) IV-curve:  $P$  (data sheet) = 165 W,  $P$  (bad module measured) = 133 W [15]

Figure 11 shows the IR-image and IV-curve of a module with cell fracture as can be seen in the EL-image. The cell with the strongest fracture has the highest temperature, here  $\Delta T > 40 \text{ K}$ . Small cell fractures, as seen in other cells of the same module, are of minor importance, no temperature increase is detected. Normally just the cell with the largest cell fracture shows the temperature increase. The temperature difference to the neighbour cells can be rather high depending on the fracture characteristics, the operating point, and the measurement conditions. (For example, we found sample module with  $\Delta T > 100 \text{ K}$  for distinct cells.) Therefore, the resulting module

power is determined by the failure characteristics. This module has a power loss of 20% due to cell fracture at mpp.

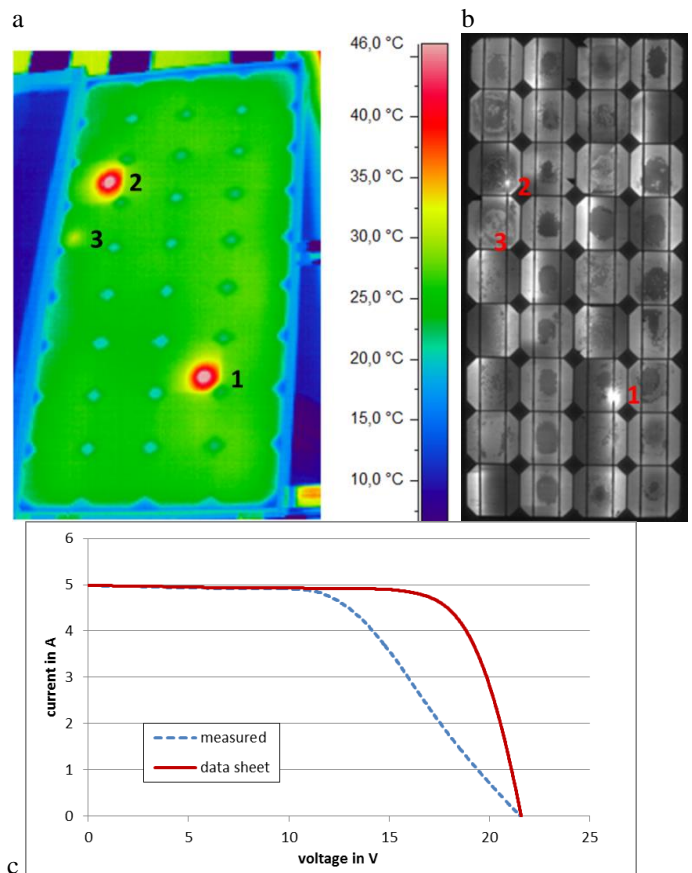
**Figure 12** Detailed analysis of a module with bad solder joints, a) IR-image at  $T_{amb} = 12^{\circ}\text{C}$ ,  $E = 690 \text{ W/m}^2$  and temperature difference at bad solderings  $\Delta T_1 = 26,3 \text{ K}$ ,  $\Delta T_2 = 25,8 \text{ K}$ ,  $\Delta T_3 = 4,2 \text{ K}$ , b) EL-image, c) IV-curves:  $P$  (data sheet) = 80 W,  $P$  (bad module measured) = 57 W

Two spots show extremely high temperatures and a third one is still recognizable. There are temperature differences of  $\Delta T > 25 \text{ K}$  and  $\Delta T > 4 \text{ K}$  measurable. The number of such visible defects depends on the number of bad solder joints. The data evaluation yields that with increasing spot temperature the negative impact on the output power grows. Here, the output

power is almost reduced by 30% due to the increased series resistance, as seen in Figure 12c.

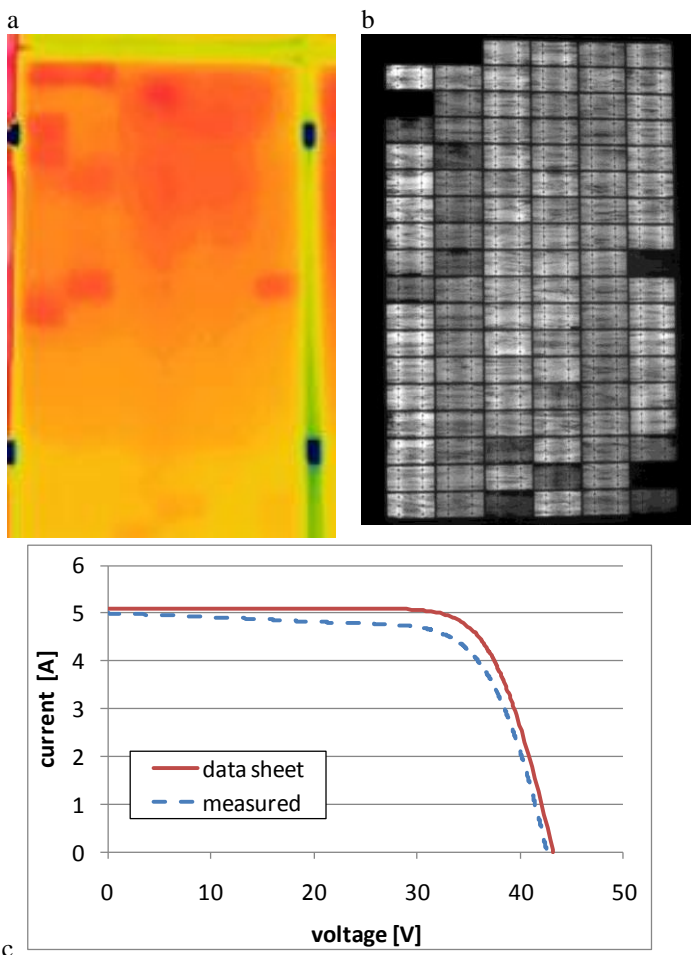
Shunted cells result if front and back contacts of a solar cell are connected electrically. Then the current flows through the low-resistant contact and not passes the cell. Therefore, the affected solar cell is kind of short-circuited. Since the absorbed energy is not usable, the cell heats up. In Figure 13a these shunted cells have a slightly increased temperature, roughly  $\Delta T > 1.5$  K. Several cells can be affected in one module. The corresponding EL-image (Figure 13b) depicts clearly, that through those cells no current flows. The cells appear darker or black. The influence on the output power is negligible for one shunted cell but for an increasing number of cells the output power can be decreased significantly. The power for the example module with 11 shunted cells is reduced by approximately 13%.

**Figure 13** Detailed analysis of a module with shunted cells, a) IR-image at  $T_{amb} = 30^{\circ}\text{C}$ ,  $E = 850 \text{ W/m}^2$  and temperature difference at bad solderings  $\Delta T = 2 \text{ K}$ , b) EL-image, c) IV-curves:  $P$  (data sheet) =  $190 \text{ W}$ ,  $P$  (bad module measured) =  $165 \text{ W}$  [15]

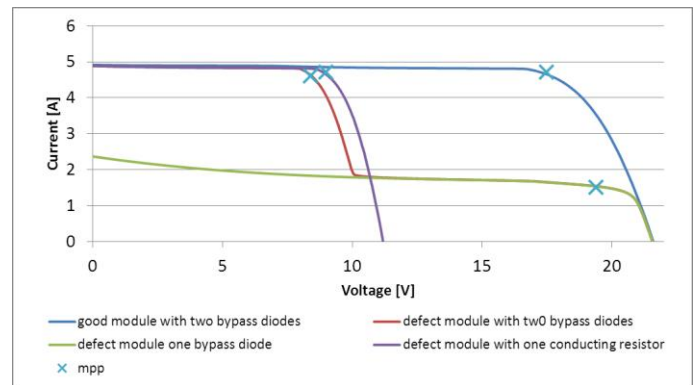
**Figure 14:** Measured IV-curves and mpp positions for different bypass diode situations of a test module: good module ( $P = 80 \text{ W}$ , 2 bypass diodes), defect module ( $P = 38 \text{ W}$ , 2 bypass diodes), defect module ( $P = 29 \text{ W}$ , 1 bypass diode), defect module ( $P = 41 \text{ W}$ , 1 bypass diode replaced by a good conducting resistor)

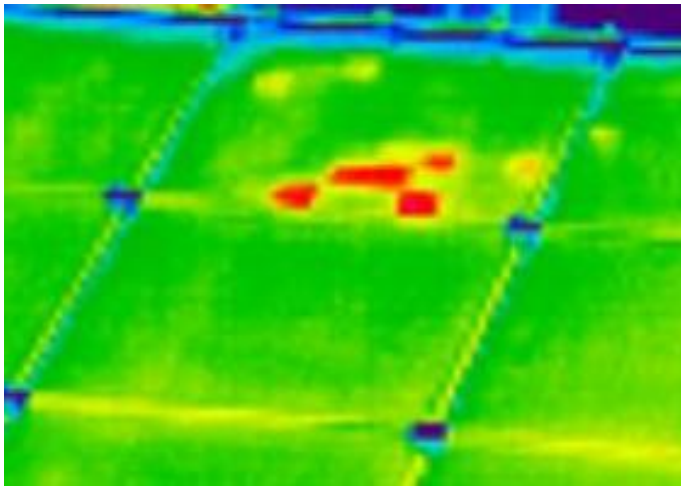
A typical IR-image of PV-module with a short-circuited bypass diode is seen in Figure 15. One out of four substrings is affected by the defect bypass diode. In this example the lower substring shows the characteristic patchwork pattern of a short-circuited substring. Several cells are driven in reverse and therefore have an elevated temperature. The resulting temperatures depend on the IV-curves of the specific cells.

**Figure 15:** IR-image of a PV-module with a defect bypass diode showing several heated cells in the lower substring, (P (data sheet) = 165 W, 4 bypass diodes), defect module (P = 118 W, 3 bypass diodes intact, 1 bypass diode short-circuited)
