Numerical investigation into the failure of a micropile retaining wall

ABSTRACT: The paper presents a numerical investigation on the failure of a micropile wall that collapsed while excavating the adjacent ground. The main objectives are: to estimate the strength parameters of the ground; to perform a sensitivity analysis on the back slope height and to obtain the shape and position of the failure surface. Because of uncertainty of the original strength parameters, a simplified backanalysis using a range of cohesion/friction pairs has been used to estimate the most realistic strength parameters. The analysis shows that failure occurred because overestimation of strength and underestimation of loads.

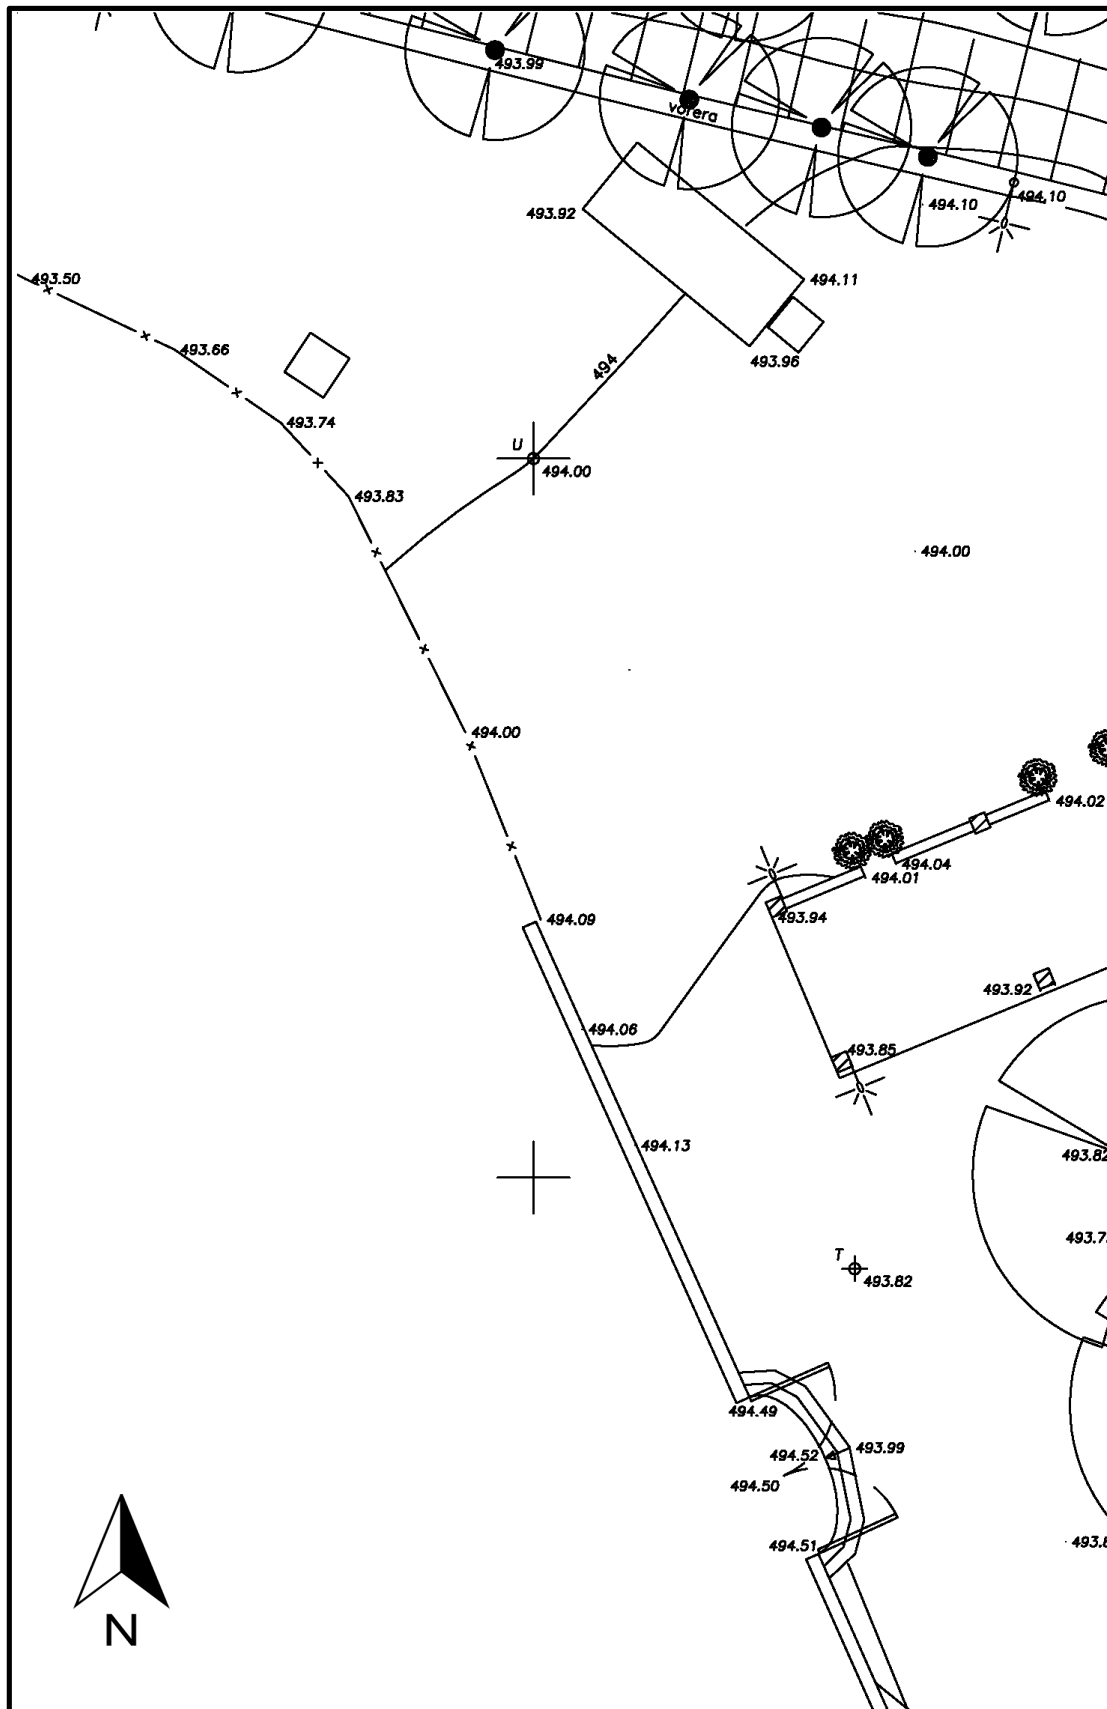
In the original design no topographic survey was conducted outside the property boundaries, assuming incorrectly that the ground surface extended horizontally into the amusement park (Figure 3 and Figure 5). Because of that, the lateral pressure on the micropile retaining wall was assumed to be caused only by the 5 m of earth surcharge left after excavating to the plane of the micropile heads. However, the actual topography outside the property boundaries, seen in a topographic survey conducted after the collapse (Figure 4), had an uphill back slope with an actual height of 10 m, instead of the 5 m assumed in the original design.

Figure 3. Topographic map (detail) used in the design of the micropile wall. The survey did not include the adjacent property (to the West), thus incorrectly showing a horizontal surface (at +494.00 m) beyond the property limits.

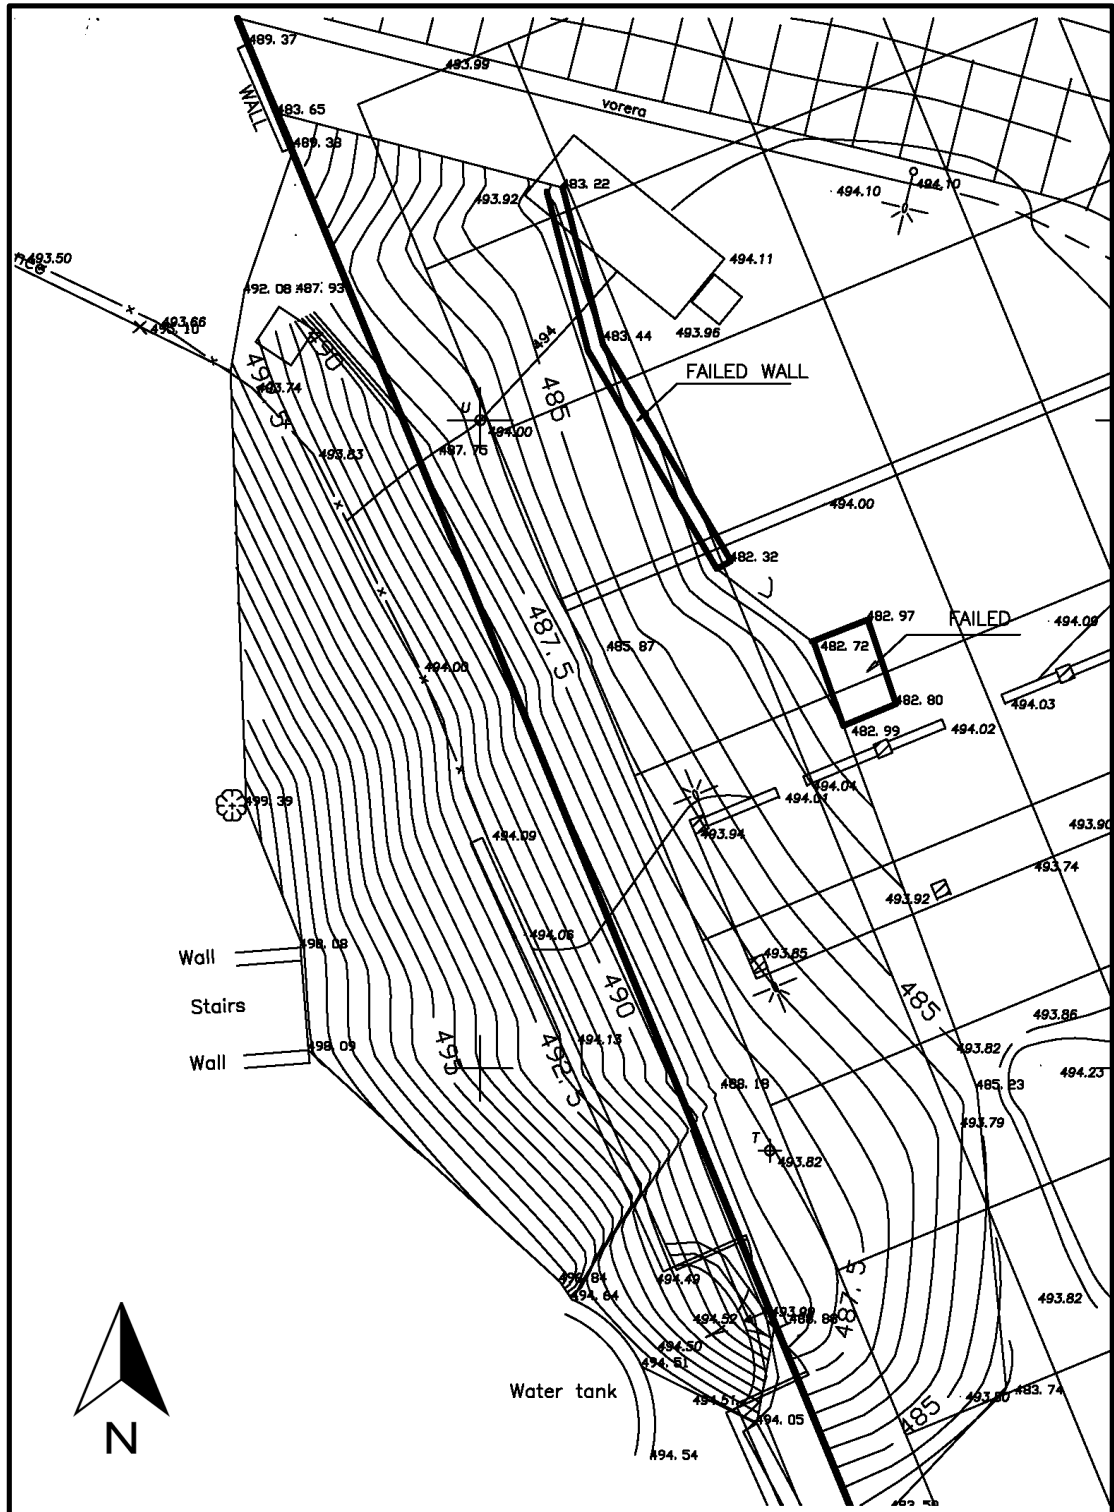
It will be shown that the failure of the micropile wall can be attributed to a poor and incomplete knowledge of the ground's geotechnical properties and a lack of detail of the topographic data (see Figure 3 and Figure 4) which led to an overestimation of strength and an underestimation of the loads carried by the wall and tiebacks.

Figure 4. Topographic map (detail) from the new survey performed after the collapse, showing the true topographic surface in the adjacent property, the original location of the failed micropile wall (thick line from top left to bottom right) and the position of the failed elements after collapse.

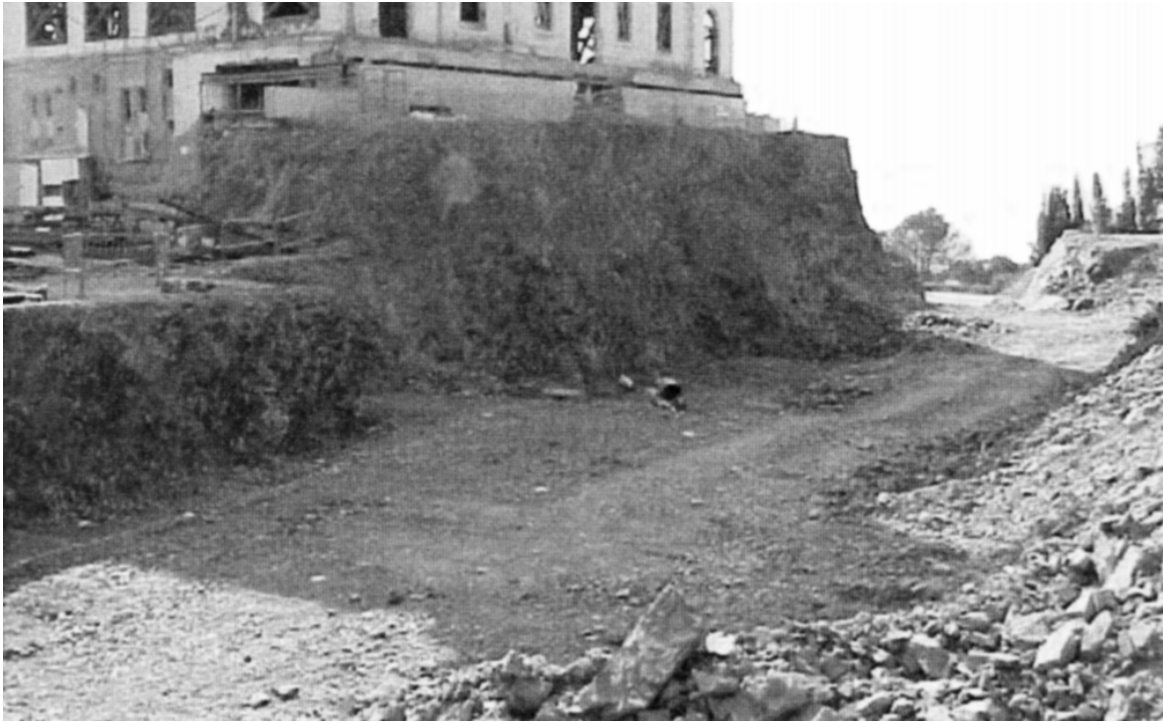
Figure 6 shows a picture of the area where the excavation was being made and where the collapse occurred (at the right of the picture). Figure 7 shows a general view of the failure area. An intact portion of the wall with the cap beam can be seen on the left of the picture. The failed portion is at the right of the image where the new slope created by the sliding ground is clearly visible. Figure 8 shows a partial view of the failed zone where parts of the broken piles and cap beam can be seen scattered on the ground surface. The conditions of the zone immediately after the failure were not preserved intact after it occurred, because swift action was taken by the contractor to clean the area. Therefore, there was only limited graphic documentation. However, verbal description given by the personnel working in the construction site suggested that most of the tiebacks failed due to excessive tension, while some were pulled out with the wall as it moved laterally with a rotation and translation motion.

Figure 6. View of the excavation zone before the wall was initiated. The location of the failure is on the right of the image.

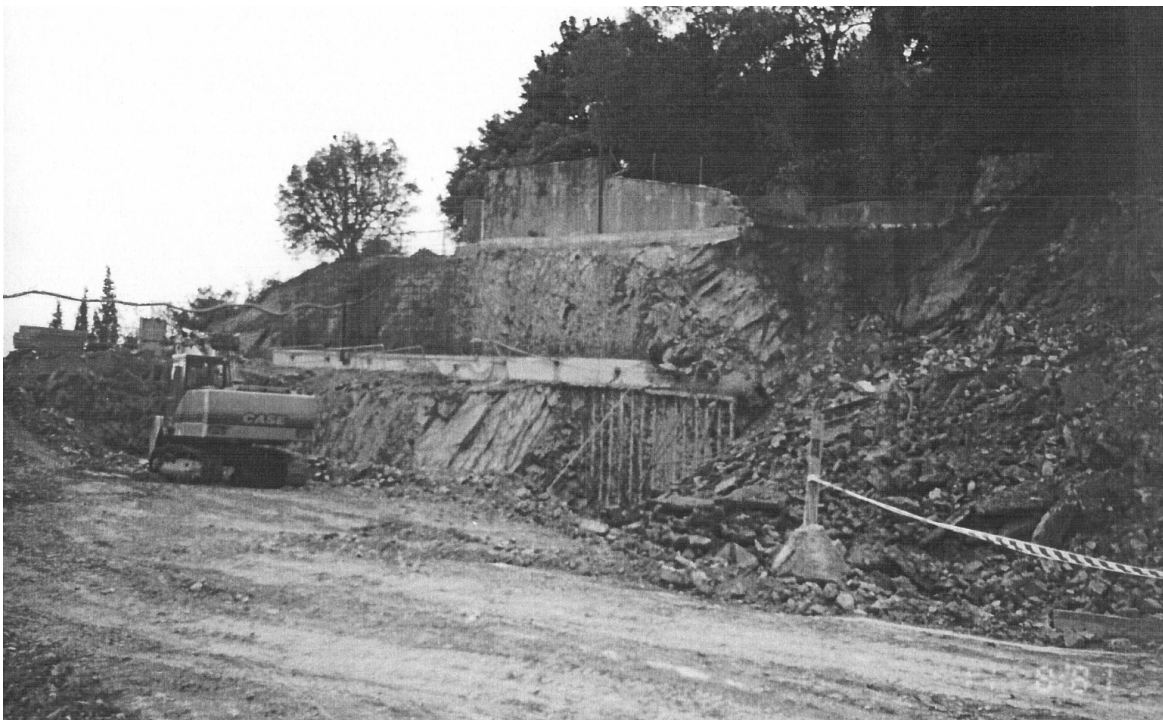
Figure 7. View of the collapsed wall. The intact part of the wall with the cap beam can be seen on the left, and the failed part on the right.

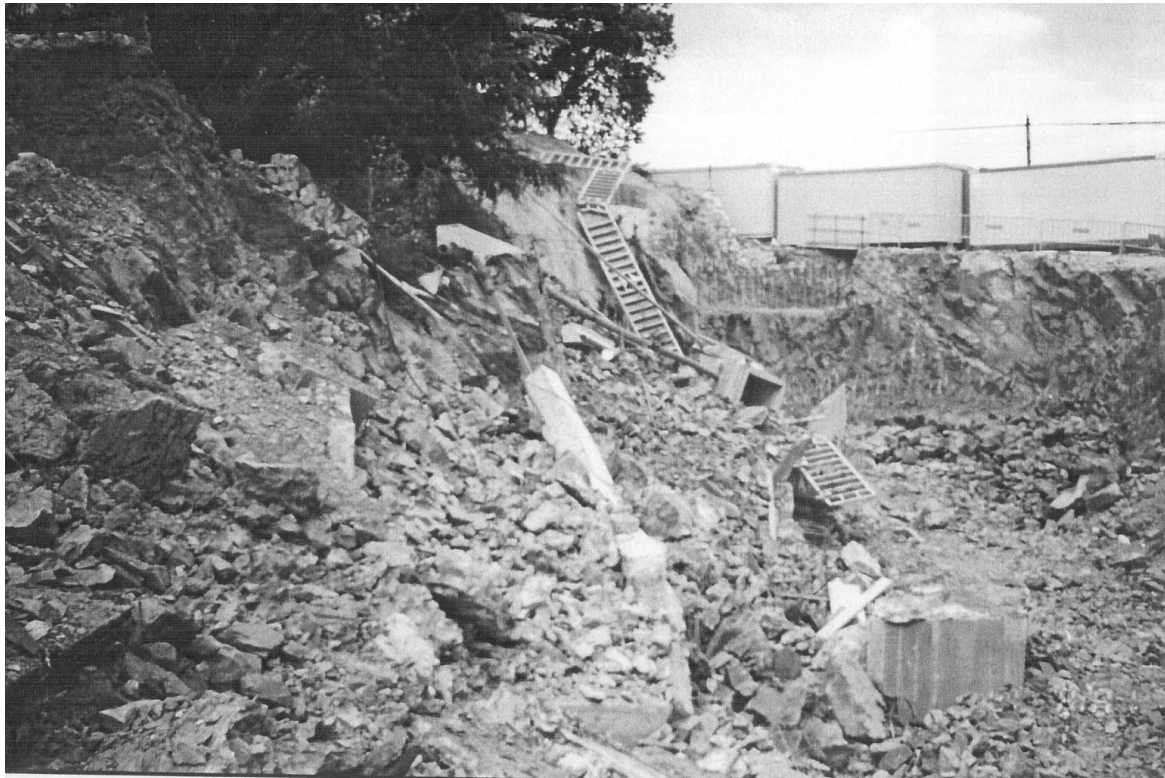
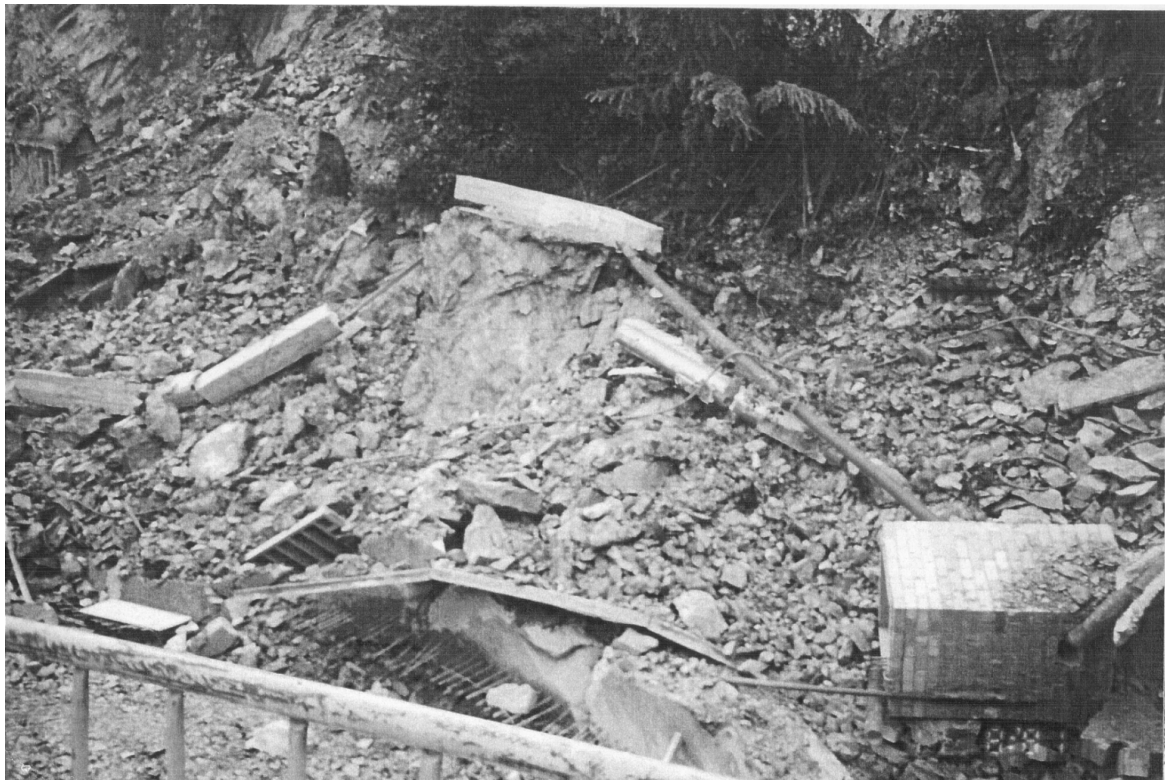
Figure 8. Detail of the failed wall. Parts of the broken piles and cap beam can be seen scattered on the ground surface.

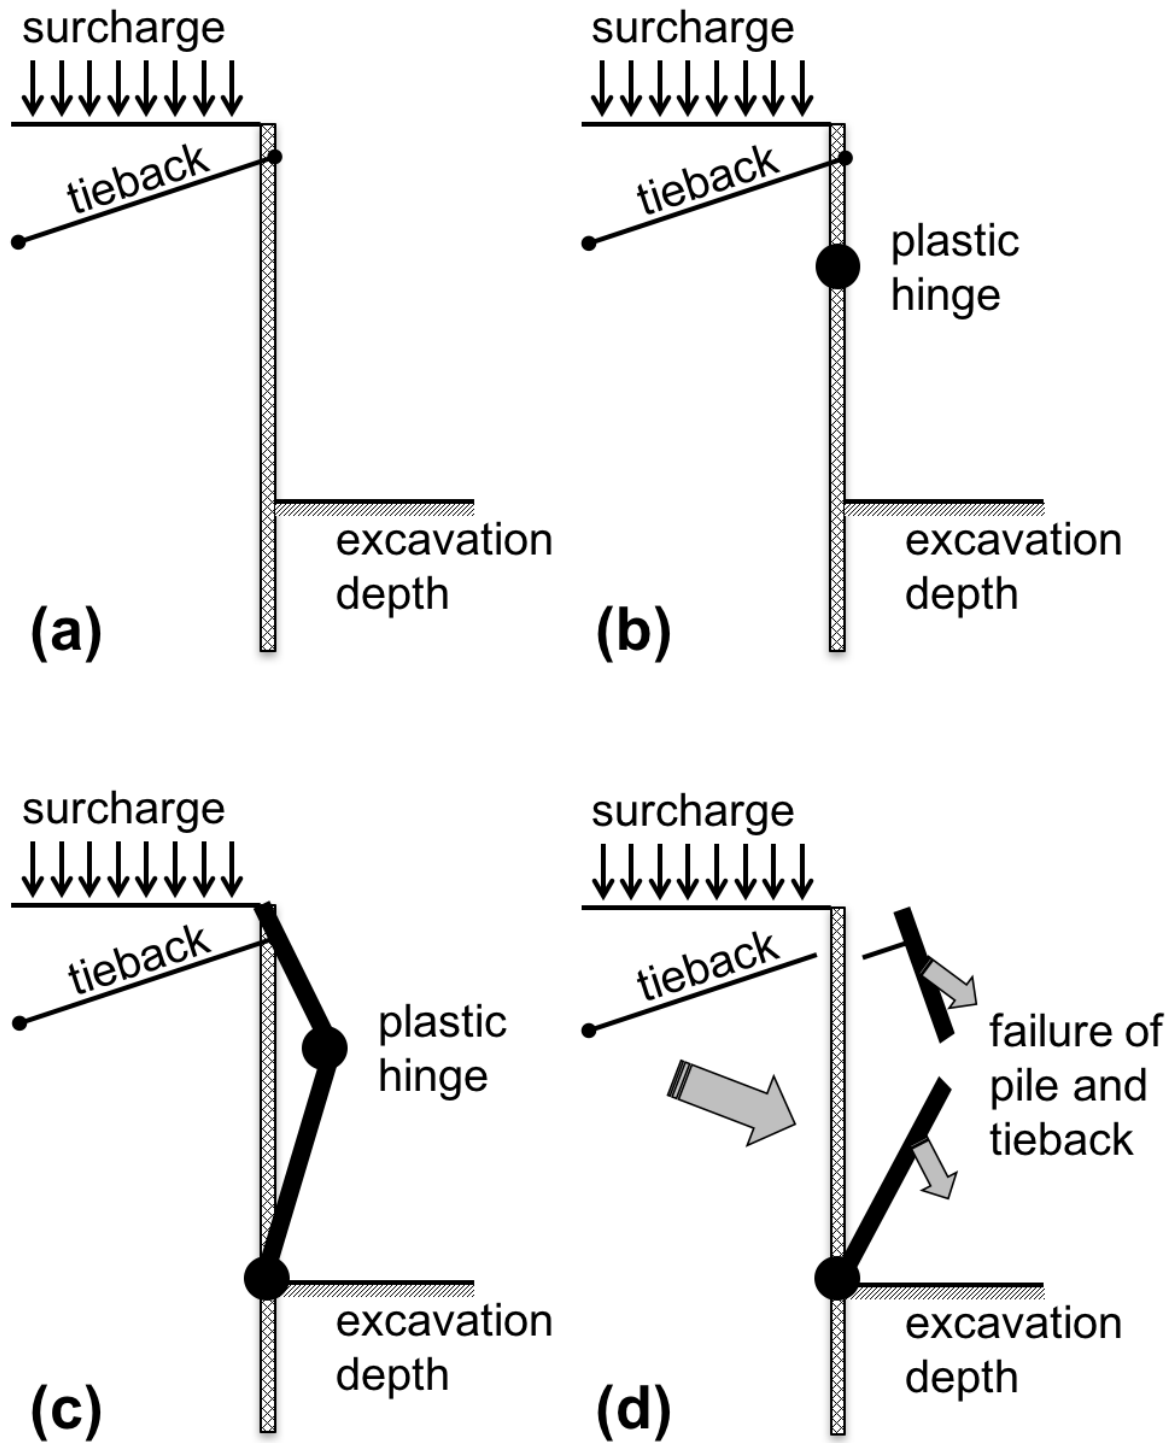
With this limited preliminary information, the most likely failure mechanism is illustrated in Figure 9, in which it is assumed, as suggested from a simple analysis using Blum's method [33], that when a plastic hinge develops in the micropile because the bending moment exceeds its bending strength, the load on the tieback is still less than its yield limit. Step (a) in this figure shows the initial condition in which the back slope surcharge acts as a load without contributing to the strength. With this conditions, when the bending moment on the micropile exceeds the yield moment, step (b), a plastic hinge forms, releasing the confinement of the earth behind the retaining wall so that the earth pressure is applied only to the less deformable elements: the tieback and the embedment. At this time the ground behind the wall has failed and has no apparent cohesion. The earth pressure is then transferred mostly to the tieback thus increasing its load until it reaches the yield limit of the steel cables, step (c). After that, failure of the tiebacks and of the micropile happens immediately, step (d), with the consequent collapse and sliding of the ground towards the existing excavation surface.

Figure 9. Collapse mechanism: (a) initial conditions; (b) a plastic hinge forms, arching occurs behind the wall and the ground cannot resist; (c) lateral deformation of the pile begins with the tieback within its strength limit; (d) large lateral deformation and failure of the tieback and pile.

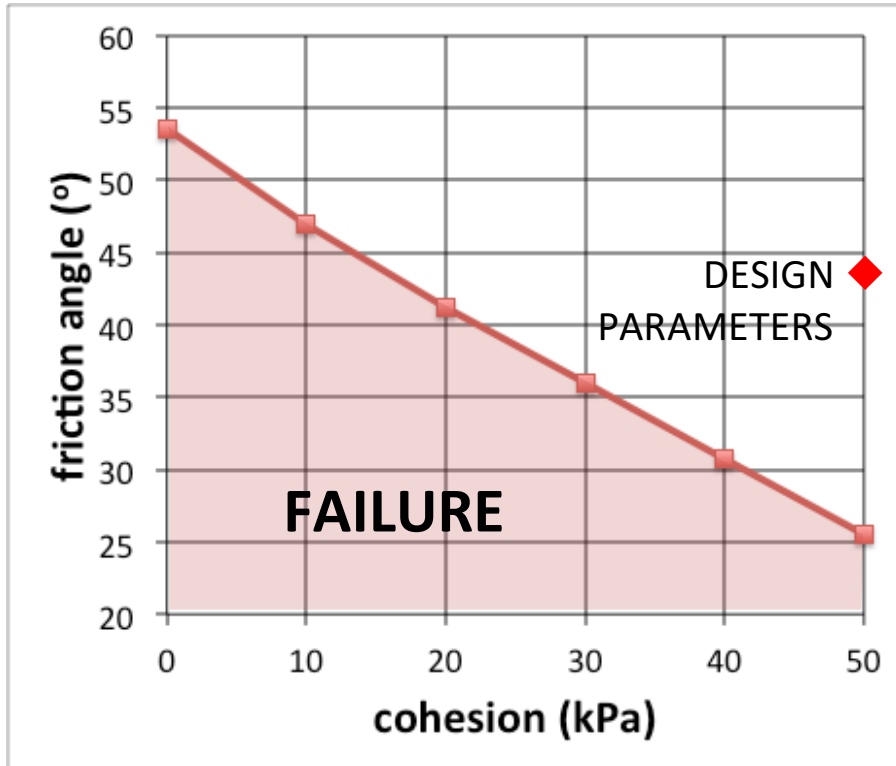
Therefore, the actual back slope height of 10 m and dry soil (because water did not play a significant role) have been adopted to analyse the failure with the 36 (c' , φ') pairs with ranges defined in Table 1. Figure 10 shows the limiting envelope of these (c' , φ') pairs considered in the failure analysis. Pairs outside the shaded area do not lead to failure and therefore cannot be the actual strength parameters since failure did happen. This shows that the design strength was largely overestimated, since the (c' , φ') pair used in the design is well outside the shaded area. The results suggest that the strength parameter sets that most likely represent the *in situ* conditions are H3 or H9 (Table 1), with $c' = 0$ or 10 kPa respectively, both with $\varphi' = 30^\circ$.

Figure 10. Limiting envelope of strength parameters combinations leading to failure.

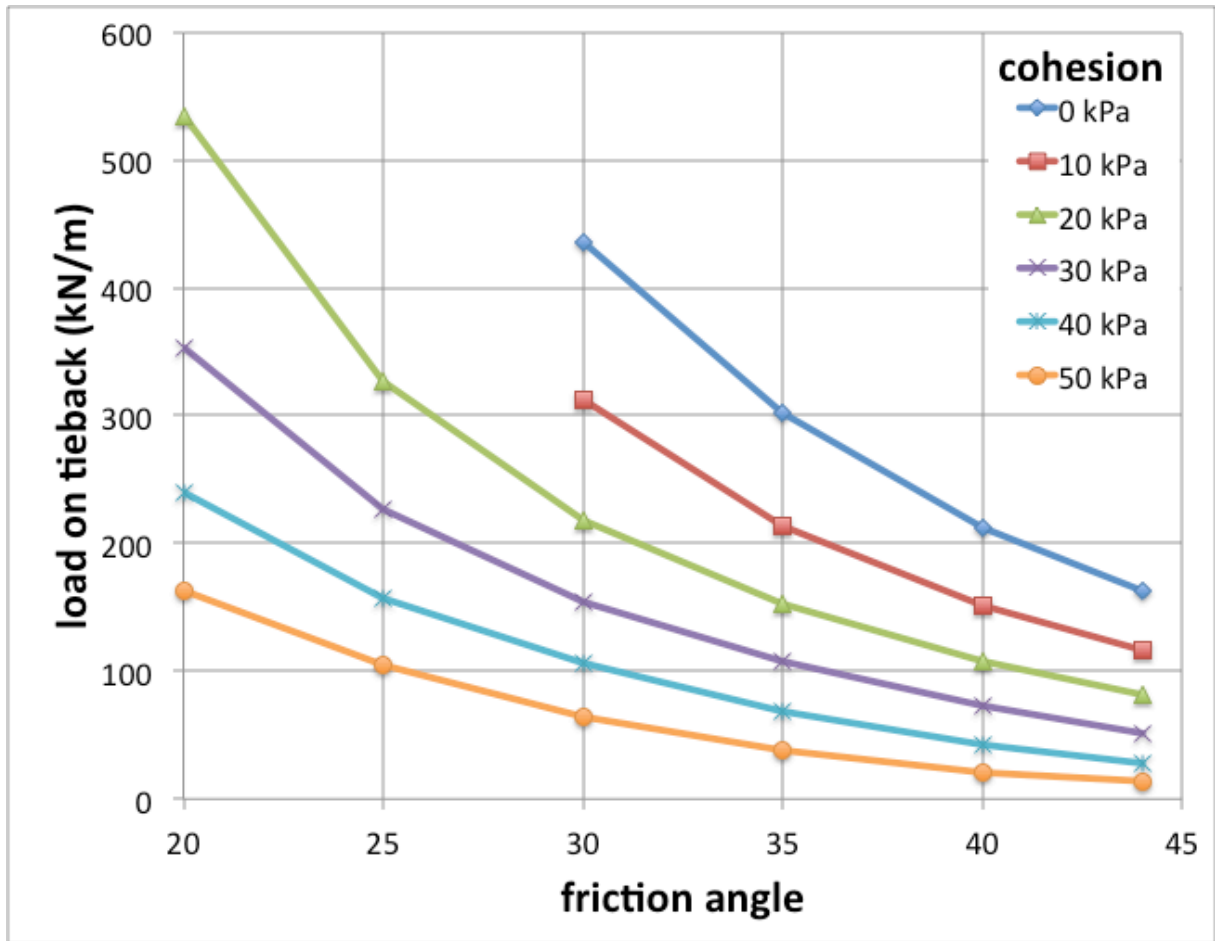
Figure 12 shows the value of the load on the same row of tiebacks at the end of step 5, which was the last actually executed and during which failure occurred. Note that for some of the (c' , φ') pairs failure happens before reaching this step. Considering only the construction steps that were actually executed before failure (step 5), the load on the tiebacks remains less than 100 kN/m with four more (c' , φ') pairs: H18 (20 kPa, 44°), H23 (30 kPa, 40°), H28 (40 kPa, 35°) and H33 (50 kPa, 30°). These latter (c' , φ') pairs are outside the range considered

most likely. Therefore, since for the remaining (c', φ') pairs the load on the tiebacks is larger than the maximum admissible, it may be concluded that at the time of failure the load on the tiebacks was larger than its yield strength, and the cables were fully in the plastic regime.

Figure 12. Predicted load on the upper tieback row at the end of construction stage 5 when the actual collapse occurred. Missing points indicate failure before reaching this stage.

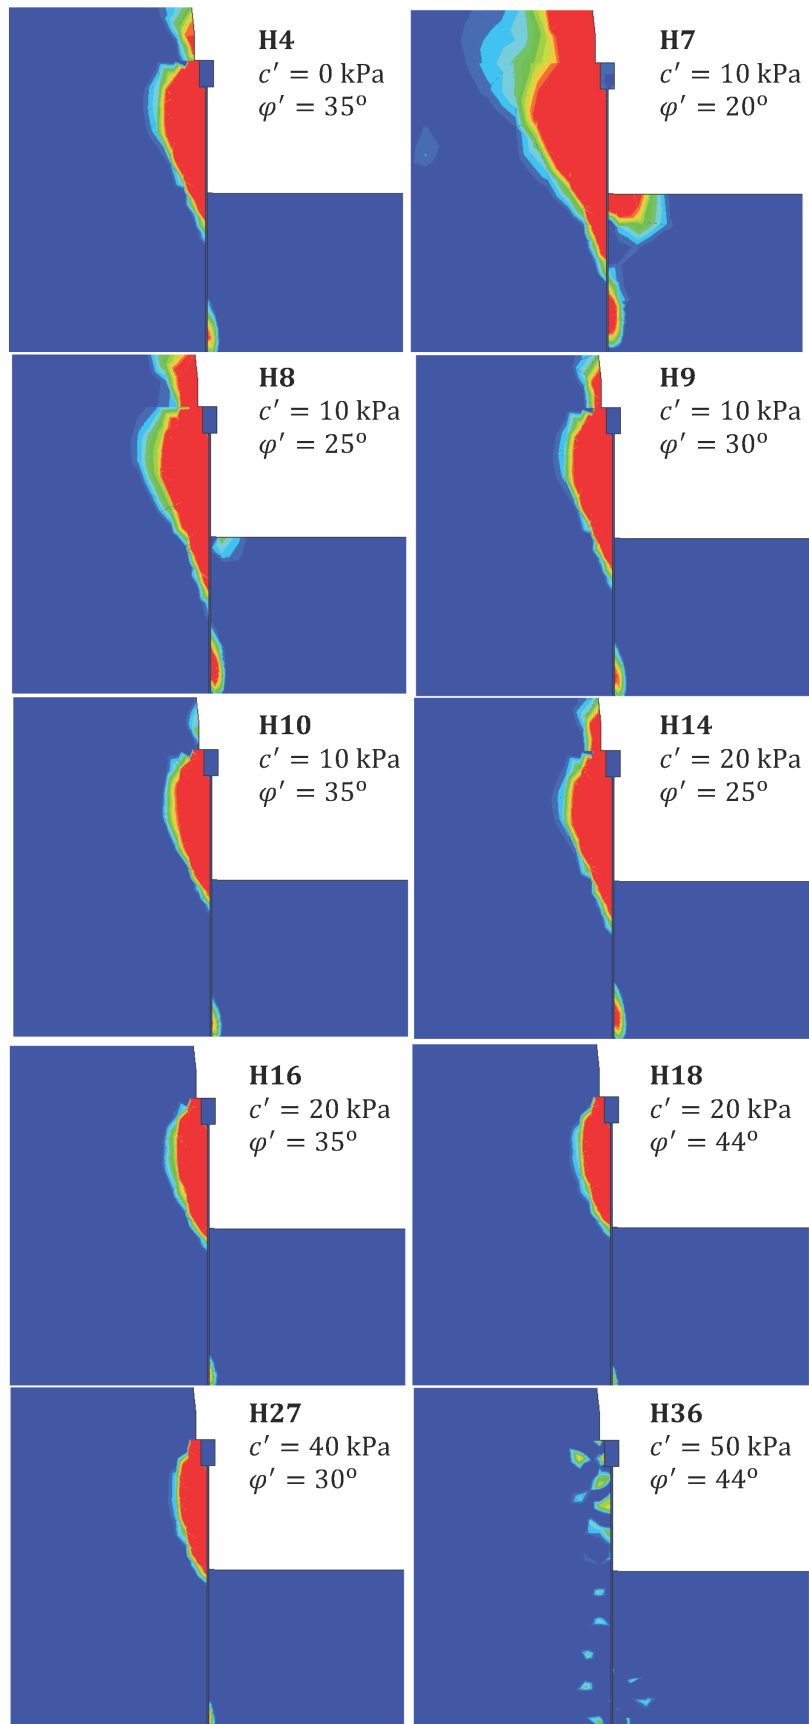
In general, the results obtained from the finite element analysis with DRAC are in good agreement with the results from the analysis with PARATIE™. Especially illustrative are the results showing the plastic deformation contours (Figure 15), which can be used to locate the position of the failure surface, and the deformed mesh (Figure 16), showing the curvature of the deformed micropile wall, a qualitative measure of the existing bending moments. High values of plastic deformation indicate the zones where the material has reached its yield limit. When this zone with high plastic deformation extends to a large volume, it indicates that the material has reached a global collapse condition. Figure 15 shows the extent of the plastic zone at the end of numerical step 7 for some selected (c', φ') pairs. The figure shows that for low values of cohesion and friction angle, the volume of the plastic zone is large indicating that the ground behind the micropile wall has failed completely, whereas this volume decreases when the values of these parameters increase. In particular, for the values of c' and φ' used in the original design of the retaining wall ($c' = 50$ kPa and $\varphi' = 44^\circ$, respectively, set H36) no significant plastic zone develops during excavation.

Figure 15. Extent of the plastic zone obtained with DRAC near the micropile wall after step 7 for the selected sets of strength parameters indicated
