TITLE: Slope stability in slightly fissured claystones and marls

AUTHORS: Eduardo E. Alonso and Núria M. Pinyol

AFFILIATION: Department of Geotechnical Engineering & Geosciences, UPC, Barcelona, Spain

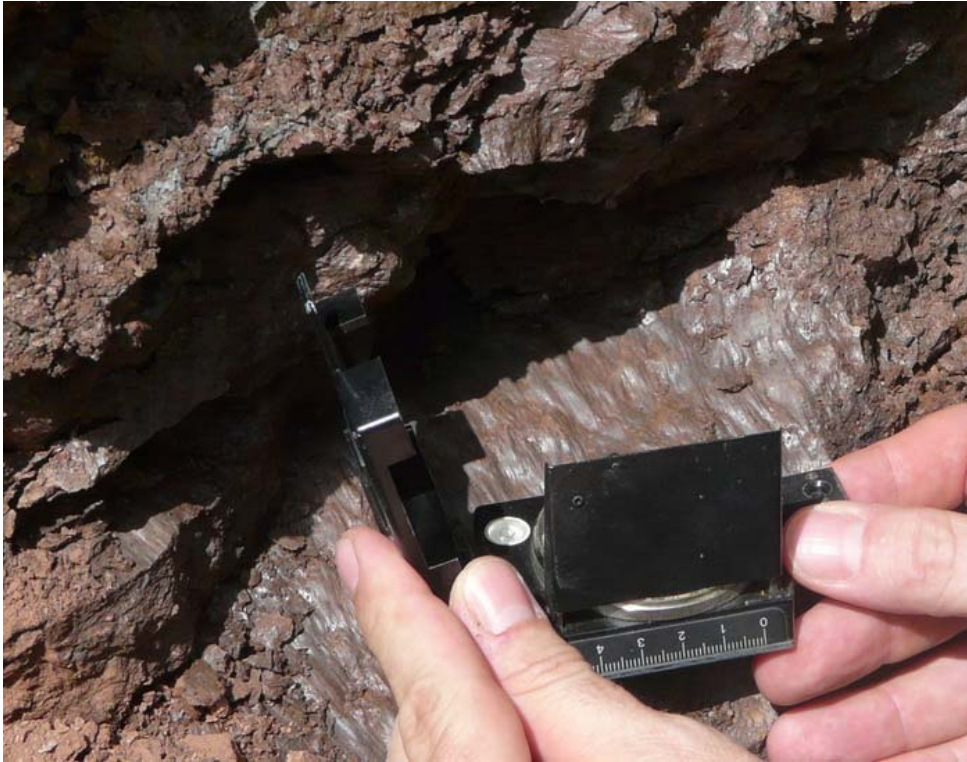
Figure 3: A sedimentation plane in Castrovido Weald claystone. Despite the sheared aspect of this surface there were indications of a sin-sedimentary feature. If this interpretation is correct, the observed geometry is a consequence of early deformations, including some shearing, at the time of deposition

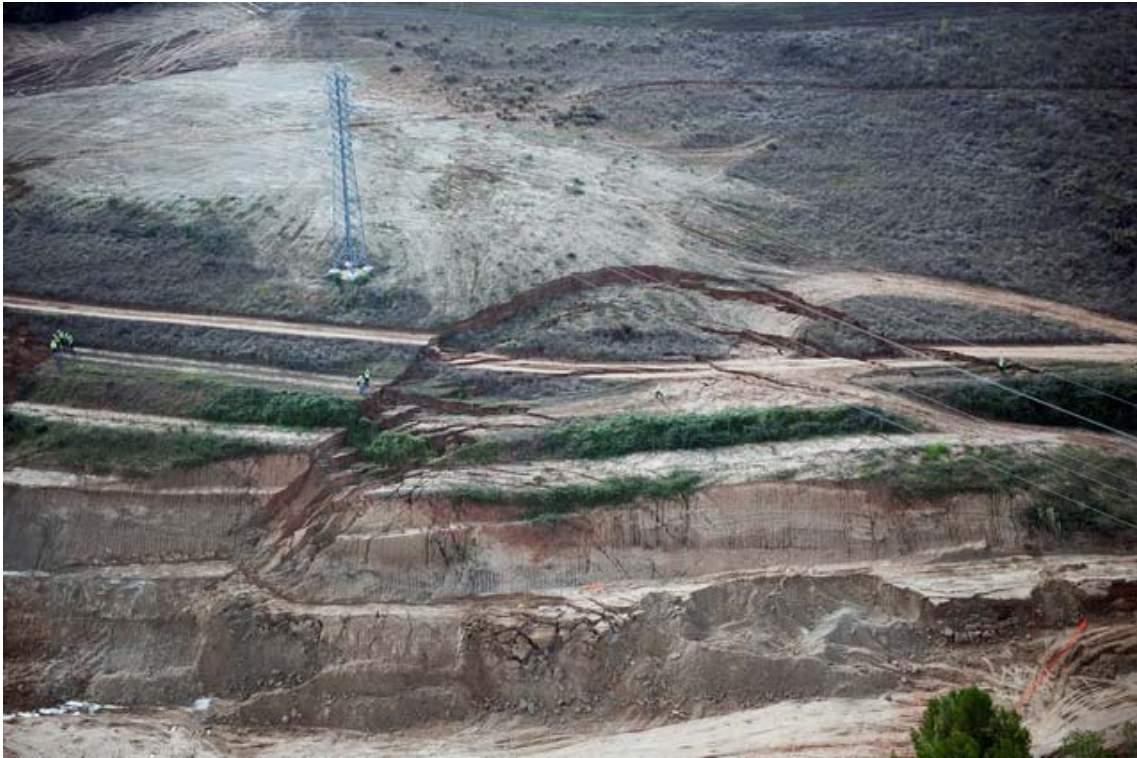
Figure 4 shows a slope failure triggered by an excavation at the toe of a relatively gentle slope ($\sim 12^\circ$). The cross section in Figure 5 shows the sequence of Tertiary claystones, siltstones and lightly cemented sands of Tertiary origin which characterize the slope. These are hard soils that could only be sampled by rotary coring.

Figure 4: Sabadell slope failure

The measured strength envelopes indicate that failure was most probably preceded by a progressive failure mechanism induced by the excavation. Tertiary deposits in the region are known to exhibit high horizontal stresses. In an investigation of the “in situ” stresses in a shallow tunnel excavated in Tertiary claystones in the neighboring city of Tarrassa, Gens et al. (1996) reported K_0 values of 1.7 – 2.2. A previous “damage” (slip contact) of the shearing strength of sedimentary planes may also explain the failure, but no evidence of striations was found in the cores recovered or in the visual inspection of the exposed slope.

The case is interesting because equilibrium was achieved for a friction angle similar to the minimum measured residual friction angle. Stabilization was achieved by a pile barrier that was designed accepting that the minimum residual friction angle was operating on the shearing surface. The failure surface was probably located within the high plasticity claystone layer (Figure 5).

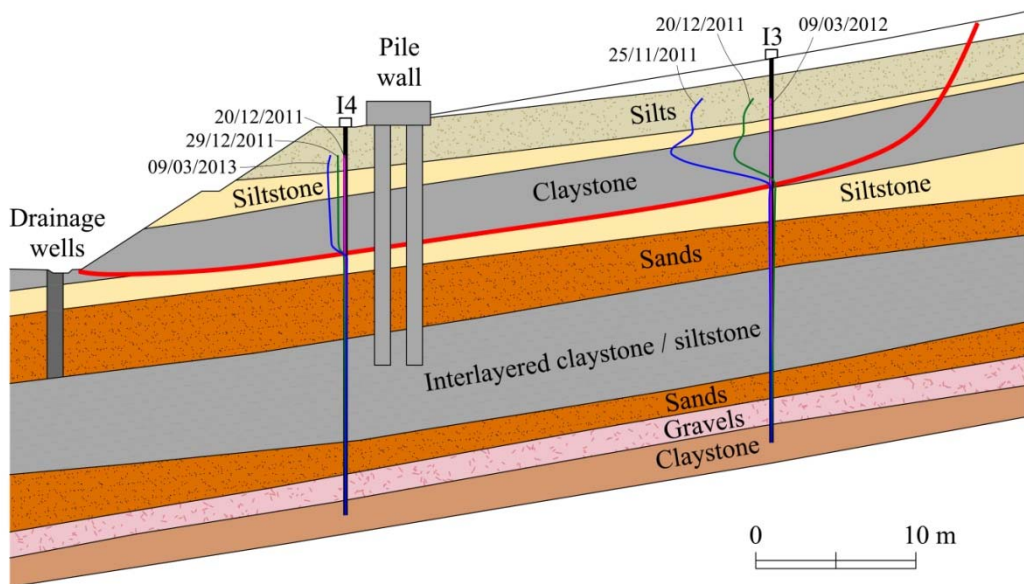
Inclinometer readings (the position is given in Figure 5), taken immediately after the failure, indicated a slope creeping motion that allowed the identification of a well-marked failure surface at a claystone-siltstone contact, which followed the inclination of sedimentary layers. It was clear that the excavation favored the development of a planar motion, which daylighted at the toe of the excavated slope.

Figure 5: Sabadell slope failure. Cross section along slide axis. The position of the sliding surface and remedial stabilizing measures are indicated.

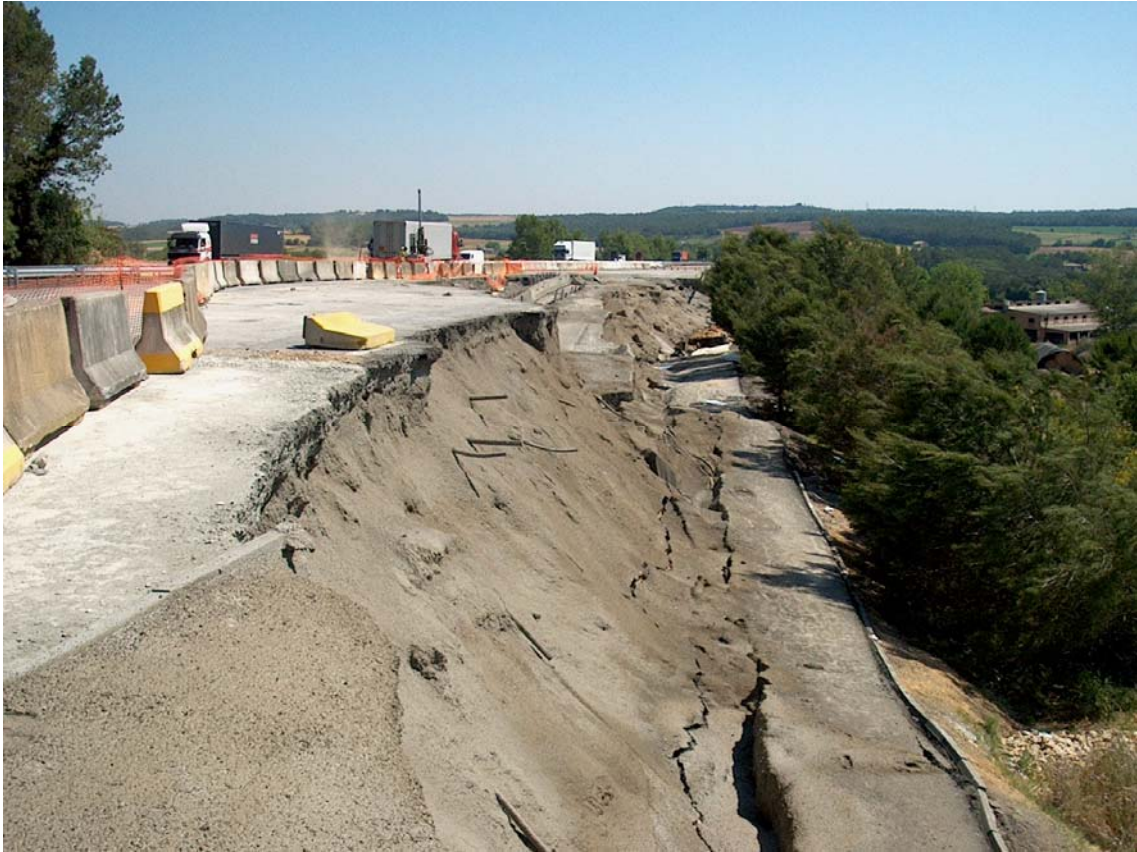
In May 2004, 200 m of a motorway embankment in the Province of Girona (Viladesens in the remaining description) experienced a progressive instability that forced the interruption of traffic. The embankment was built 30 years before and no significant incidents were recorded except for some occasional settlements. Figure 7 shows the head of the slide which destroyed one of the motorway lanes. The embankment was built on a natural clayey slope of gentle inclination (8°). The failure was unexpected because of the long period of stability after construction.

Figure 7: Scarp of Viladesens slide. May, 2004

However, the nature of the natural soil, an overconsolidated high plasticity clay, suggests that a slow creeping motion combined with a progressive failure mechanism could have played a critical role. Figure 8 shows a representative cross section of the embankment. The sliding surface was located, by interpreting inclinometer readings, close to the contact between the compacted embankment and the brown stiff natural clay. The slide may be described as a translational motion essentially parallel to the natural slope. A water table was also identified in the lower third of the embankment height. During the months prior to failure, intense rainfalls were reported.

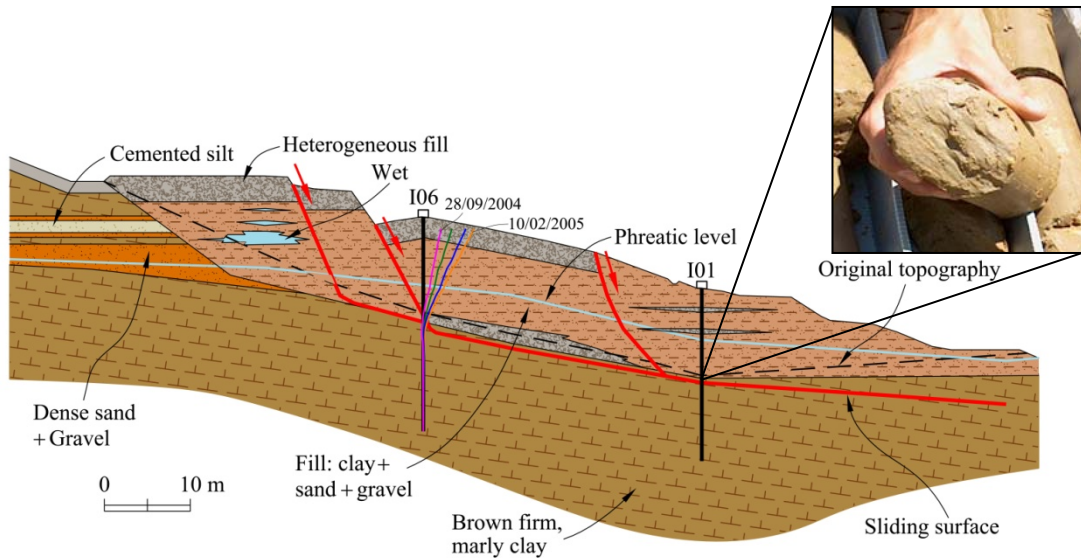
Borings performed immediately after the first cracks were detected on the pavement identified a substratum described as stiff, sometimes hard, overconsolidated and fissured clay. Sand lenses were also detected in the upper levels of the natural formation, close to the embankment contact. These pervious materials may have contributed to increase the water pressure on the embankment-natural clay interphase.

Figure 8: Cross section of Viladesens slide and striated and polished surface in brown clay observed in recovered cores.

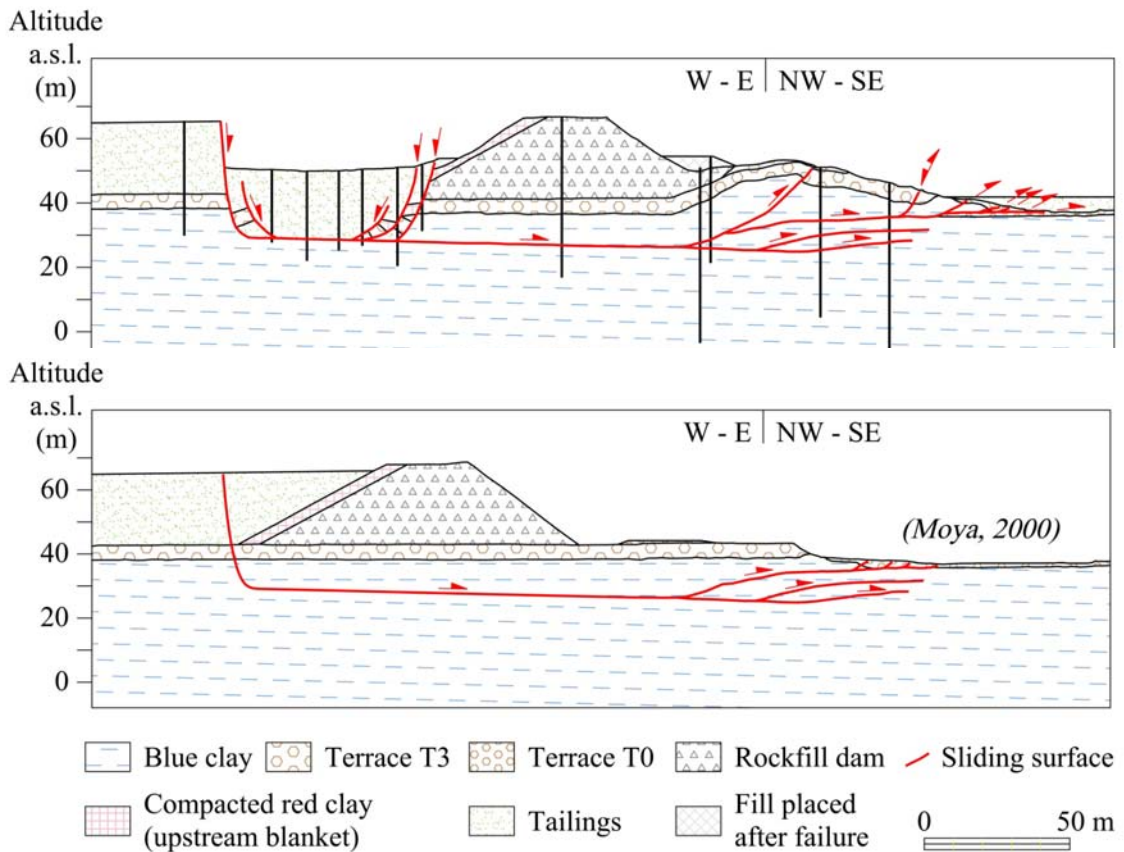
Aznalcóllar dam failure was a case of sliding of the dam and an upper slab of foundation soil on a high plasticity overconsolidated marine Miocene clay. It has been described in a number of papers (Alonso and Gens, 2006a, b; Gens and Alonso, 2006; Zabala and Alonso, 2011). The failure, represented in Figure 10 was attributed to the persistence of high load-induced pore water pressures in the foundation clay, the brittle behavior of the clay and the “downstream” construction method of the dam, which generate high shear stresses under the evolving dam toe. Aznalcóllar is a good example of a progressive failure phenomenon, analyzed in Zabala and Alonso (2011). Figure 11 is taken from this reference and shows the predicted position of the shearing band, eventually transformed into a full failure surface, when the dam reached a height of 25 m, 2 m below the dam height at the time of collapse.

Figure 10: Cross section of Aznalcóllar slide: (a) geometry after slide, as interpreted from borehole data and surface topography; (b) reconstruction of position of sliding surface before failure (Alonso and Gens, 2006a).

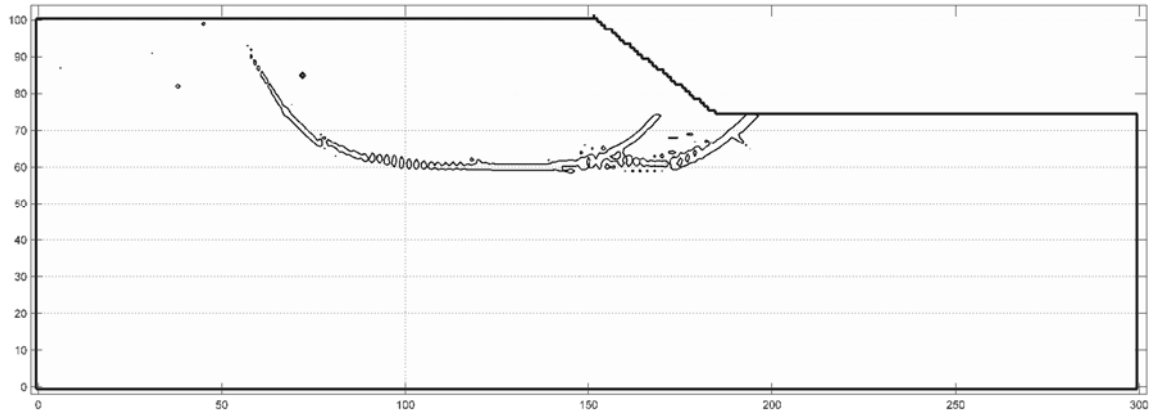
Figure 11: Development of the failure surface. The plot shows the contours of equivalent plastic strain calculated in the foundation of clay when the dam reached a height of 25 m $K_0 = 1$ (Zabala and Alonso, 2011).

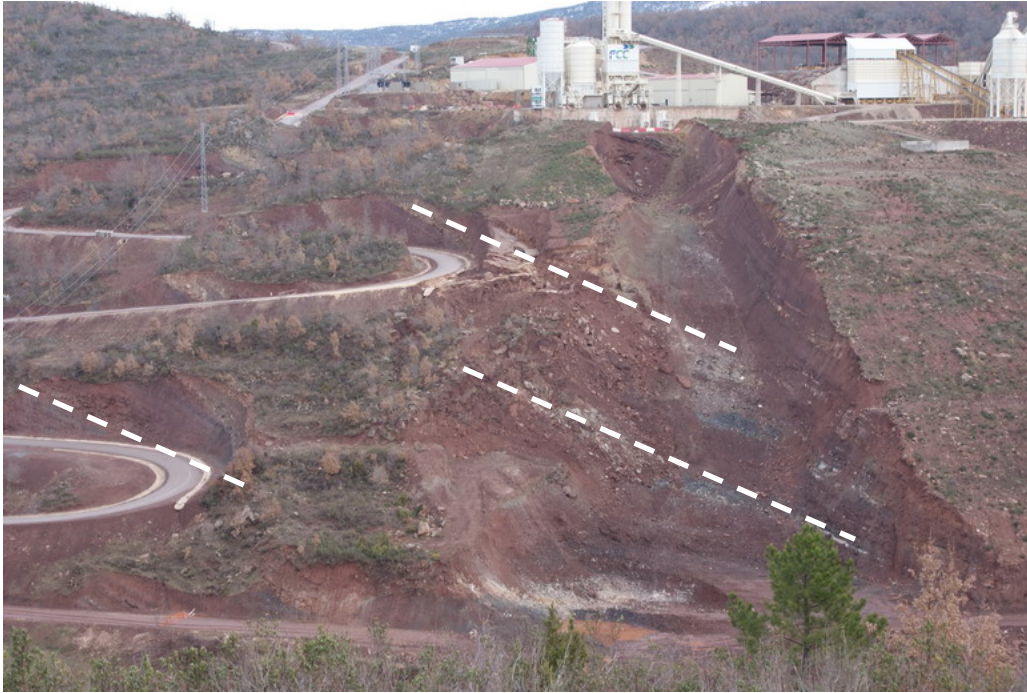
Two types of slope instability are present in the Castrovido dam area: shallow failures and planar failures controlled by sedimentation planes (Fig. 19). The photo shows the large excavation of the right abutment of the dam and a collapse of the downstream side of the excavation. The discontinuous lines show the dip of the sedimentation planes. At a large scale the Weald formation is a sequence of claystone and interbedded sandstone layers although the claystone lithology dominates the sediments.

Figure 19: Planar failure in Castrovido claystone controlled by sedimentation planes

Slope stability and, indeed, the stability of the concrete gravity dam designed depend critically on the strength available in these sedimentation planes. Three types of contacts were identified in the course of a detailed field surveying campaign: sandstone-sandstone, sandstone-claystone and planes inside the claystone. One significant aspect of this soft rock formation was the presence of Muscovite mica. Mica platelets were dispersed in the claystone matrix but they were often found also in some sedimentation planes inside the sandstone strata. The shear strength of stratification planes was investigated by direct shear tests at two scales: (a) tests were performed on block samples, up to 30×30 cm, recovered from several locations of the entire dam excavation area, and (b) large-scale “in situ” tests, 80×80 cm in size.

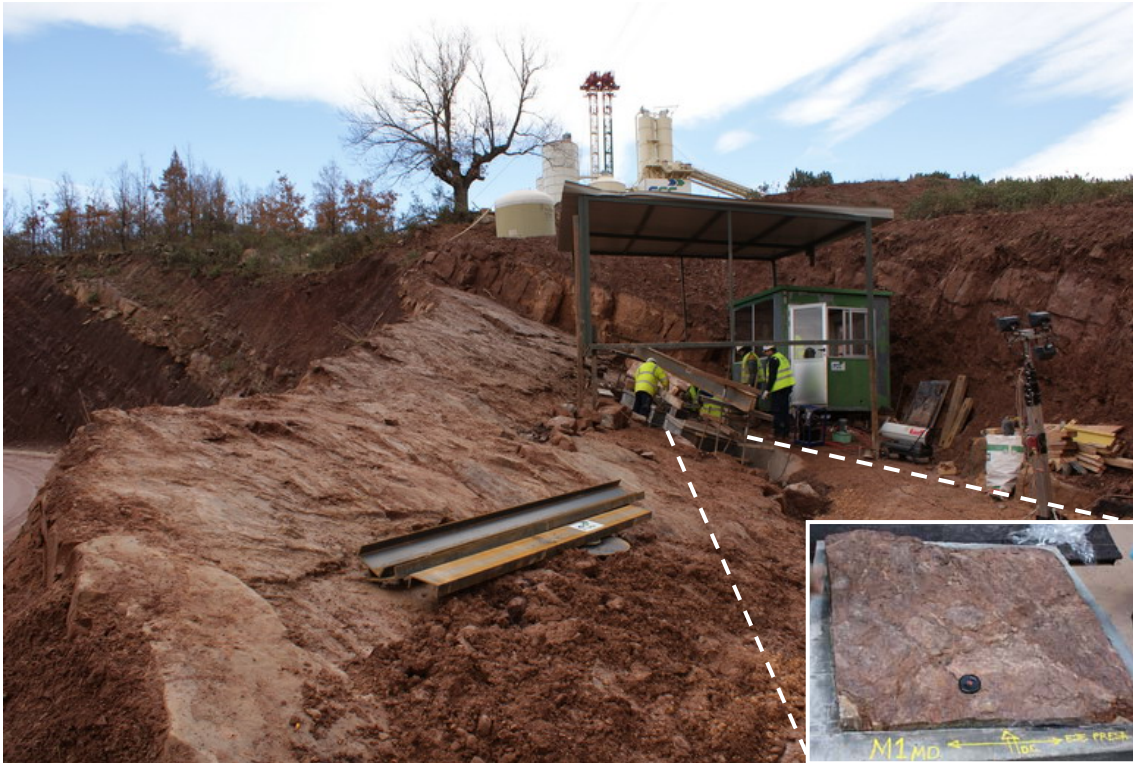
This is better illustrated if one examines the roughness of a natural claystone-sandstone contact at a much larger scale (Fig. 20). The figure shows an uncovered contact during the preparatory works to locate the large-scale “in situ” shearing tests. Subvertical local fractures led a rough surface having abundant “jumps”, difficult to characterize by a typical random roughness. The “in situ” shear tests were arranged to test the contact plane shown in Figure 20. Figure 20 also shows the tested plane in one of the six tests performed.

Figure 20: Castrovido Weald form. Exposed sandstone-claystone sedimentation surface. Zoom-in of contact after insitu shearing test.
