MATERIAL PERFORMANCE INVESTIGATION ON THE FAILURE OF AN AIRCRAFT (ABT-18) NOSE WHEEL STRUT

ABSTRACT

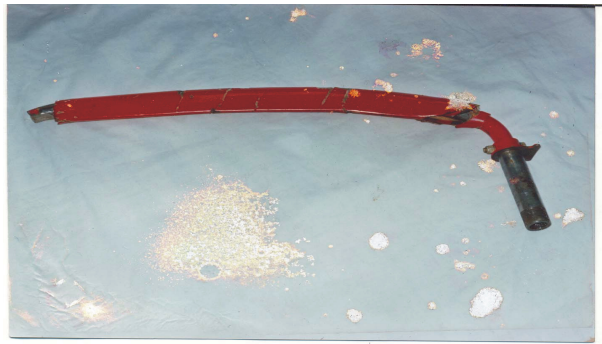
Plate 3: As-Received Failed Sample, F

Visual inspection via unaided eye showed a buckled and fractured strut material with V-shaped markings (Chevrons) on the fracture surface. It showed that the markings converge to the origin of the fracture.
