Wear mechanisms of silicon carbide-whisker-reinforced alumina (Al₂O₃-SiCw) cutting tools when high-speed machining aged Alloy 718

Bushlya, Volodymyr; Zhou, Jinming; Avdovic, Pajazit; Ståhl, Jan-Eric

Published in:
International Journal of Advanced Manufacturing Technology

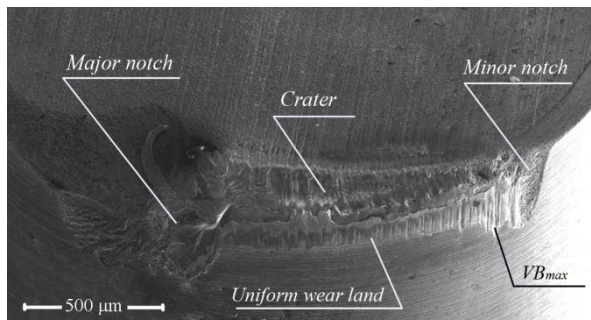
Irrespective of cutting conditions or coolant application the morphology of the worn-out tools comprises (see Fig. 1) of a notch on the major cutting edge (hereinafter major notch); crater; flank wear land (VB); notch on the minor cutting edge (hereinafter minor notch). Term major notch is used because the discovered morphology and formation mechanisms cannot be fully represented by a common term “depth-of-cut notch”, as shown in *section 3.1*.

Fig. 1 Typical morphology of worn-out insert ($v_c=250$ m/min, $f=0.19$ mm/rev, $a_p=0.53$ mm)

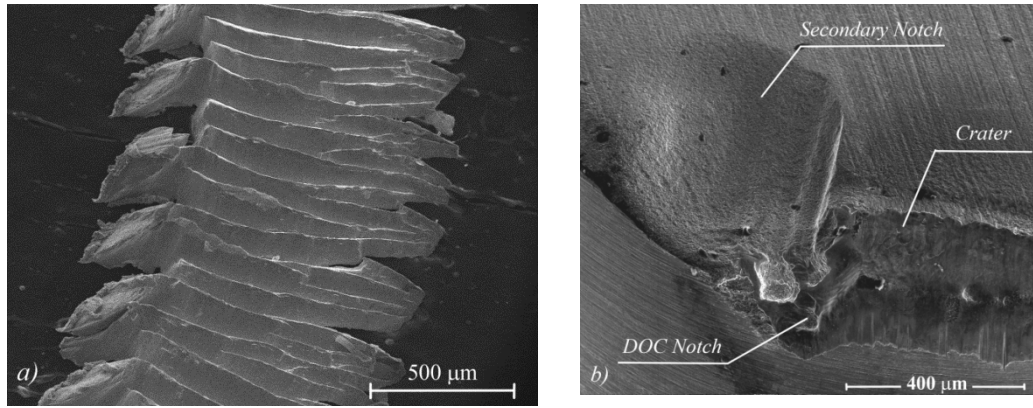
When machining with coolant, the amount of adherent material is less profound (see Fig. 4.b) and is limited to microwelding. Figure 4.b presents clear evidence that burrs do not influence the formation of the secondary notch since it is limited to the tool rake only. Furthermore limited amount of adherent material imply attrition wear mechanism. While the cause behind notch formation was found different, the acting mechanisms of adhesion and attrition comply with finding by Xiao et al. [13].

Fig. 4 (c) Segmented chips ($v_c=250$ m/min, $VB_{max}=0.17$ mm, coolant) and (b) Formation of the secondary notch by chip attrition ($v_c=200$ m/min, coolant)

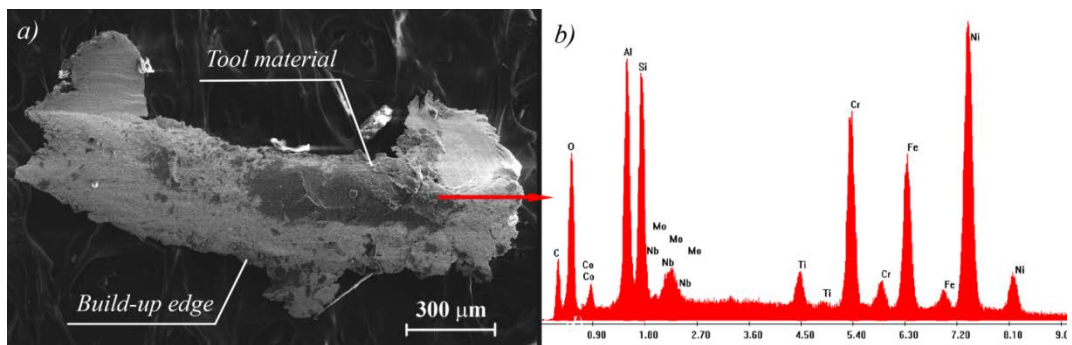
Fig. 5 (a) Build-up edge of Alloy 718 with removed tool material and (b) respective EDX

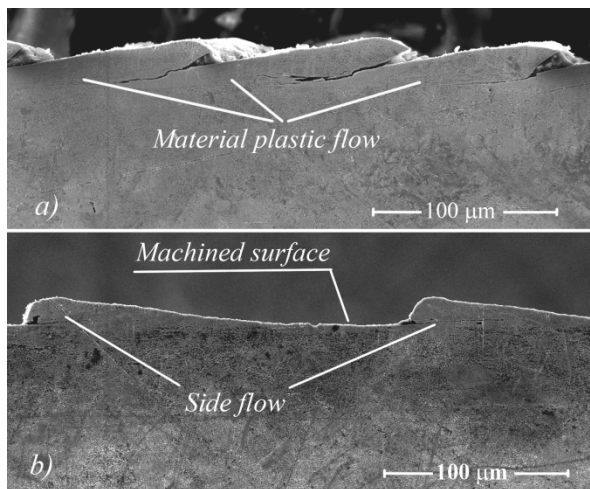
It was found in this study that minor notch is related to the defects left on the surface during machining. Two types of related surface defects were identified: severe plastic flow and side-flow. Presence of severe material plastic flow (Fig. 6.a) was observed under both dry and wet conditions. Similar surface defect was registered by Kitagawa et al. [1] and Narutaki et al. [9] when machining Alloy 718 with whisker reinforced, mixed alumina and Si_3N_4 tooling at cutting speed around 150 m/min. In current study presence of material plastic flow was observed under majority of test conditions, yet intensity of this surface defect varied with process conditions. Increase in feed, speed and application of coolant strongly reduces presence of this type of damage up to the full disappearance. Machining under dry conditions and with slightly worn tools promotes formation of this damage. It was observed that as the tool wear progresses ($VB>0.1-0.15$

mm) the material plastic flow is suppressed and replaced by formation of side-flow in its typical understanding (see Fig. 6.b).

Appearance of material plastic flow can be explained through the findings of Gatto and Iuliano [12] who have reported the presence of transverse material flow when machining Alloy 718 with ceramic tools. Such transverse flow, along with dramatic increase in ductility of Alloy 718 at temperature around 1000 °C up to 160 % [23] may facilitate separation of the chip at thickness higher than its otherwise minimum value h_{1min} . The remaining chip element is then ploughed to a side towards minor edge and left on the surface in the form of a continuous or discontinuous scale (Fig. 6.a).

Fig. 6 (a) Formation of plastic flow and (b) Side flow on the machined surface

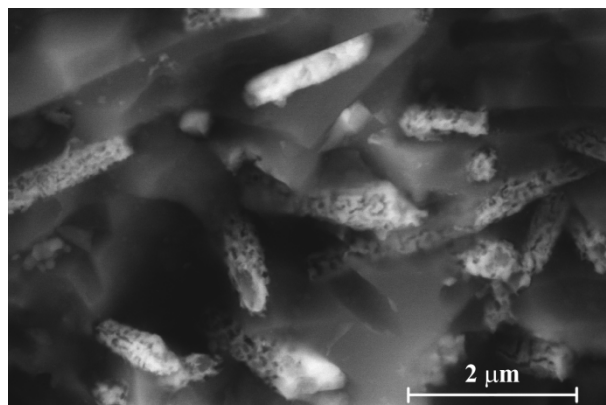
Decomposition of the whiskers and replacement of silicon in them reduces mechanical properties of both whiskers and the ceramic as a whole therefore enhancing susceptibility to mechanical damage. The back-scatter electron image of SiC whiskers on the tool rake (Fig. 9) shows that they completely or partially degrade due to diffusion of Ni, Cr, Fe. Weakening of tool material accompanied by intensive adhesion of Alloy 718 has been observed to lead to fracture, cracking and pluck out of both whiskers and Al₂O₃ matrix (see Fig. 9). This particular type of degradation was observed to have the highest intensity in the area of DOC notch and on minor cutting edge where unstable tribolayer intensifies adhesion.

Fig. 9 Diffusional degradation of SiC whiskers on the crater

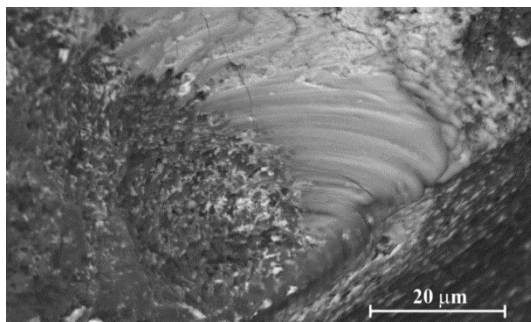
As seen from the observations, formation of either silica or aluminosilicate glass takes place during machining. Liquid, at high temperatures, glassy phase is pushed to a region of lesser tool/workpiece pressure and is squeezed outside chip area on major and minor cutting edge where it solidifies on cooling (see Fig. 14). Similar structures were observed both under dry machining and machining with coolant.

Fig. 14 Liquefied tribolayer on the minor cutting edge side of the crater ($v_c=250$ m/min, $f=0.25$ mm/rev)

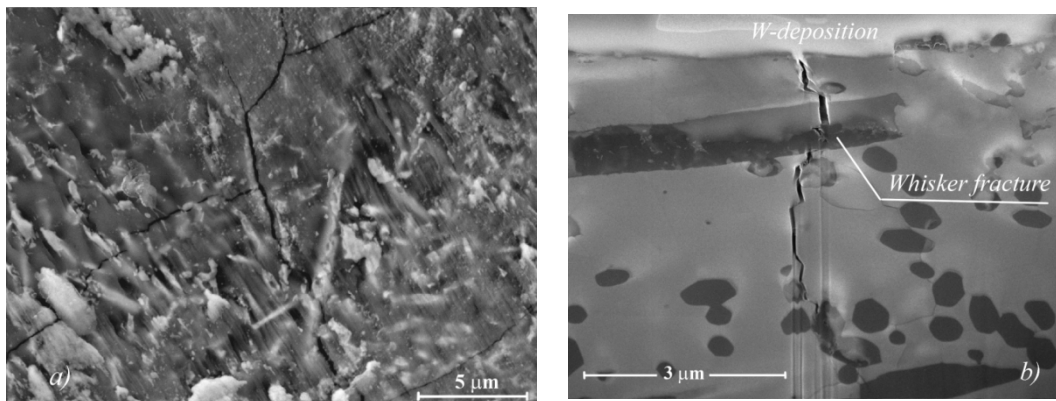
Cracking on the tool surfaces is known to form when machining Alloy 718 with ceramic and cemented carbide tools. It is attributed either the thermal shock or the thermal fatigue [6, 29]. Tiegs and Becher [30] have shown that as manufactured whisker reinforced alumina has low susceptibility to thermal stress cracking. Flexural strength of $\text{Al}_2\text{O}_3\text{-SiC}_w$ has not degraded either upon single or multiple high temperature shock. The principal mechanism behind thermal cracking is the thermal expansion mismatch between alumina and silicon carbide. Thermal expansion of the SiC whiskers ($\alpha_L=2.7\cdot 10^{-6} \text{ }^\circ\text{C}^{-1}$) is less than the Al_2O_3 matrix ($\alpha_L=6.3\cdot 10^{-6} \text{ }^\circ\text{C}^{-1}$). In this case, the tensile stresses at elevated temperatures change to compressive ones upon cooling while formation of a crack requires the opposite. Diffusional ingress of Ni, Cr and Fe into SiC leads to an increase

in thermal expansion coefficient for whiskers and therefore promotes cracking (see Fig. 15.a) through formation of tensile stresses upon cooling.

On the other hand, it was reported [16] that cracking may arise in the tribolayer upon tool disengagement and cooling. In such case the cracks are limited to the layer and do not penetrate into the tool bulk. FIB cross sectioning through the cracked region in our case has allowed to detect that cracks significantly extend into the bulk (see Fig. 15.b). It was observed that crack may deflect on whiskers with formation of a mesh of smaller cracks along with the main crack. Diffusion assisted problems with thermal expansion mismatch leading to the development of compressive stresses at high temperatures are known to further strengthen the bonding between alumina matrix and SiC whiskers. Such behavior is expected to promote whisker fracture instead of debonding (Fig. 15.b).

Fig. 15 (a) Cracking on the crater and (b) propagation of the crack into the tool bulk
