Using resistivity measurements for dam safety evaluation at Enemossen tailings dam in southern Sweden

Sjödahl, Pontus; Dahlin, Torleif; Johansson, S

Published in:
Environmental Geology

2005

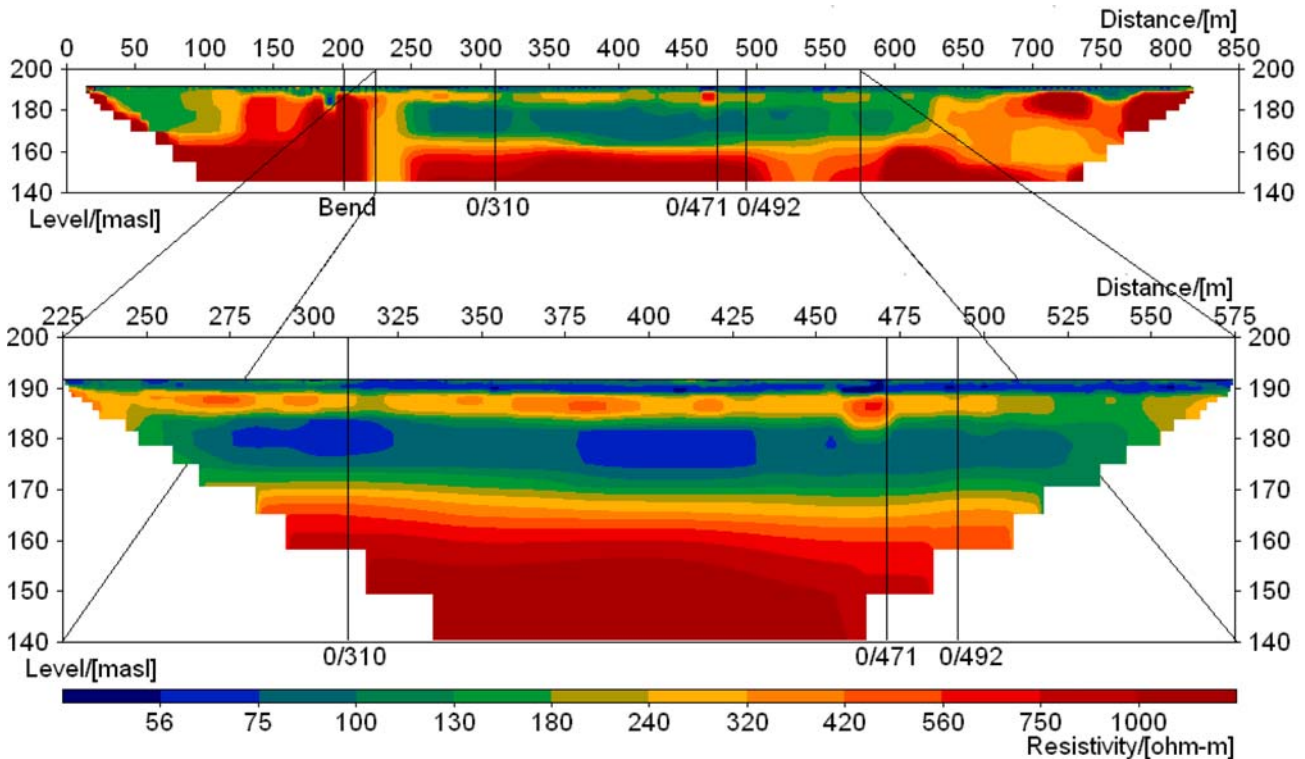
The resistivity measurements along the dams as well as the cross lines provided data of high quality, resulting in low model residuals (≈ 1 –3%) for the inverted sections. The upper part of Fig. 2 shows an inverted section from the 5 m spacing survey along the entire dam X-Y. Data from the 2 m spacing and the 5 m spacing survey along the central part of the dam were combined and inverted jointly (Fig. 2).

A high-resistive bottom layer is evident throughout the section, at depths that correlate well with the somewhat sparse and uncertain information available about variations in bedrock level. The high-resistivity bottom layer comes close to the surface at the ends of the line. The central part the line exhibits three principal layers above the high-resistive base layer. Starting from the top; a couple of metres thick layer of around $100 \Omega \text{ m}$, a medium-resistive layer of a few hundred Ohm m down to approximately 10 m depth, and below that a layer around $100 \Omega \text{ m}$ reaching circa 30 m depth.

When comparing the longitudinal sections and the cross sections, it is evident that the former, which are measured along around –10 m in the cross section, will suffer from severe 3D effects. The top layer observed in

Fig. 2 Inverted resistivity section from the X-Y dam. Above: based on measurements from the 5-m spacing survey (mean residual 2.5%). Below: based on measurements from both the 2-m electrode

spacing and the 5-m spacing survey (mean residual 1.4%). Cross section profiles at 0/310, 0/471 and 0/492 m are marked out. Level refers to meters above sea level

Fig. 2 corresponds to the uppermost part of the dam core, and the second layer corresponds to the upstream support fill. The third layer in the length sections show the combined effect of the dam core, the water-saturated support fill and the saturated tailing sand.

The resistivity profiles along the dam show low-resistivity areas at chainage 0/280–0/340 m, 0/390–0/

425 m, and 0/525–0/550 m. The resistivity in the area of the latest sinkhole (at chainage 0/500 m) is similar compared to the other parts of the dam. The cross section at chainage 0/492 m shows, however, a lower resistivity in the downstream part of the core. This is similar to the result at chainage 0/310 m where a high-resistivity zone (corresponding to the upstream support fill) is interrupted by a large low-resistive zone. This can be interpreted as an effect of anomalous seepage through the dam, which fits well with the occurrence of previous sinkholes. The overall conclusion, based on the result from these investigations, is that none of the detected resistivity or temperature anomalies immediately need any further investigation, but the result shows the importance and need of the ongoing monitoring program for the dams.

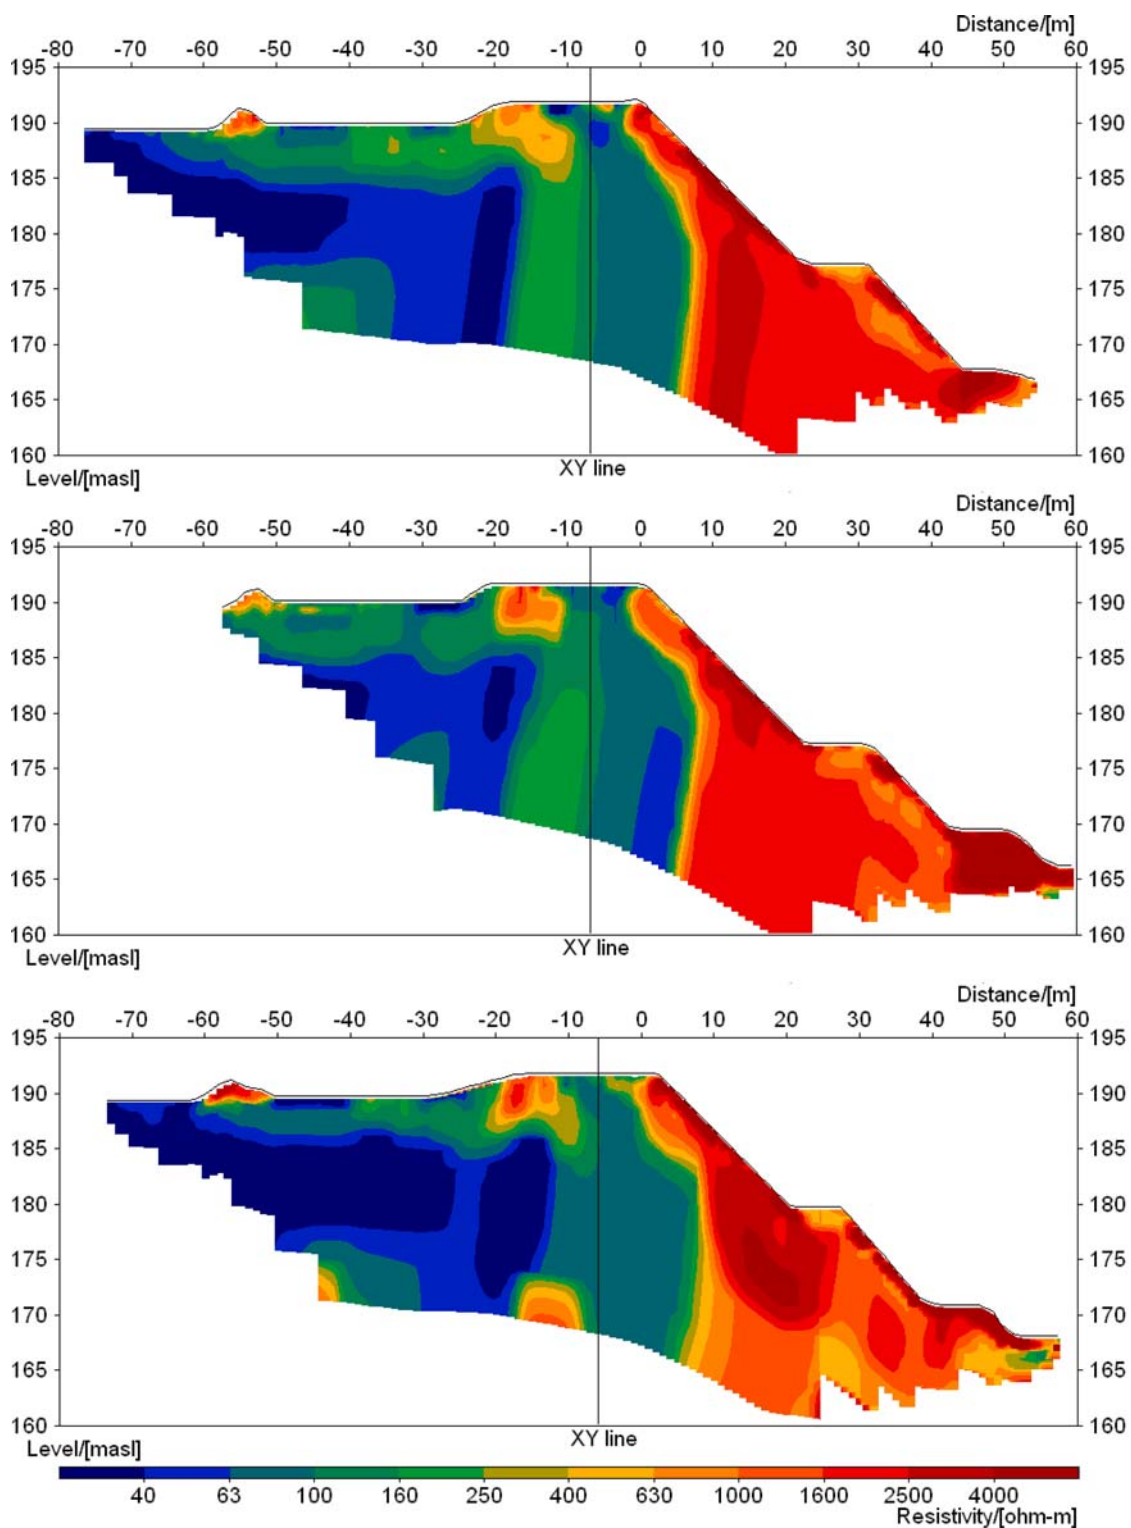
The cross section at chainage 0/471 m (Fig. 3) shows a sequence of zones with different resistivity with steep to vertical interfaces, going from low ($\approx 40 \Omega \text{ m}$) over intermediate ($\approx 200 \Omega \text{ m}$) and rather low ($< 100 \Omega \text{ m}$) to very high ($> 1,000 \Omega \text{ m}$). These zones correspond well with that which can be expected from the way the dam is built. Starting from the upstream side on the left in the diagram, the low-resistive zone that continues up to –

20 m corresponds to saturated sand, and with a resistivity of $10 \Omega \text{ m}$ of the pore water, a resistivity of $40 \Omega \text{ m}$ is reasonable if Archie's law is applied to the high porosities that can be expected for well-sorted sand. Thanks to the well-sorted character of the sand, it is possible to identify the groundwater surface in the diagram, being at the surface in the upstream edge of the diagram and decreasing to a relatively stable level of 185 masl going in the downstream direction. This fits perfectly with the observation wells at chainage 0/500 m that show a level of 185–186 masl. The higher resistivity above the level 185 masl corresponds to the tailings sand above the groundwater level. The zone with higher resistivity next to the low-resistive zone matches up with the position of the upstream support fill of the dam, with a water level at 185 masl visible as a decrease in resistivity. The next zone, of relatively low resistivity, corresponds to the core of the dam, where the inclined shape at the top followed by a more vertical part is well visible. There is also an indication of a reverse slope for the lowest part of the zone that can be interpreted as the core, however, not as inclined as on the drawing (Fig. 1). The highly resistive downstream zone corresponds to the downstream rockfill, whereas the filters cannot be readily identified.

The cross section at chainage 0/492 m (Fig. 3) agrees well with the one at 0/471 m, but the top high-resistive part corresponding to the upper part of the upstream support fill is not so well developed. The latter explains the high-resistive zone at 0/471 m in the sections measured along the dam (Fig. 2). The extra low-resistive part of the zone interpreted as the core might be an indication of a change in the properties connected to the sinkhole development. The groundwater level was recorded at elevation 165 masl at +3 m on the cross section (chainage 0/500 m).

The cross section at chainage 0/310 m (Fig. 3) is similar to the one at 0/471 m with one important exception. The high-resistivity zone corresponding to the upstream filter is interrupted by a large zone (around 10 m high) with resistivity below $100 \Omega \text{ m}$. This can be interpreted as an effect of anomalous seepage through the dam, which fits well with the occurrence of old sinkholes. Measured groundwater levels at elevation 187 masl at –40 m and elevation 185 masl at –20 m fit well with the image. At +3 m the measured groundwater level at 171 masl is not visible, as would neither be expected in fine-grained material. The bedrock level at elevation 165 masl at –15 m may be situated below the depth penetration. At +20–25 m the bedrock at elevation 171 masl appears to be slightly less resistive than the downstream support fill.

Fig. 3 Inverted resistivity cross sections from the X-Y dam. Above: chainage 0/471 m (mean residual 3.1%). Centre: chainage 0/492 m (mean residual 3.3%) Below: chainage 0/310 m (mean residual

1.7%). Level refers to meters above sea level and chainage to length along the dam in meters
