## Design of Safe Timber Structures - How Can we Learn from Structural Failures in Concrete, Steel and Timber?

**Division of Structural Engineering**  
Lund Institute of Technology, Lund University

Report TVBK-3053  
Lund 2007

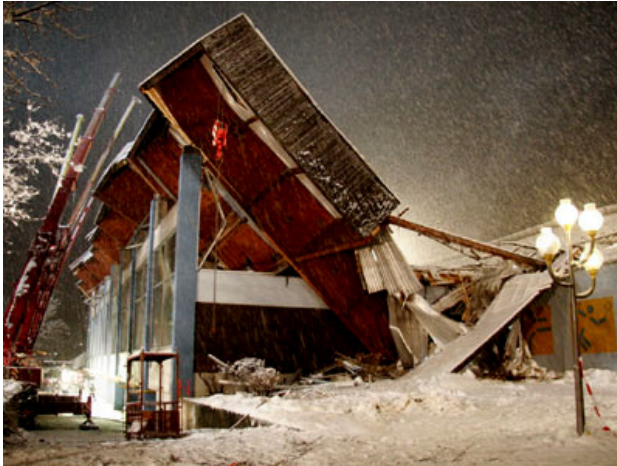
*Fig. 1. Collapse of wooden roof for ice skating arena in Bad Reichenhall, Germany*

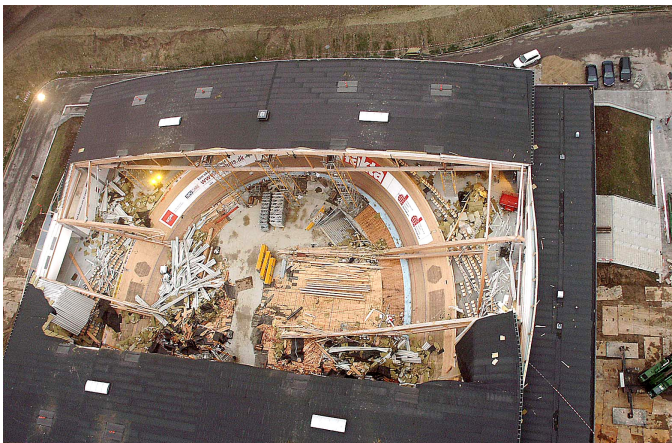
*Fig. 2. Photo taken from above after the failure of the Ballerup arena roof.*

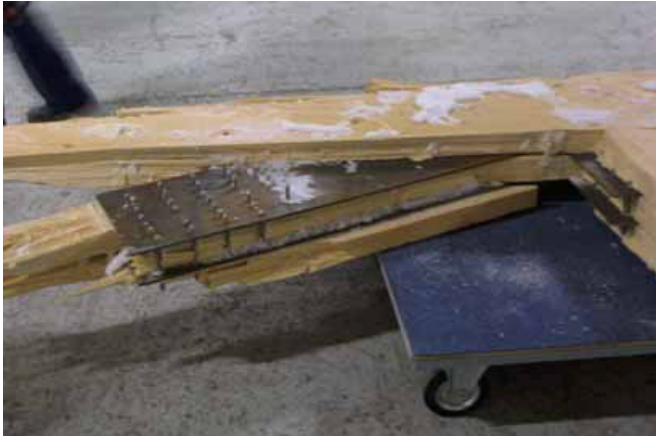
The same winter 2003 another structural collapse took place in Finland. Four main roof trusses for exhibition hall B2 of Jyväskylä Paviljonki collapsed two weeks after the hall was opened for the public [15,16]. The snow load at the time of failure was about 50 kg/m<sup>2</sup> and there was no wind. The design snow load at this location is 200 kg/m<sup>2</sup> according to the Finnish code. The primary cause of failure was manufacturing errors leading to malfunctioning slotted-in steel plate joints in the main glulam trusses, see Fig. 3. The failure was initiated in a joint where only 7 out of 33 dowels were in place.

*Fig. 3. Slotted-in steel plate joint where dowels were not mounted as intended.*

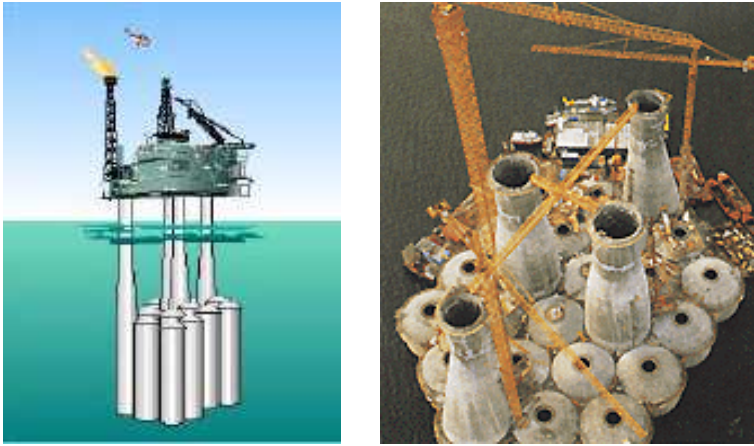
total base area of 16000 m<sup>2</sup>. Errors in detailing of the reinforcement in the vertical joints between the concrete cells lead to shear failure during the operations to sink the platform to the seabed, see e.g. [30]. The economical loss from this detailing error was estimated to 700 Million US\$, the most expensive shear failure in history.

*Fig. 5. The Sleipner A offshore platform*

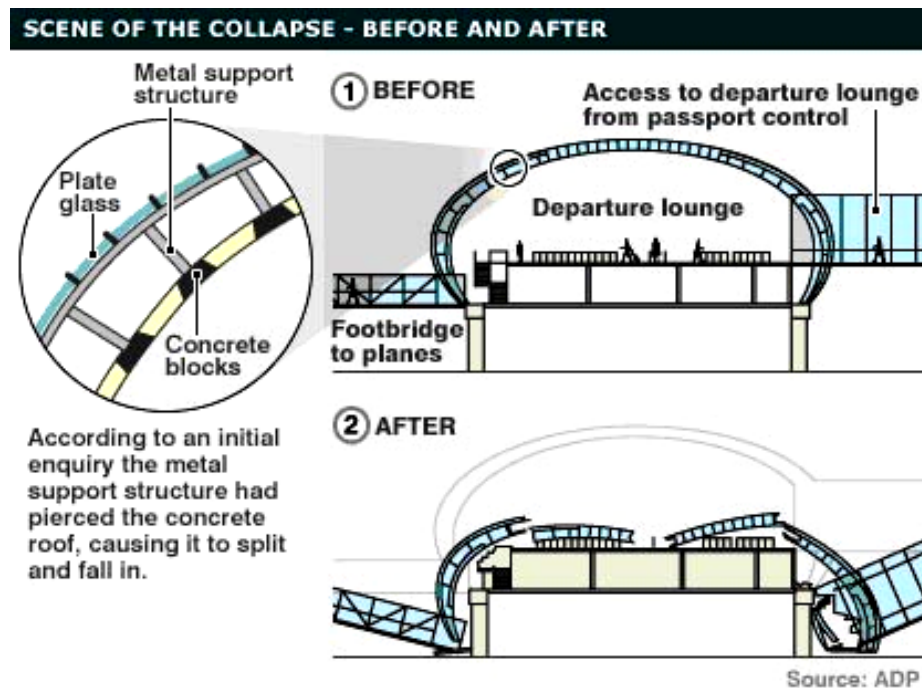
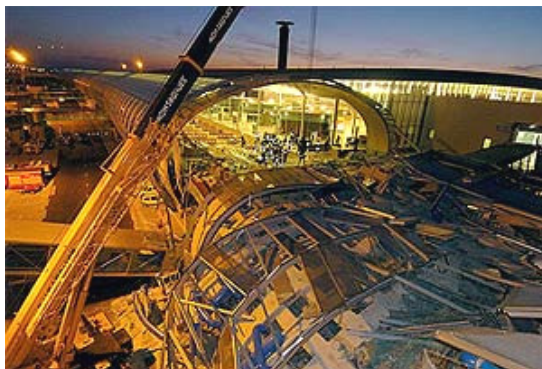
An example of an innovative concrete structure is the terminal building at Charles de Gaulle airport in Paris, which was built with an elliptical reinforced concrete shell roof. The roof suddenly collapsed in May 2004, 11 months after it was opened, killing four people, see Fig. 6. The official investigation identified four errors in design and construction of the unusual type of structure.

Fig. 6. Collapse of terminal roof at Charles de Gaulle airport in Paris

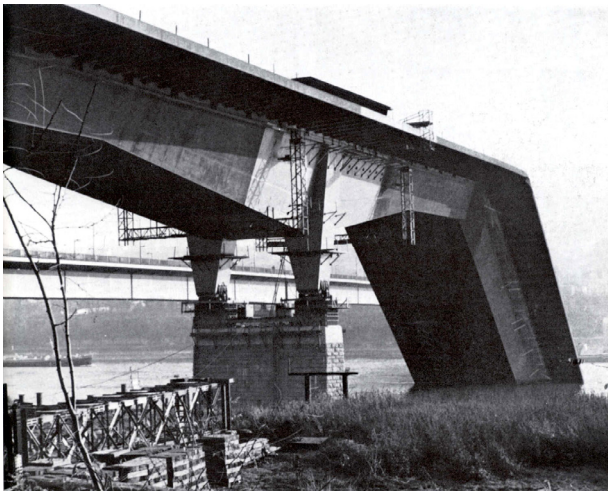
*Fig. 8. Collapse of steel box girder during cantilever construction, Rheinbrücke, Koblenz, 1971, Source: Ref. [31].*

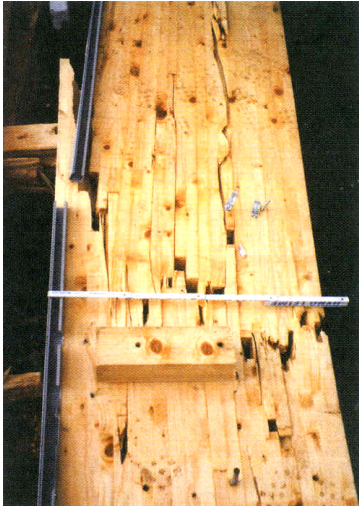
*Fig. 10. Failed glulam beam due to low quality finger joints. The failure line is staggered and coincides with the finger joints. Source: Ref. [9].*

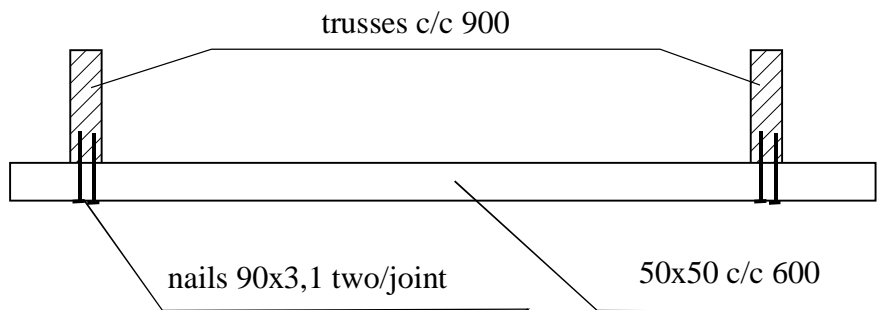
withdrawal capacity of the nails fastening the 50 x 50 mm<sup>2</sup> wood battens for the ceiling to the bottom chord of the roof truss. The designer had prescribed three nails in each joint, but only two were provided during construction. One reason for this was that the designer did not realise that there was not enough space – as given in relevant standards – for three nails in the contact surface between the battens and the bottom chord of the truss. In this case the failure was classified as 0.5 (50 %) due to poor manufacturing principles and 0.5 (50 %) due to design error. In cases where only one cause was identified, the weight for this error type was set to 1.0. With this method the sum of all error types over all cases will equal 127, and the corresponding percentages can be calculated.

Figure 11. Support connection for ceiling in supermarket.

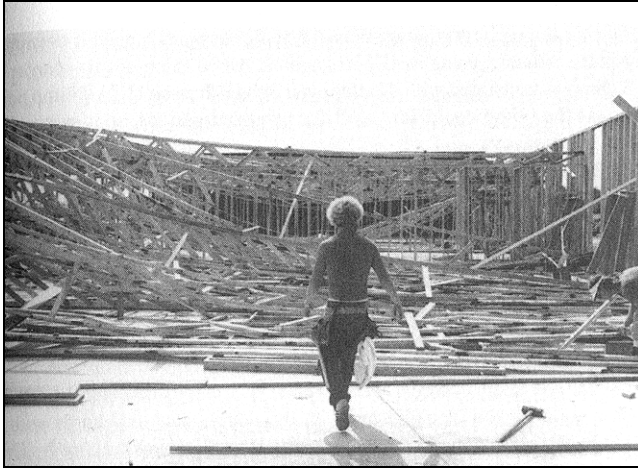
Figure 16. Collapse of timber truss roof during construction. Source: Ref. [33].

This type of failure is very typical and can be avoided by planning of the erection sequences to minimise the risks and by giving clear instructions to the construction workers at the site on how to provide temporary bracing. Generally, more careful work preparation is needed at the building site. For more complex structures, the designer should be responsible for giving instructions about appropriate methods of bracing also in the construction phase.

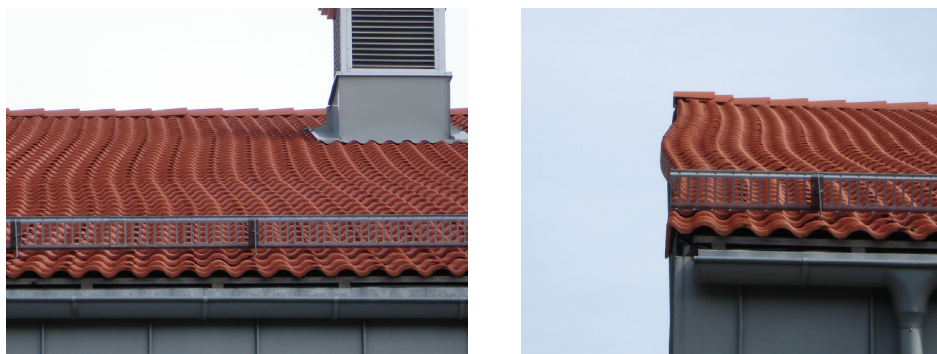
Instability failure due to insufficient bracing is also quite frequent after the building is completed. A typical example is case 114, which is a timber truss roof with span of more than 20 m, which was built with insufficient lateral bracing of the top chord. This led to lateral buckling of the top chord as shown in Figure 17, with large lateral deformations. The tiling battens connecting the trusses with each other fell down between the trusses in several positions, which worsened the situation. A number of similar cases have occurred in Sweden, where the current structural code does not have any quantitative guidelines for design of lateral bracing. However, any engineer responsible for a structure of this type should be competent enough to realise that lateral bracing is necessary for the top chord of slender trusses.

Figure 17. Deformations in roof due to lateral buckling of top chord of roof trusses.

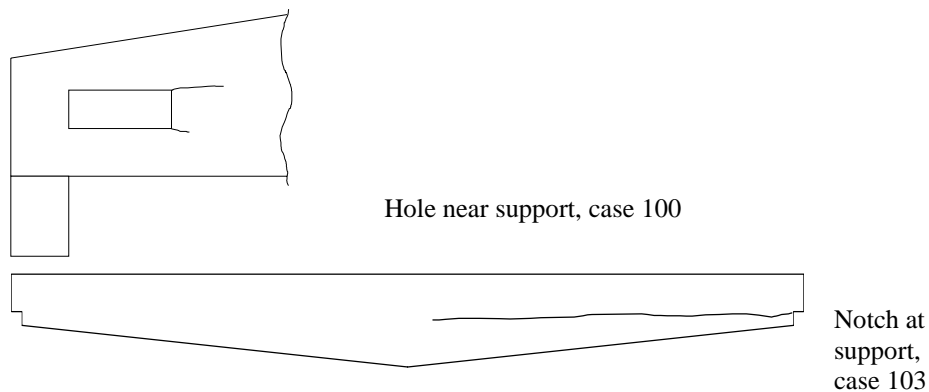
Figure 18 shows cracking patterns from two cases, *100* and *103*, with inappropriate design of holes and notches respectively, which led to perpendicular to grain failure.

*Figure 18. Schematic illustrations of perpendicular to grain failures in connection with holes and notches in large glulam beams.*

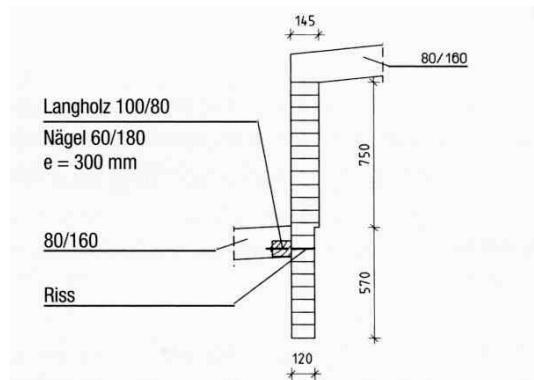
Figure 19. Section through glulam beam where failure was initiated, case 6.  
Source: Ref. [7].

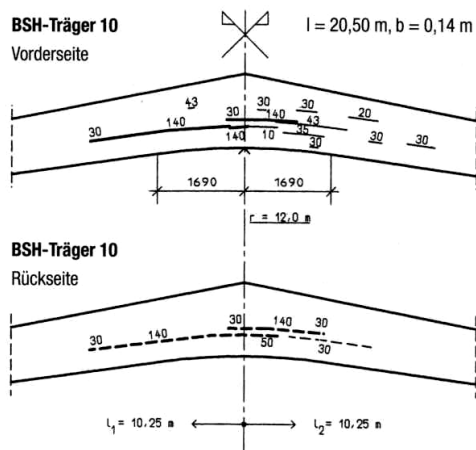
An example is case 4, where the structure consists of a pitched cambered glulam roof beam of 21 m span, see Figure 20. In the cambered part near the ridge, vertical glued-in rods were installed with the intention to take up parts of the tension stresses perpendicular to the grain occurring in this zone. The beams are located in a heated industrial building. Approximately 4 years after inauguration, deep cracks were detected in the cambered part of all 28 beams of the structure. It was concluded from the investigation that in this zone, free shrinkage was inhibited by the glued-in rods, resulting in 3-4 mm wide cracks at mid height of the beam. It was estimated that the shrinkage corresponded to drying from 11.5%, when the beams were installed, to 7.5-8% moisture content in the heated building during winter time.

Figure 20. Cracks in pitched cambered roof beams due to restrained shrinkage. Views of both sides of a beam. Source: Ref. [7].

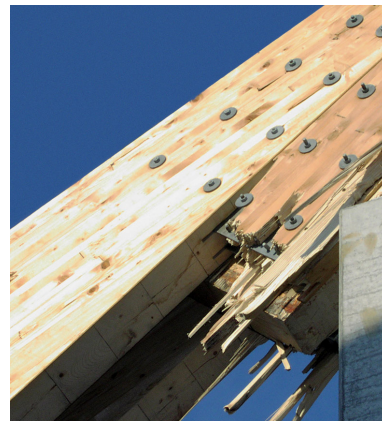
**Failed heel joint**

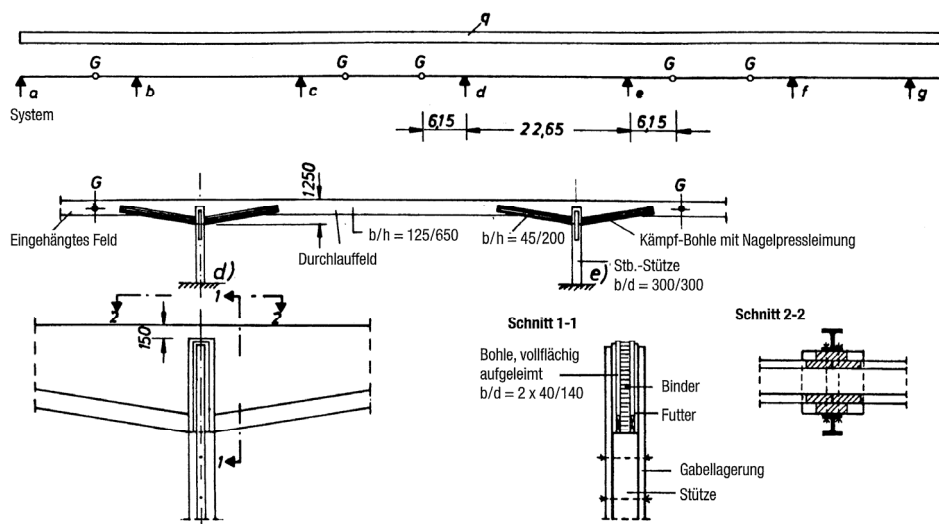
A 125 m wide industrial building is covered by continuous glulam beams with Gerber type hinges in every second span (span 22.6 m), see figure 7-1. Near the supports, the beam is tapered to increase the depth near the support. The roof is completely flat, leading to large water pools after rain. Glulam beams and purlins have been designed for uniform load comprised of dead load, extra load due to fixtures and fittings and snow load. The beams had been designed with full utilization both in the bays and at supports. As the support area is too small to transfer the support load with respect to compression perpendicular to the grain, standing boards were glued to both sides of the beam. The boards transfer the support load via their end grain to the concrete column.

Figure 7-1. Top: Continuous glulam beams of Gerber type with hinges in every second span. Middle: Strengthening with boards, glued to lower edge of beams in the tapered area, carried out after first failure. Bottom: Detail at support before first failure. Picture from Dröge G. & Dröge T.: Schäden an Holztragwerken, Schadenfreies Bauen, Band 28, Fraunhofer IRB Verlag, 2003.

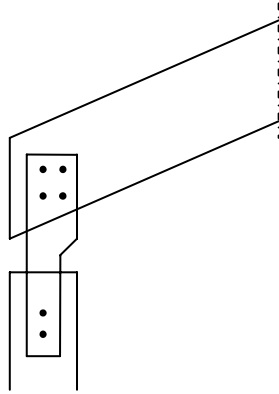
The failure is caused by insufficient design of the load-bearing structure. The execution of the connection between column and beam is not adequate.

Figure 34-1. Detail of beam-column connection. After Skaug (2004).

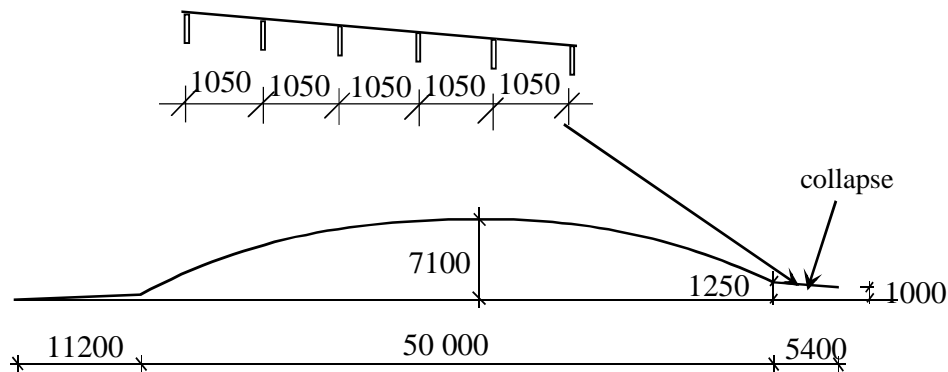
Figure 76-1: Roof structure of ice rink. The straight part on the right side of the building collapsed.

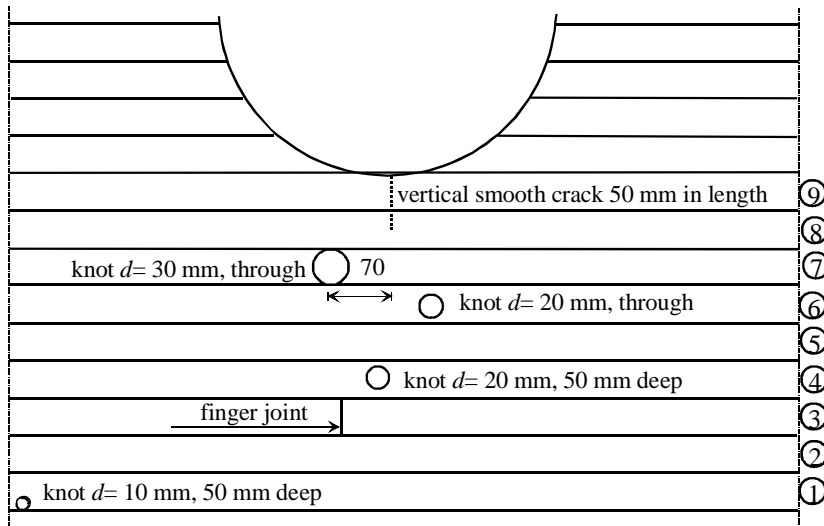
Figure 79-1: Part of fractured beam.

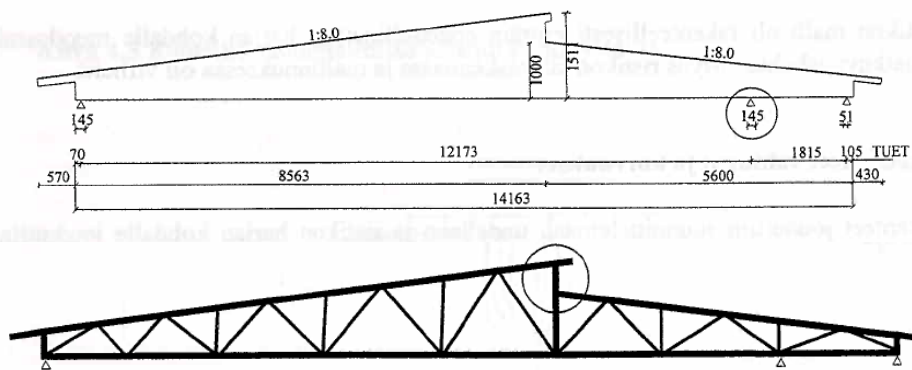
Figure 89-1: The top chord is not aligned at centre span causing a high bending load on the vertical member.

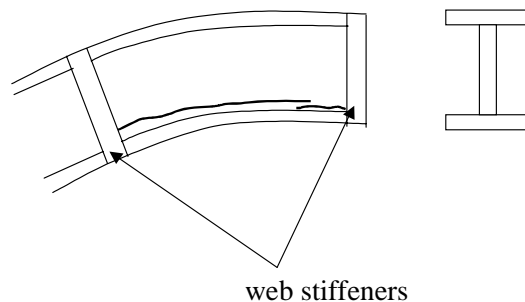
*Figure 105-1. Schematic of arch apex with cracks. The crack length was about 4 m.*

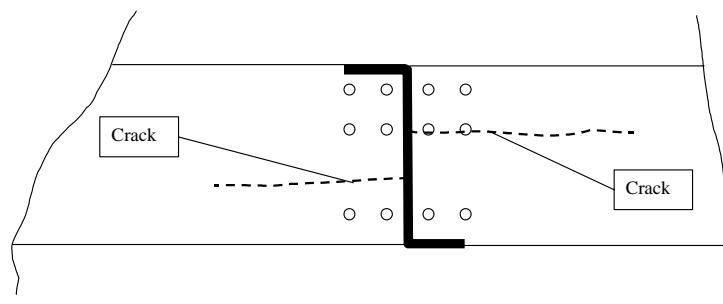
Figure 109-2. Schematic of beam connection and cracks found.

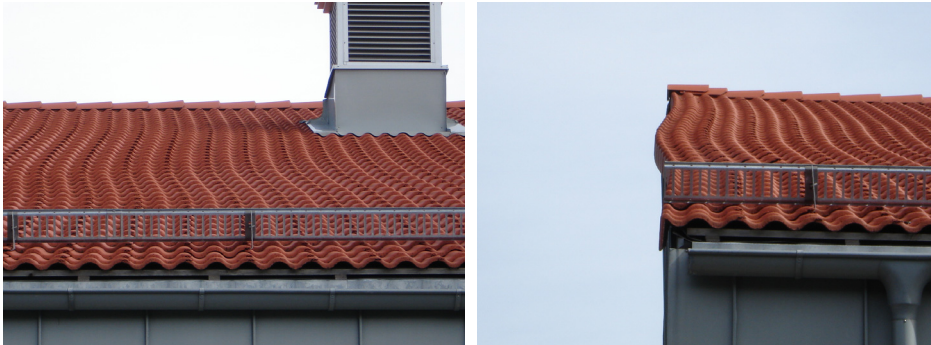
Figure 114-3. Example of deformations at failure.

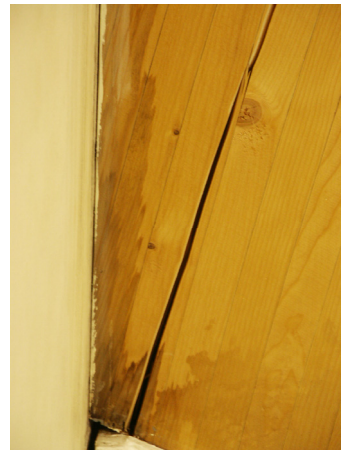
*Figure 115-2. Crack at column fitting to the steel part.*

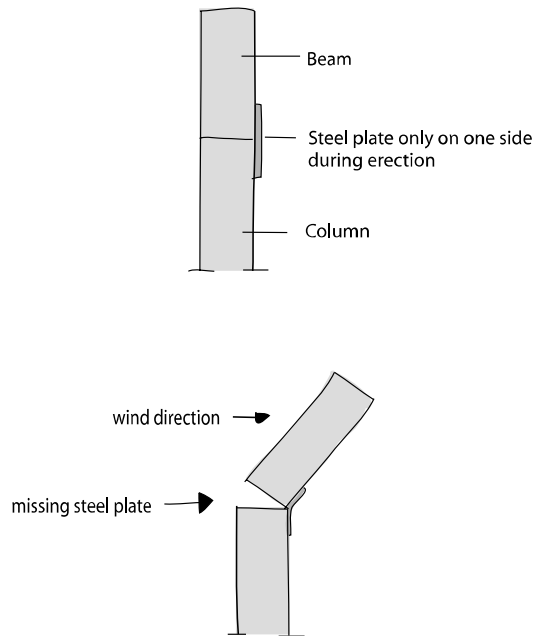
*Figure 125-2: Joint between columns and beams. Left: joint as executed, right: failed joint.*

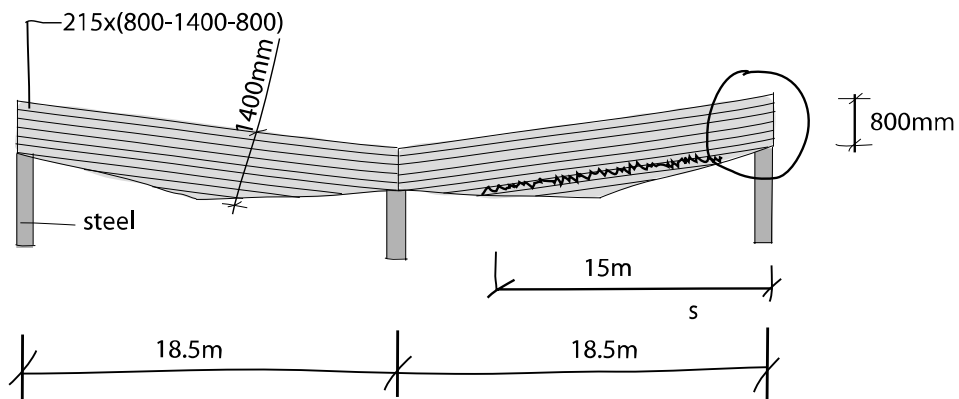
Figure 126-1: Roof structure in shopping center with double-tapered beams oriented downwards. Jagged line indicates cracking.

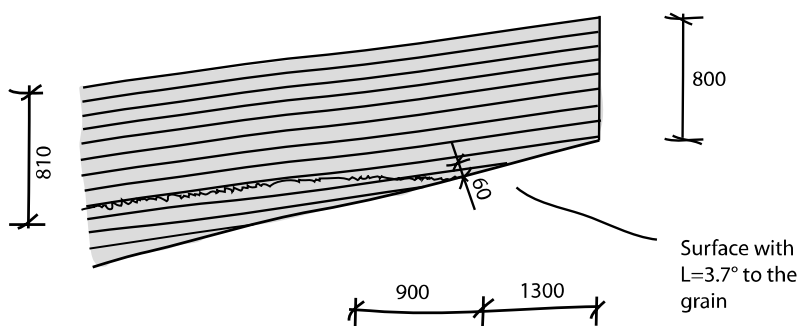
Figure 126-2: Detail view of double-tapered beam (near right support). Jagged line indicates cracking.

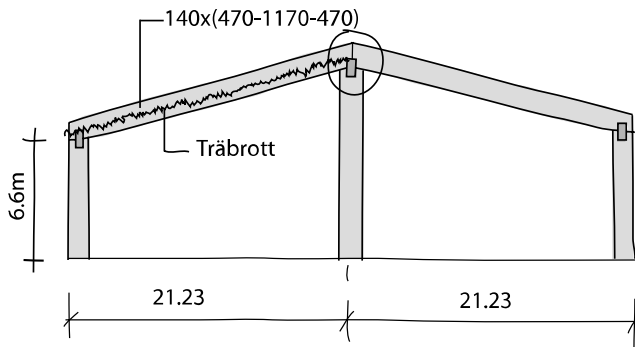
Figure 127-1: Storage building with glulam columns and glulam beams. Jagged line indicates timber failure.

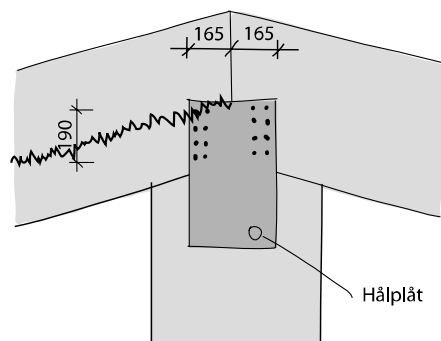
Figure 127-2: Detail of joint between beam and column at the centre of the building. Jagged line indicates timber failure.
