Post-fire investigations of prestressed concrete structures

**Fifth International Workshop on
Performance, Protection & Strengthening of Structures
under Extreme Loading
June 28-30, 2015**

Title: Post-Fire Investigations of Prestressed Concrete Structures

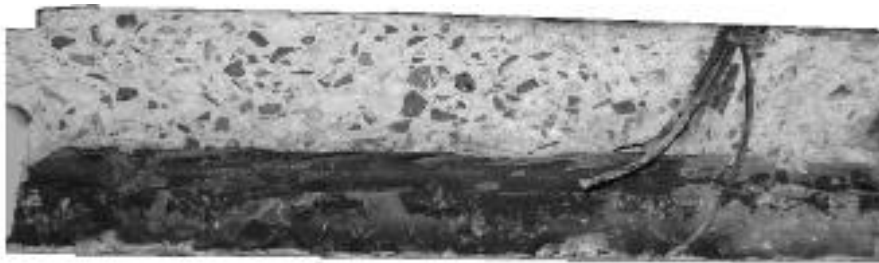
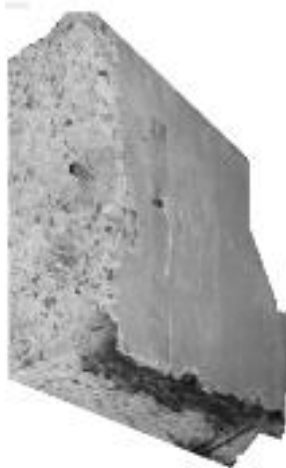
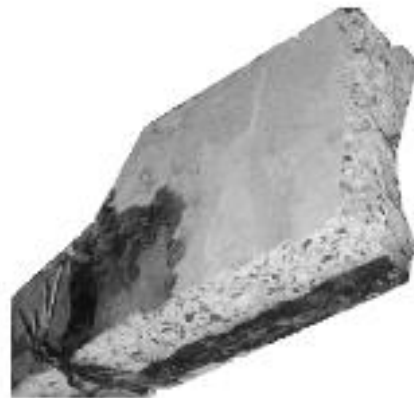
Side view

Soffit view

Top view

Concrete slab after testing in fire: Note the black substance is melted polypropylene used to protect the steel embedded in the slab. The protruding wires are glass fibre temperature gauges (thermocouples)

When exposed to fires, concrete will spall, crack and change color depending on the temperature reached. The slabs tested exhibited small transverse cracks along the soffit on the side not exposed to heating. On the underside of the slabs, exposed to heating, longitudinal and transverse cracks were respectively located directly below the prestressing steel, at the center and on each side of the heated zone. The concrete color can be used as an additional indicator for post-fire investigation as concrete changes color depending on the temperatures reached. However, this only provides a very general estimation. The afore-mentioned laboratory tested slab, exhibited an area of pink concrete extending only 10 mm into the slab on the side exposed to heat. This typically occurs at temperatures above 300C and the prestressing steel was heated to critical. Figure 2b illustrates a portion of the slab. Of interest is the black concrete. This was caused by the sheathing melting during the test and seeping out of the concrete.

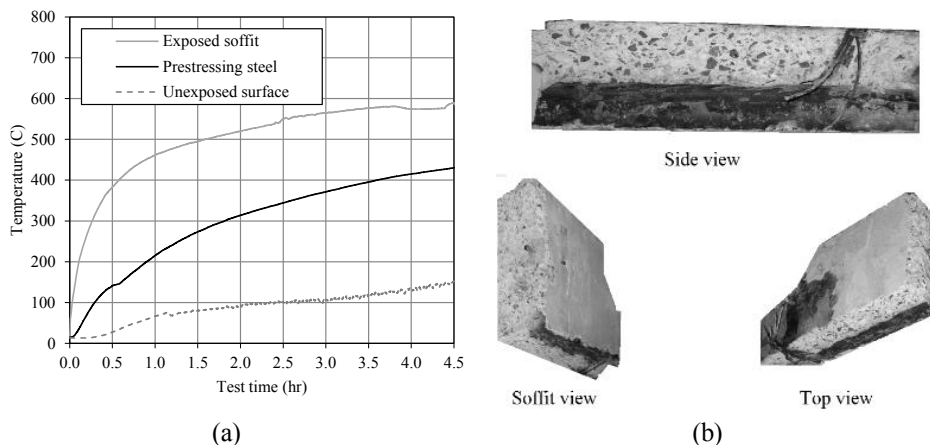
Figure 2. (a) Measured temperatures for slab test [4] (b) Excavated slab [4]

The slab was subjected to localized heating under the mid-span until the prestressing steel temperature reached critical at 426C. The slab was then allowed to cool. Of importance for discussion is that this slab was unbonded. That means the tendon was installed in a sheathed and greased configuration. The aforementioned bridge studies relied on a pre-cast bond between the tendon and the slab. The structural consequences of the slab tests are therefore not applicable for comparison with the previous discussion; however the indicators such as concrete color and temperature exposure of the prestressing steel (measured by two thermocouples) are applicable to instill confidence in the hardness test calibration procedure.

After heating, the slab was cooled naturally. The prestressing steel was de-stressed and a section from the heated area was extracted to analyze its residual properties and the concrete in the heated zone was inspected for color changes. The tendon extracted from the slab was tested for residual strength and hardness: hardness was obtained as previously described and translated to a strength value of 1691 MPa by the above equation. The central strand of the tendon underwent destructive tensile testing and failed at a stress of 1685 MPa (a 16% drop in strength from original stress of 2000 MPa, but only a 9% drop on grade strength). With this negligible difference from the value predicted by the hardness, there appears to be support that hardness testing can be used as an accurate indication of strength post-fire. However, this result should be treated with a moderate caution. Hardness correlations depicted in Figure 1a are based on a soak time of 1.5 hours. If the soak time is extended however, the strength will further decrease due to continual metallurgical changes however this effect can be considered less than 10% for temperatures up to 400C. This relation is illustrated above in Figure 1b. Further research beyond this temperature is encouraged as there may be important consequences in the case of a prolonged and highly severe fire.
