ANALYSIS OF A THAUMASITE ATTACK IN A RAILWAY TUNNEL

ABSTRACT

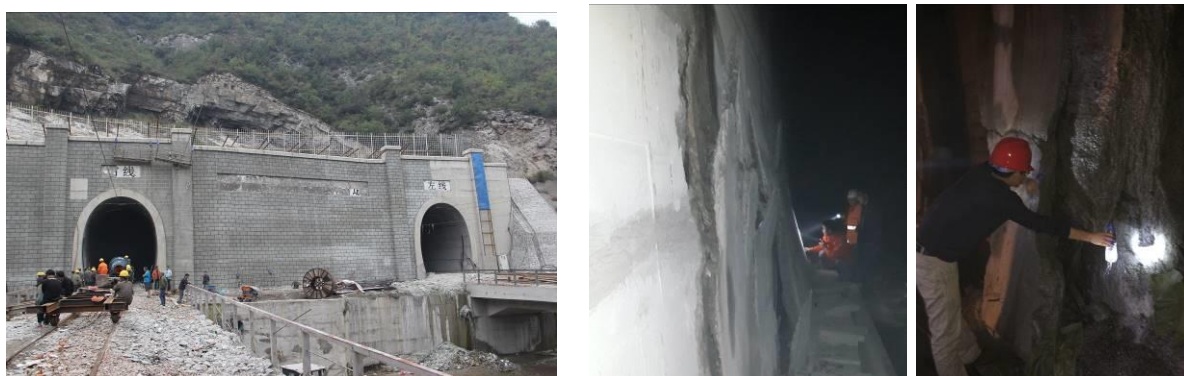
In September 2014, some severe deterioration was found in the initial shot-crete lining just before the acceptance of the tunnel. Even the second plain concrete lining was damaged by the expansion, shown in Fig.1

Figure 1 Profile of the tunnel, extruded 2nd lining and surrounding rock water collection

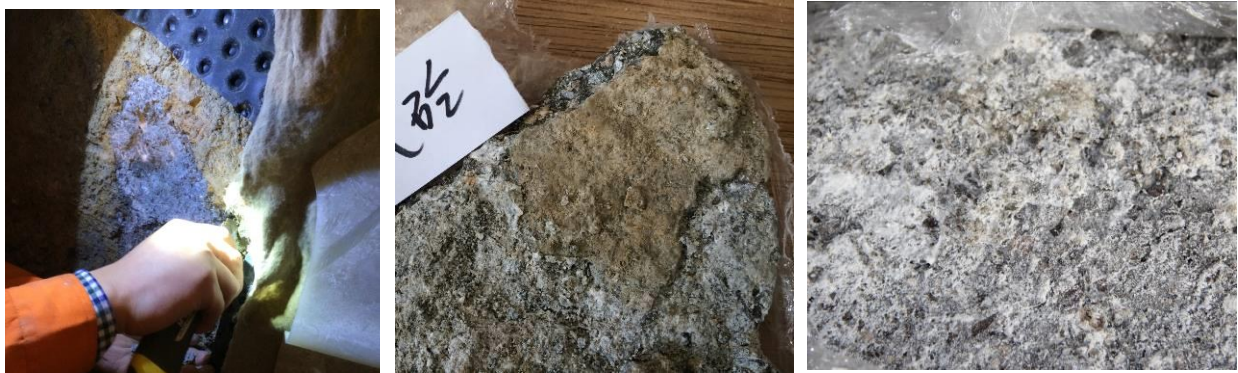
From the primary investigation, it can be deduced that the expansive reaction is the main factor. In order to know what happened to the concrete lining, water, soil, and corrosion products samples were taken from the tunnel site, shown in Fig.2. Since the waterproofing was broken by the expansion, plenty of surrounding water was found in the tunnel. The sediment in drainpipes was also taken to lab.

Figure 2 Deteriorated concrete behind the waterproofing board and a white substance on surface

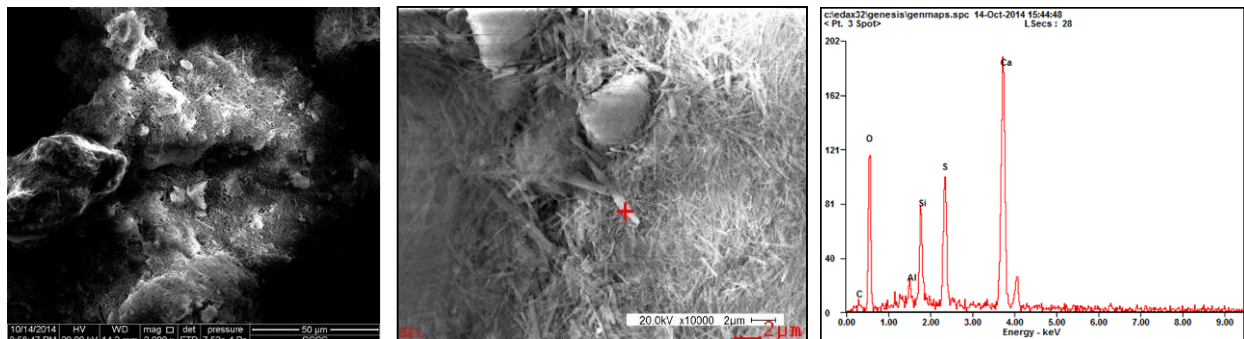
Different minerals was found in the sediment in drainpipes including thaumasite, ettringite and gypsum, as shown in Fig. 3, which are products of slufate attack. In normal leakage water, calcite always can be found. XRD and EDS also prove that.

Fig.3 SEM photograph of typical crystal found in sediment

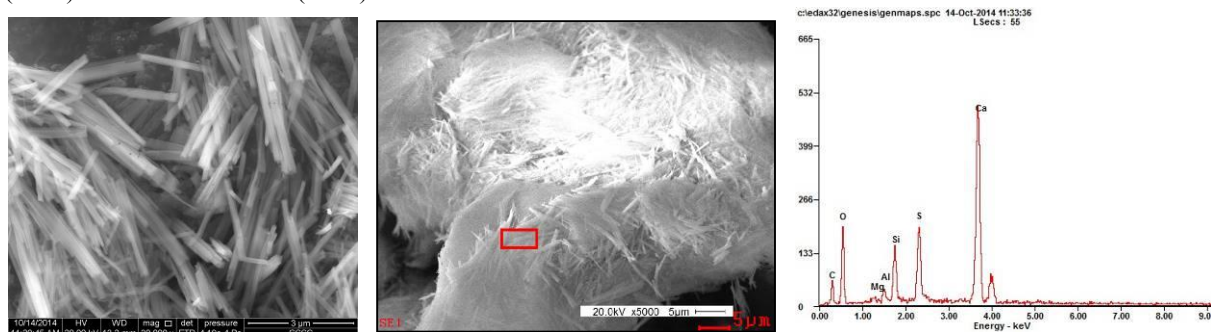
XRD, SEM and EDS analysis identified an ettringite/thaumasite mixed crystal as being the main reaction product in the deleterious concrete, similar to the cases reported by Baoguo Ma *et al* (2006), Crammond *et al* (2003) and H. Justnes *et al* (2006).

Figure 4 Thaumasite found in deteriorated shot-crete

The main cause of the deterioration of the tunnel lining is the external sulphate attack, resulting strength degradation by thaumasite and expansion by ettringite. Design code of mountain tunnel should be improved to enhance the prevention of deleterious thaumasite formation in the future.
