Corrosion in the Flue Gas Cleaning System of a Biomass-Fired Power Plant

Published in:
Journal of Failure Analysis and Prevention

Publication date:
2017

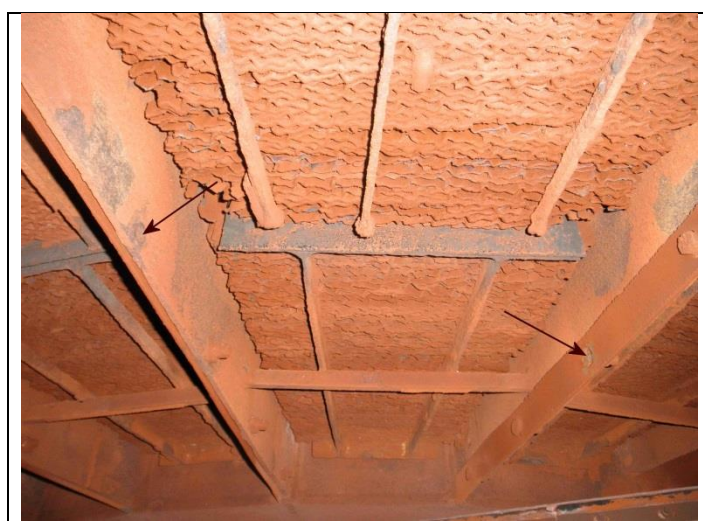
After 15000 hours of operation, significant corrosion damage was observed in the lower part of the GGH closest to the centre of the rotor (Figure 2). Here there was up to 2 mm metal loss and many of the UNS S31600 bolts had failed leading to the unfortunate consequence that radial sealing strips had been found further on down the system in the duct before the booster fan. There were also large amounts of spalled rust in the ducts after the GGH which had originated from the GGH rotor. In addition there were deposit agglomerates of unknown composition or origin. In some cases there was the appearance of “wet” corrosion products when the FGCS was inspected during downtime.

Figure 2 shows the lower part of the gas-gas heat exchanger where severe corrosion was observed. Oxide had formed on the frame of the rotor fabricated in weathering steel. Some UNS SS31600 bolt heads had ruptured (as shown by the arrows) which had resulted in detachment of the UNS N10276 sealing strips.

Figure 2: Photo of lower part of gas-gas heat exchanger where arrows indicate missing bolts.

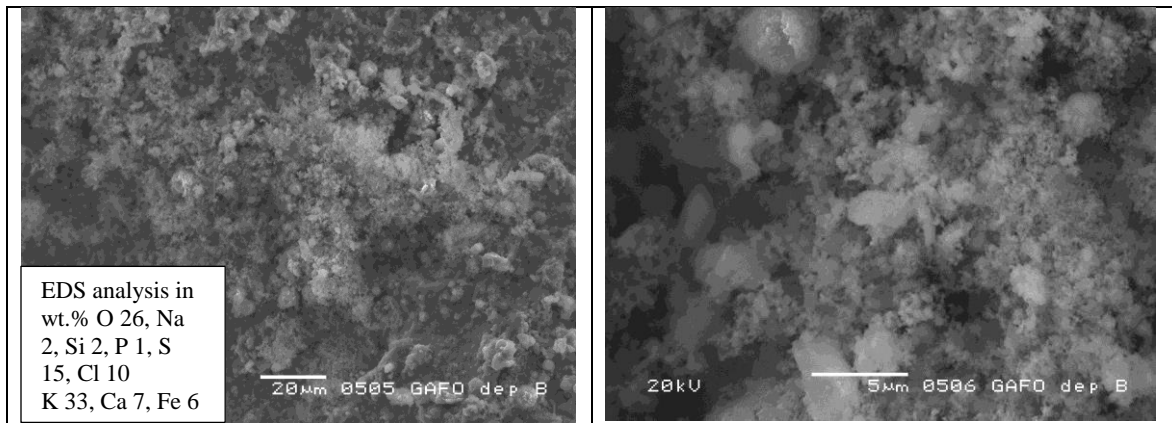
Fine white powder was observed at the top of the GGH and in the DeNO_x unit. If more straw had been fired in the time period preceding inspection, then more “white powder” was observed. These particles have the morphology and composition as shown in Figure 3, and with XRD, the phases KCl (sylvite JCPDS 41-1476), K₂SO₄ (arcanite JCPDS 70-1488) and K₃Na(SO₄)₂ (JCPDS 74-0398) have been identified. Neither ammonium chloride nor ammonium bisulphate was detected. Wet analysis was undertaken to investigate the presence of ammonia compounds as described in [4] but only trace amounts were detected. Similar sized submicron particles were also present in other areas after the FGD and were also present in the crevice between the sealing strips and weathering steel rotor. The micrograph to the right reveals submicron particles.

Figure 3: SEM-EDS analysis of fine particles typically found in GGH and DeNOx unit.

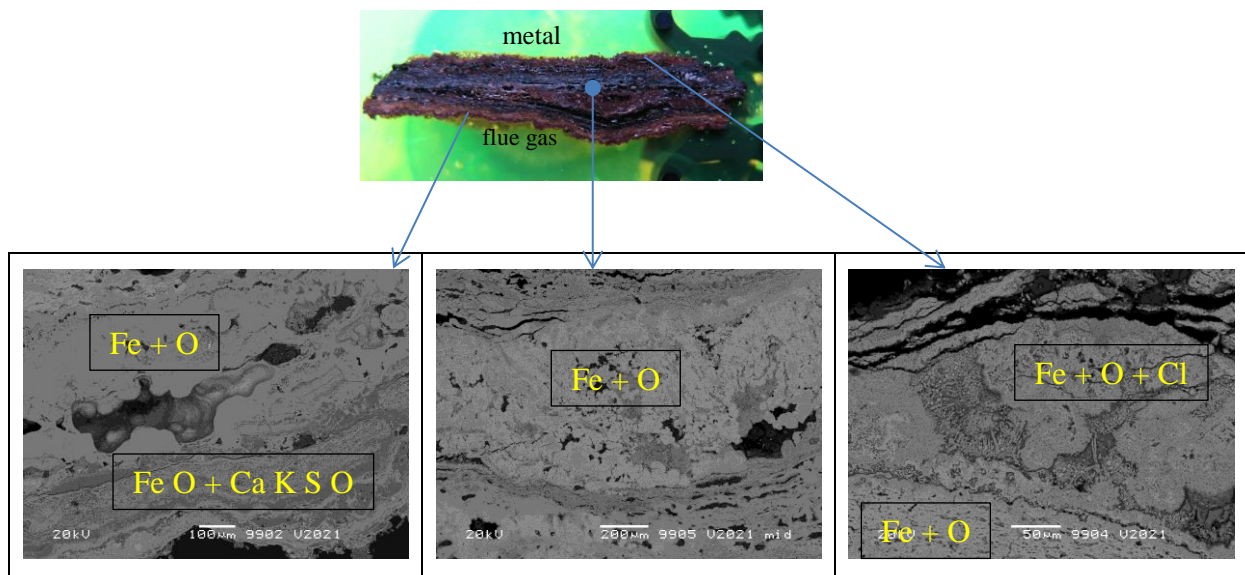
The oxide thickness on the weathering steel was up to 5 mm after two years exposure and consisted of many layers of oxide and not a single protective oxide as is expected for a weathering steel to yield good protection. A cross-section of the deposit removed from the inner part of the rotor is shown in Figure 4, where the lower brown layer was furthest away from the steel surface and closest to the flue gas. Different areas across the oxide were investigated with SEM-EDS.

Figure 4: Cross-section of corrosion product from the GGH rotor.

On the flue gas side (LHS micrograph), there was a high content of calcium, potassium and sulphur together with iron and oxygen indicating iron oxide together with calcium sulphate and potassium sulphate. Chlorine was not present. The middle of the oxide layer (middle micrograph) contained iron and oxygen, and the oxide closest to the steel surface (RHS micrograph) was predominantly iron and oxygen however there was a higher concentration of chlorine. Thickness of oxide layers was variable depending on location; for example, the oxide removed from the centre of the GGH rotor was twice the thickness of the oxide closer to the outer circumference. SEM-EDS analyses elemental composition (but not the elements below oxygen) so this technique was supplemented with x-ray diffraction to give more information about the phases present. The specimens were ground to obtain a fine powder, thus it is the

whole of the specimen that is analysed and not a particular surface. Phases which constitute under 3 vol.% of the total sample will be below the detection limit. Based on both SEM-EDS and XRD, the following phases were detected: akageneite β -FeOOHCl, goethite α -FeOOH and maghemite Fe_2O_3 . In addition the presence of amorphous phases which cannot be determined with XRD were revealed from the diffractogram.

For the rust specimens removed from the GGH, SEM-EDS studies reveal that chlorine is a main constituent in the oxide especially close to the metal surface. XRD revealed that goethite, akaganeite and maghemite were formed. This indicates that some of the desired goethite is formed; however the presence of akaganeite and maghemite indicates that the wet-dry cycle did not facilitate formation of a protective layer, and that chlorine also contributes to the formation of a non protective layer. Chlorine is concentrated in corrosion products at the corrosion front and therefore must diffuse through the oxide, again indicating that the oxide is non-protective. In contrast, sulphur was found primarily on the outer side of the corrosion product and probably condenses onto the surface oxide during shutdown. The lower part of the GGH where the temperature is continually fluctuating every few minutes around the dewpoint of water and HCl will corrode the most compared to areas higher in the GGH and in the booster duct which have a more constant temperature. CFD calculations indicated localised areas of high humidity in the GAFO which corresponded to the areas of high corrosion. Thus local differences in temperature and humidity result in higher corrosion rates of the GGH where thick non-protective oxide flakes were formed which were transported further down the plant and resulted in erosion problems of the booster fan.

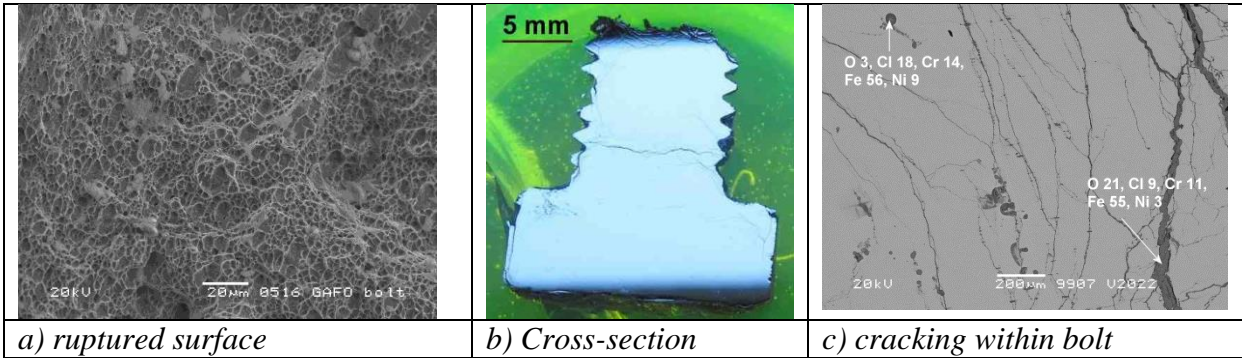
One of the ruptured bolts was examined on the fractured surface with SEM-EDS and revealing an equiaxed dimple structure. Particles containing K, Cl, S, and O were also present in these areas Figure 5a. The bolt was also cut longitudinally and examined with LOM and SEM-EDS (Figure 5b and c). There were many cracks in the bolt and analysis at the bottom of the thread revealed high content of chlorine, some sulphur, but only traces of potassium and calcium.

Figure 5: Failed stainless steel bolts revealing widespread cracking. Analysis in wt. %.

The corrosive species detected within the bolt were predominantly chlorine and oxygen together with the constituents of the stainless steel. In addition traces of sulphur could be detected. As can be seen from the crack morphology, there is transcrystalline attack and chlorine was detected within the cracks. A bolt was also removed from the middle part of the GGH weathering steel rotor where there was less visible corrosion. The corrosion attack that was most prevalent for the bolts was pitting corrosion approx. 50 µm deep (Figure 6).

The UNS N10276 sealing strips suffered almost no corrosion in this environment; however their detachment occurs because UNS SS31600 bolts rupture. These bolts revealed transgranular cracking in locations where there were high corrosion rates of the weathering steel rotor and chlorine was present within the cracks. In areas where there was less corrosion of the weathering steel, the bolts exhibited pitting corrosion. Due to the thick oxide formed on the weathering steel in these areas, the bolts are subjected to increasing tensile stress during exposure as 2 mm of steel is replaced by an oxide layer with a 2-3 times greater volume on either side in a period of 2 years. The presence of chlorine via the flue gas and the tensile stress results in rupture as stainless steels have a high sensitivity to stress corrosion cracking. Figure 11 is a schematic showing how the bolt is subjected to tensile stress on both sides as shown by arrows, resulting in fracture.

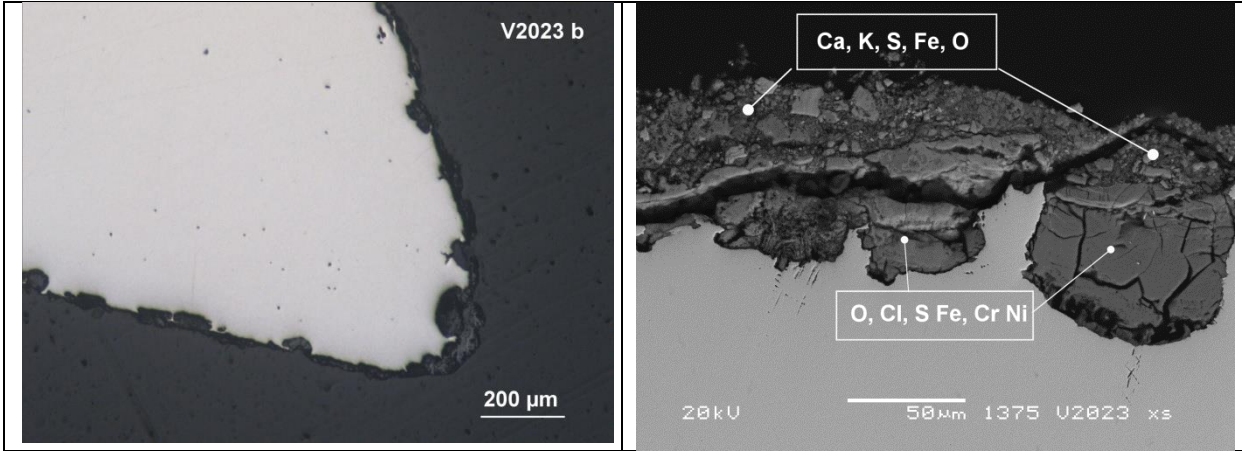
Figure 6: Analysis of a bolt (not ruptured) from the middle of the GGH. Analysis in wt. %

There were occasional cracks present however not to the extent that the bolt would risk rupture. The chemical composition of the corrosion products within the pits revealed by SEM-

EDS was potassium and calcium on the outer side closest to the flue gas and chlorine and sulphur within the corrosion product closest to the metal.

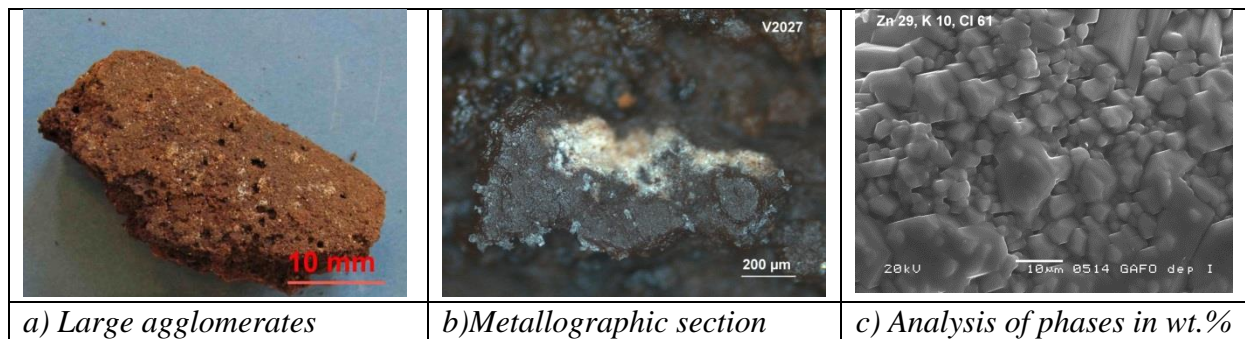
A large amount of spalled oxide was observed immediately before the booster fan which had the same composition and appearance of that found in the GGH. The fact that deposits/oxides accumulated in this area could be due to a 90 degree bend in the duct before the booster fan, but also due to the presence of the booster fan in the duct as a physical hindrance to large airborne particles. The transportation of these spalled oxides from the GGH also result in erosion of the booster fans blades. In addition large deposit agglomerates were found here in the initial years of service. One of these agglomerates is shown in Figure 7a and it was clear that these deposits were difficult to prepare for analysis as they were very hygroscopic (Fig. 7b). Analysis of these deposits with SEM-EDS in Figure 7c revealed the presence of Zn, Cl and K.

Figure 7: Analysis of large agglomerates found in the duct after the GGH.

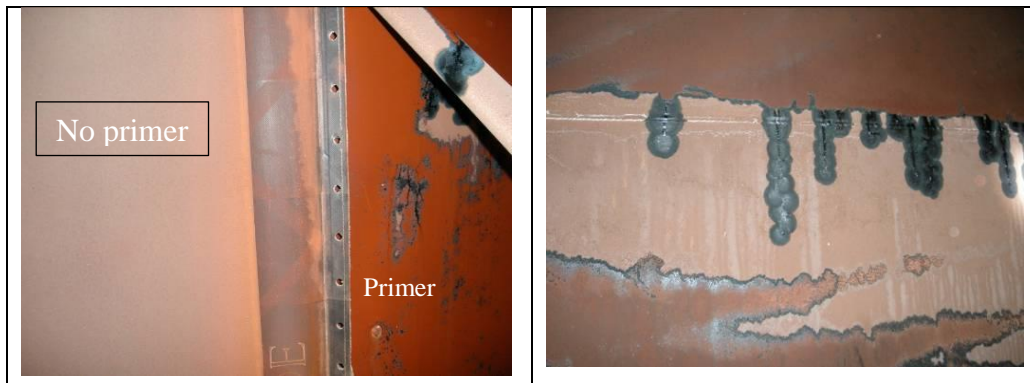
During inspections in 2013 and 2014, in some areas the protective primer was still visible, and in other areas this coating had been removed by corrosion/erosion. Figure 8 compares two different locations in the FGCS after the GGH showing the red colour of the primer and what is observed at the interface. Figure 8 (left) shows two areas of the duct adjacent to one another where primer was and was not used. Some pitting attack of the primer is observed exposing the underlying material. Figure 8 (right) from the silencer shows the interface between coating and non coating, where a black fluid was seeping out.

Figure 8: Duct before booster fan (left) and duct before silencer (right).

There was a difference in appearance between components with a primer coating and those without. Those without a primer coating exhibited general corrosion. For structures coated with a primer, in some places it was observed that there was no primer as this had been removed due to corrosion and erosion. At the interface between the original primer surface and the steel surface, a black compound was present, which was hygroscopic during shutdown, had an acidic pH and was rich in Zn and Cl. ZnCl₂ products are more hygroscopic than iron chlorides or KCl [3]. Especially during shutdown as the temperature decreases below the dewpoint, pitting corrosion can occur where hygroscopic deposits are present, because of the localised high concentrations of chlorine and low pH. It is not known whether the coatings result in reducing or increasing corrosion rates, however they can give an appearance of increased attack. The primer probably reduces corrosion during the first years of operation, however when the coating is broken down and the Zn in the coating starts to react with the HCl, or KCl, then localized pitting attack will occur.

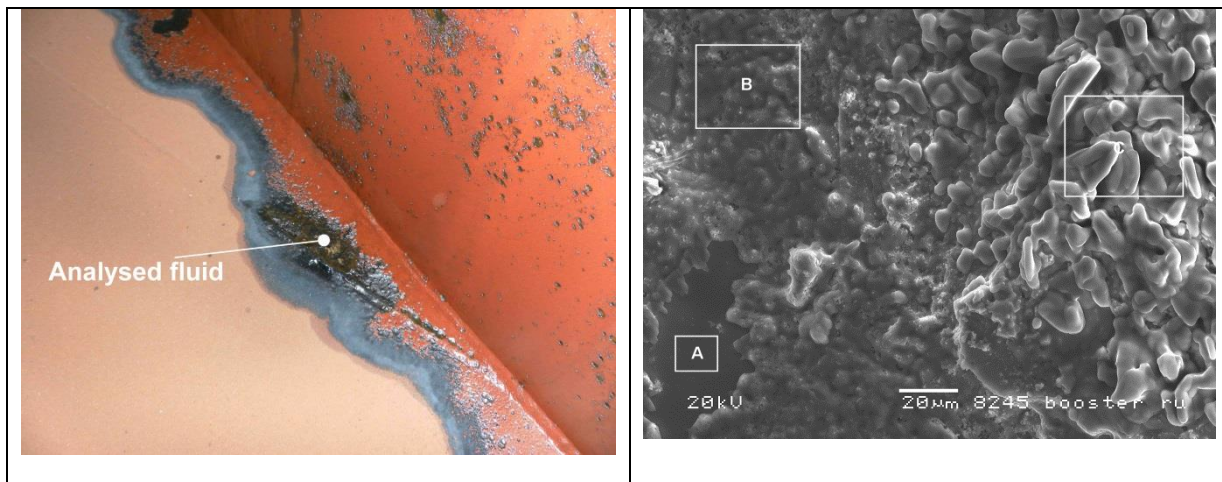
Figure 9 shows such a location where liquid was apparent, and this was collected with a pipette, and measured with universal indicator paper to have a pH of 3.5-4.5. The main components as measured with ion chromatography were 407 g/L Cl^- and 4.8g/L SO_4^{2-} and using ICP, 235g/L Zn, and 1.6g/L Mg was measured. Other elements/compounds were measured to mg/l level, e.g. ammonium 0.16mg/l (measured with Fagerberg testkit). Since the presence of ammonium chloride was suspected based on [4], different samples collected after the GGH were analysed with wet chemistry methods and XRD, however ammonium was only present at very low levels. A portion of the fluid was allowed to crystallise on filter paper and this crystallised product was analysed with SEM-EDS (Figure 9 right) to contain Zn, Cl, K and Fe together with oxygen probably indicating a mixture of ZnCl-KCl and Fe-O-Cl .

Figure 9: SEM-EDS analysis of liquid from booster duct where Zn primer had been used.

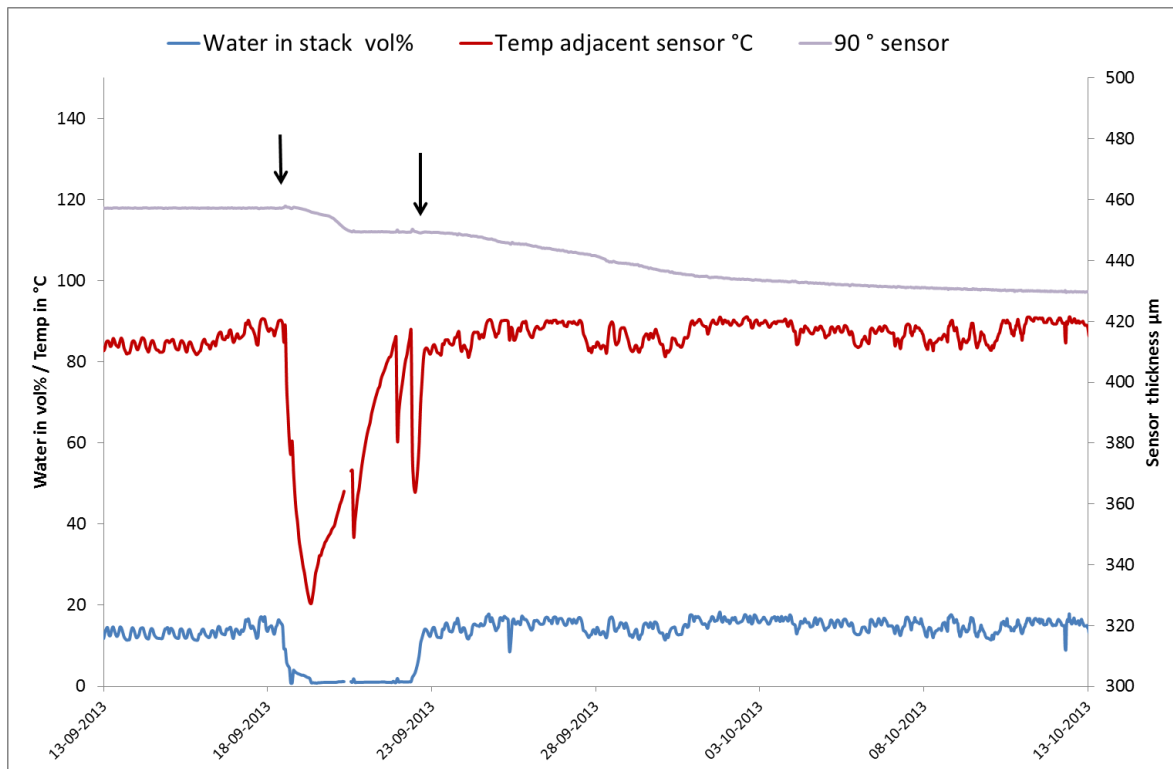
As a consequence of corrosion in the FGCS after only two years operation, various corrosion products and deposits were analysed, and on-line corrosion monitoring was installed. An example of the on-line monitoring is shown in Figure 10 where the sensor thickness decreases

(right hand y-axis) when temperature changes as the FGCS is started up and shutdown. By correlating operation data with on-line sensor thickness just after the GGH, it was clear that corrosion was linked to start-up and shutdowns. The first arrow indicates shutdown and therefore downtime corrosion and the second arrow is plant start-up which also gives rise to corrosion. The corrosion during start-up was observed to decrease when firing only with wood pellets compared with straw pellets. Further detailed results are given in references 5 and 6.

Figure 10: Correlation of reduction in sensor thickness and operation parameters temperature and water content.

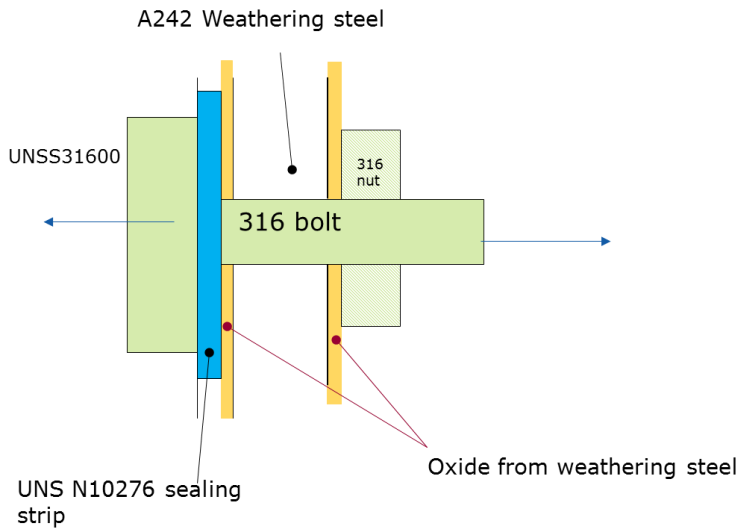
Figure 11: Schematic diagram showing how tensile stresses can occur for the AISI 316 bolt.

Stress corrosion cracking tests at 43°C, 85°C and 120°C for AISI 304 and 316 steel revealed that failure occurred at 43°C and not at 85°C or 120°C[11]. As expected AISI 304 was more susceptible to SCC than AISI 316 steel. Another study on SCC of AISI 304 steel revealed that SCC occurred to a greater extent at 45°C and 60°C compared to 30°C. From these results the temperature range of 43-60°C is most critical and this is within the temperature range of the lower part of the GGH. In addition a relative humidity of 60% results in a higher susceptibility to cracking at 45°C and 60°C compared to 100%[12]. Thus relative humidity was also a contributory factor where a semi moist environment is more critical than if the component was fully immersed. Yang et al [13] measured the corrosion current of both carbon steel and 316 stainless steel at 50°C under KCl salt with increasing humidity. It was found that by increasing the humidity, the corrosion rate increased uniformly for the carbon steel (i.e. relevant for CORTEN) however for the 316 steel, the corrosion current increased drastically at 70% relative humidity. In both cases the corrosion current increased with increase in relative humidity to 95%. Thus where there was less corrosion of the weathering steel, the bolts were attacked by pitting corrosion and therefore there would be a longer time to failure. In these areas, the humidity was probably lower perhaps due to a decrease in humidity and entrained water droplets. These bolts were replaced with UNS N10276 bolts in the vulnerable locations resulting in no further failure of bolts. Later, the plant was rebuilt so the FGD could be bypassed when only biomass was used as a fuel. Thus during operation, the temperature of the lower part of the GAFO was higher than 50-80°C and therefore above the dewpoint of HCl and water. This reduced corrosion of the weathering steel rotor immensely.

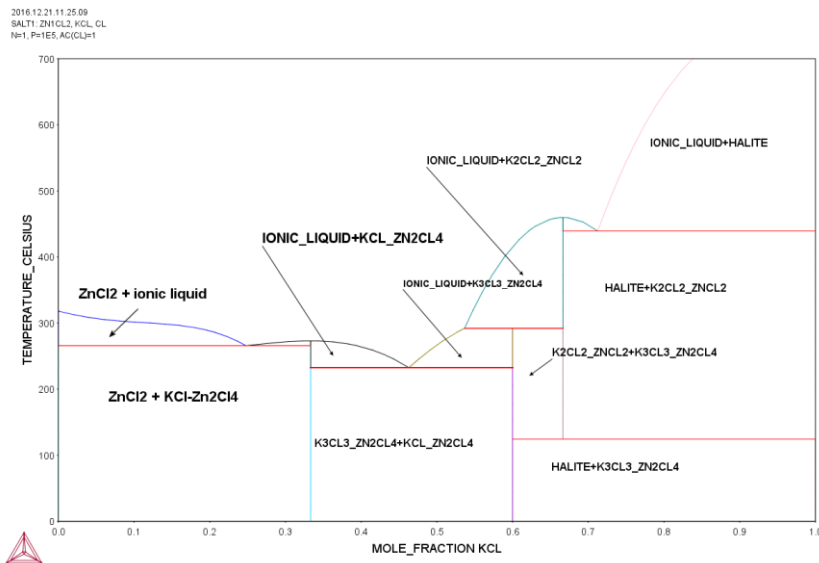
Analysis of deposits found in the duct after the DeNOx in the first few years reveals the presence of very hygroscopic Zn-K-Cl agglomerates. The fuel used in AMV1 is wood and straw pellets, and not demolition wood. From deposit analysis from the boiler, no Zn was found, and it was not present in the GGH. It is suggested that the presence of Zn-K-Cl agglomerates indicate that a reaction has occurred in the DeNOx between KCl particles from the flue gas and Zn containing primer used to protect the DeNOx components during construction. At 280-305 °C which is the working temperature in the DeNOx unit, KCl particles could react with Zn to form K-Zn-Cl volatile components, see Figure 12. These have probably been en-

Figure 12: Eutectic molten salts of KCl-ZnCl₂ [14].
