Corrosion failure analysis of hearing aid battery-spring contacts

Published in:
Engineering Failure Analysis

Publication date:
2017

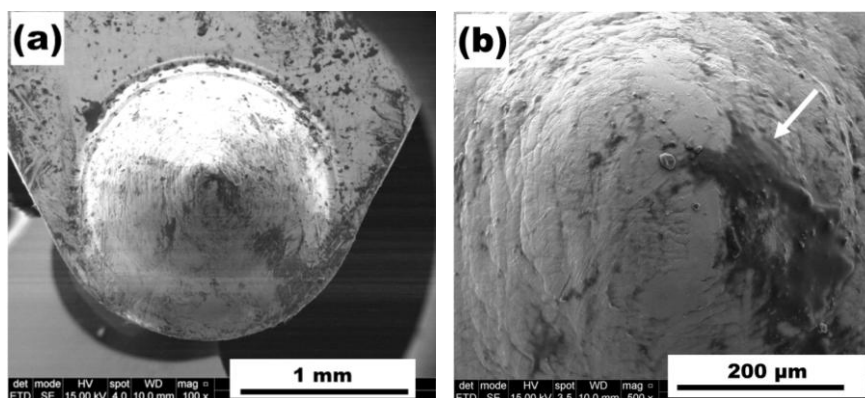
The Au plated *Contact-1* surface shown in Figure 3 displayed no features that correspond to general wear or corrosion of the contact surface. The Au plating was found to be intact, however presence of organic compounds as contamination was observed. The EDS analysis (see Table 1) of this contamination shows presence of high amounts of C, F and Si in addition to traces of K and Na. In contrast, the dome surface of *Contact-2* clearly displayed delamination of the applied Au plating at the contact point as seen in Figure 4. In addition, the exposed substrate displayed wear track morphology. This is due to the repeated wiping motion that occurs while changing the battery during the service of the device. Organic

Figure 3: Secondary electron image showing: (a) hemispherical dome *Contact-1* and (b) contamination at the *Contact-1* surface.

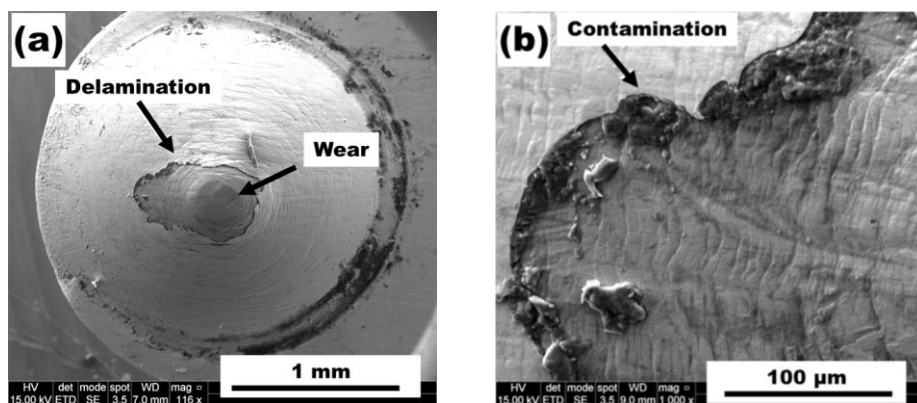
contamination containing C, O, F, Al, and Si was detected on the exposed substrate surface of the contacts (see Table 1).

Figure 4: Secondary electron image showing: (a) delamination of Au coating on *Contact-2* and (b) contamination on the exposed substrate in *Contact-2*.

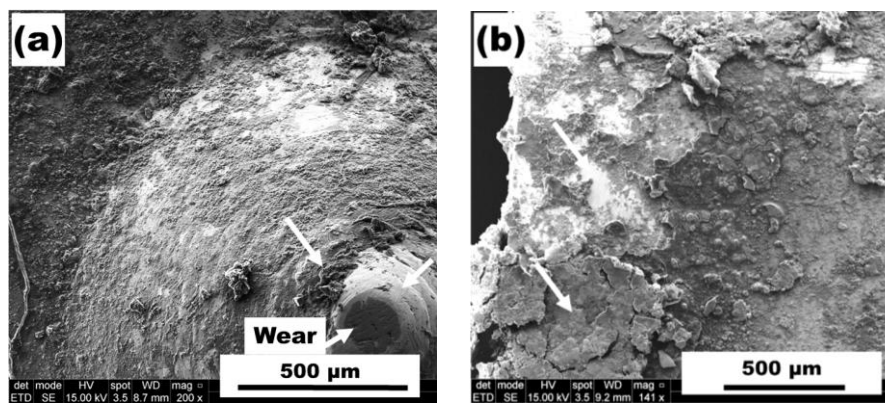
The *Contact-3* surface showed no delamination of the Au plating, but displayed wear out of the Au plating resulting in exposure of the underlying substrate (see Figure 5). Severe organic contamination was observed on the hemispherical dome. The EDS analysis showed that it consisted of C, O, Na, Mg, Al Si, S, Cl in addition to the elements from substrate material which is a Ni-based material (similar composition for *Contact-2* substrate, see Table 1). In addition, several locations displayed features corresponding to corrosion and associated corrosion products as shown in Figure 5 (b). Heavy corrosion products with mud crack morphology were observed. In order to get a better overview of the nature and composition of the corrosion products, an EDS elemental mapping was carried out on the area shown in Figure 5 (b) (see Figure 6).

Figure 5: Secondary electron image showing: (a) wear of Au coating on *Contact-3* with exposed substrate and severe contamination on the dome, and (b) severe corrosion of the Au coated spring material in *Contact-3*.

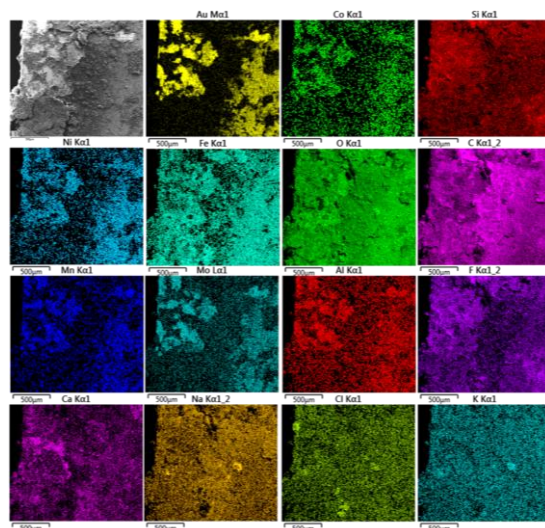
The EDS elemental maps for corroded region on *Contact-3* (shown in Figure 5 (b)) are shown in Figure 6. The bright appearing surface in the secondary electron image corresponds to the Au plating which also shows presence of Co. Cobalt is generally added to Au plating baths to obtain hard Au coating with better mechanical properties compared to the pure Au which is softer [11]. In addition to Ni from the substrate, Fe also is present, which is an alloying element for the Ni-based substrate alloy. However, the distribution of Fe does not follow that of Ni. A closer observation at the distribution of Fe shows that it follows the distribution of O suggesting the presence of Fe-O based phases like Fe_2O_3 or Fe_3O_4 (corrosion product, Rust). In addition, the maps for C, Si, and F follow each other and this is attributed to the organic contamination that has been observed on the surfaces of various contacts as

discussed earlier. Other elements such as Na, K, Al, and Ca along with Cl are detected, which suggest the presence of salts and silicates arising from the atmosphere in the form of mist, dust particles and/or from human perspiration.

Figure 6: Secondary electron image and EDS elemental maps of the corroded surface region on *Contact-3*.

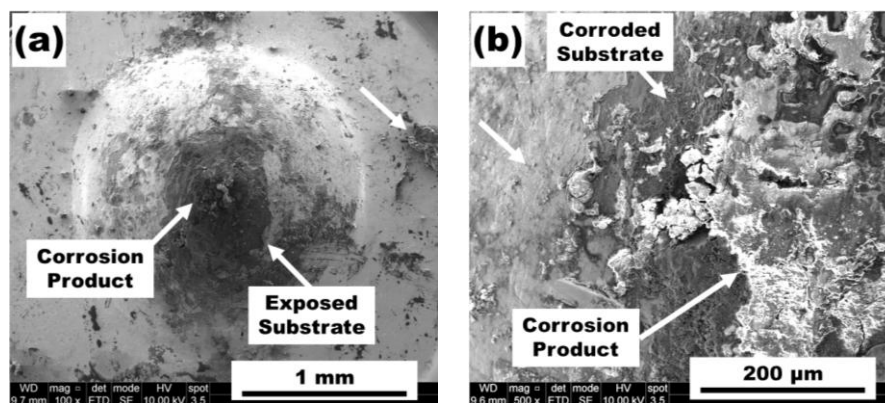
Figure 7 shows the corrosion and contamination on *Contact-4* surface. Corrosion products were observed at the contact surface and in addition, crystals of salts based on chlorides of Na and K were detected as seen in Figure 7 (c) (see Table 1 for composition). The Au plating appeared to be intact all over the surface of the contact with exception to the contact point as seen in Figure 7 (b). However, a closer look at the surface morphology of the Au reveals that there are a huge number of pores in the Au surface (see Figure 7 (d)). The origin of these pores can be attributed to either inherent porosity in the Au plating or due to corrosive attack by the salts that are found on the contact surface.

electrolyte to the underlying not so noble metals like Ni (see Figure 7 (d)) causing 'pore corrosion'. This causes corrosion of the underlying material that is accelerated due to the galvanic coupling between a small active metal surface (anodic site) at the bottom of the pore and a high surface area of noble metal (cathodic sites). Severe localised corrosion of the underlying metal results in volume expansion and forms halos around the pinhole on the surface of the gold, and in extreme cases total delamination of the top gold layer [10,27,28]. The presence of corrosion under the top gold layer in Figure 8 is a manifestation of severe underlying metal corrosion due to pores in the gold layer.

Figure 7: Secondary electron image showing: (a) delamination of Au coating and corrosion on *Contact-4*, (b) corrosion products, corroded substrate and contamination on the exposed substrate region in *Contact-4*, (c) crystals of salt on the *Contact-4* surface and (d) pores in the surface of the Au plating.

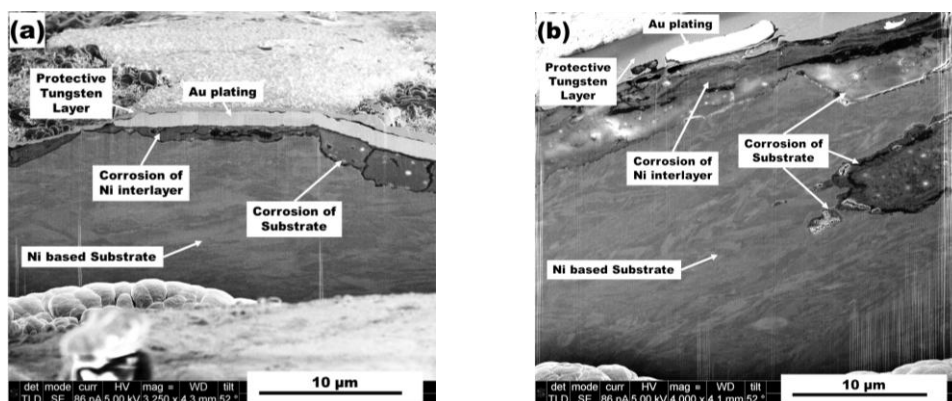
Focused ion beam cross-sections prepared on the corroded contact surface show that even though the top Au plating is intact in certain locations, corrosion has propagated way below the surface of the contact. Figure 8 shows two such instances where a portion of the Au coating is still intact, but the underlying Ni underlayer, and the Ni substrate have been severely corroded. This is evident from the difference in morphology compared to the substrate Ni alloy and the corroded areas. The EDS elemental maps performed on these corroded areas below the Au plating showed presence of Ni, O, and Cl in the corroded region below the Au plating (see Figure 9). Iron was also detected (not shown in map) in the corroded region of the substrate in addition to Ni and O, which is expected as the substrate contains Fe.

Figure 8: FIB cross-section of (a) *Contact-4* and (b) *Contact-5* showing propagation of corrosion under the Au plating.

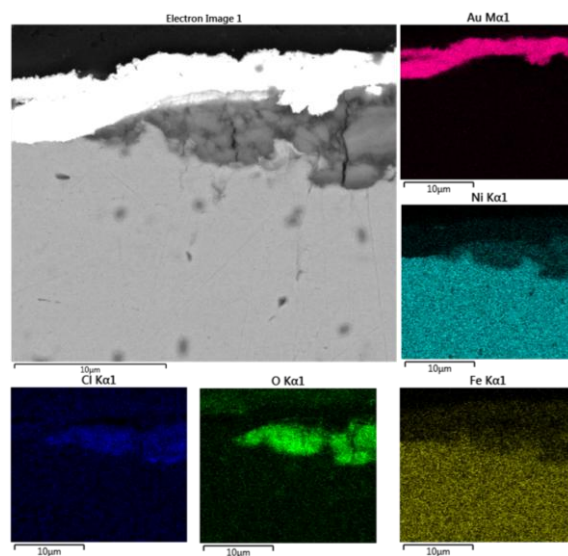
Figure 9: EDS elemental maps of the corroded region in the Ni substrate below the Au plating showing oxides and chlorides as corrosion products.
