**Corrosion of fasteners in furfurylated wood – final report after
9 years exposure outdoors**

Jöran Jermer*, Bo-Lennart Andersson**, Joanna Schalnat[#]

Paper prepared for the IRG48 Scientific Conference on Wood Protection
Ghent, Belgium
4-8 June 2017

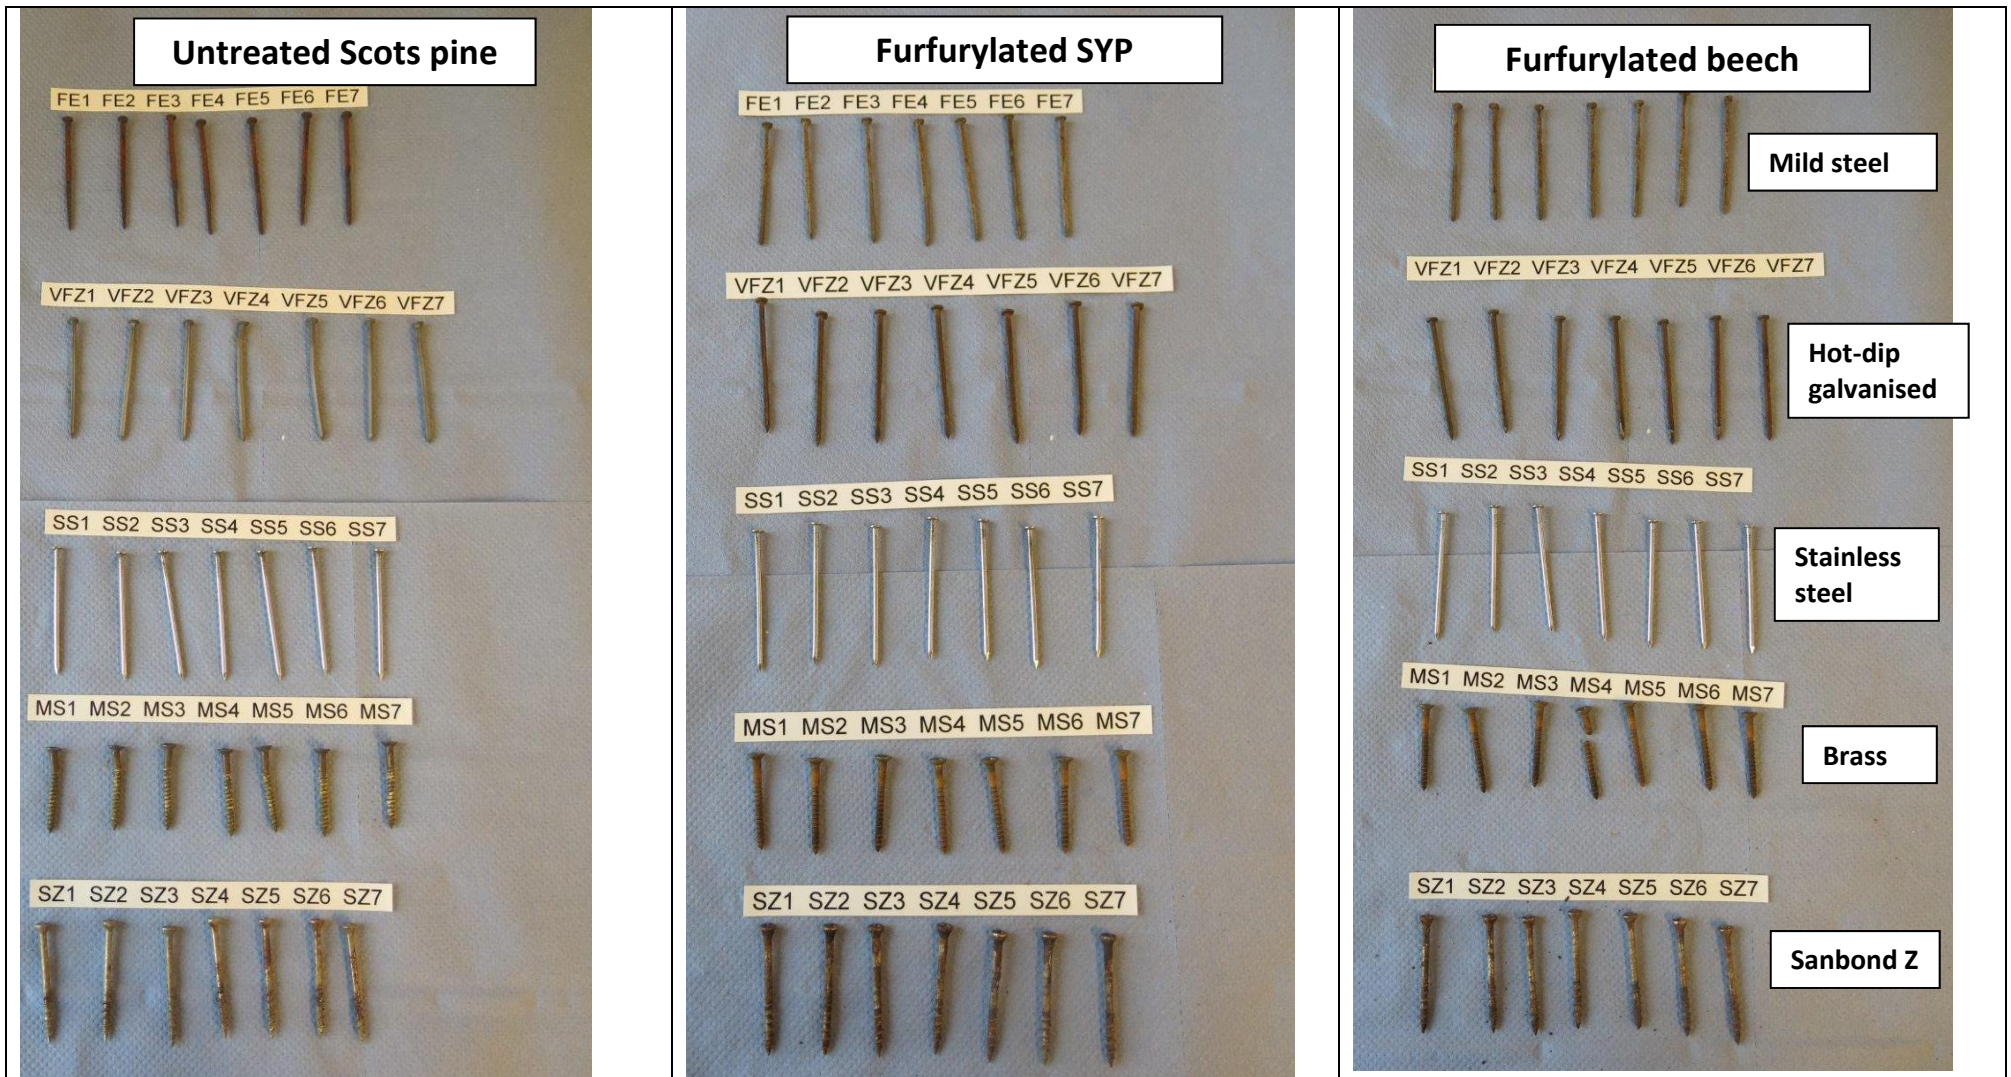
Figure 5. Appearance of the different fasteners after 9 years' exposure in untreated Scots pine, furfurylated SYP and furfurylated beech after pickling

Stainless steel has not been attacked at all and is therefore strongly recommended for furfurylated wood in outdoor applications.

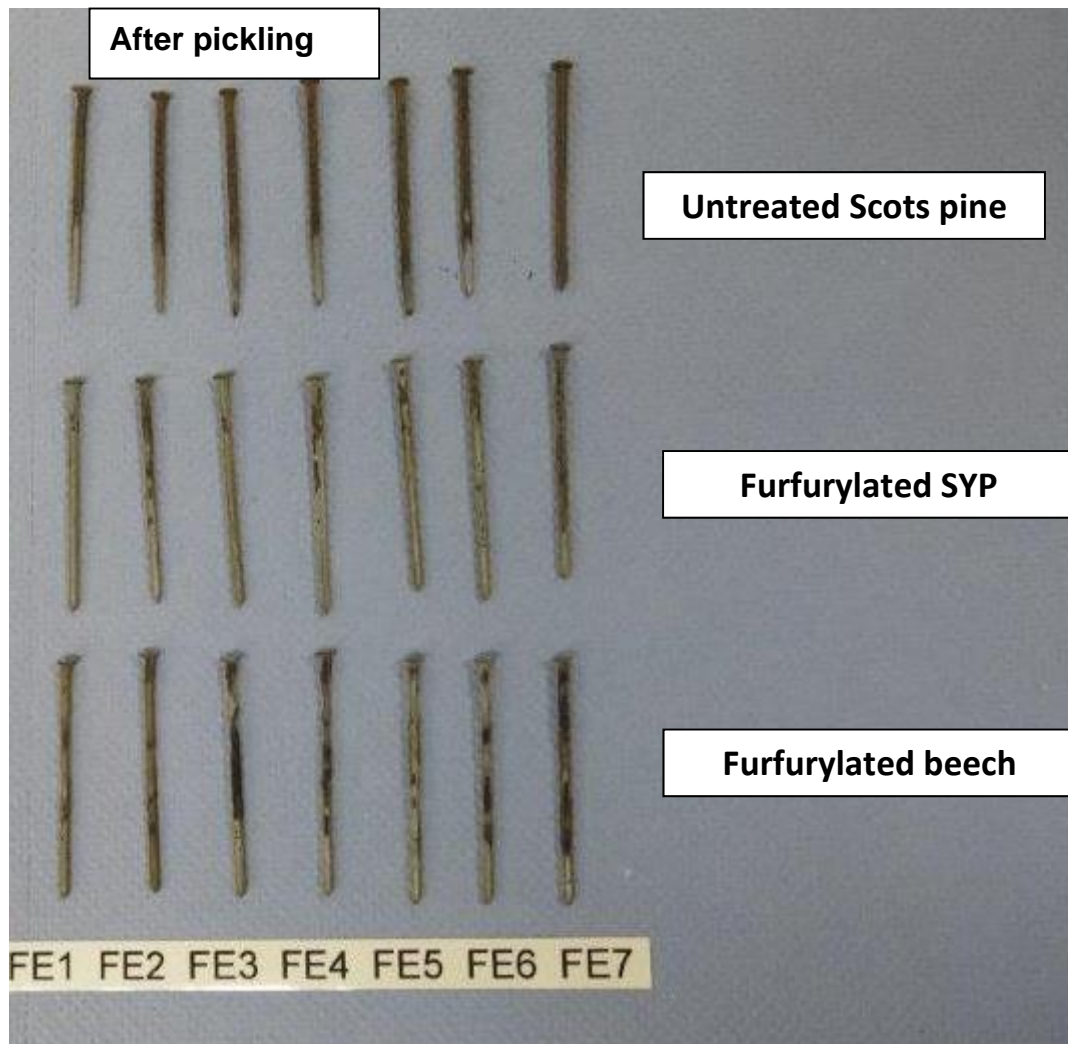
Usually, the corrosion of mild steel shows a typical waistline formation 15-20 mm below the nail head owing to aeration cells and different electrochemical potential along the nail. In this test, the corrosion of mild steel in Scots pine was most severe at the tip of the nail which indicated that air has reached all the way down to the tip through cracks in the wood (Figure 7).

Figure 7. Mild steel nails after pickling.

Not surprisingly, mild steel showed the poorest performance in both furfurylated materials. The typical waistline formation could not be observed, most likely due to crack formation that allowed air to reach all the way down to the tips of the nails.

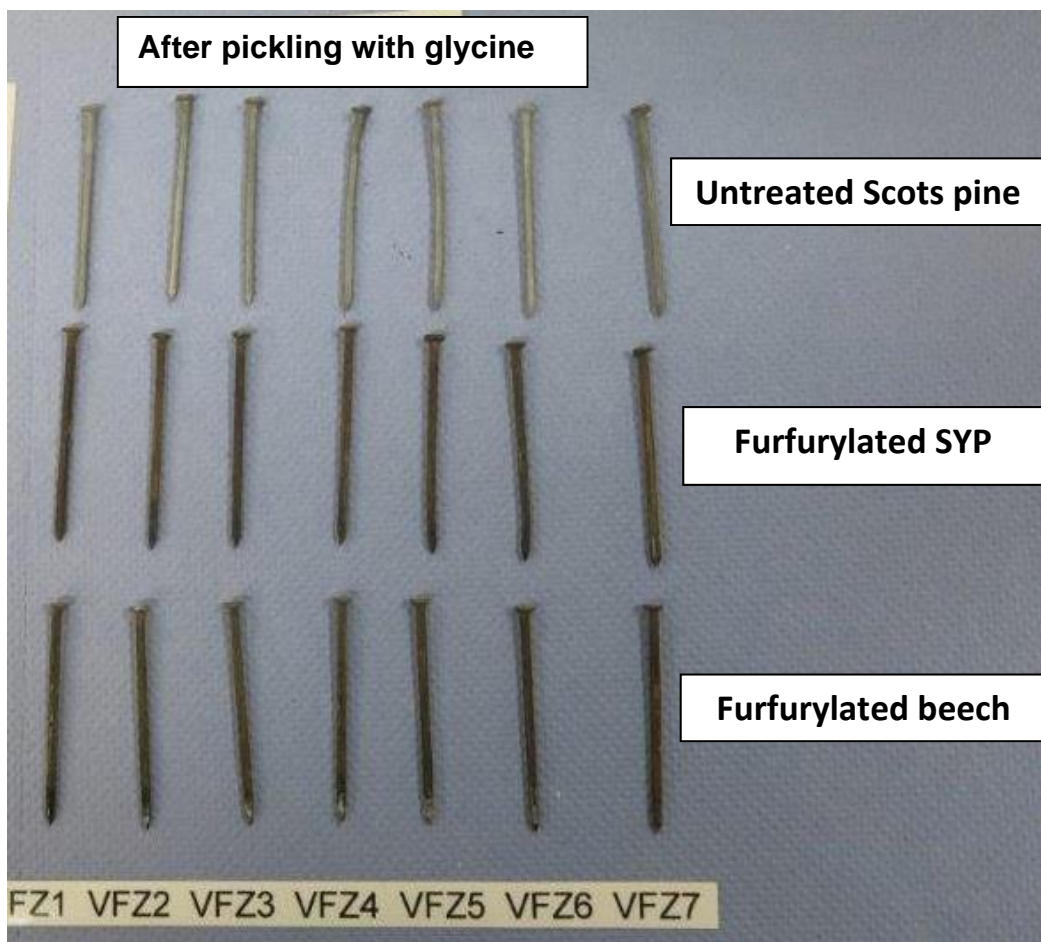
The original coating thickness for the hot-dip galvanised nails was just below 100 μm . Approximately 80 % zinc remained on the samples of the untreated Scots pine, whilst approximately 40 % zinc remained on the other samples. Some basic metal corrosion may have occurred on fastenings of the furfurylated samples. As was found with mild steel, the corrosion rate decreased over time for furfurylated SYP. For furfurylated beech it was nearly constant, but for the untreated wood there was a remarkable increase during the last 4 years, see Figure 8.

Figure 9: Hot dip galvanised steel nails after pickling with glycine.

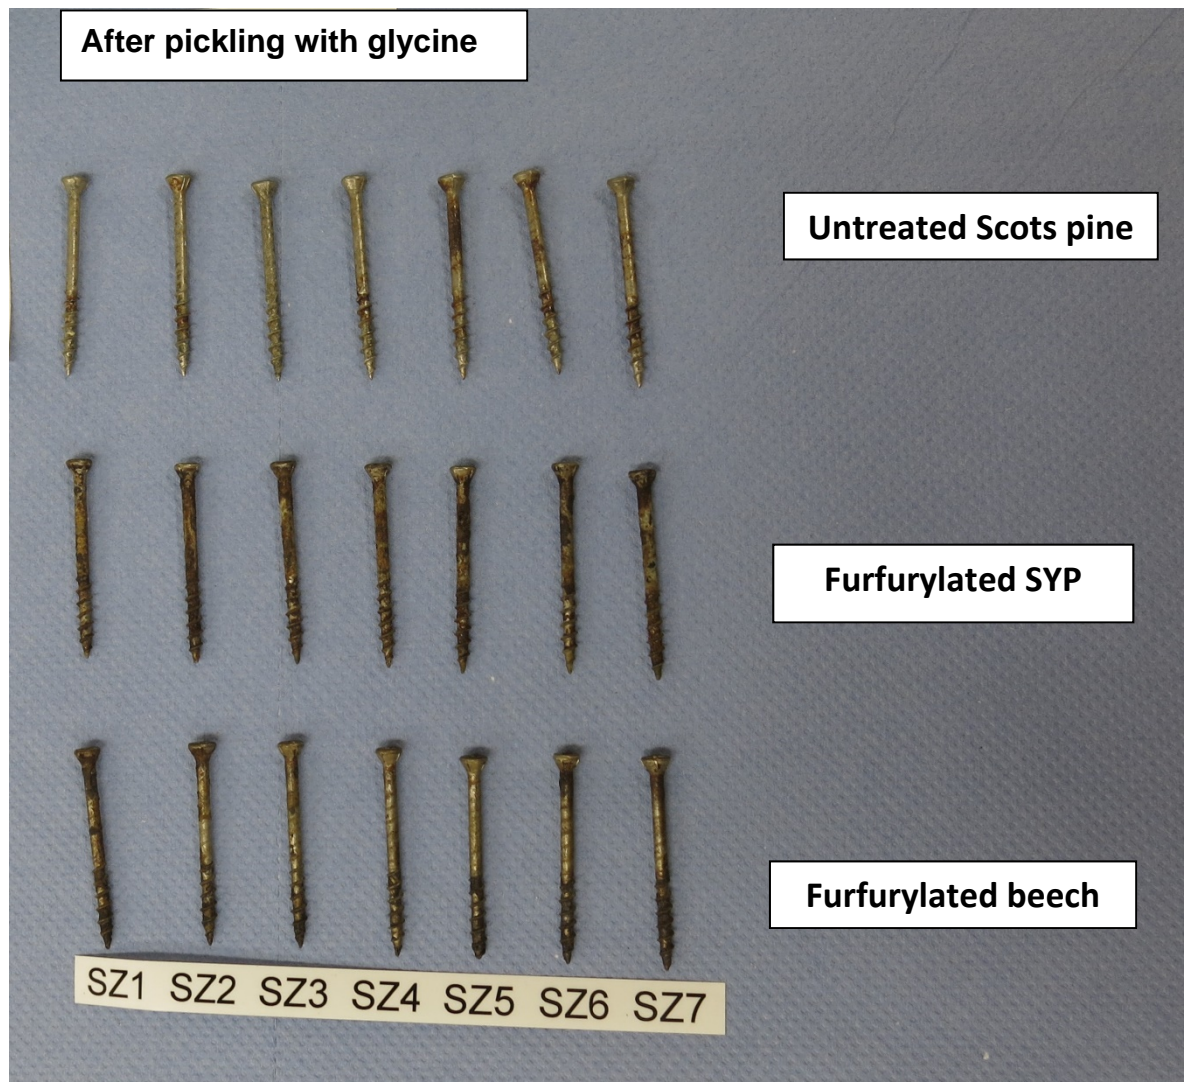
A typical Sanbond Z coating thickness is 16 μm zinc. After 9 years, approximately 25 % zinc remained on samples from untreated Scots pine, whilst on the other samples all zinc had corroded away.

Figure 10. Sanbond Z coated screws after pickling with glycine.

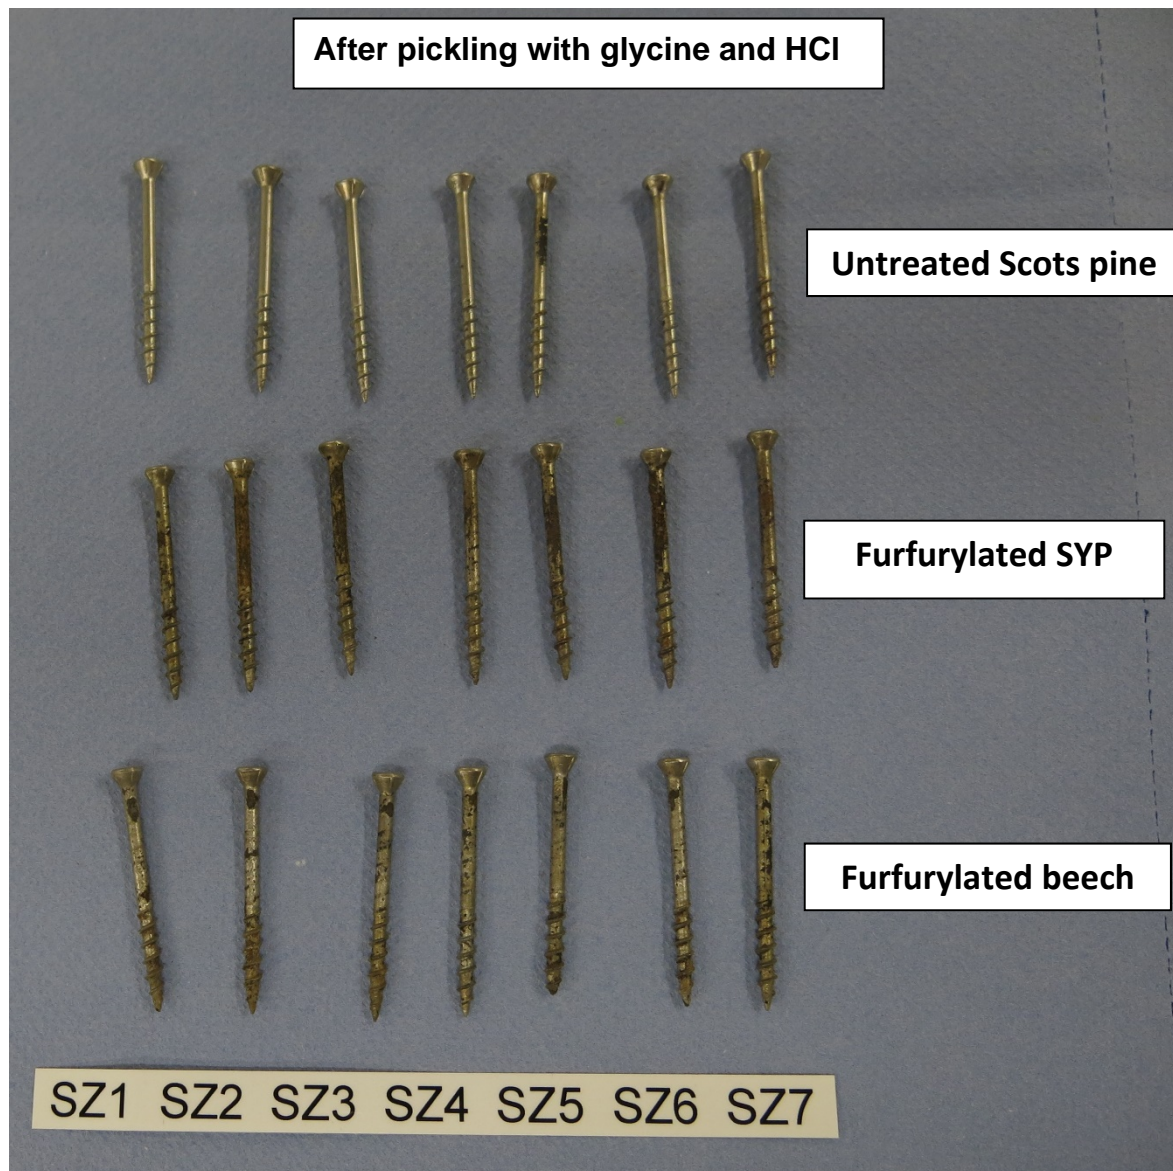
Figure 11. Sanbond Z coated screws after pickling with glycine and hydrochloric acid.

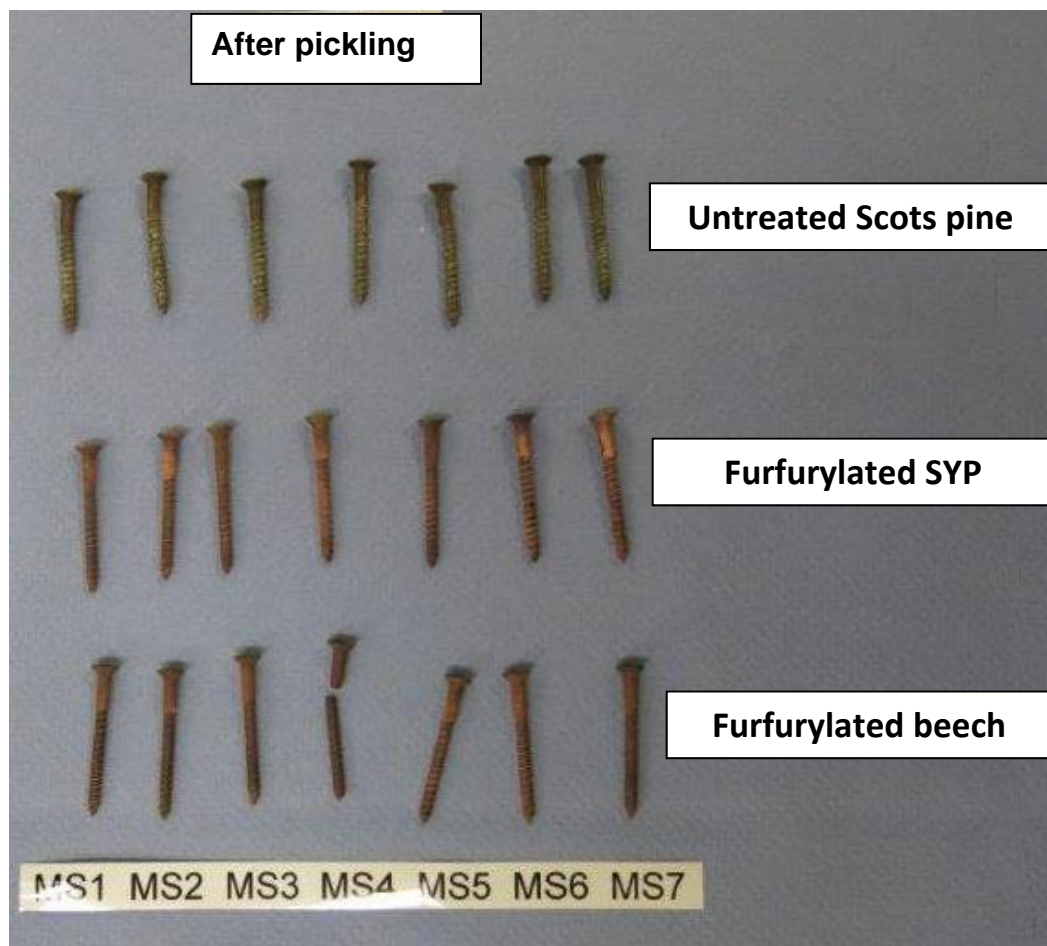
The brass screws and Sanbond Z coated screws in the furfurylated wood showed similar corrosion patterns, i.e. a metal loss (mg/cm^2) that is approximately 5 times higher than for the untreated Scots pine. They also had a reddish appearance after pickling, which indicated selective corrosion commonly referred to as de-zincification.

Figure 12: Brass screws after pickling with amidosulphuric acid.

The Sanbond Z coated screws and the brass screws performed relatively well, and much better in the untreated wood than in the furfurylated materials. In the furfurylated materials, the brass screws were subject to severe corrosion caused by de-zincification. According to experience, the loss of zinc will affect the strength properties of the brass more than the weight loss indicated.
